**weston hall • weston on trent**  
**discharge of planning condition 9:**  
**confirmation of chimney structure repairs and interventions**

**WESTON HALL**  
WESTON ON TRENT

RE-ROOFING, STRUCTURAL REPAIRS & ASSOCIATED  
WORK

**discharge of Planning condition 9:  
confirmation of chimney structure repairs and interventions**

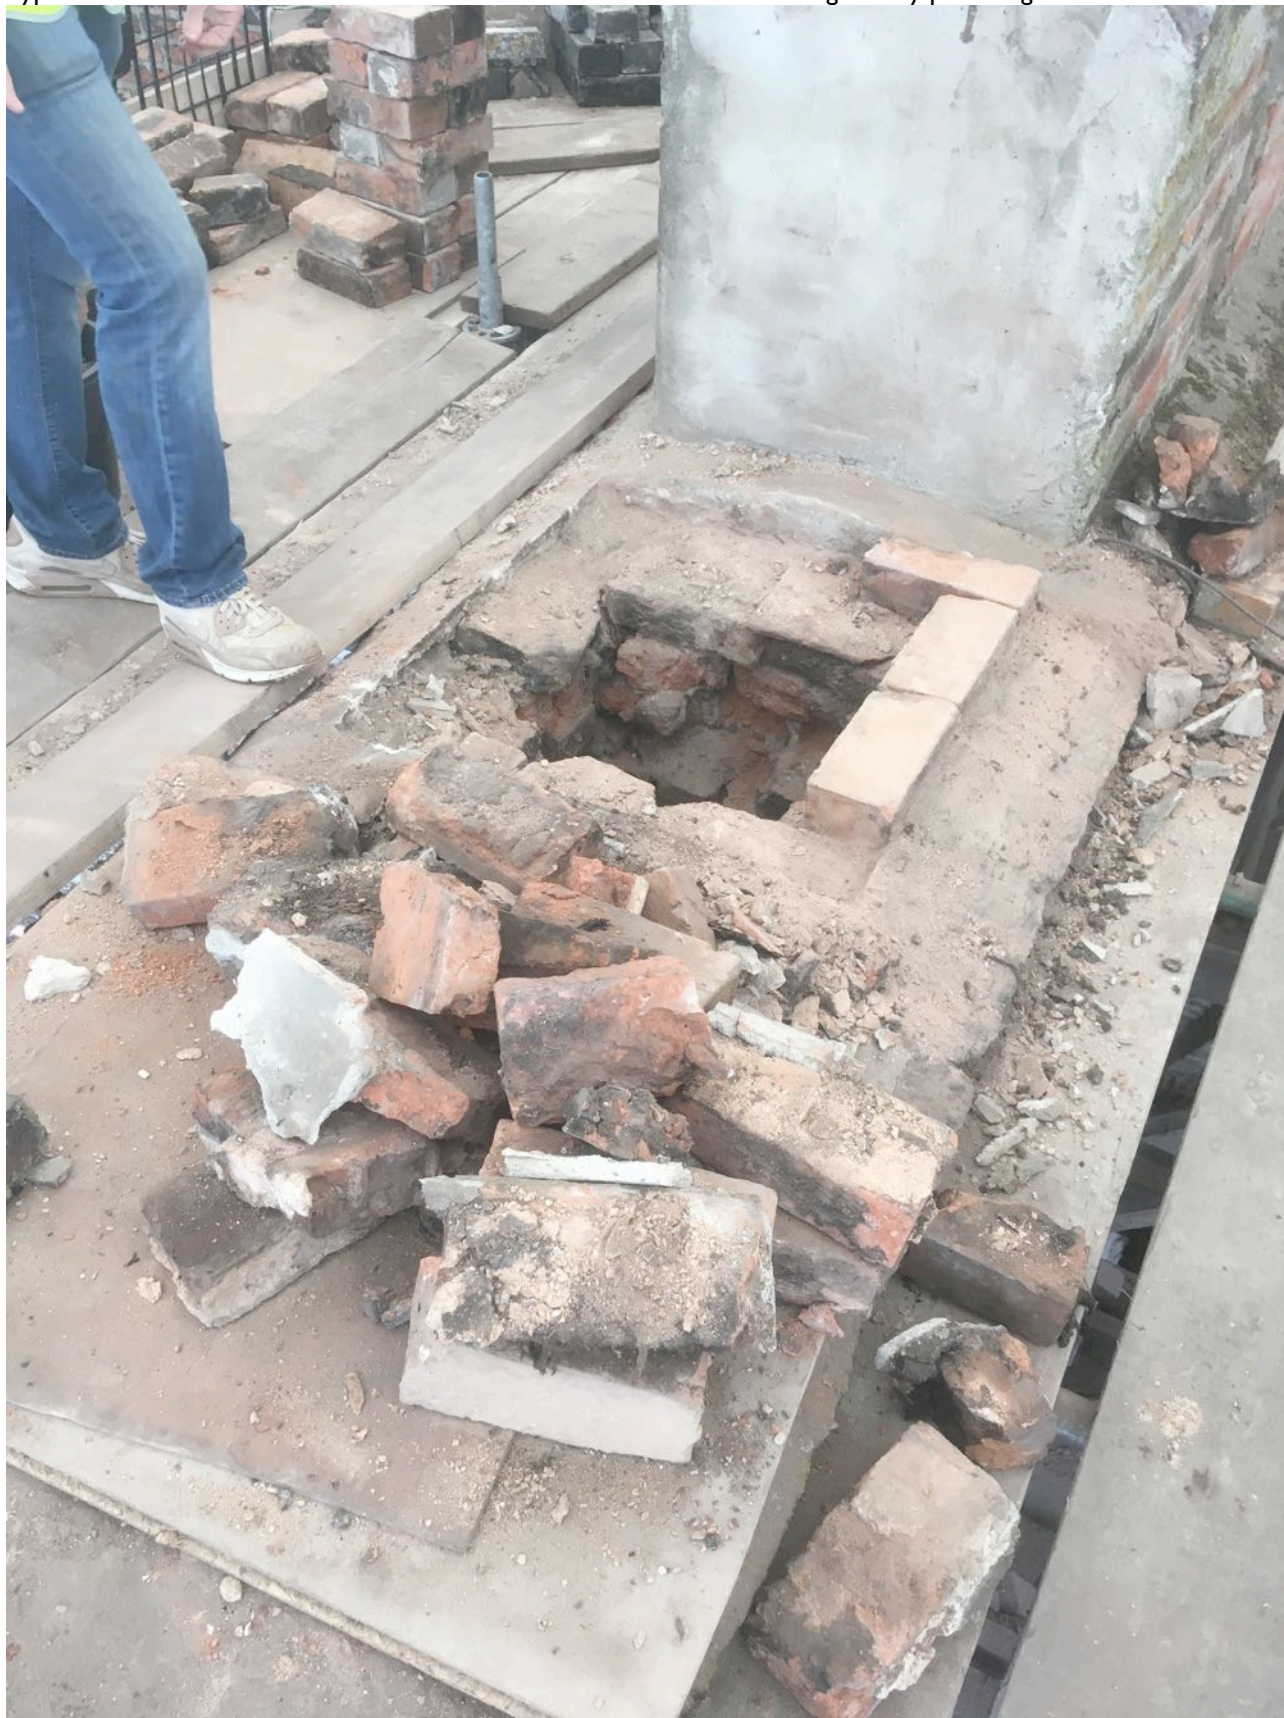
Several of the flues were found to be in a much poorer state than anticipated due to both poor initial construction (with slates being used as make-do 'lintels' to support the upper stages of the chimneys, with weathering and decay causing the slates to delaminate and fall apart) as well as sulphate attack on the bricks lining the chimney flue and external weathering of the mortar and brick faces causing the effective structural width of the chimneys to be reduced beyond a safe minimum.

Typical state of the worst case flues – minimal constructional thickness and generally poor original construction

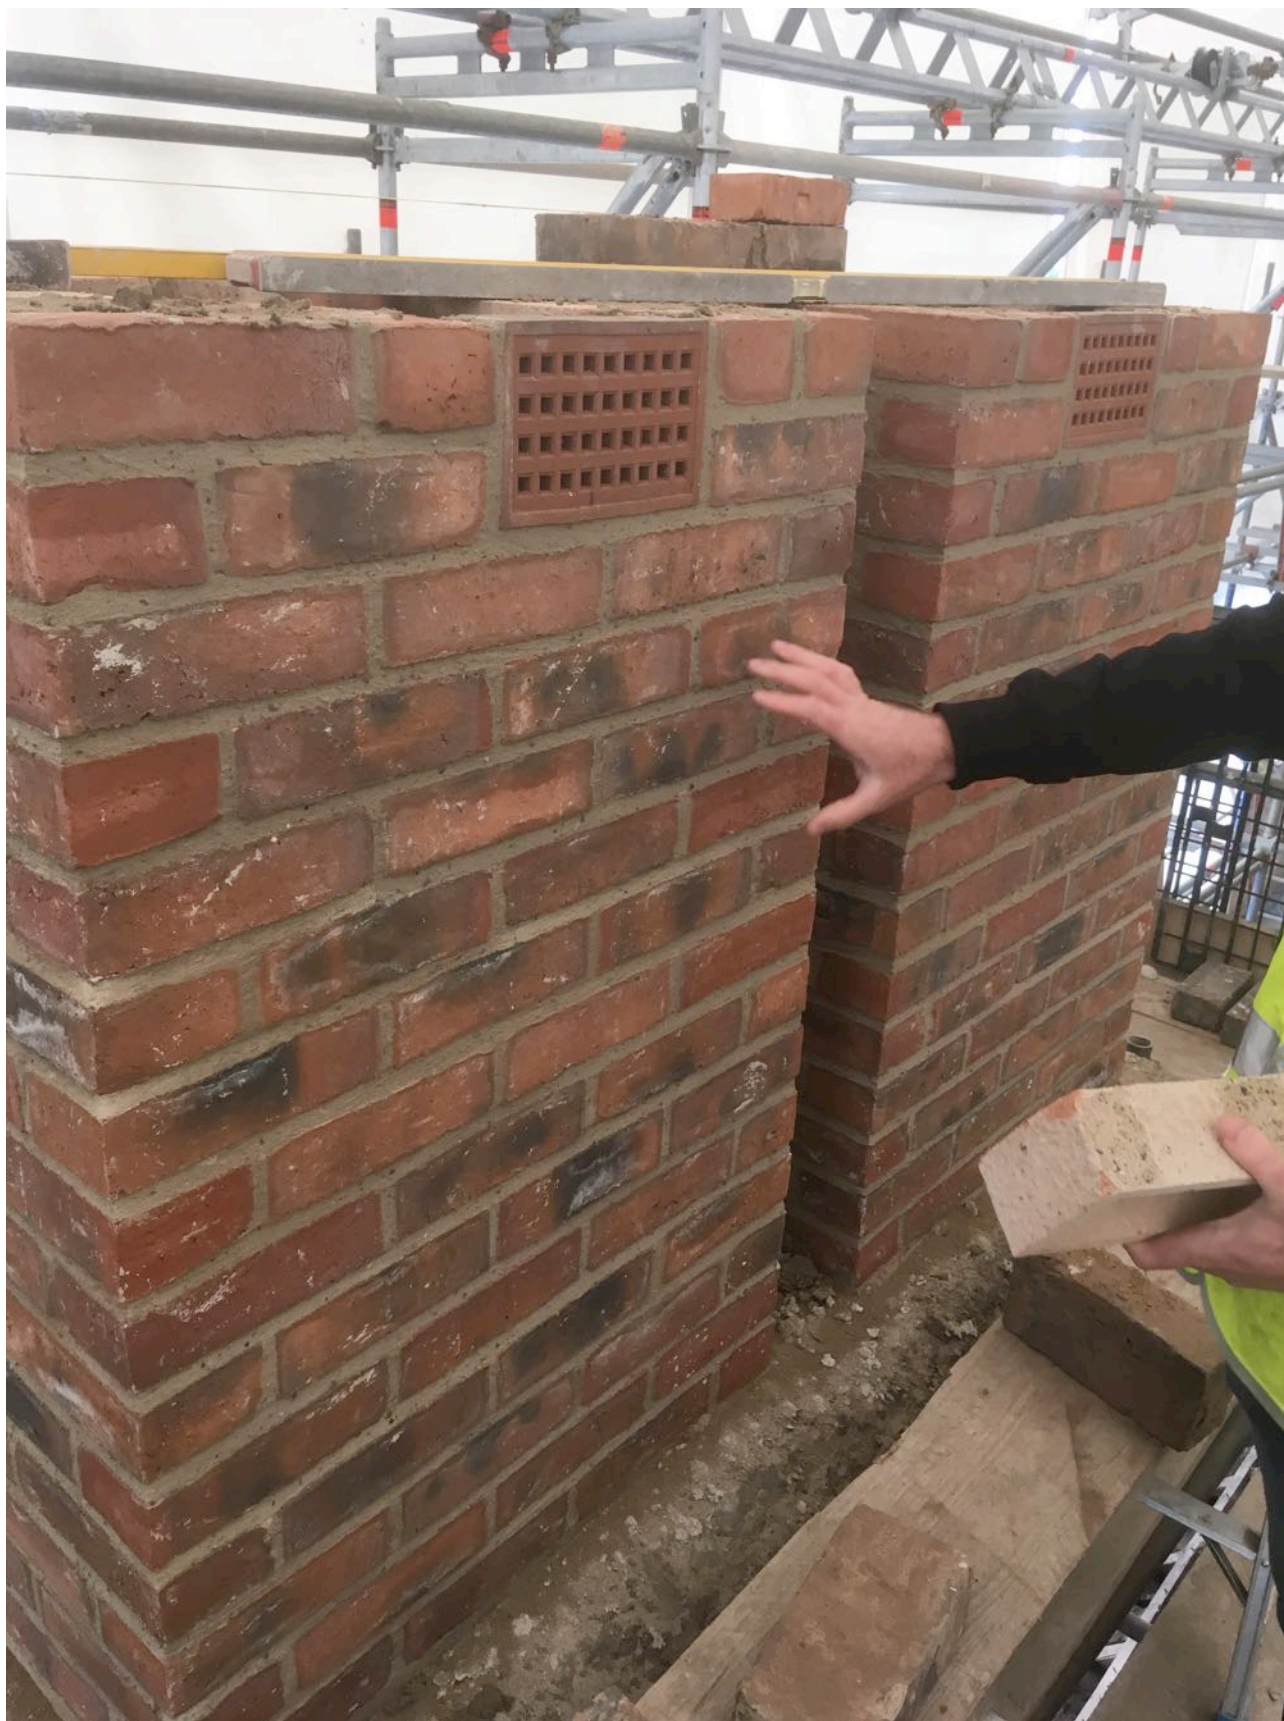
Installation of new air bricks to the rear of the rebuilt upper portion of chimney 6 – rebuilt from the level of the stone string course seen below.
