**REPORT ON SHALLOW MINING SITE INVESTIGATION WORKS**

**UNDERTAKEN ON LAND AT  
COPPICE SIDE, SWADLINCOTE DE11 9AA**

**Q083 SFK (TLC967) rep CH LKConsult 130818  
March 2018**

**Report Number** : TLC967

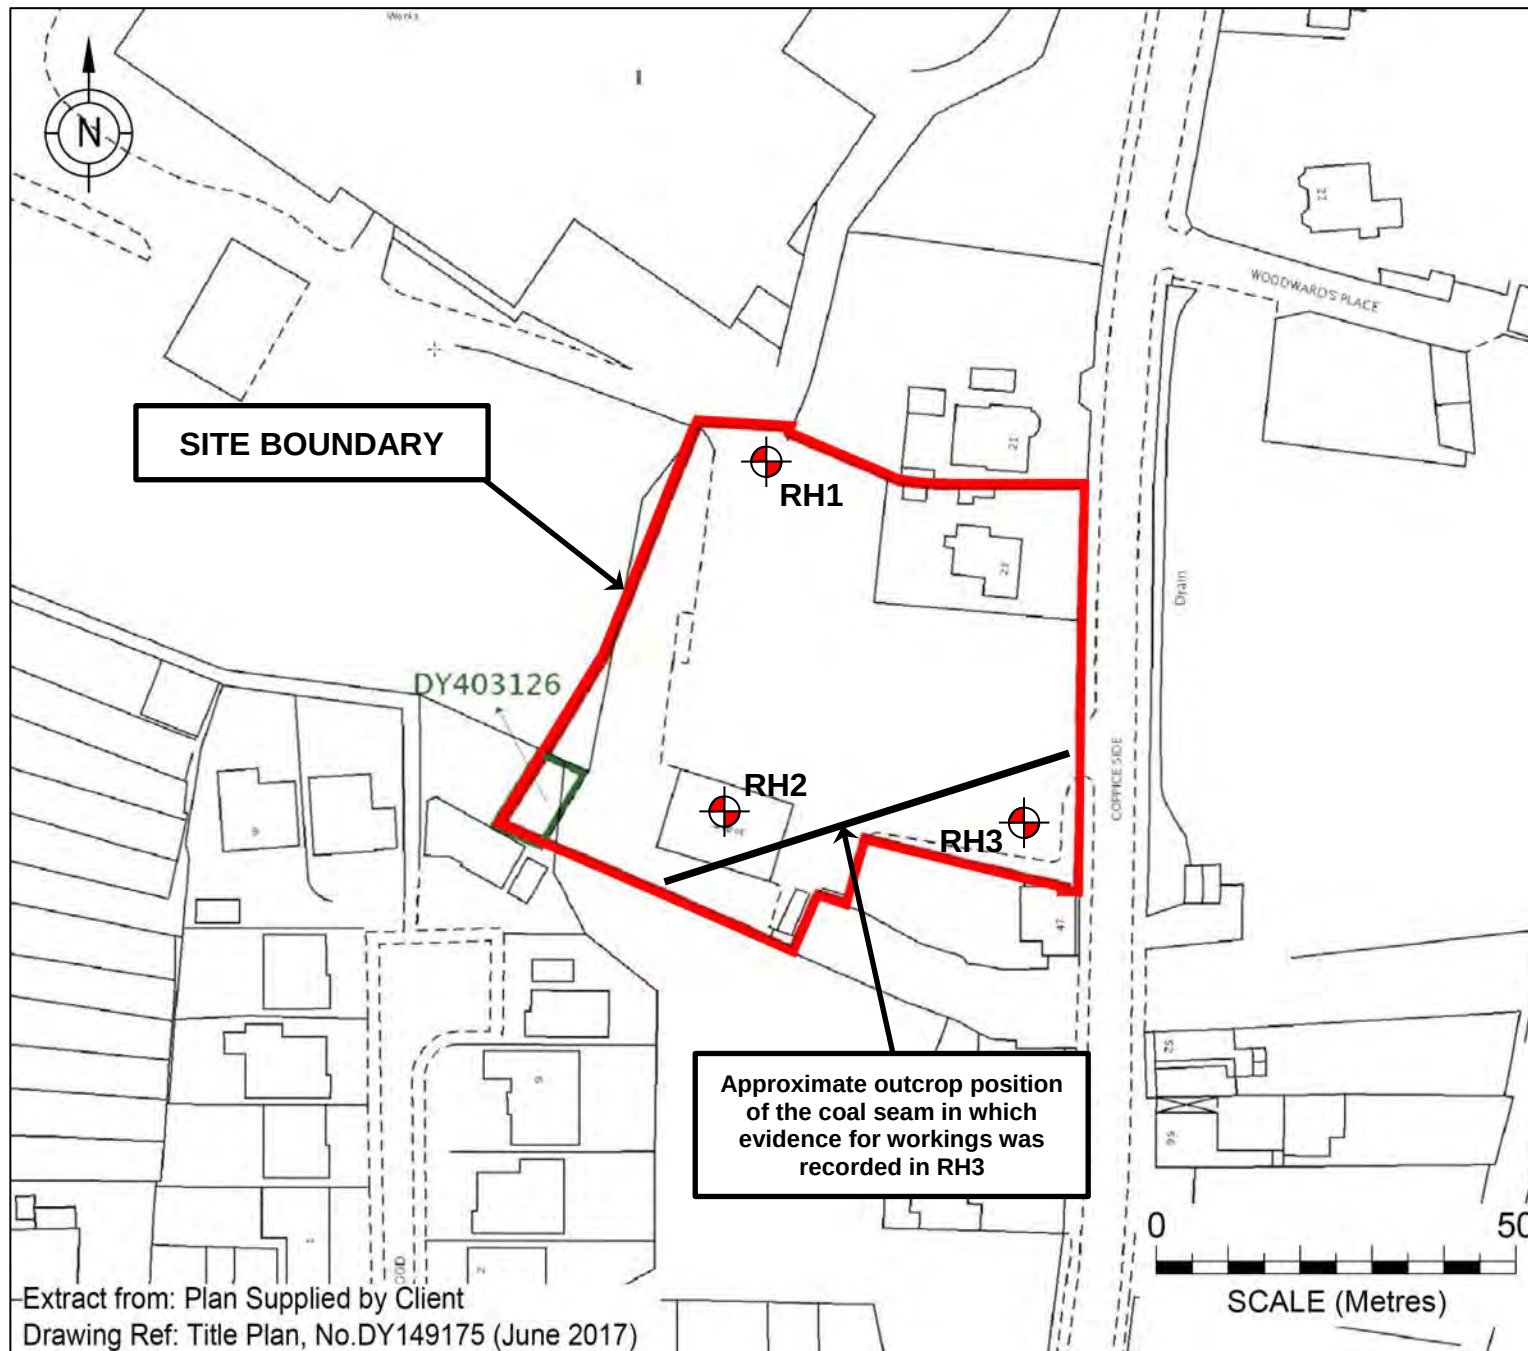
**Drawing No.: TLC967/02**

- 2.2 Drawing No. TLC967/02 displays a depot building in the south-western corner of the site, and a residential building (and two small outbuildings) in the north eastern corner. It should be noted that these buildings are no longer present on site. However, the concrete floorslab to the depot building is still present.

- 4.1.4 The drill holes were sunk at the locations indicated on Drawing No. TLC967/02 in Appendix A. All drill holes were terminated at a depth of 40.00mbgl.

- 5.2.8 In RH3, a 2.70m thick zone of broken drilling and voids was recorded at 2.70m bgl together with a complete loss of the flushing medium. It is highly likely that this zone represents workings within the coal seam whose identity is uncertain. Although steady drilling was reported below this zone to 40.00m depth, the drilling flushing medium did not return, so a positive identification of the sequence of encountered strata was not possible. However, it is likely that the strata penetrated comprised of mudstone and/or sandstone with the occasional bands of 'soft' drilling comprising of coal.

- 5.2.9 Given the drill hole observations, it is likely that the outcrop position of the coal seam of uncertain name is orientated WSW to ENE and located between the RH2 and RH3 drill hole positions; the rock dip is likely to be very gentle and down to the SSE.

- 6.9 RH3 encountered a zone (2.70m thick) of probable workings (total loss of flush, broken drilling and voids) at 5.80m bgl. It is likely that these workings are within the coal seam of uncertain name. The outcrop position of this coal seam is likely be between RH2 and RH3 (i.e. WSW-ENE strike) – see Drawing No. TLC967/02 in Appendix A.

- 7.1 Based upon the results of this shallow mine workings site investigation, both the P39/P40 coal and the very shallow coal workings recorded within a coal seam (name uncertain) in the south-eastern corner of the site, pose a definite threat to surface ground stability as a result of the presence of unrecorded/recorded shallow mine workings. Stabilisation works are therefore advised to take place prior to development works proceeding.
