# REPAIRS TO THE OLD ENGLISH GARDEN AT ELVASTON CASTLE COUNTRY PARK:

## DESIGN, ACCESS & HERITAGE STATEMENT

Prepared by: Alex Gilbert (Historic Buildings Architect)

Revision: 00 / Date: 21/06/2021

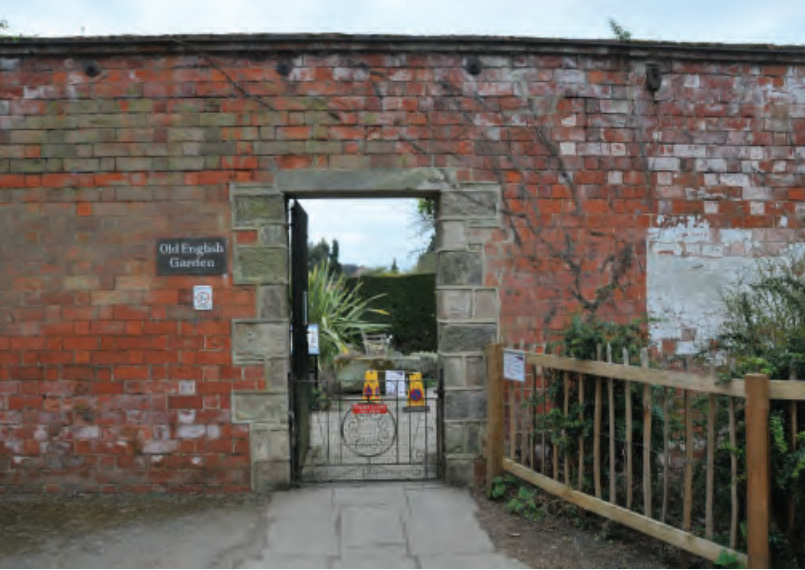
**Fig. 4:** Visitor entrance from north side (exterior) of the former heated garden wall; to be rebuilt to the same size.

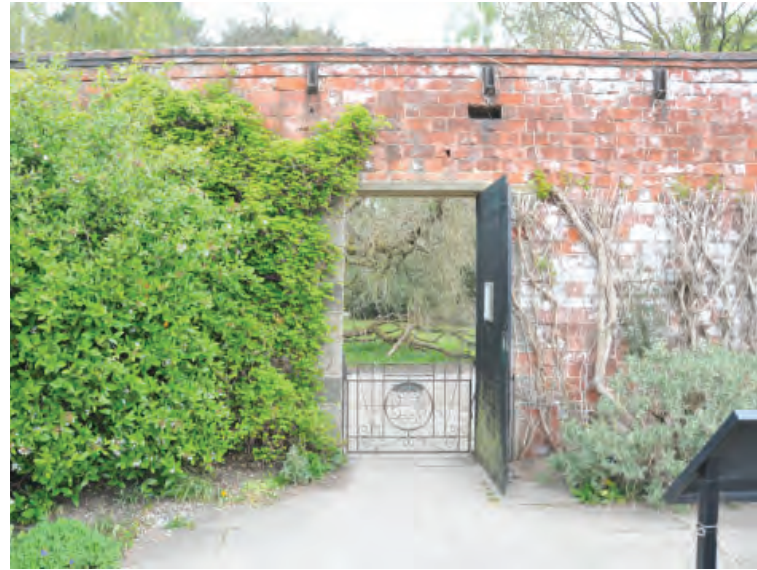
**Fig. 5:** Entrance from south side (interior) of the wall; the double gate arrangement is to be replaced with a single gate.

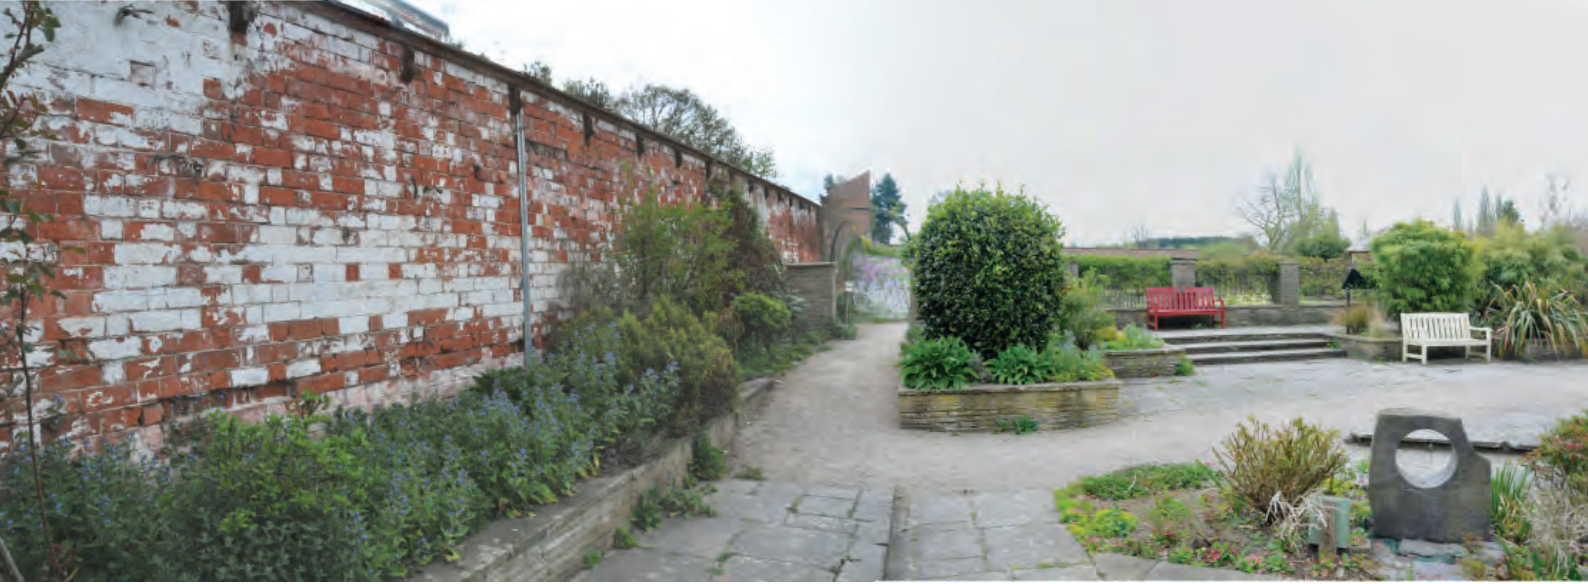
**Fig. 7:** Panoramic view of south elevation of the heated wall (facing east); note the poor condition of the wall with multiple missing areas of brickwork. The wall is to be rebuilt along its entire length to the same height, proportions & materials.

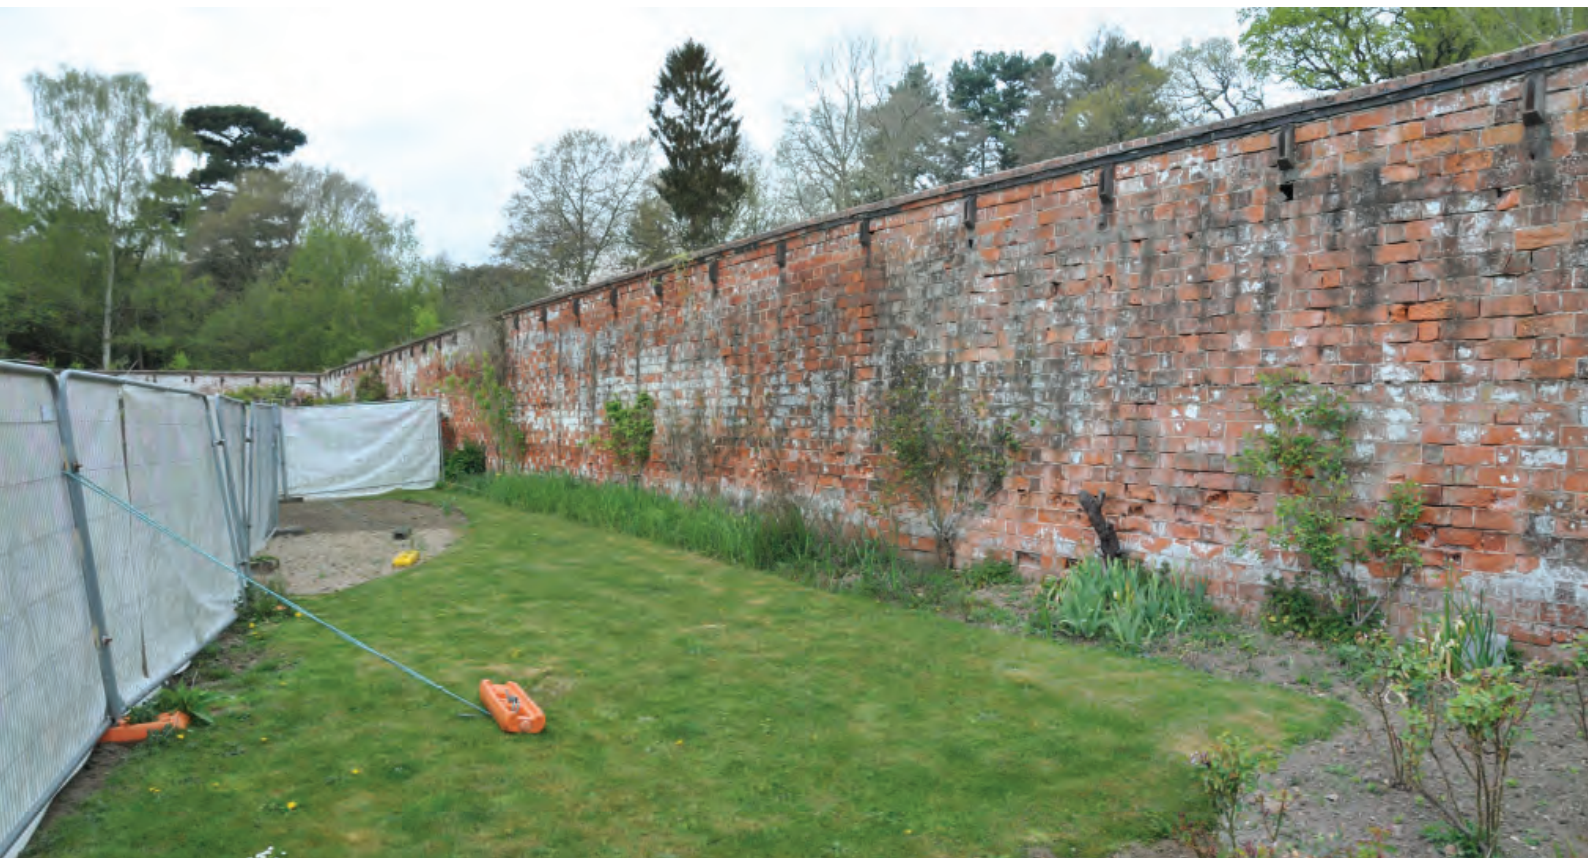
**Fig. 8 (above):** Panoramic view of south elevation of the heated wall (facing west); note the presence of further areas of missing and badly eroded bricks along its length.

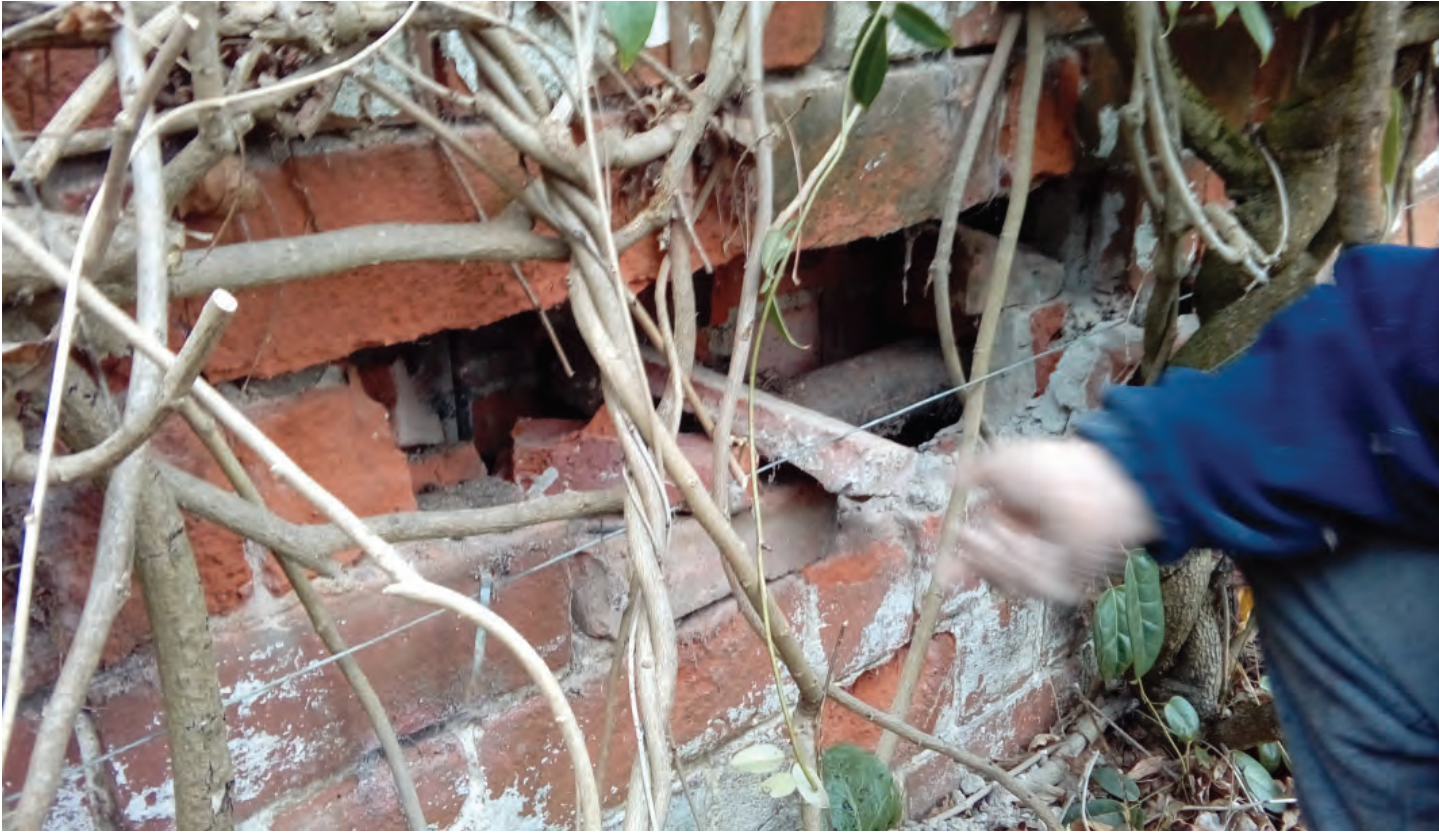
**Fig. 13 (top):** A substantial existing hole, of approx half a metre in length and 1-2 courses in depth, within the wall at a low level was sufficient to permit a camera to be inserted by hand to inspect its internal construction. The cast-iron heating pipe, running horizontally, is just visible at the bottom of the opening.

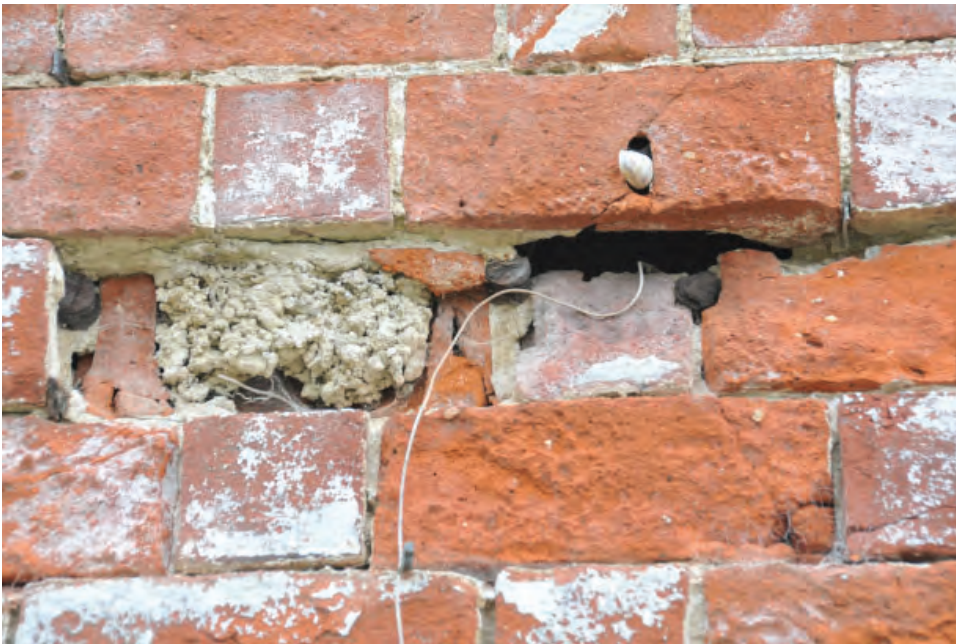
**Fig. 14:** Longitudinal failures of the brick units, such as those pictured here, are unfortunately very common along the south wall. This type of failure is thought to have been caused by frost damage and possibly by the expanding corroded circular ‘ties’ which are also visible on the picture. This type of failure, however, has allowed the identification and measurement of a number of the brick types present in the wall.

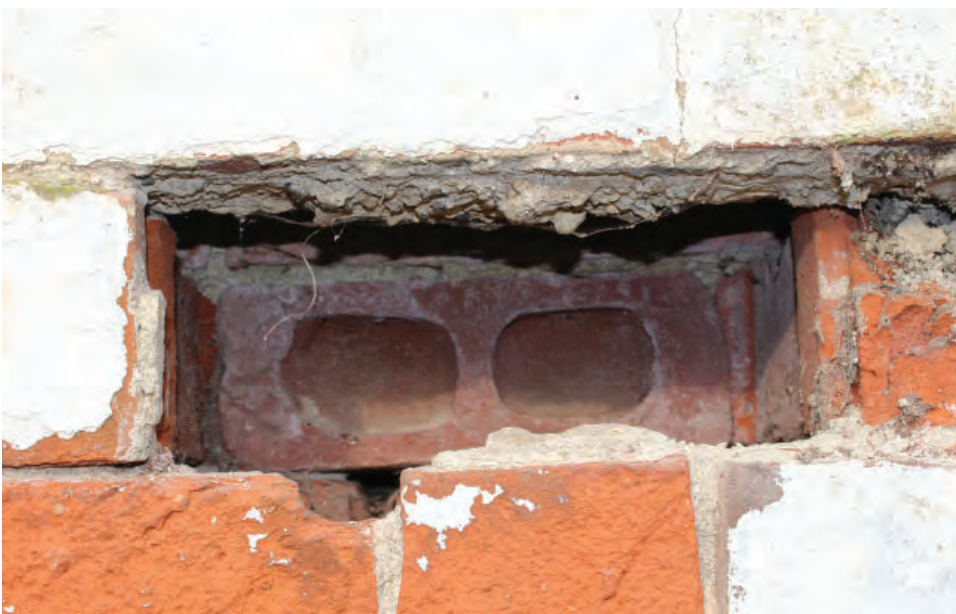
**Fig. 15:** A further, existing, hole in the wall approximately 1.8m above ground level where the inner face of the cavity wall is visible. A double-frogged brick is clearly visible, a type which appear to have been used exclusively within the interior wall.

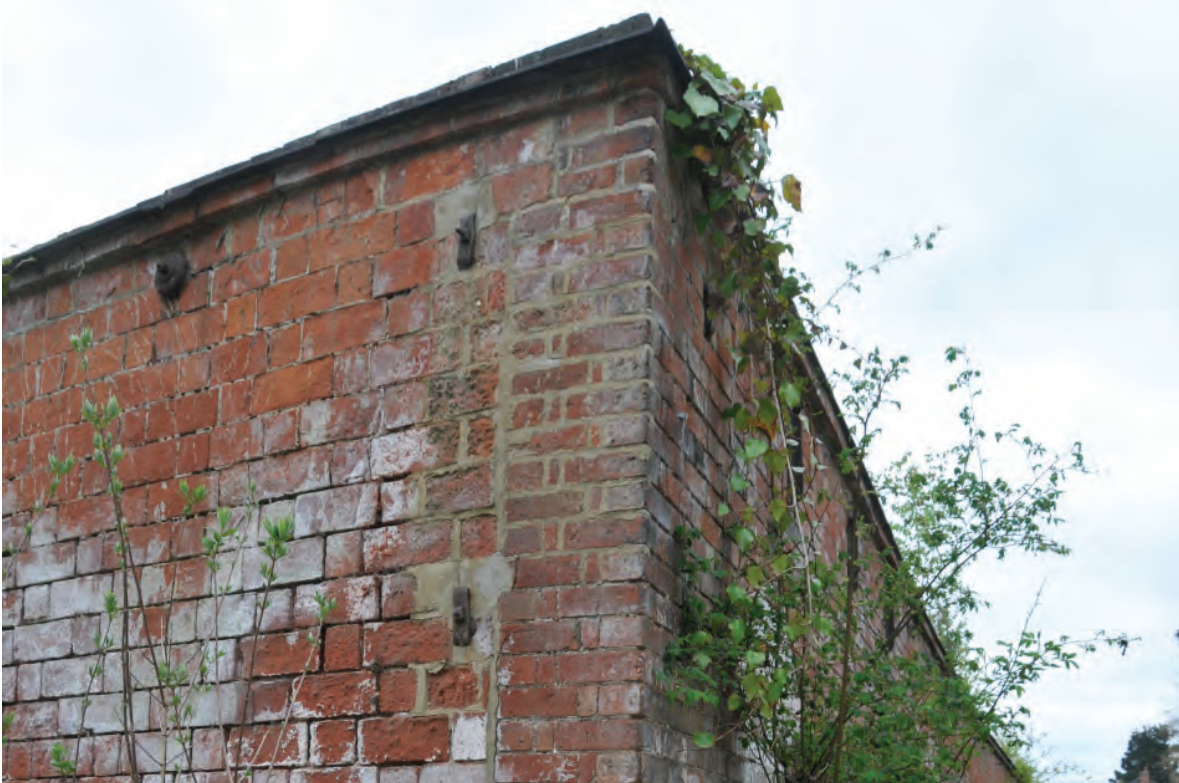
**Fig. 27:** A crude junction between the north heated wall and west wall of the OEG; notwithstanding the differing sizes in bricks these the adjoining structures simply abut each other rather than being toothed or properly tied together to ensure greater structural stability.

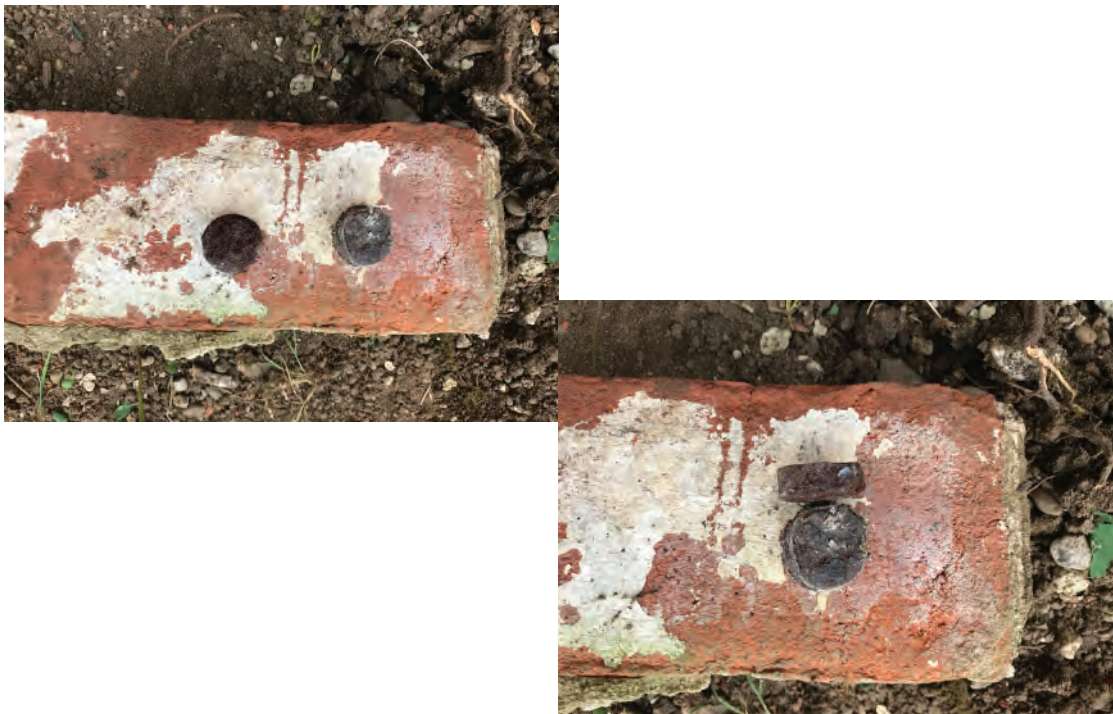
The exact function of the “metal disc” ties noted in the report above is not clear. What is clear, though, is that they have corroded and expanded, thus causing or exacerbating some of the cracking and spalling which is evident to the wall.

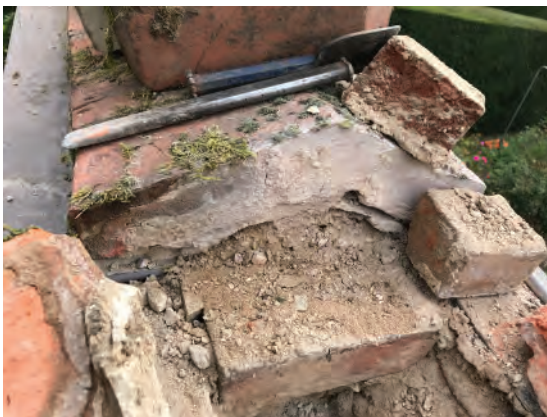
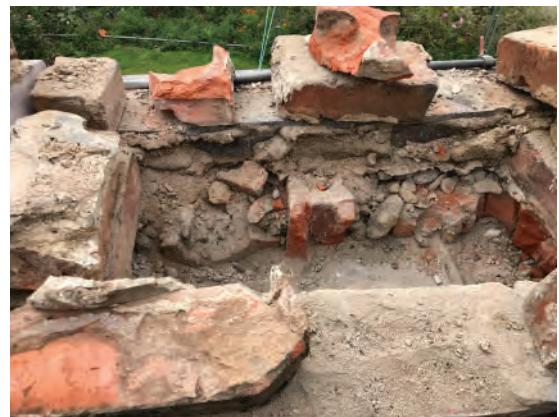
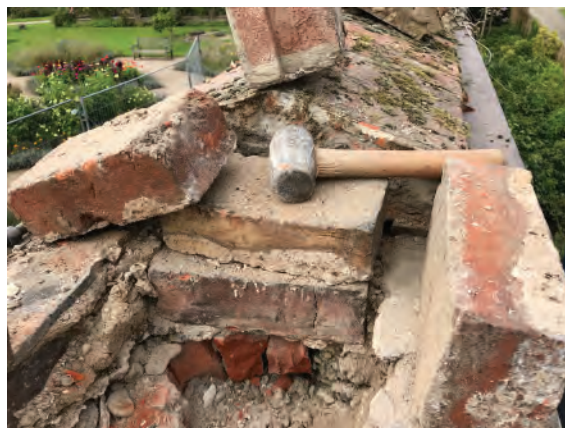
### **3.03 Construction at the Top of the Wall:**

It appears that, at some time in the relatively recent past, the coping bricks, the tile crease course on which they are laid and the course of bricks immediately below the tile course have been rebuilt. Hard cementitious mortar was used in the rebuilding and the careful dismantling of a small section of wall proved to be quite difficult. On removal of a small section of brickwork, it could be seen that the top section was constructed in solid brickwork infilled with cementitious mortar.

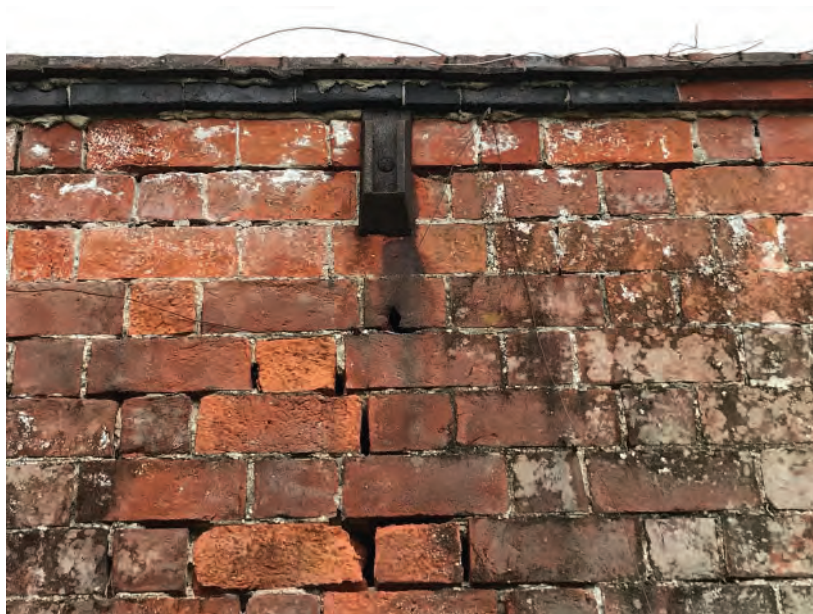
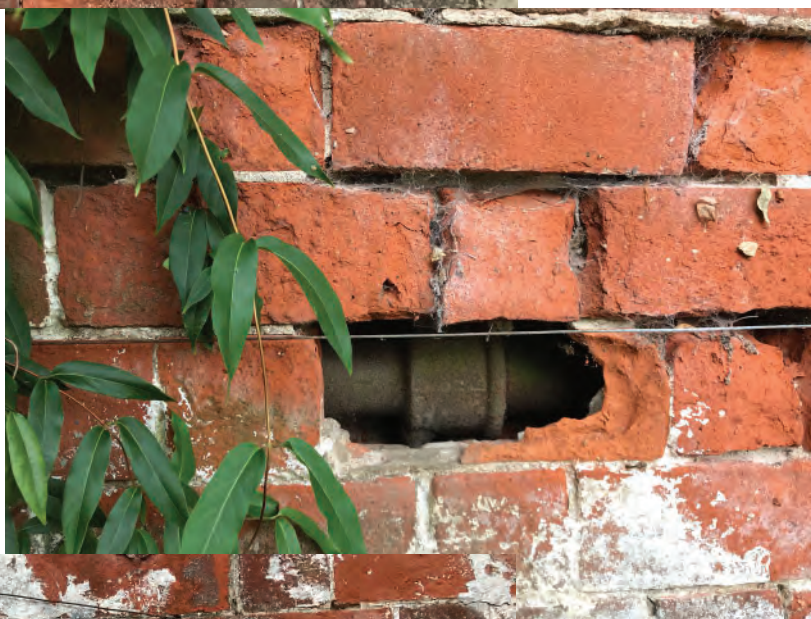
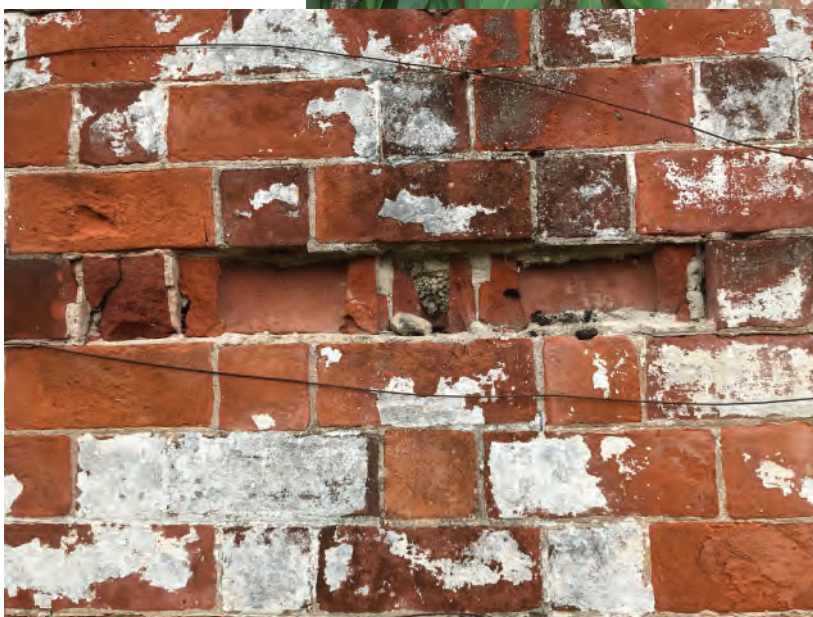
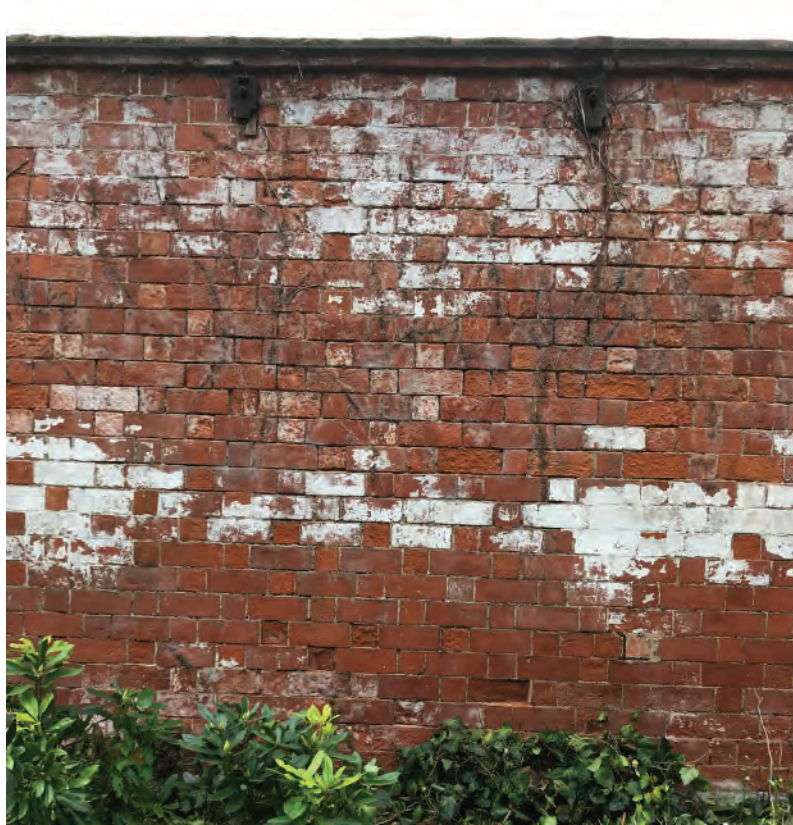
Photographs from September 2020

It is clear that significant deterioration has occurred since the writer carried out his original inspection of the wall in 2005. Significant further spalling has occurred to the brickwork and much more of the core of the wall has been exposed. As recommended in the report prepared by Derbyshire County Council in 2014, protective fencing has now been erected to each side of the wall to prevent pedestrian access and to keep personnel safe in the event of collapse.

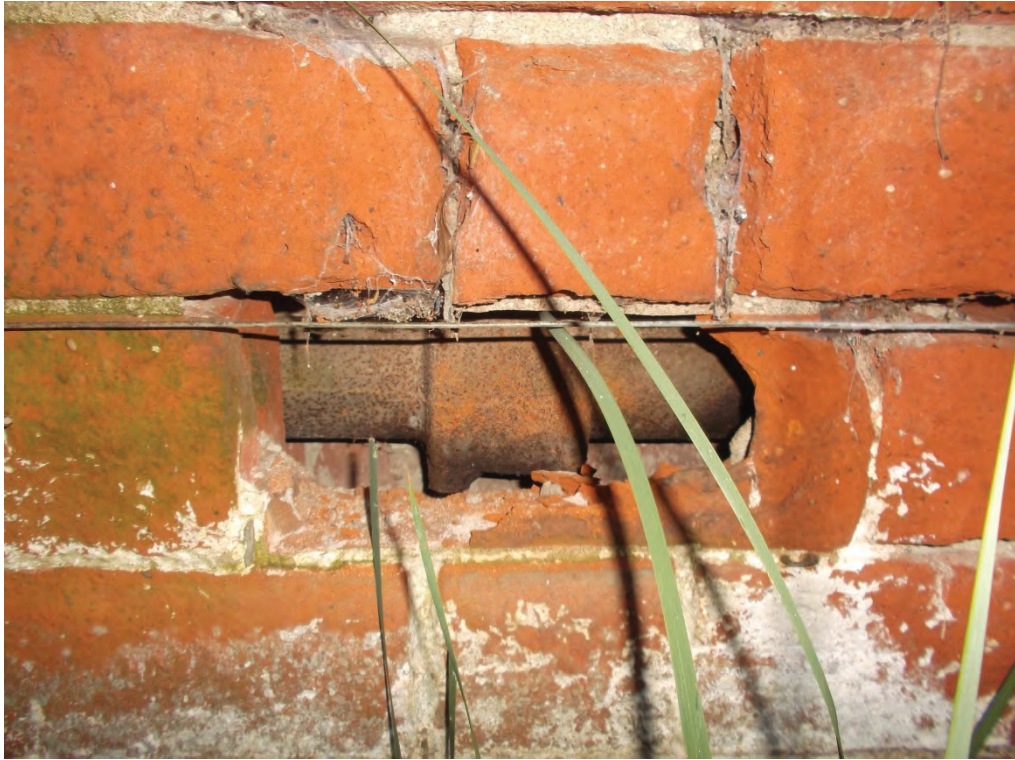
Photograph 1 - Wall A - cast iron heating pipe within cavity

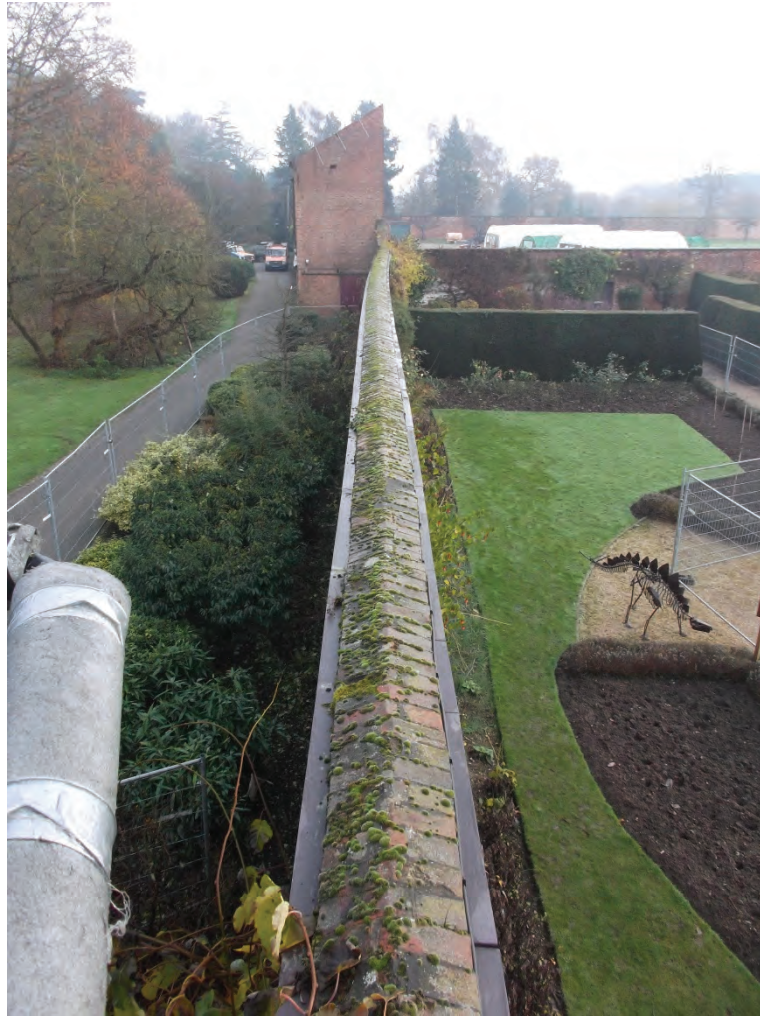
Photograph 2 - Wall A -bowing towards entrance.

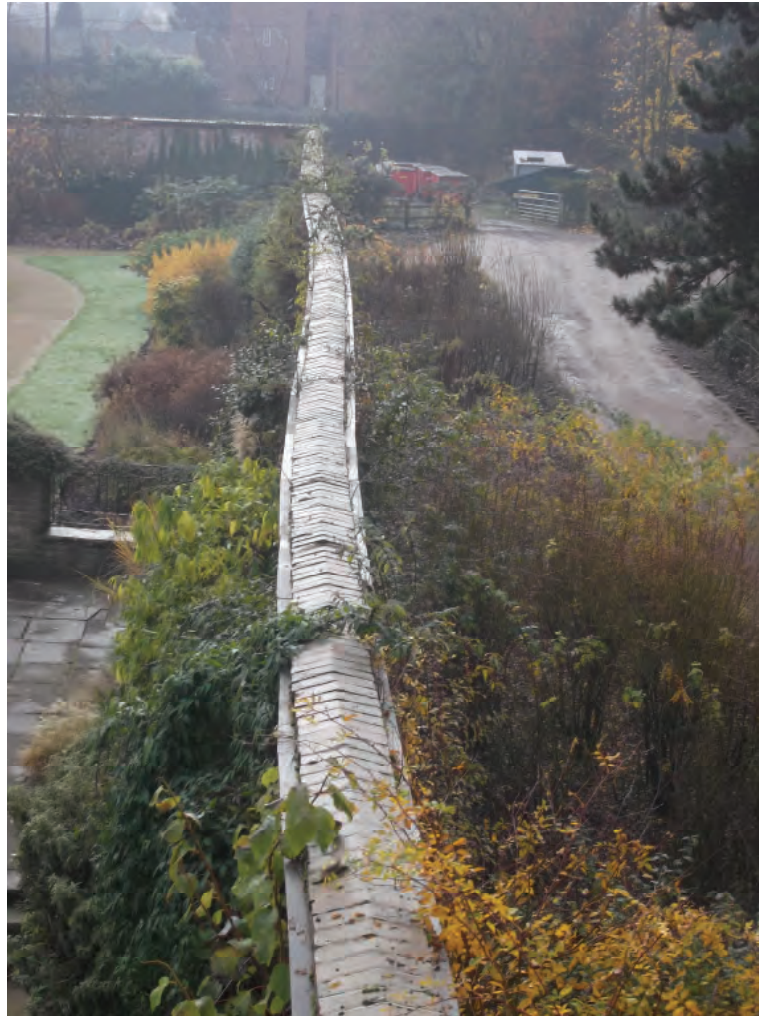
Photograph 3 - Wall B - showing distinct S shaped movement.

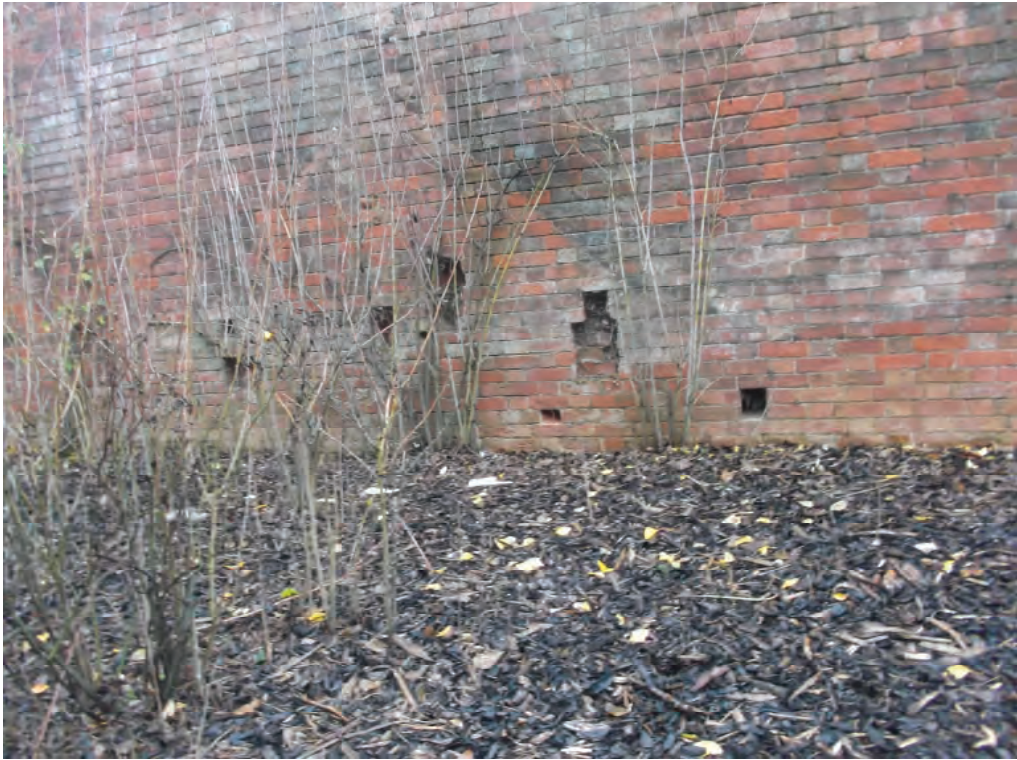
Photograph 4 - Wall B - west side- missing bricks in wall.

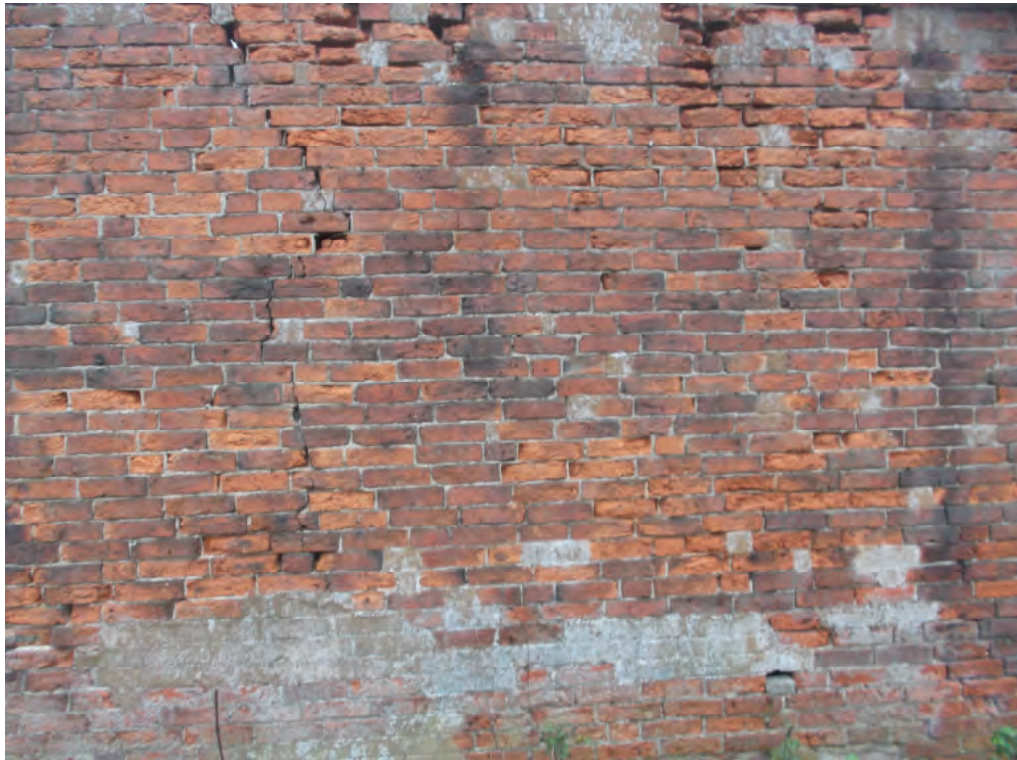
Photograph 6 – Wall E mid-way between junctions with walls D and C – vertical crack and point at which wall can be rocked.
