## REPORT ON THE STRUCTURAL APPRAISAL

The Stables

for Victoria Philips

**H364-CHG-00-XX-RP-S-0001**

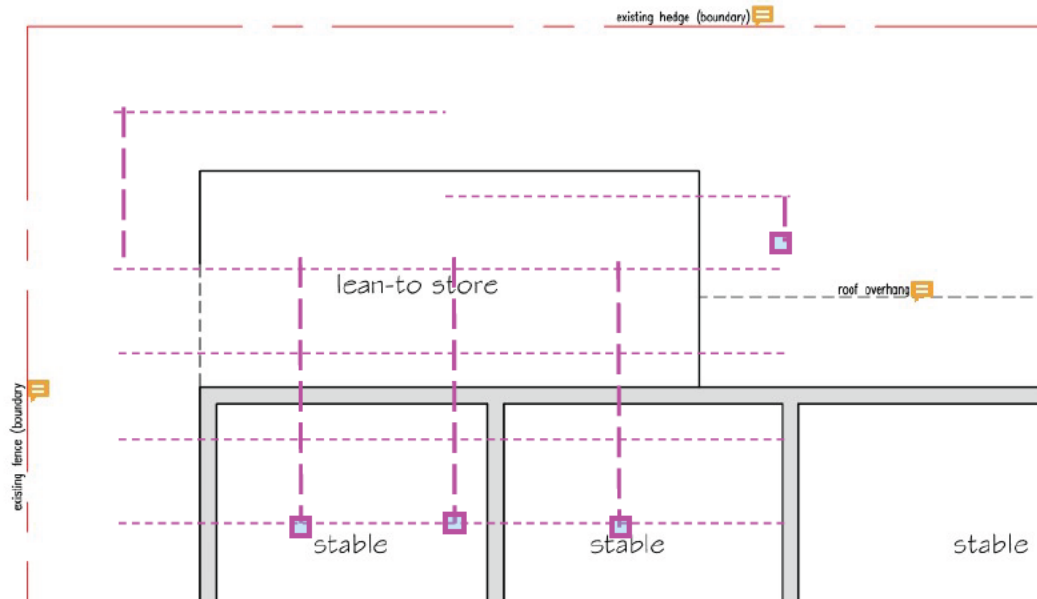
Figure – plan of structural form as existing

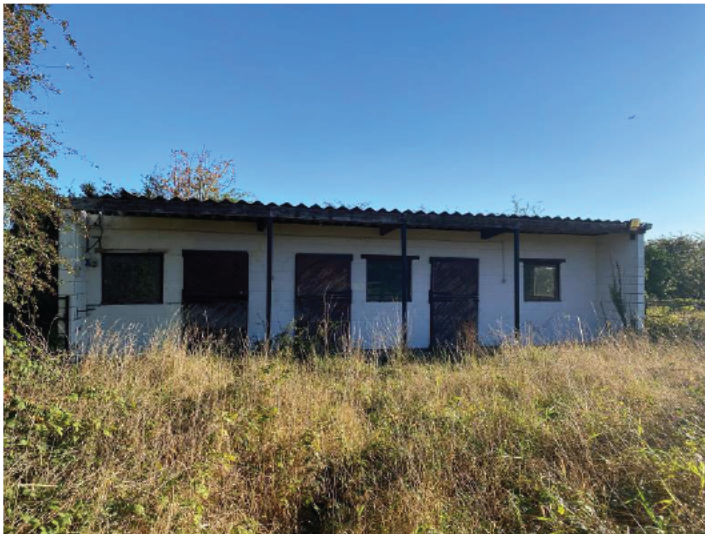
Figure – front elevation with expressed steel posts

The steelwork post supporting the canopy to the front door and sound structural condition and whilst local corrosion is evident to the top of a number of plates this could be addressed through cleaning priming and painting elements.

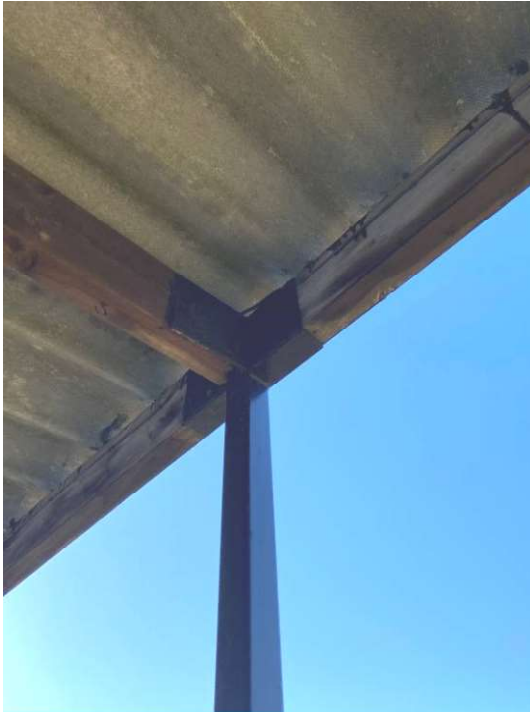
*Figure – corrosion to top of column brackets*

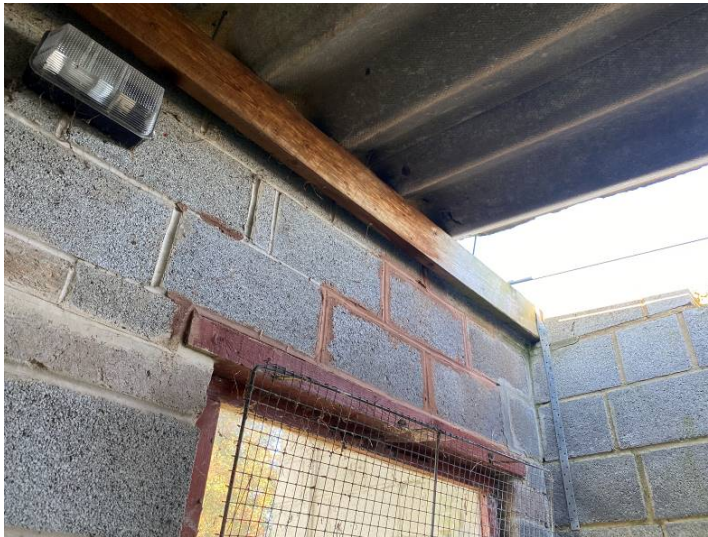
Externally the exposed blockwork to the front elevation is in sound structural condition with the being masonry partially protected from the weather by the overhang to the front elevation, although broken sheets are present to the left-hand end. Viewed externally we noted concrete lintels exist to the main doors however timber has been used as a lintel for several windows. The timber lintels are deteriorating and evidence of repointing over the openings has been undertaken. We suggest that these will require replacement with either a steel or concrete lintel.

*Figure – timber lintel over window and local re-pointing. Note exposed to elements due to broken roof sheeting*

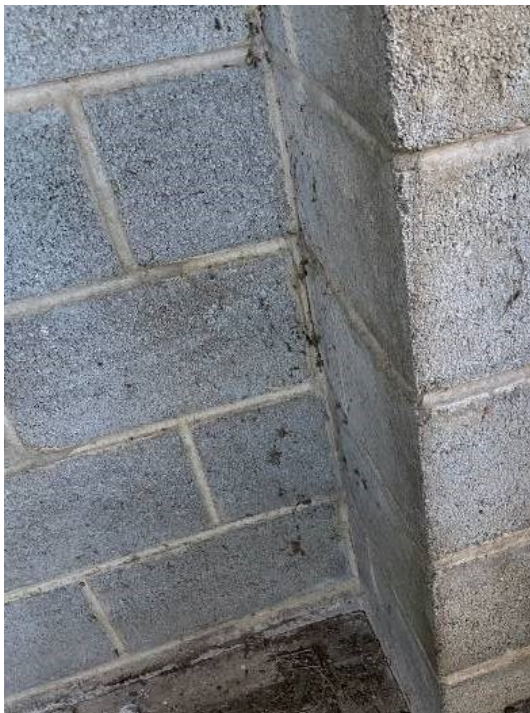
*Figure – floor slab cast within masonry walls – not off.*

The concrete ground floor slab has been cast within the block work walls and therefore the walls would appear to be built off their own independent foundations. Whilst the foundations were not inspected, the structure is showing no signs of any

instability and as a result the structure is currently in equilibrium with its current environment.

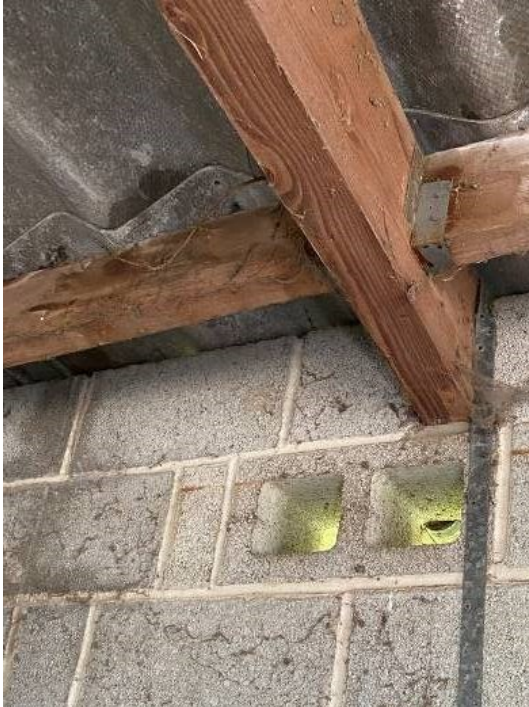
The mono pitch roof with its exposed timber purlins and restraint straps are evident. with approximately 150 x 50 mm purlins spanning across each bay. There is a primary beam spanning front to rear onto the timber posts exposed on the front elevation being approximately 225 x 75 mm in cross-section. And all the timber is in sound structural condition although local deterioration is evidenced towards the supports which may require are the splicing or likely replacing.

*Figure – primary beam penetrating front wall with restraint strap and incoming purlins*

The timber purlins to the roof may require strengthening to supported an increased weight roof covering with an insulated roof and ceiling, however the members as they currently stand are in sound structural condition with appropriate strapping to prevent uplift.

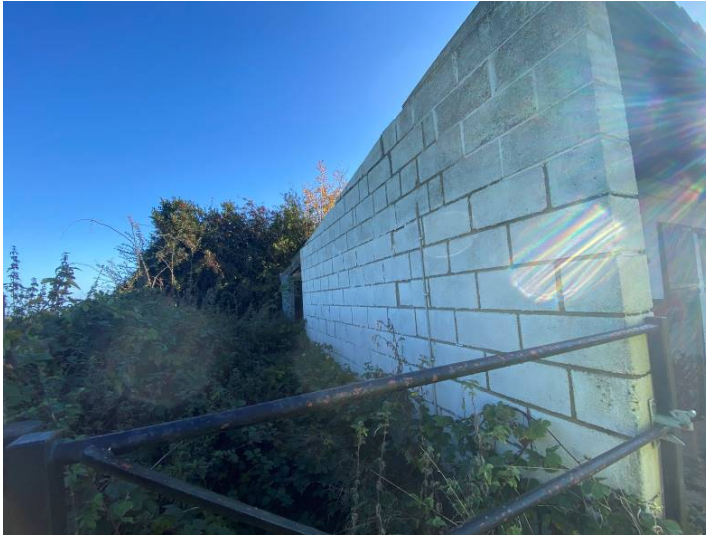
Externally to the left-hand gable the plain blockwork has been painted and there are signs of weathering to the pointing and masonry. The weathering is not significant in relation to the overall stability or integrity of the structure. Improvements to the thermal efficiency and visual appearance to the structure with an external coating will address any further deterioration of this block work.

*Figure – left hand gable*

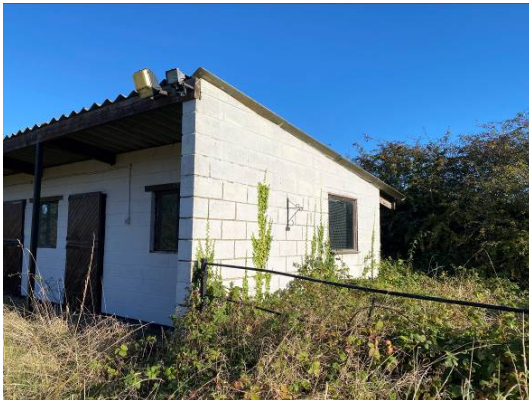
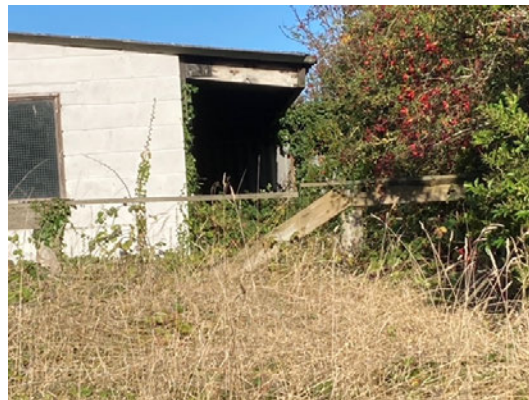
The right-hand gable as viewed from the front is also notionally weathered although there were no signs of any structural fractures, similarly there was no sign of any instability and the block work has a good line and level. There would appear to be a steel column to this rear corner of the property for the canopy and further columns may be present.

*Figures – right hand gable*
