# ARBORICULTURAL REPORT AND SAFETY SURVEY

**Client:** Lee Bestall  
**Site:** 22 Main Street  
Newton Solney

**Date:** 07 December 2021  
**Ref.:** THL-R21-154

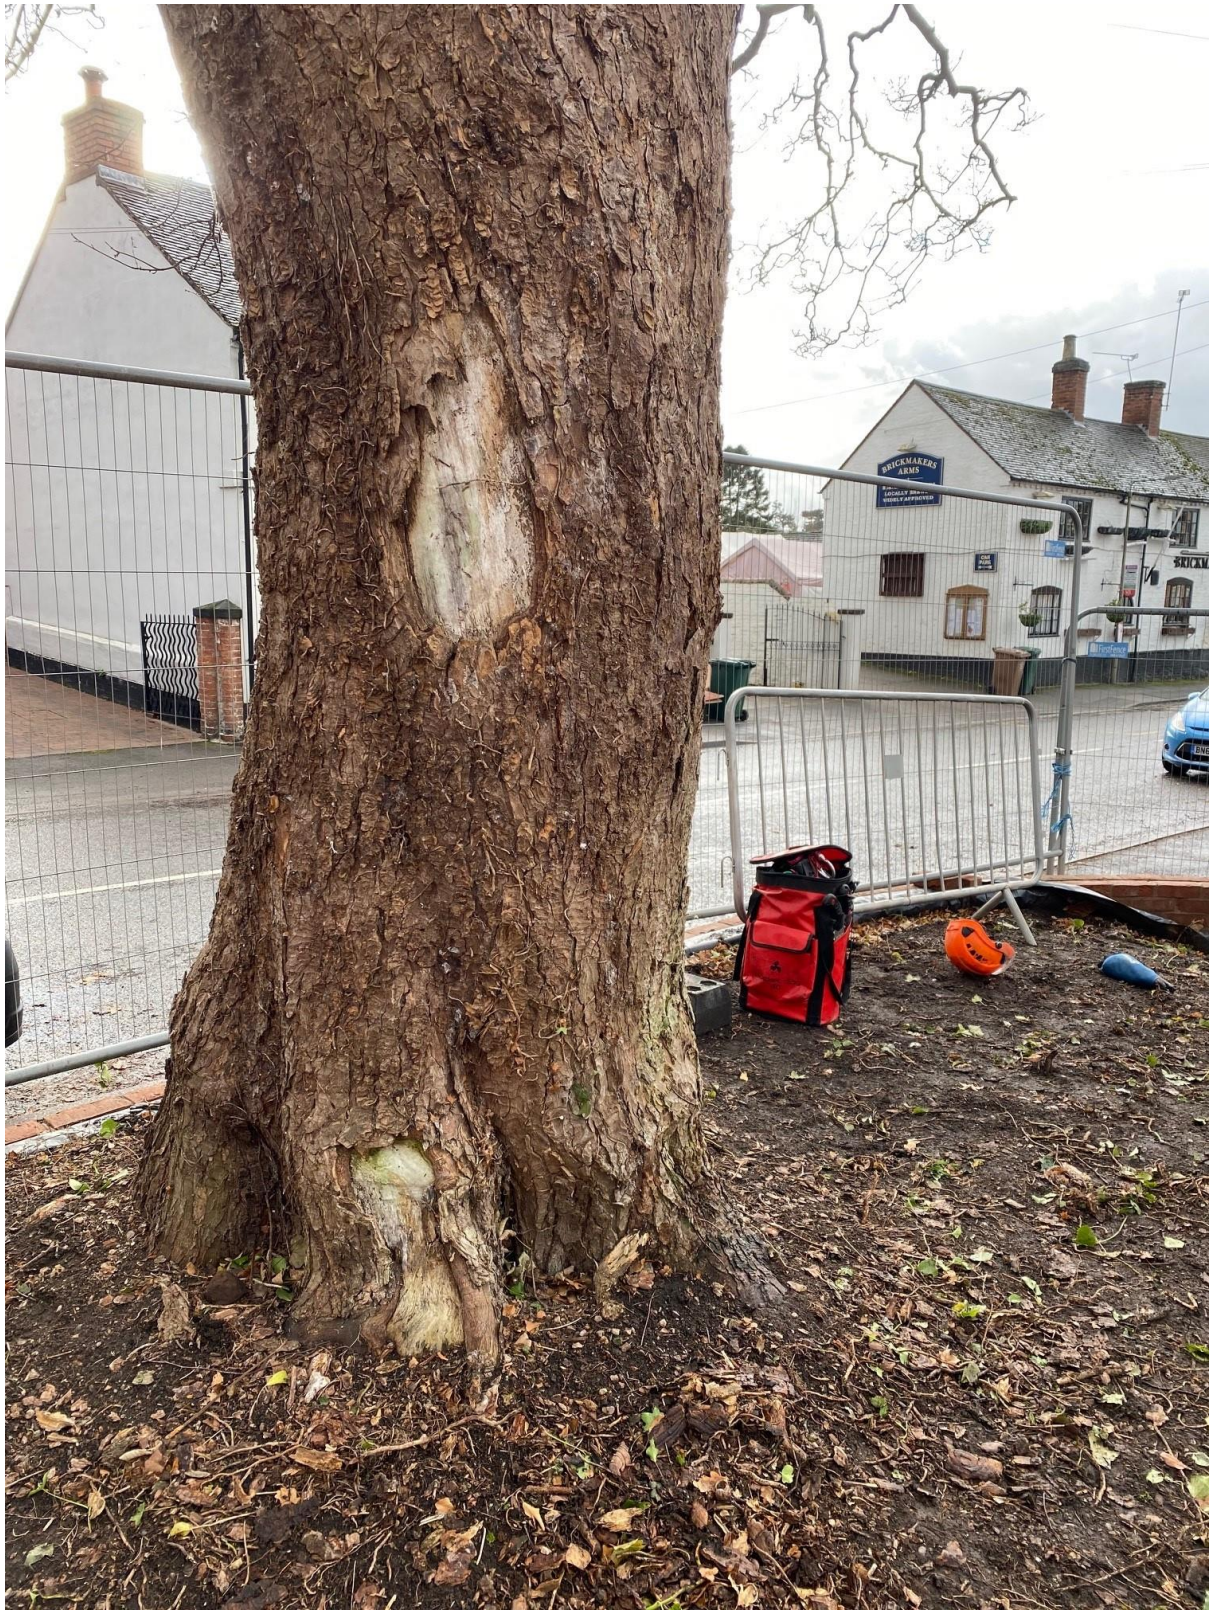
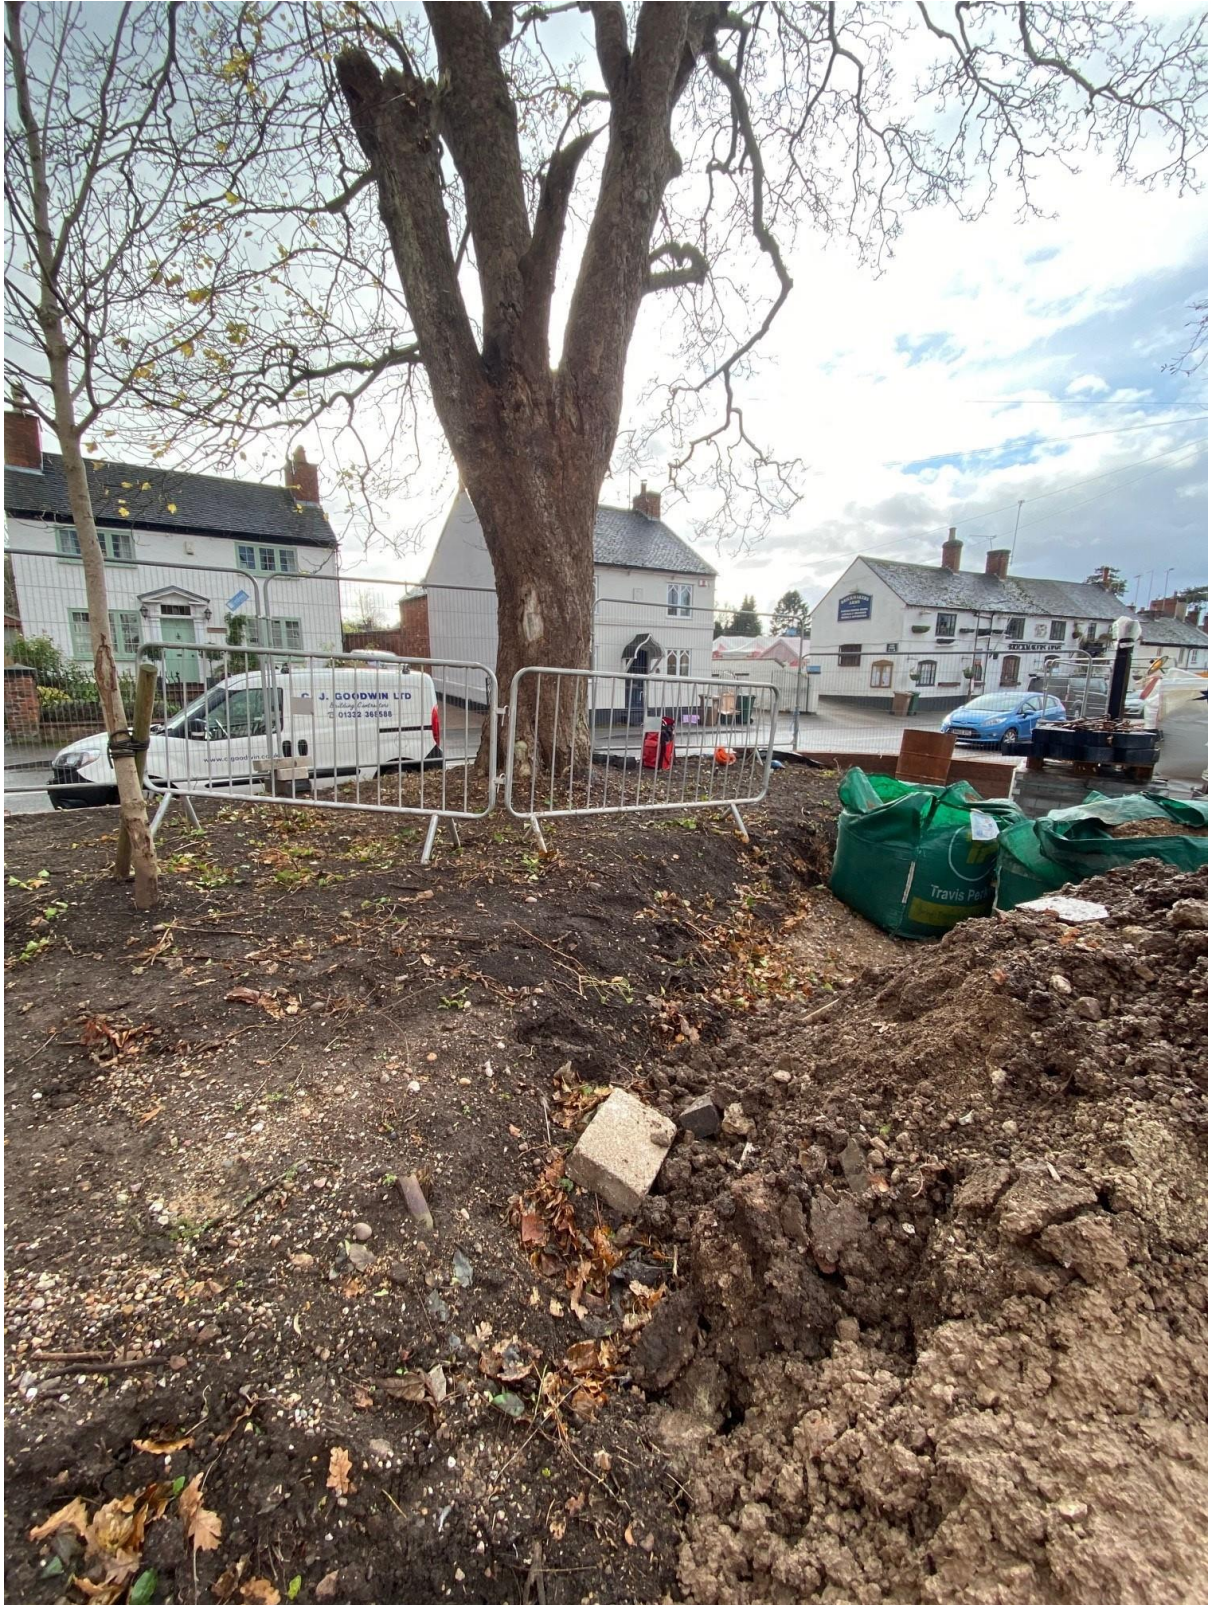
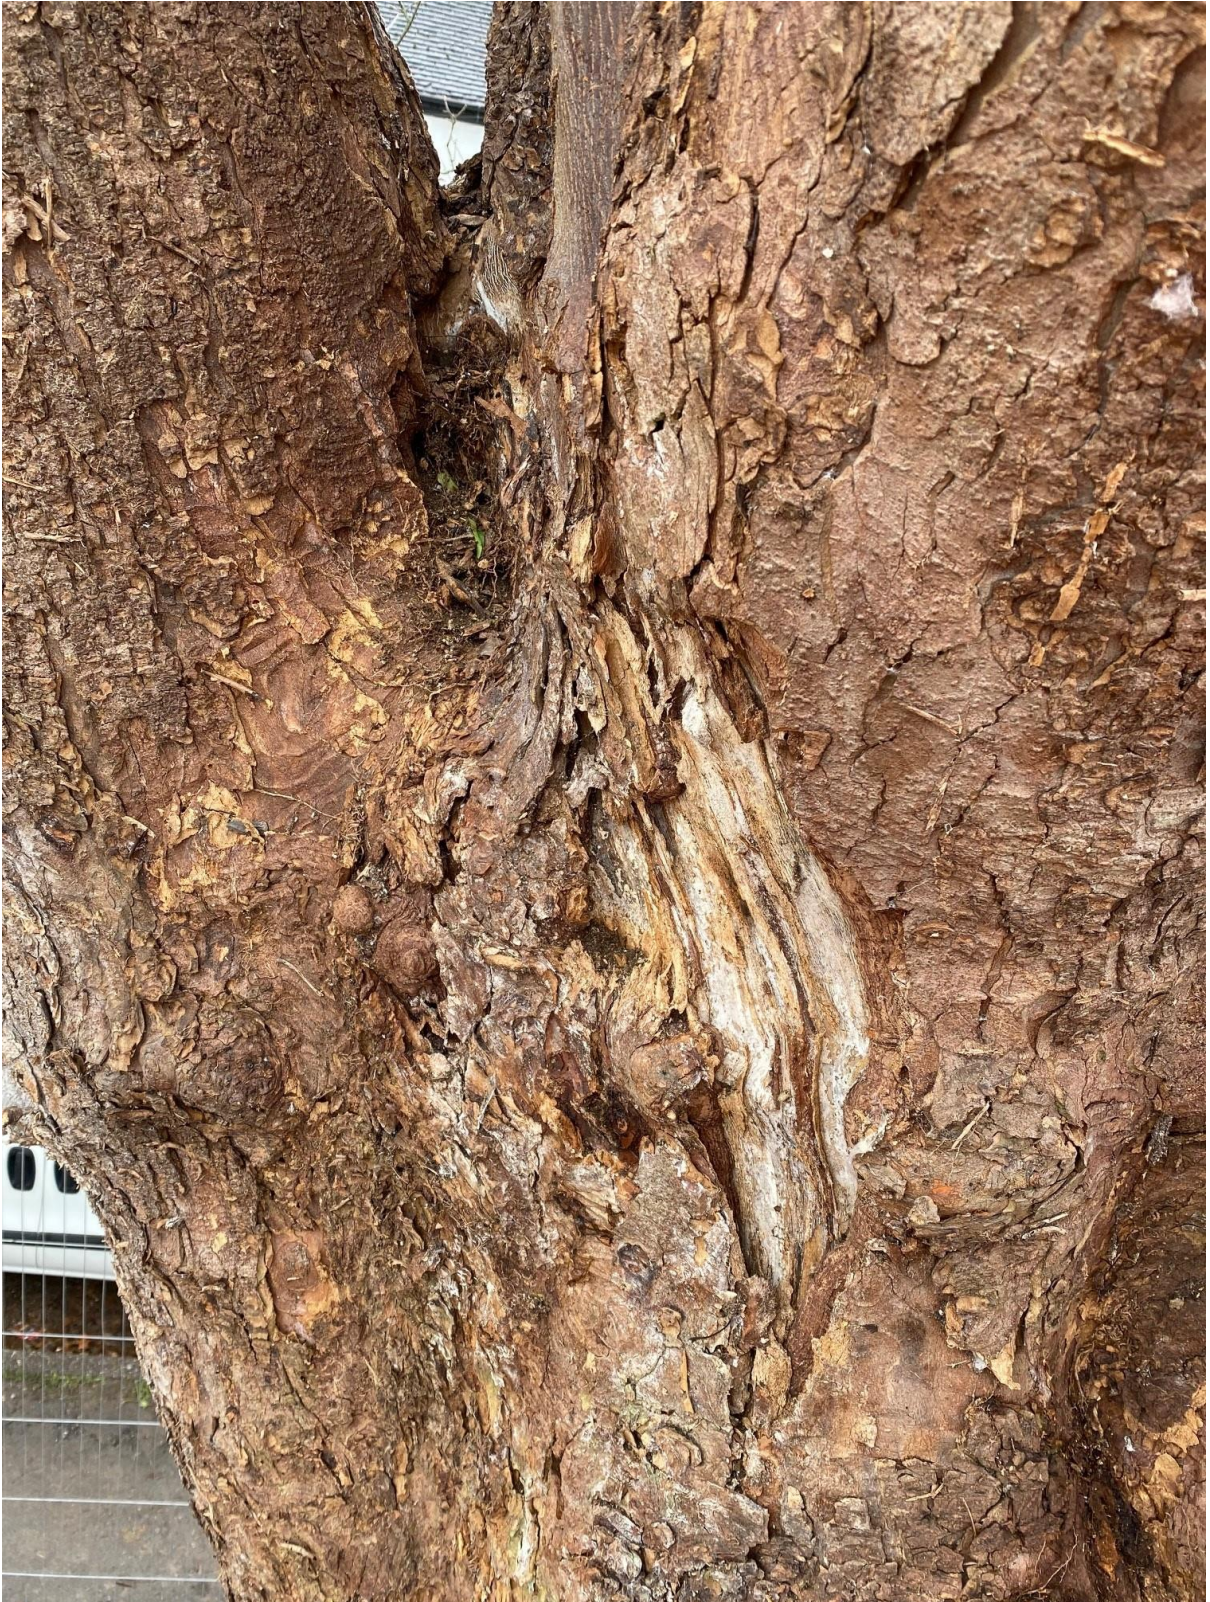
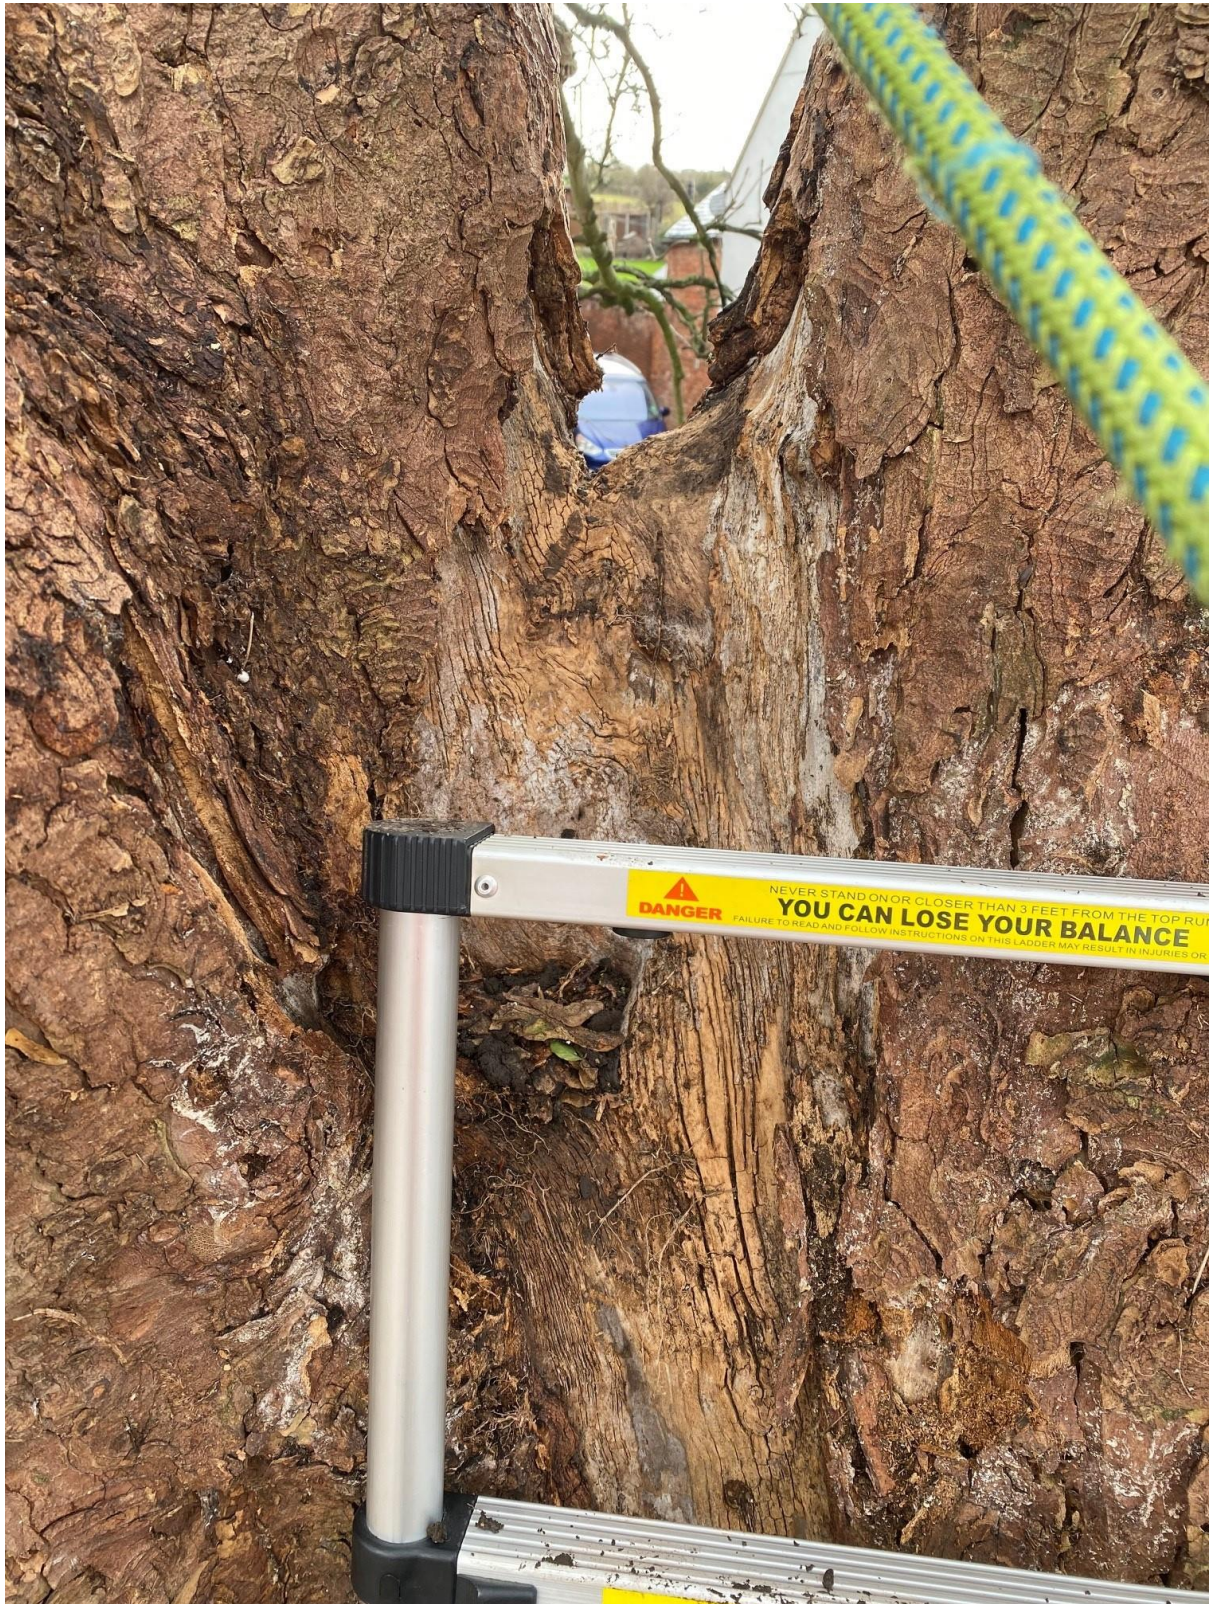
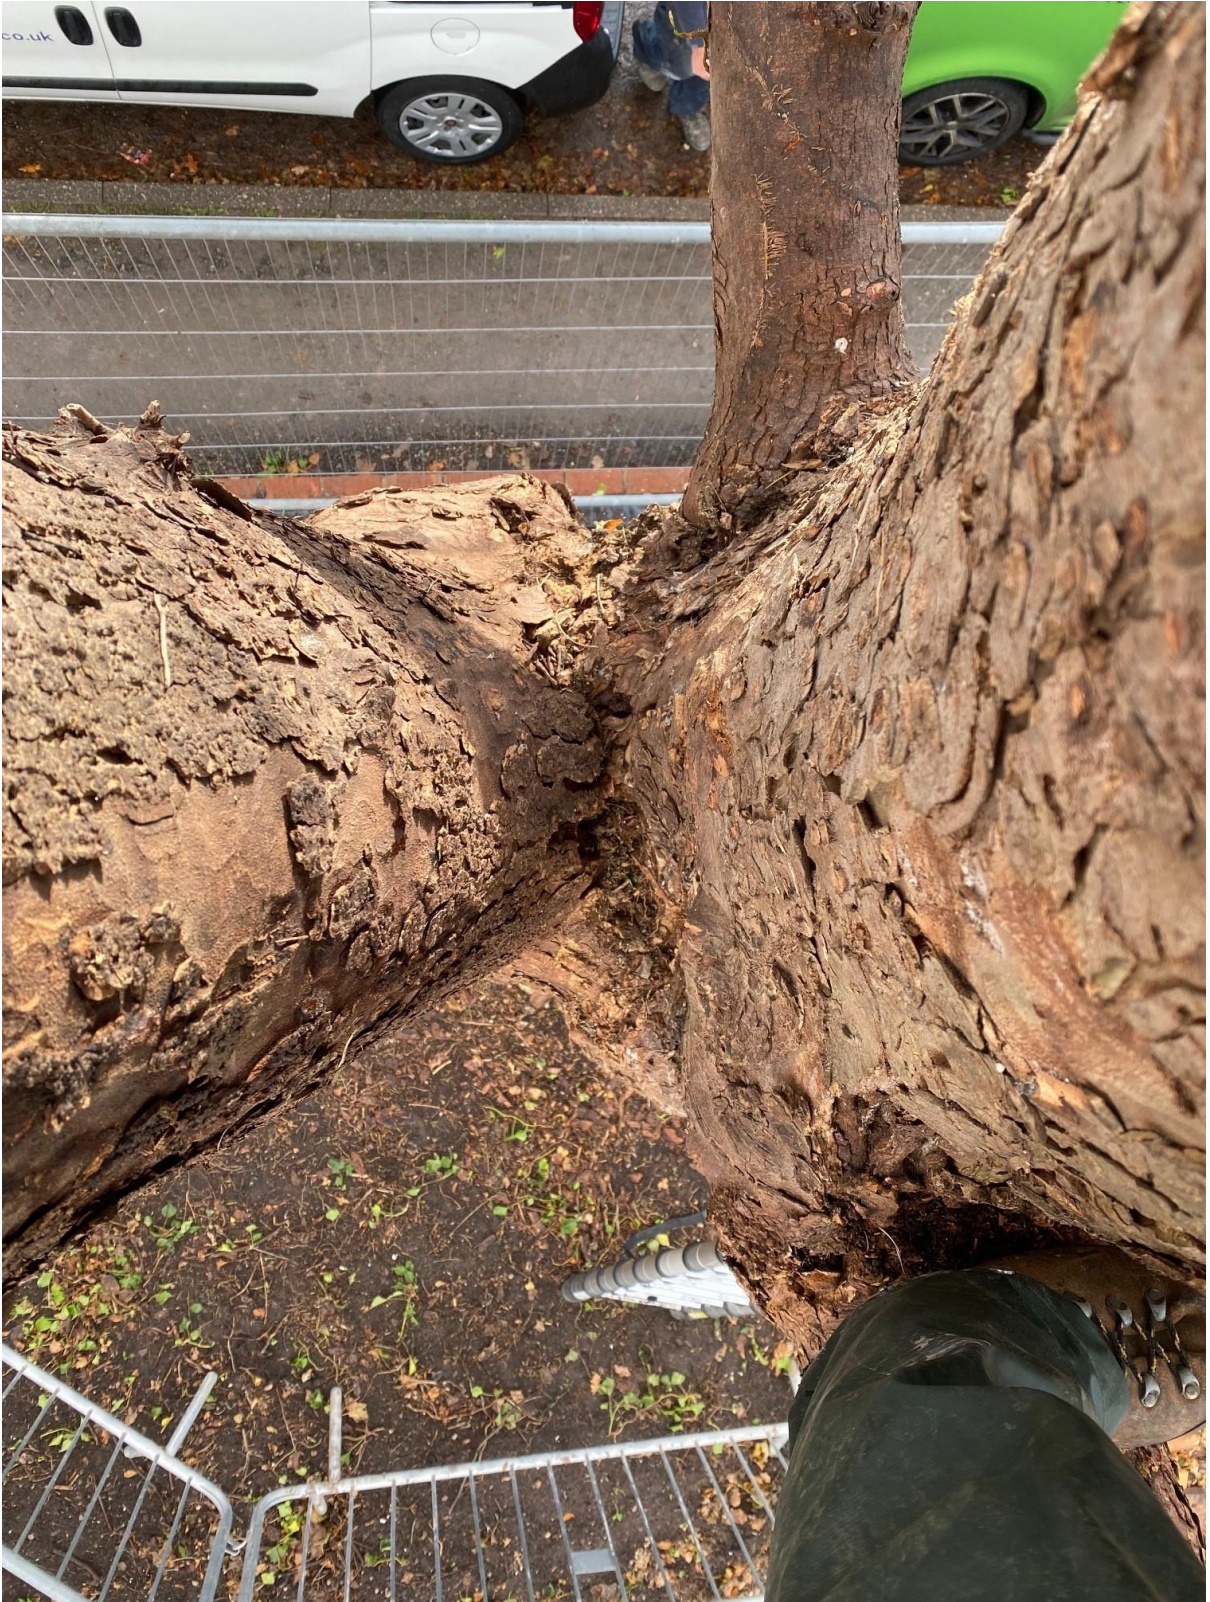
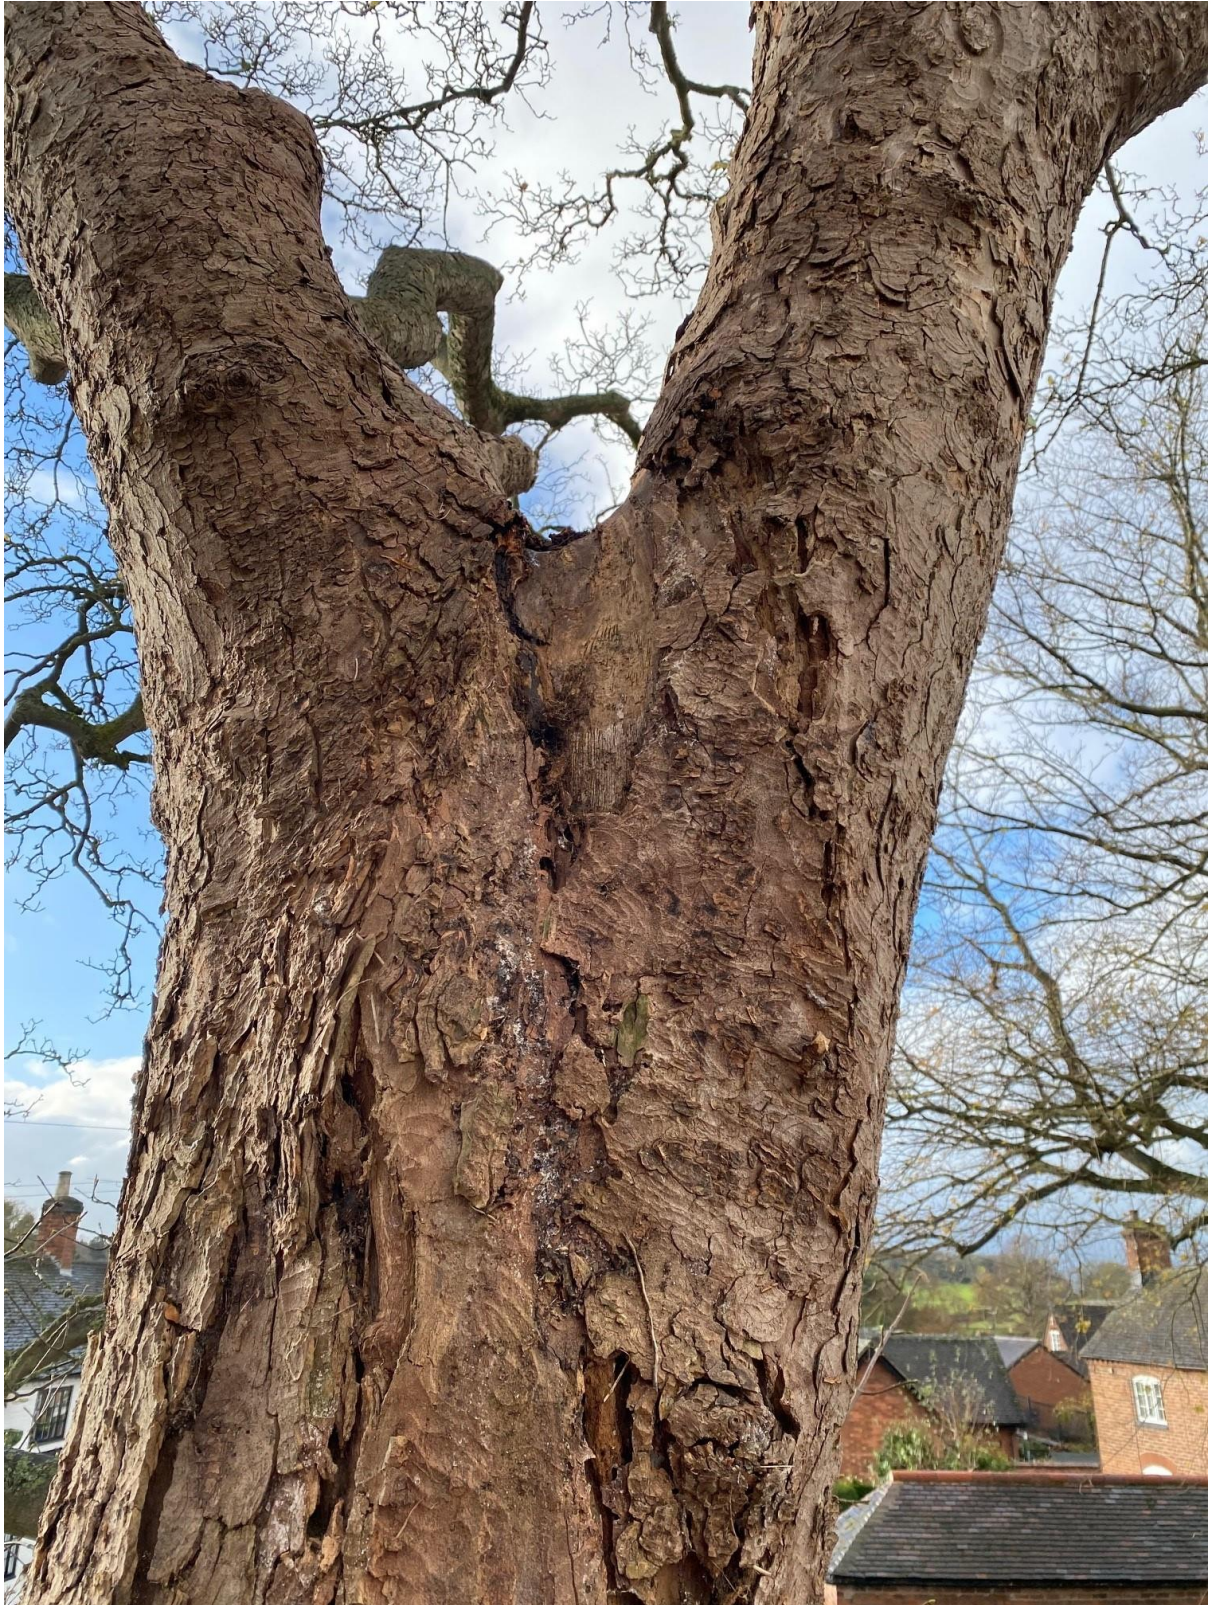
## Photographs of Sycamore (T1)

- 7.4 There was bark missing from around the main forks and decay within the forks was visible. The tree was climbed so the forks could be inspected more closely. Photographs of the tree are attached below.
- 7.5 There was significant decay present in both main forks, as well as an upper fork. There was a large stump from a previous failed branch which was heavily decayed. The decay was evident throughout the upper stems. Due to the way the canopy is weighted and the decay present in the forks, the concern would be that the tree fails onto the road.
- 7.6 Given the decay present in the base and stem of the tree, and the decay present in the main forks and upper stems, there is concern over the safe retention of this tree adjacent to the main road. The recommendation is to remove the tree on the grounds of safety.

| Ref | Species | Structure | Size | Life Stage | Description & Targets | Survey Notes | Condition | Recommendation | Work Timescale |
|---|---|---|---|---|---|---|---|---|---|
| T1 | Sycamore<br>( <i>Acer pseudoplatanus</i> ) | Tree | Large | Mature | Target # - road | Weak fork.<br>Decay present in stem.<br>Decay present in main forks.<br>Ground disturbance within RPA. | Fair | Fell tree. | 03-Jun-2022<br>(Priority 2 (6 months)) |
