# Report of Structure

Field House Farm, Coton Road, Rosliston, Swadlincote, DE12 8HN

July 2021 - 130718

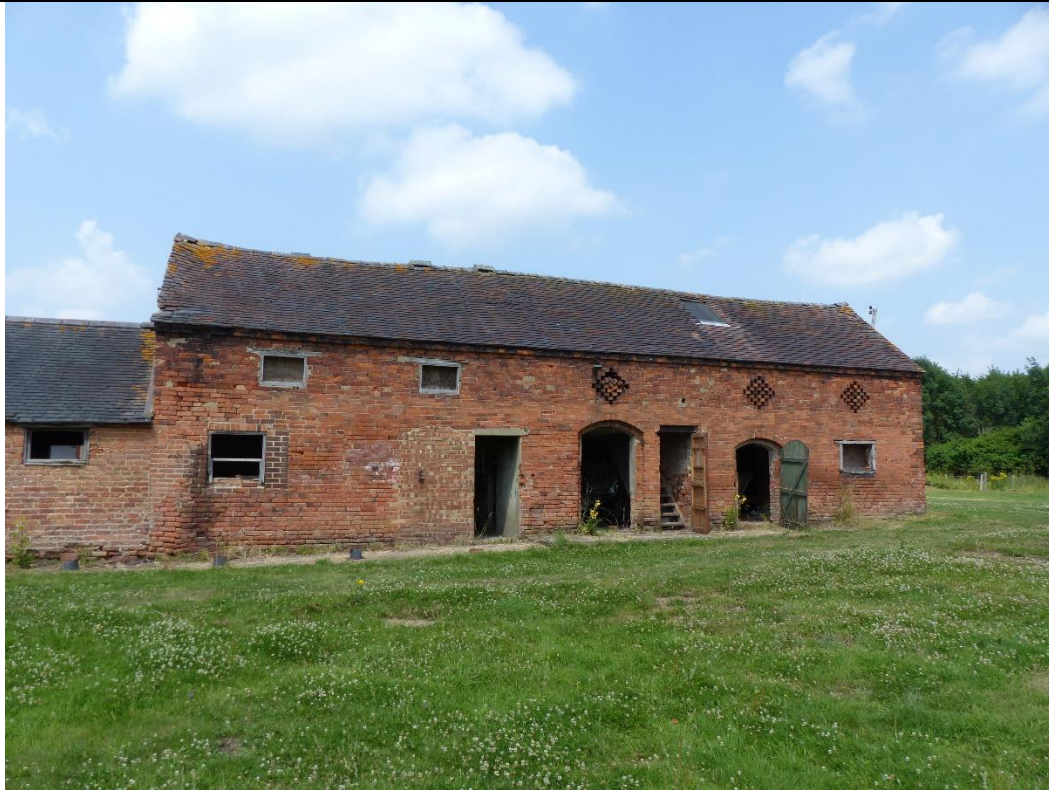
Photo 1 - General view of Barn 1 - Elevation A1

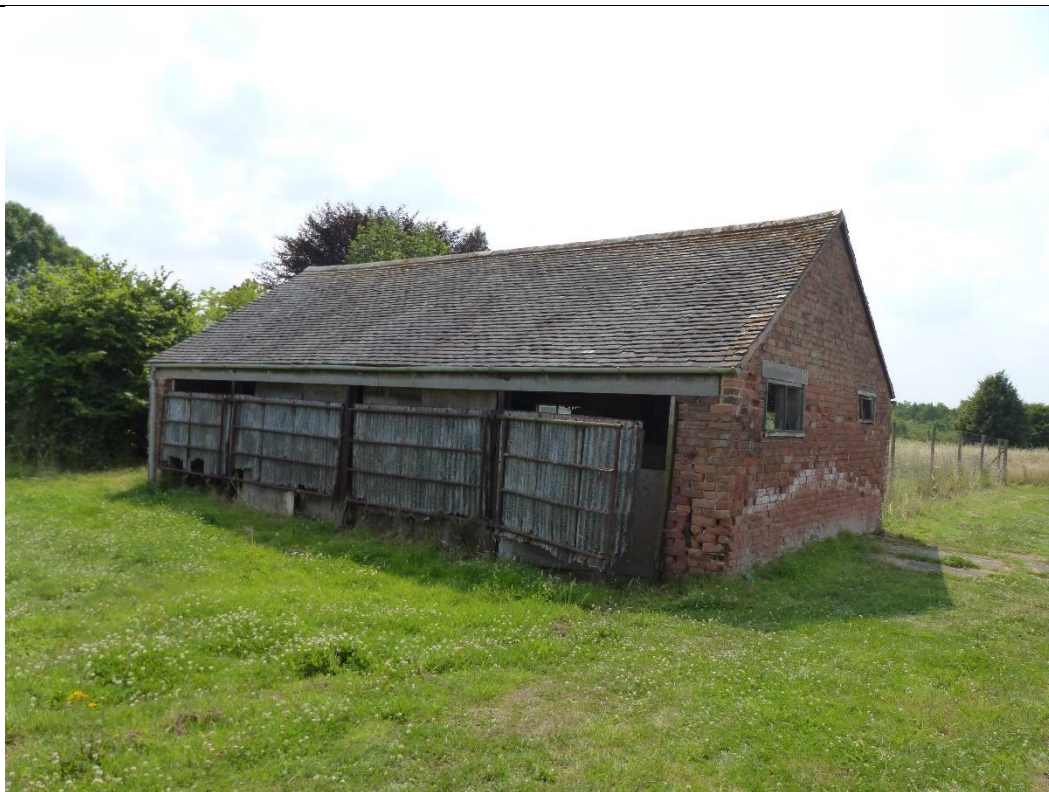
Photo 2 - General view of Barn 2 - Elevation B1

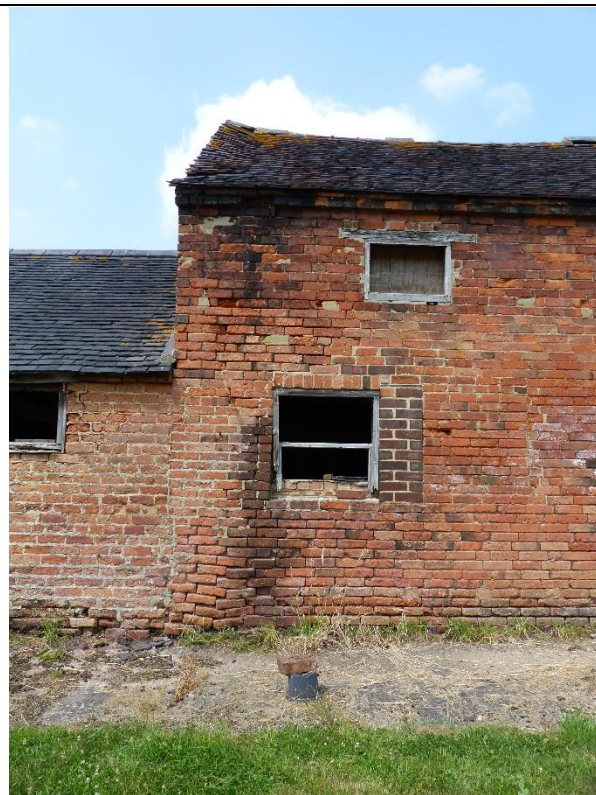
To elevation A1 at the junction of the extension, a large area of brickwork has visually dropped and visually unstable. This area of the wall will require re-building as part of any conversion works. Again, it is assumed a mixture of shallow foundations and lack of ground drainage / rainwater goods has contributed to the deterioration of this section of wall.

**Photo 4** – Barn 1 – Failed Masonry Wall

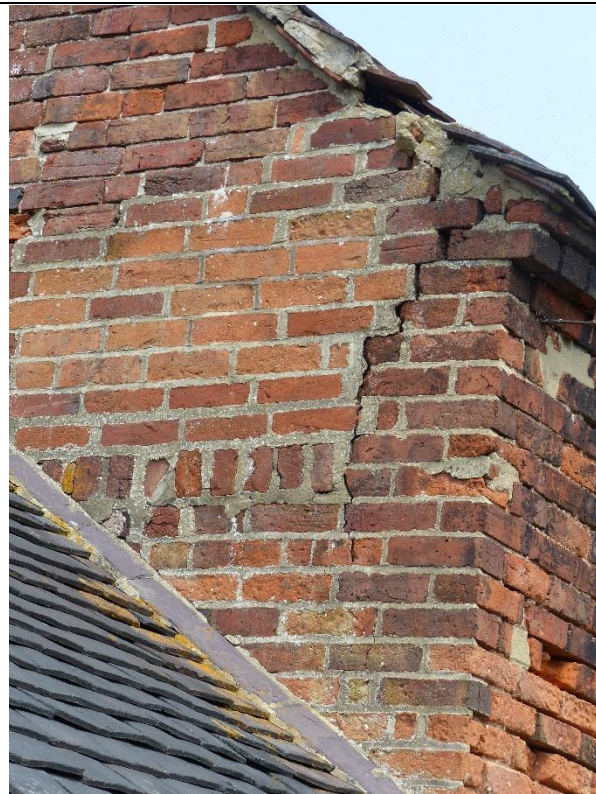
There are various slipped and damaged tiles primarily to the main barn. An area of tiles and verge pointing has become displaced/missing to the main gable to the west elevation A4. Internally, it was evident that the timber roof battens have been subject to wet rot, however there were no signs of major failure.

Photo 5 - Barn 1 – Failure of gable end / roof junction

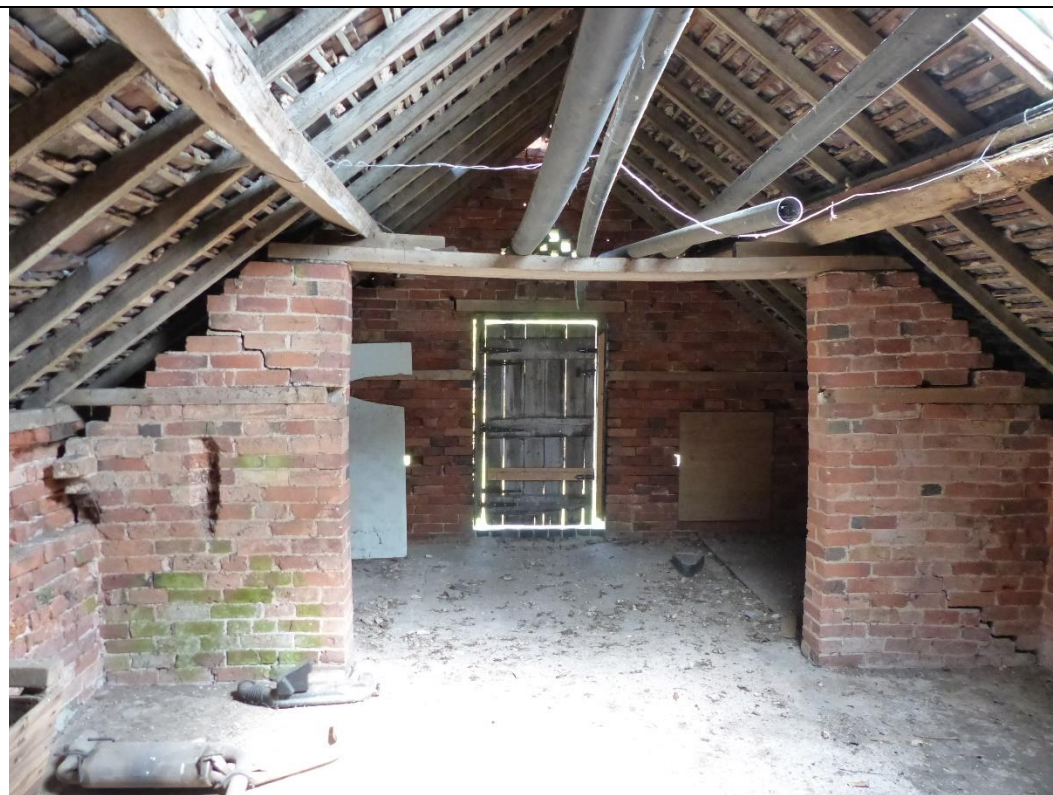
The dual pitched barn roof is supported by a timber purlin rafter roof system with 4no mid-span timber horizontal timber tie beams, with 3no supported on the internal load-bearing masonry walls. These masonry walls are heavily cracked and have become displaced due to the incorrect transfer of loads. The last Queen post type truss arrangement towards the west elevation appears only to be supported off the upper floor structure below. The timber purlins are supported within the external masonry gable walls and bedded on small timber pads. The timber purlins are approx. 190mm X 90mm and the rafters are approx. 70mm X 55mm @ 450mm cc. Along both pitches of the main roof there is evidence of dishing to the roof covering and the whole roof structure is out of alignment, currently leaning towards the east elevation A2. This is assumed to be due to the lack of any lateral restraint.

The main timber roof structure is defective and if left alone, will eventually collapse. The roof structure will need to be modified as part of any conversion works to ensure all loads are transmitted to the building's foundations correctly. It is assumed the majority of the timbers can be retained following close up inspections, with any timbers to be retained to be treated with a suitable fungicidal and woodworm treatment. Any timbers showing signs of wet rot should also be replaced.

The masonry walls visible within the roof space are showing severe cracking and leaning due to the improper loads transmitted from the roof structure. These walls will need to be partly re-built. Numerous historic horizontal timber roof ties were seen within the internal walls within the roof space. This will need to be removed and either replaced with concrete lintels or brickwork.

Photo 6 – Barn 1 – Deflection of main roof / failure of internal load-bearing masonry walls

- 1) Roof
  - a. Structural alterations to the roof structure to the main barn will be required to eliminate future movement and ensure the loads are evenly distributed through the structure to stop further cracking of the internal walls. It is assumed the majority of the existing roof timbers can be retained and any timbers where wet rot and beetle infestation is too far gone to be replaced. All retained timbers to be treated with a suitable fungicidal and woodworm treatment

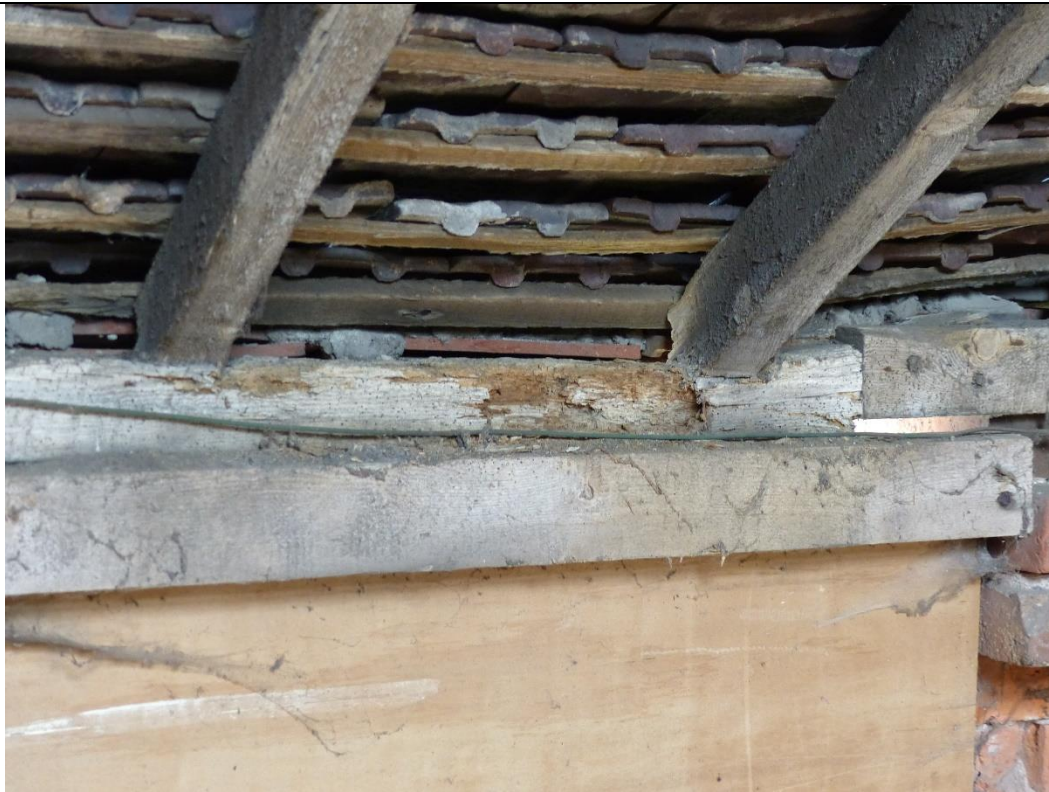
Flight holes were noted to the majority of the timbers within the roof space and localised wet rot amongst the timbers, although there were little signs of there being any active infestation on the basis very little 'frass' was noted.

Photo 7 – Barn 1 – Beetle infestation to timbers

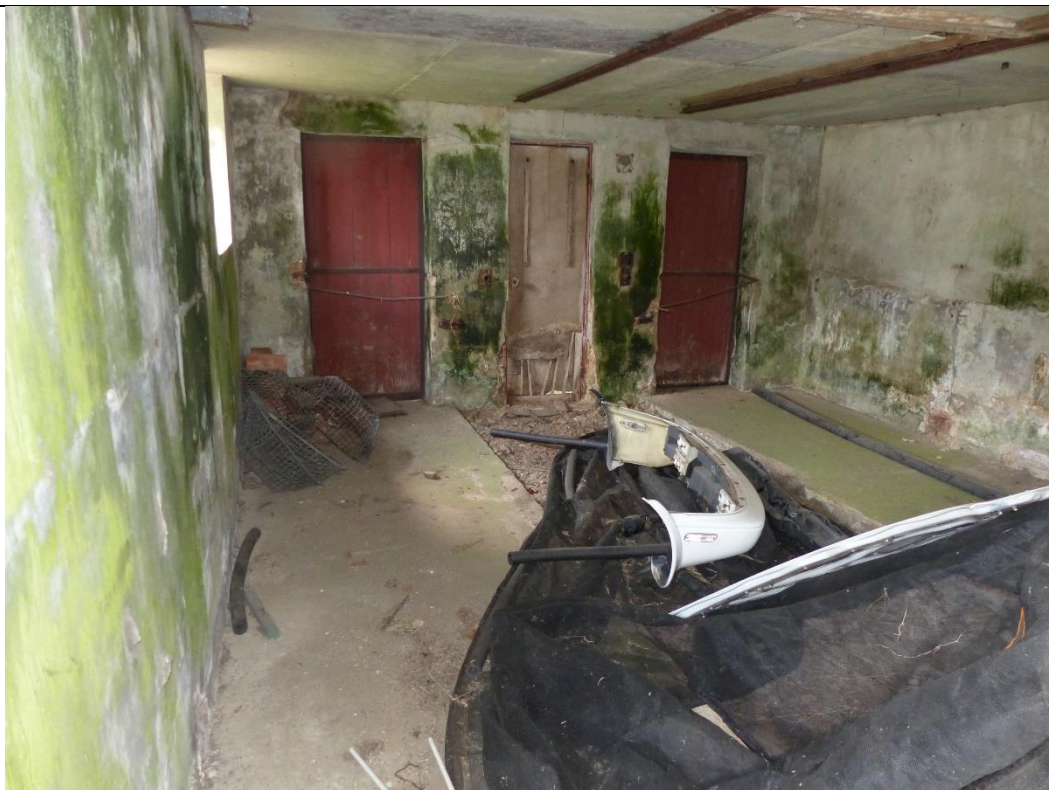
Photo 8 – Barn 1 – Typical ground floor internal finish

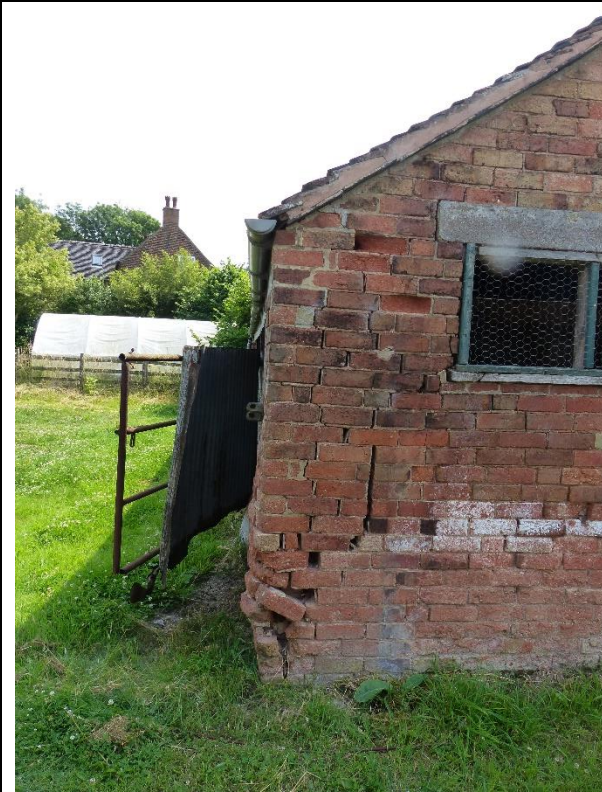
The high level brickwork to both gables appears to have been re-built at some point with a distinct colour and style difference. Both gable walls showed signs of bowing and minor distortion. The right hand brick pier to elevation B1 and B2 is severely cracked and brickwork displaced and if works are not undertaken, could lead to localised collapse. It is assumed the cracking is due to a number of reasons, pointing loading from the timber wall plate, insufficient bonding to the main structure and failure of the foundations. Metal gate hinges were visible partly bedded within the masonry and it may be that the brickwork could not support the load of a previous gate.

Photo 9 – Barn 2 – Failure of brick pier

- c. Part re-build of 2no brick piers either side of elevation B1
  - d. A programme of brick replacement works, and re-pointing will be required to all elevations where bricks have spalled. All cement pointing/brick replacement works to be pointed and bedded with a lime mortar

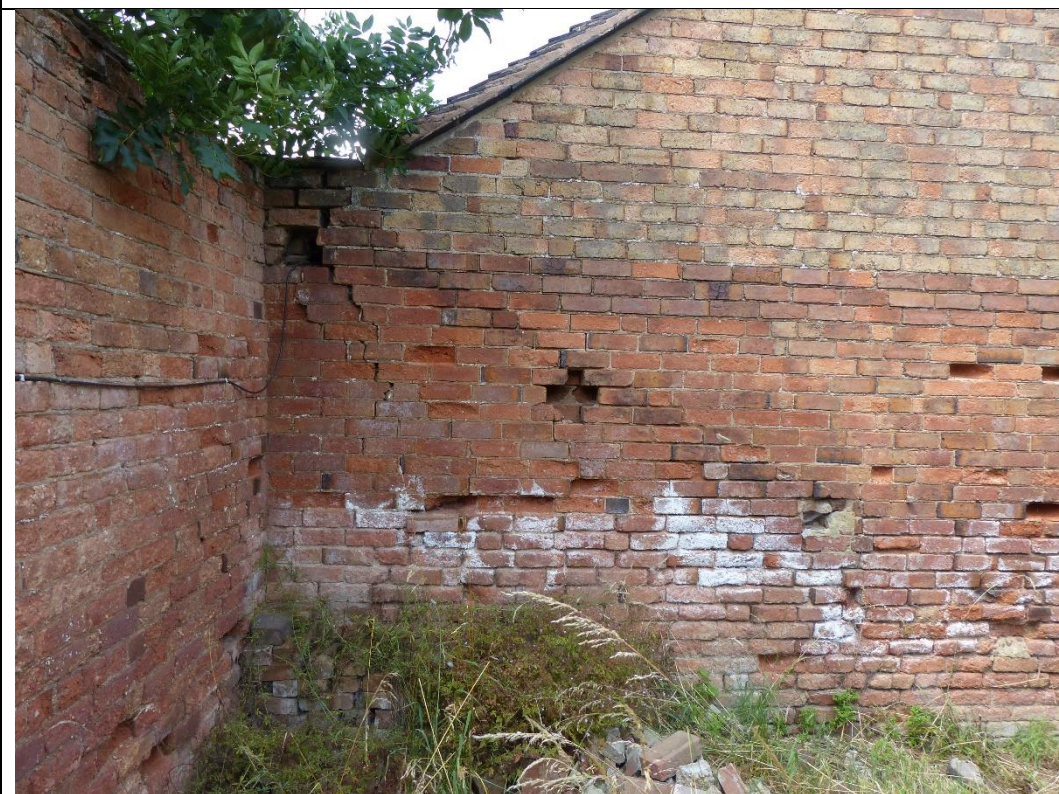
Brick spalling and failed mortar joints were also noted to both gables primarily at low level. A white band approx. up to 1metre high was visible to both gables which is assumed to be salts. This suggests there is a large amount of moisture being 'wicked' up the wall which may be accelerating the damage to the brickwork. Internally, the internal face of the gable walls have been finished with a cement render. The non-porous cement render is trapping moisture behind resulting in the salts and on-going brickwork damage. As part of any conversion works, following brickwork repairs/replacement works, it is recommended that all elevations are re-pointed with a lime-based mortar, with the existing mortar being raked back to a minimum of 25mm before re-pointing. All new brickwork to be reclaimed and match existing.

Stepped cracking and bowing brickwork was noted to the rear corner of elevation B4, due to the close proximity of the young ash tree located behind the adjacent boundary wall. This tree should be removed, and localised brickwork repairs undertaken.

Photo 10 – Barn 2 – Failure of brickwork due adjacent ash tree and brick spalling / salts

- 2) External Walls
- a. Remove adjacent ash tree and undertake isolated repairs
  - b. Part re-build and reinforced bed joints to both masonry gables at high level

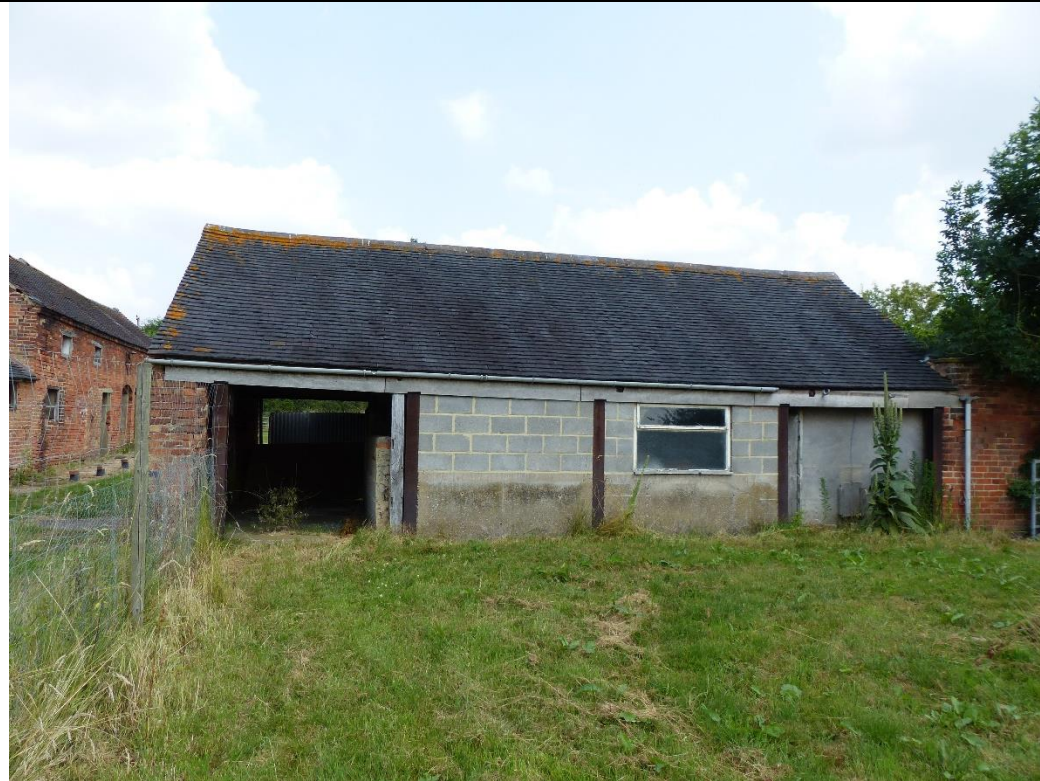
The external gable walls are one brick thick approx. 230mm with both elevations B1 & B3 being open fronted with lintels/wall plates spanning the entire elevations, with the wall plates supported by 3no steel columns to each elevation. Blockwork infill panels were noted to part of elevation B3.

Photo 11 – Barn 2 – Blockwork infill sections

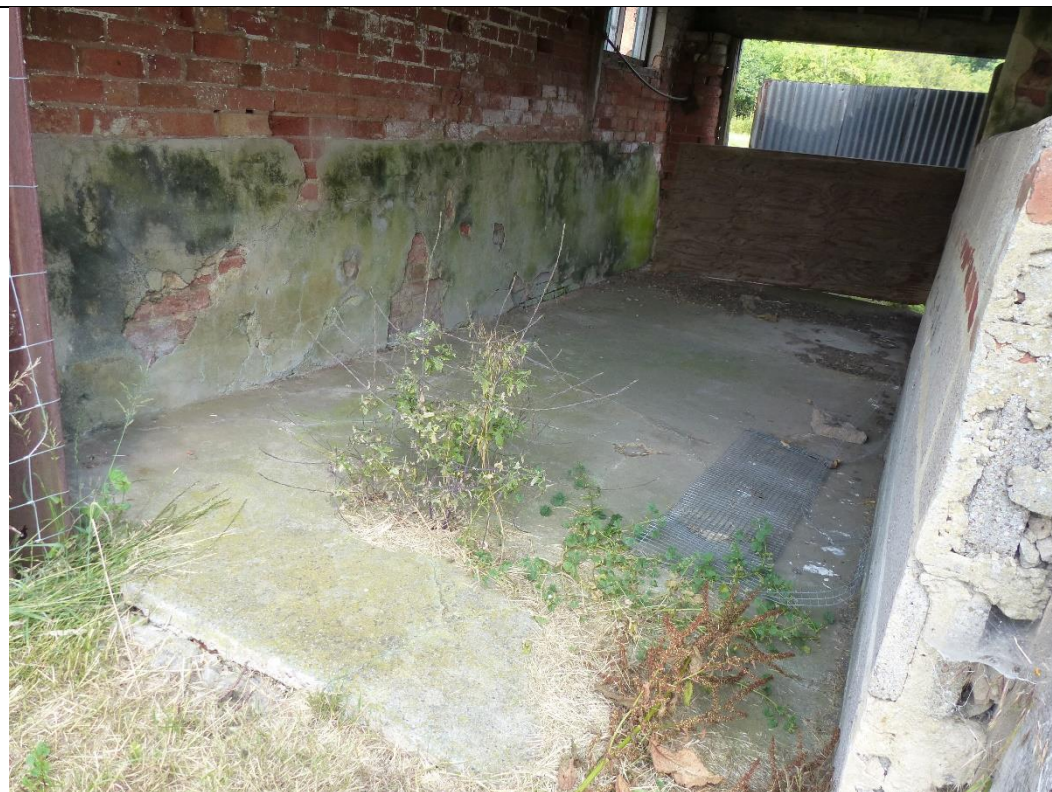
The ground floor to the barn is formed out of an assumed non-insulated cast-in-situ concrete slab. The majority of the slab was in satisfactory condition, however a large area of cracked and displaced concrete was seen to the end bay adjacent to gable B2. It is not known what has caused this and may be due to the weight of previously parked vehicles/machines.

Photo 12 – Barn 2 – Failure of concrete floor slab and internal render causing external damp issues

As part of any conversion works, the ground floor slab will need to be broken up and new ground bearing slab formed with damp proof membrane and insulated to meet current building regulation requirements.

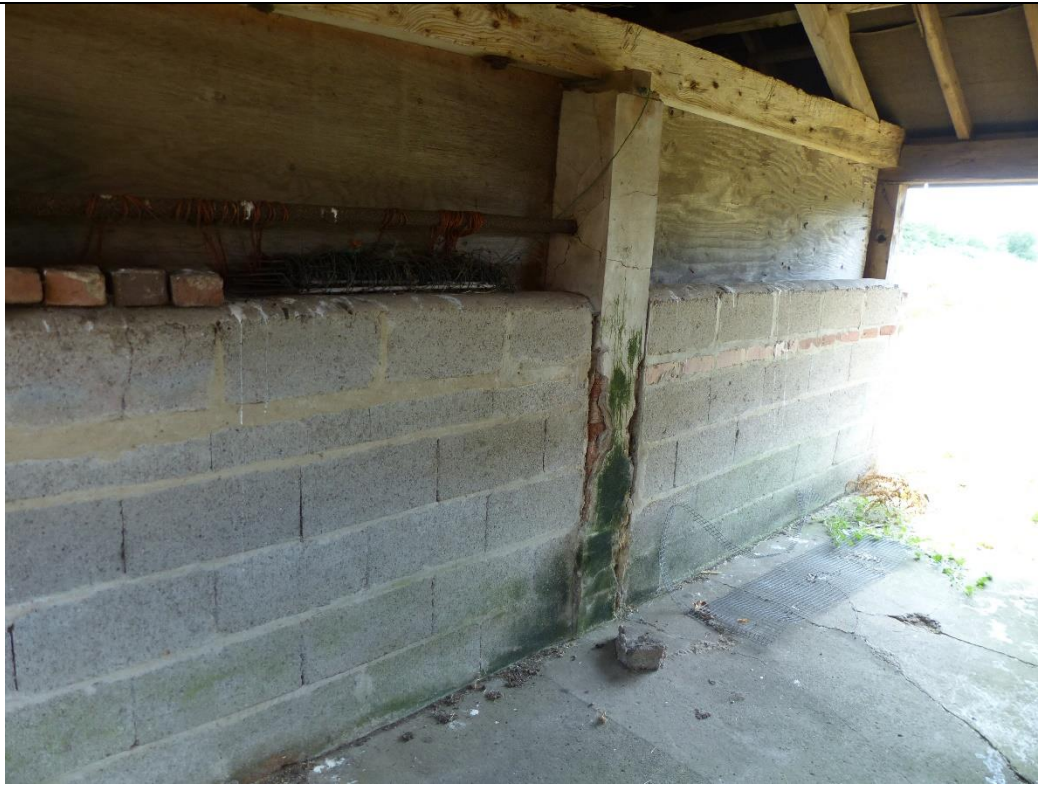
post truss. The pier towards elevation B2 was damaged revealing brickwork below. Due to the large span of the King post trusses, the piers were introduced at some point to stop potential deflection of the roof. This will need to be investigated during any future conversion works and it may be that if the piers are removed the roof trusses will need to be reinforced.

**Photo 13** – Barn 2 – Failing brickwork pier supporting King post trusses

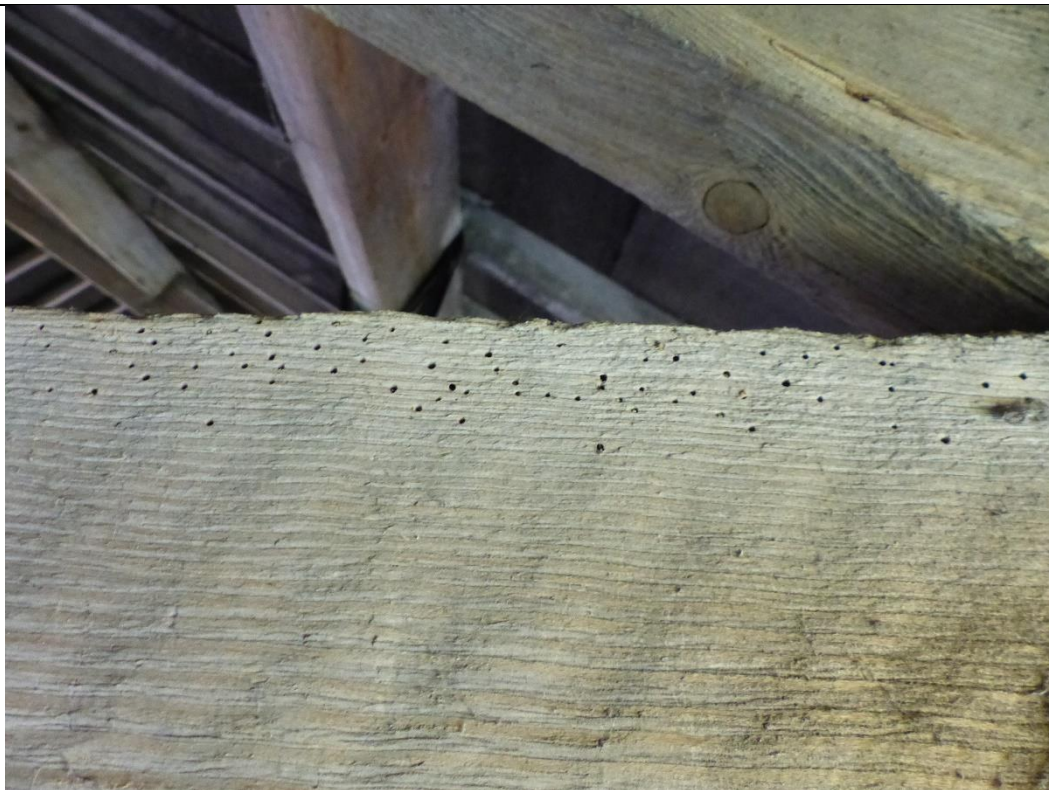
The timber wall plates which support the King post trusses and rafters, are supported along elevations B1 & B3 on a mixture of steel columns and concrete blockwork. The timber purlins bear into the external gable walls and are not supported on any pad stones or similar. As part of the conversion works, the majority of the roof timbers are in serviceable condition and can be retained following close up inspections. Flight holes were noted to the timber wall plates and the bottom cords to the king post trusses. It is not thought the woodworm is active, however, any timbers to be retained to be treated with a suitable fungicidal and woodworm treatment.

**Photo 14** – Barn 2 – 'Flight' holes noted to King post truss bottom cord and timber wall plates
