## CDM 2.0 Pre-Construction and Works Information Package

### SECTION ONE Pre-Construction Information

| General Data | | | |
|---|---|---|---|
| Waterway | Trent & Mersey Canal | | |
| Functional Location | TM-146-003 | | |

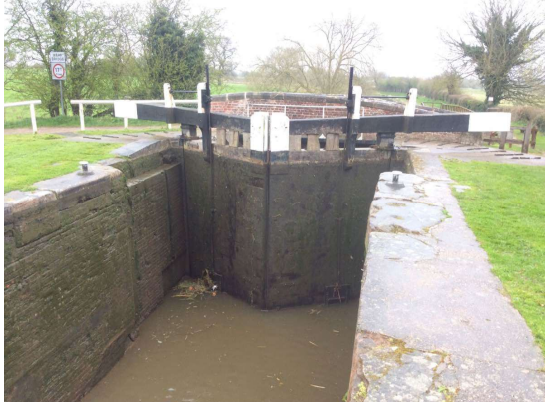
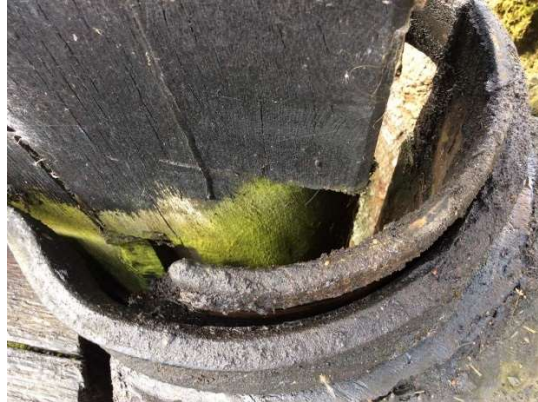
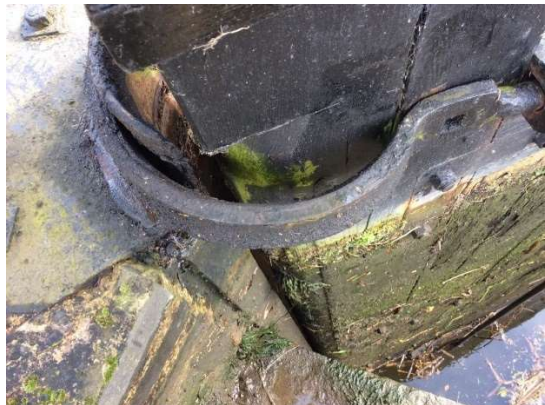
12222570 Plate 1 2016

15.10.2019. Given description that the batter of the lock wall is contributing to this issue, believe the solution to this problem will be same as was recently carried out at Aston, i.e. install a new quoin at a more vertical angle than the batter on the lock walls. The situation has improved slightly. This will require the lock gates to be replaced, but the gates will need to be measured up only once the new quoins haven been installed. Extended stoppage will be required.

- The quoins are fixed at a batter. If the quoins were replaced to a more vertical angle, this should make the gates easier to operate ( similar works completed at Aston lock previously)

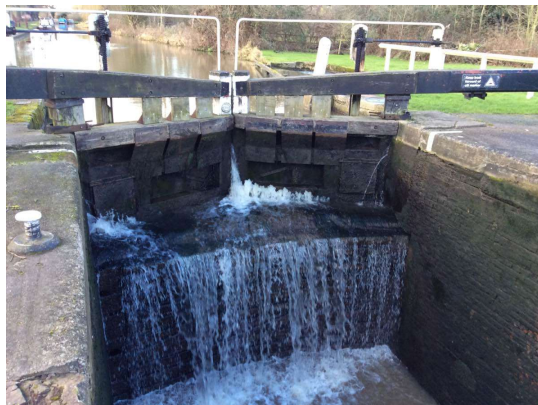
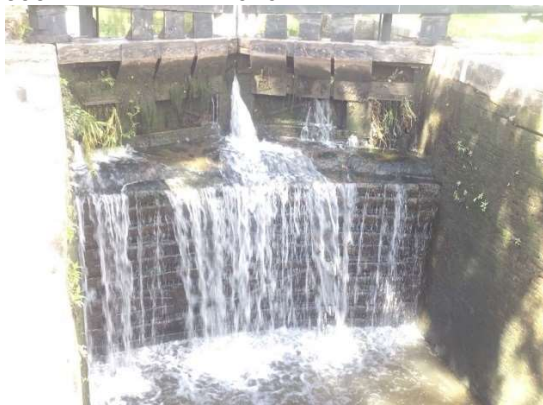
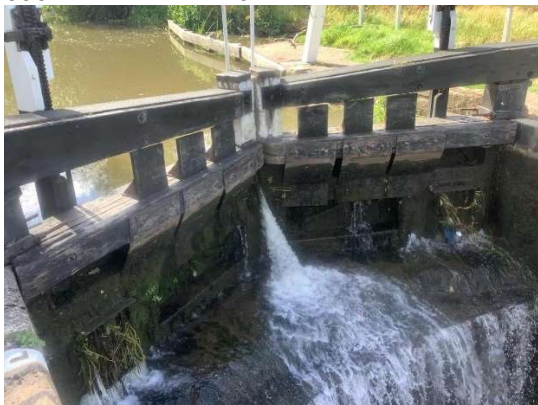
13932471 Plate 10 2016

12.10.2016. Leakage flow amended to heavy - photo added.

15.10.2019. There does not appear to be an issue with the gates themselves based on the photographs, this appears to relate more to debris given the variation in the leakage in the supplied photographs.

04.08.2022 Updated photo added as requested. Minimal Cill leakage on day of visit.

- Extensive leakage at the cills was observed.
- The cills should be replaced at the same time as the lock gates are replaced.

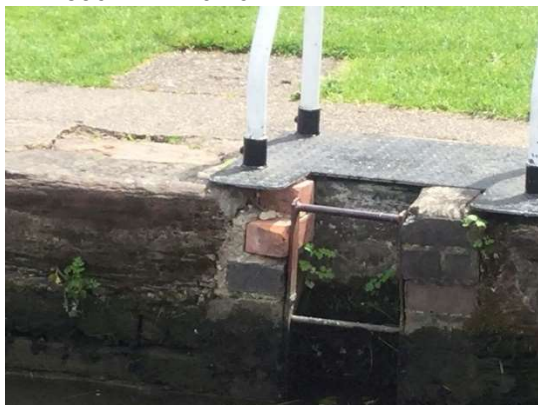
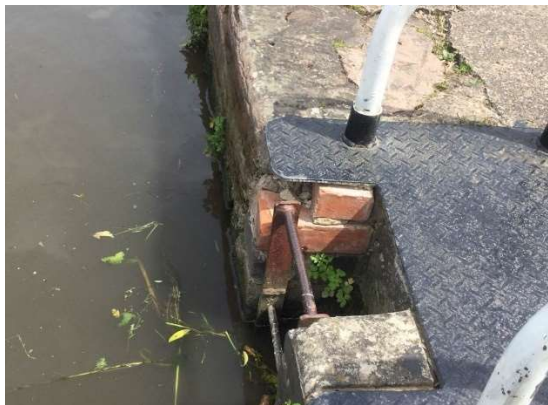
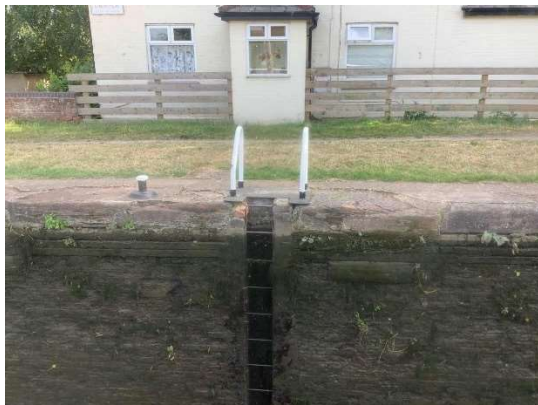
14742836 Plate 16 2017

06.06.2017. The d/s corner top of the t/p ladder recess requires brick repairs. There are two bricks that are loose and another missing.

- The ladder recesses will require widening to accommodate the new ladders. The brickwork should be repaired as part of these works.

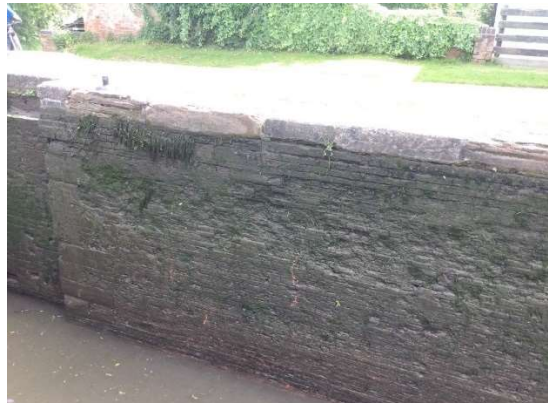
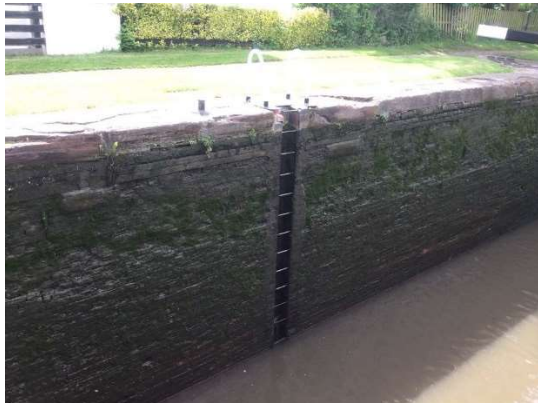
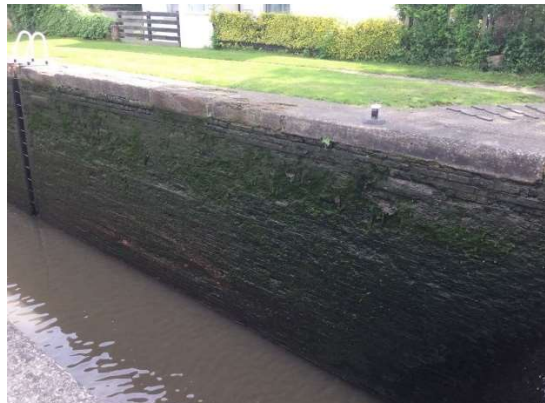
14742839 Plate 19 2017

06.06.2017. Localised areas of mortar loss noted along full length of the towpath side chamber wall. Loss appears worst in the upper 1m of brickwork immediately beneath the lock side copings.

- At the time of the site visit, it was difficult to inspect the chamber wall due to algae growth on the brickwork.
- There may be areas of brickwork which require replacement estimated at 3m2.
- Approximately 10m2 of the chamber wall will require repointing including the bed joint beneath the copings.
- The chamber wall will require pressure-washing prior to commencing works to enable a more detailed inspection of the brickwork to be completed.

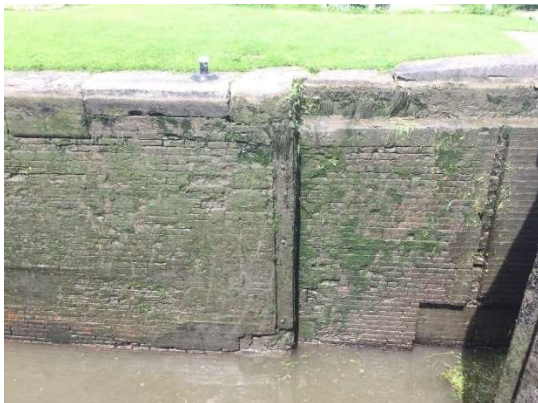
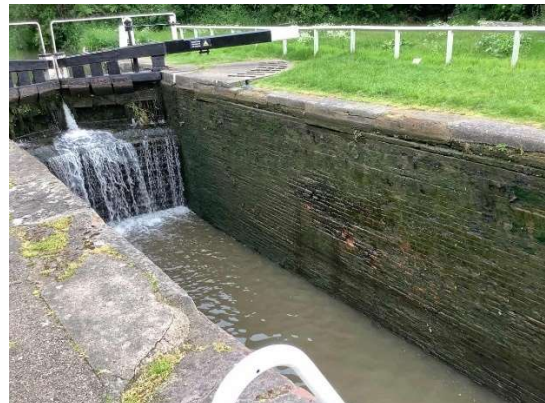
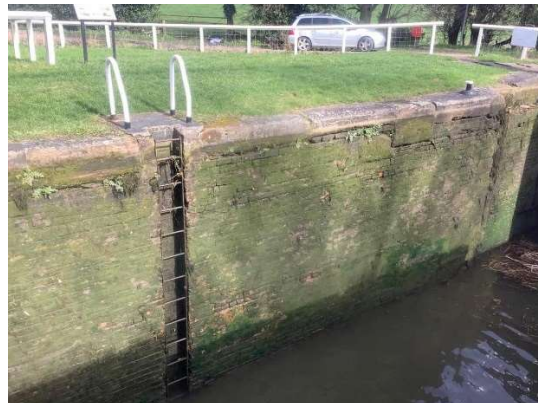
14742840 Plate 22 2017

26.05.2022 Damage to OS brick chamber wall from boat impacts (7metres from top gate) and 2m from top of coping.

- At the time of the site visit, it was difficult to inspect the chamber wall due to algae growth on the brickwork.
- There are areas of brickwork which require replacement estimated at 6m2.
- Approximately 10m2 of the chamber wall will require repointing including the bed joint beneath the copings.
- The chamber wall will require pressure-washing prior to commencing works to enable a more detailed inspection of the brickwork to be completed.

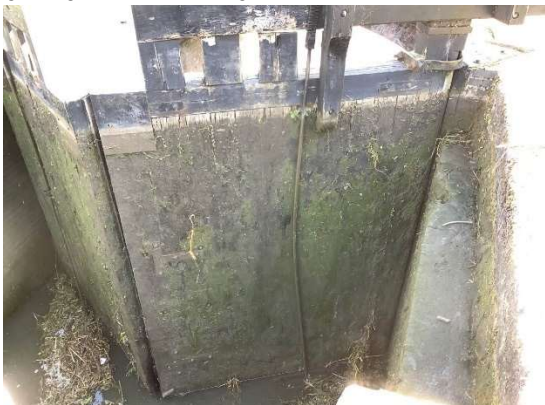
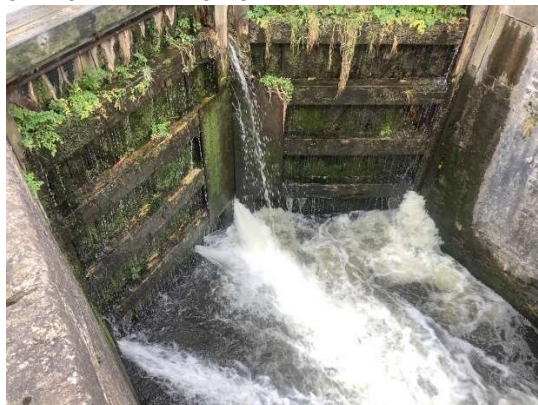
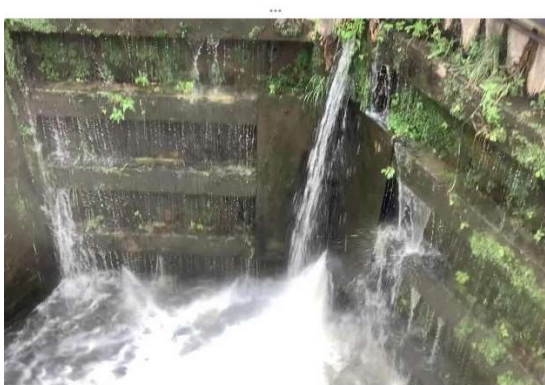
16142671 Plate 27 2021

21.03.2022 Leakage through bottom gates now so severe that lock is barely able to fill. Please prioritise gate replacement. Anticipate that lock will struggle to make it through coming season. Photo added.

- The gates are in poor condition and should be replaced along with the clap cills and gate cups.
- Replacement gates should be manufactured to the existing gate style / specification for this area of the Trent & Mersey Canal.

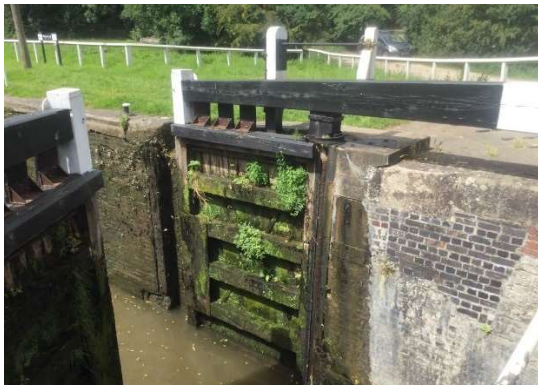
16488730 Plate 30 2020

20.08.2020. The mitre is not aligning on the gates when they close, meaning the o/s gate, if closed last, swings open. This will be resolved when gates replaced in B22 so assume NFA until then.

28.08.2020. Look to resolve during gate replacement, proposed for B22 but may be subject to change.

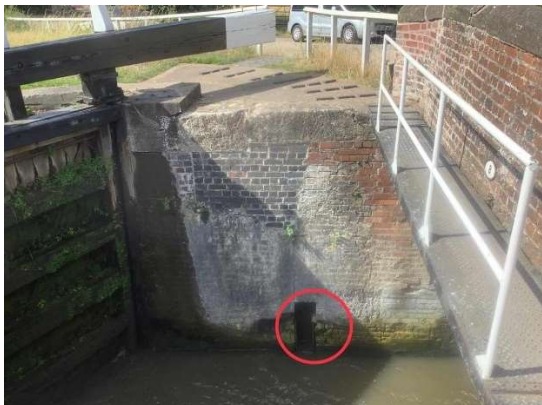
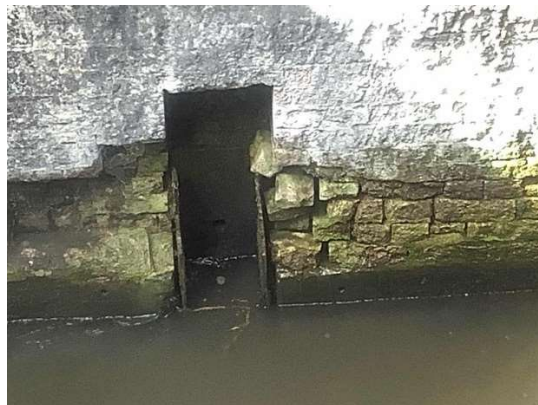
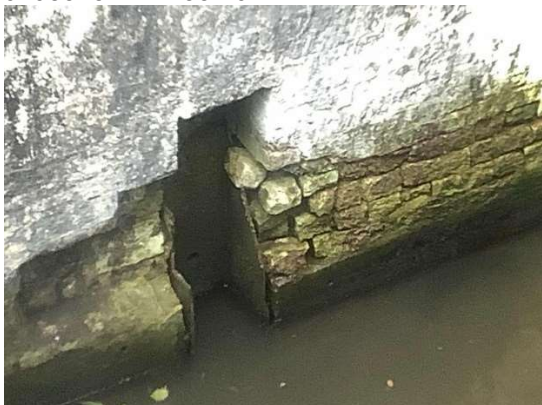
16768315 Plate 33 2022

14.04.2021. The bottom o/s stop plank groove opening would benefit from brickwork repairs. Missing, loose bricks and general repointing works required.

- There is approximately 0.75m<sup>2</sup> of brickwork to be repaired around the top of the stop plank groove on the offside approach wall at the downstream end of the lock.
- Loose bricks can be removed and re-laid.
- Missing brickwork should be replaced with bricks to match the originals in size and colour

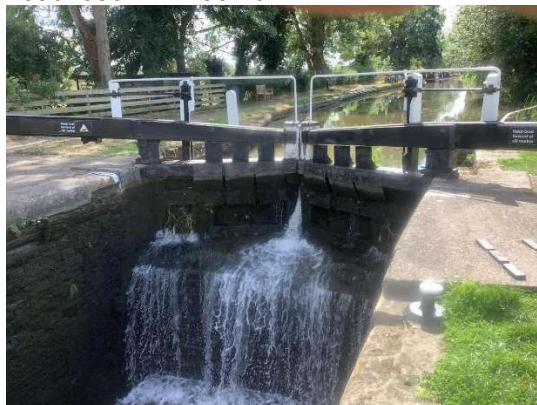
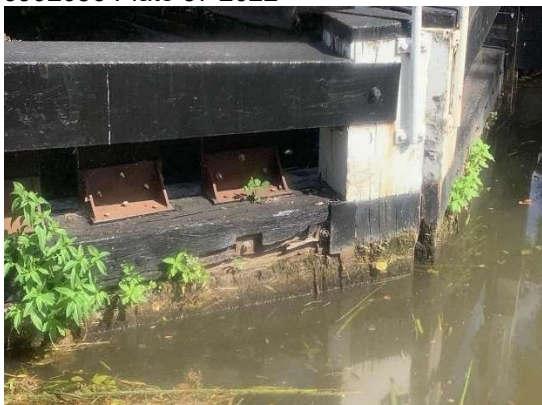
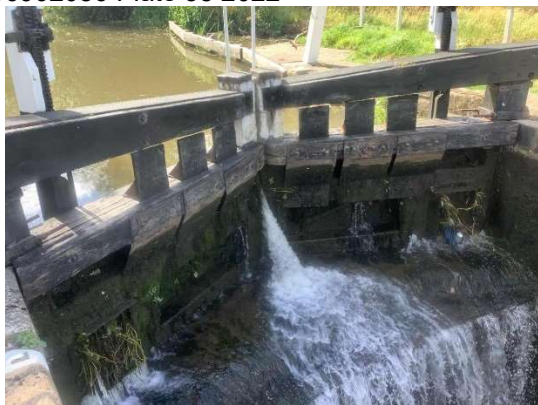
16902086 Plate 36 2022

06.07.2021. Gate to be replaced alongside the Grade 5 bottom gates, cost effectiveness.

- The gates are in poor condition and should be replaced along with the clap cills and gate cups.
- Replacement gates should be manufactured to the existing gate style / specification for this area of the Trent & Mersey Canal.

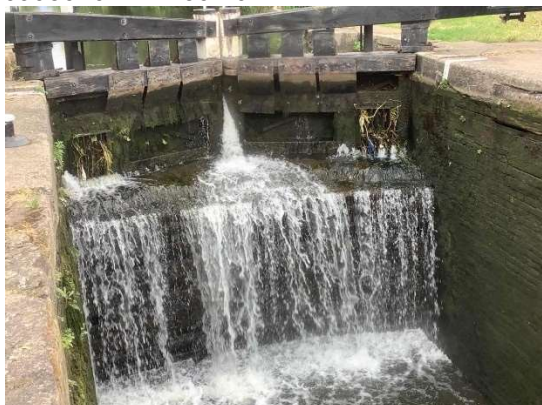
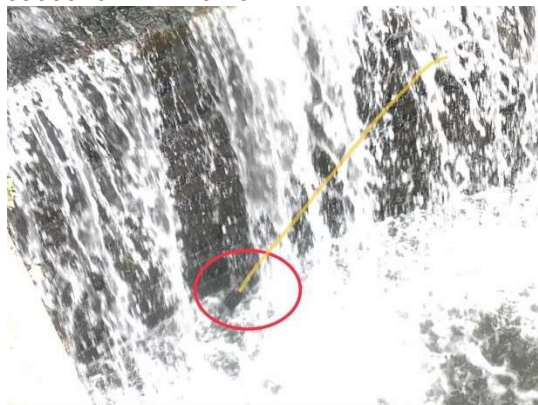
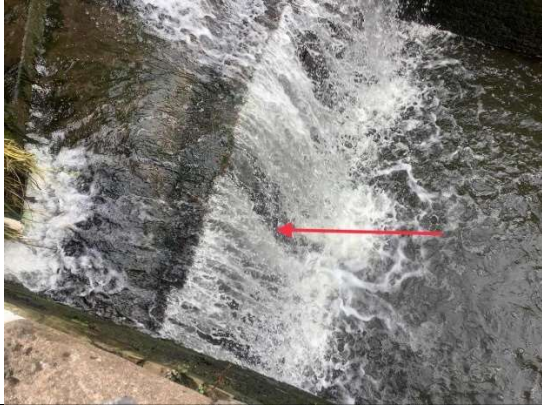
16905076 Plate 39 2022

03.08.2022. Photos of dropped Cill fender iron rail that has dropped and will have caused a gap that could be a potential snagging point.

- The cill fender rails are fitted horizontally across the face of the cill wall and can pose a snagging risk to craft.
- A suitable solution would be to provide timber fenders as was recently completed at lock 6, Stenson lock.
- The existing cill fender rails should be removed and replaced with timber fenders fixed to the wall to form a flush face.

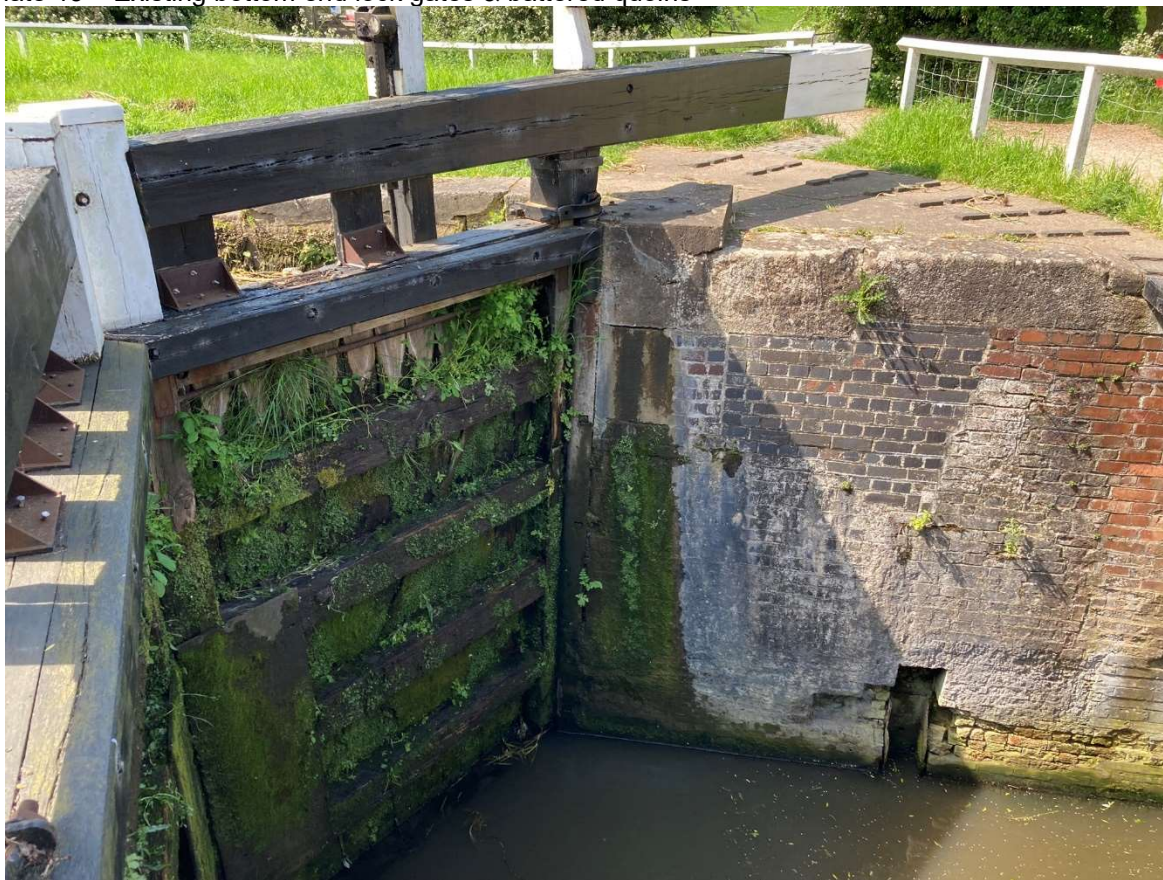
- On the day of the site visit, I was able to operate both gates ok, however, these are large gates with heavy balance beams.
- The quoins are fixed at a batter. If the quoins were replaced to a more vertical angle, this should make the gates easier to operate ( similar works completed at Aston lock previously)
- Listed building consent would be required for this work and the measurements for the new gates would need to be taken after the quoins have been repositioned.

Plate 45 – Existing bottom end lock gates & battered quoins

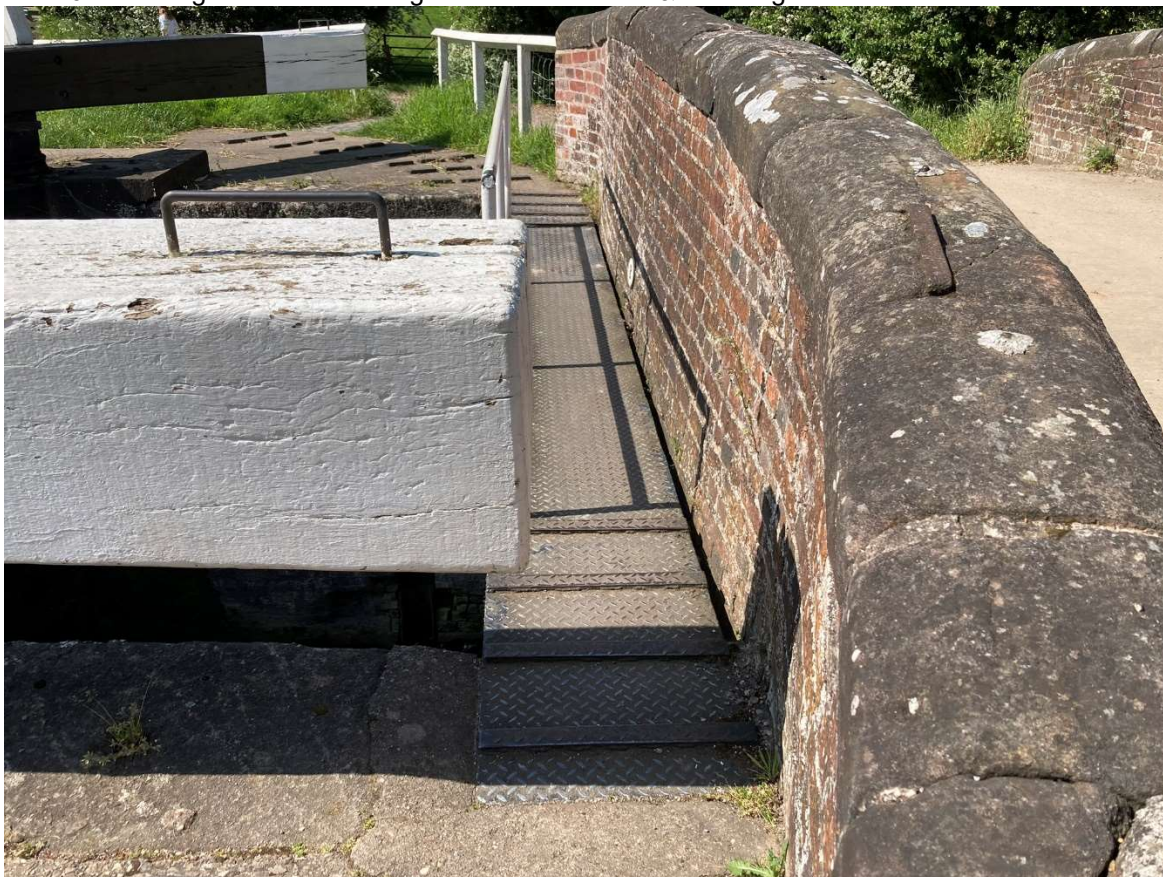
Plate 46 – Existing bottom end lock gate balance beams & footbridge

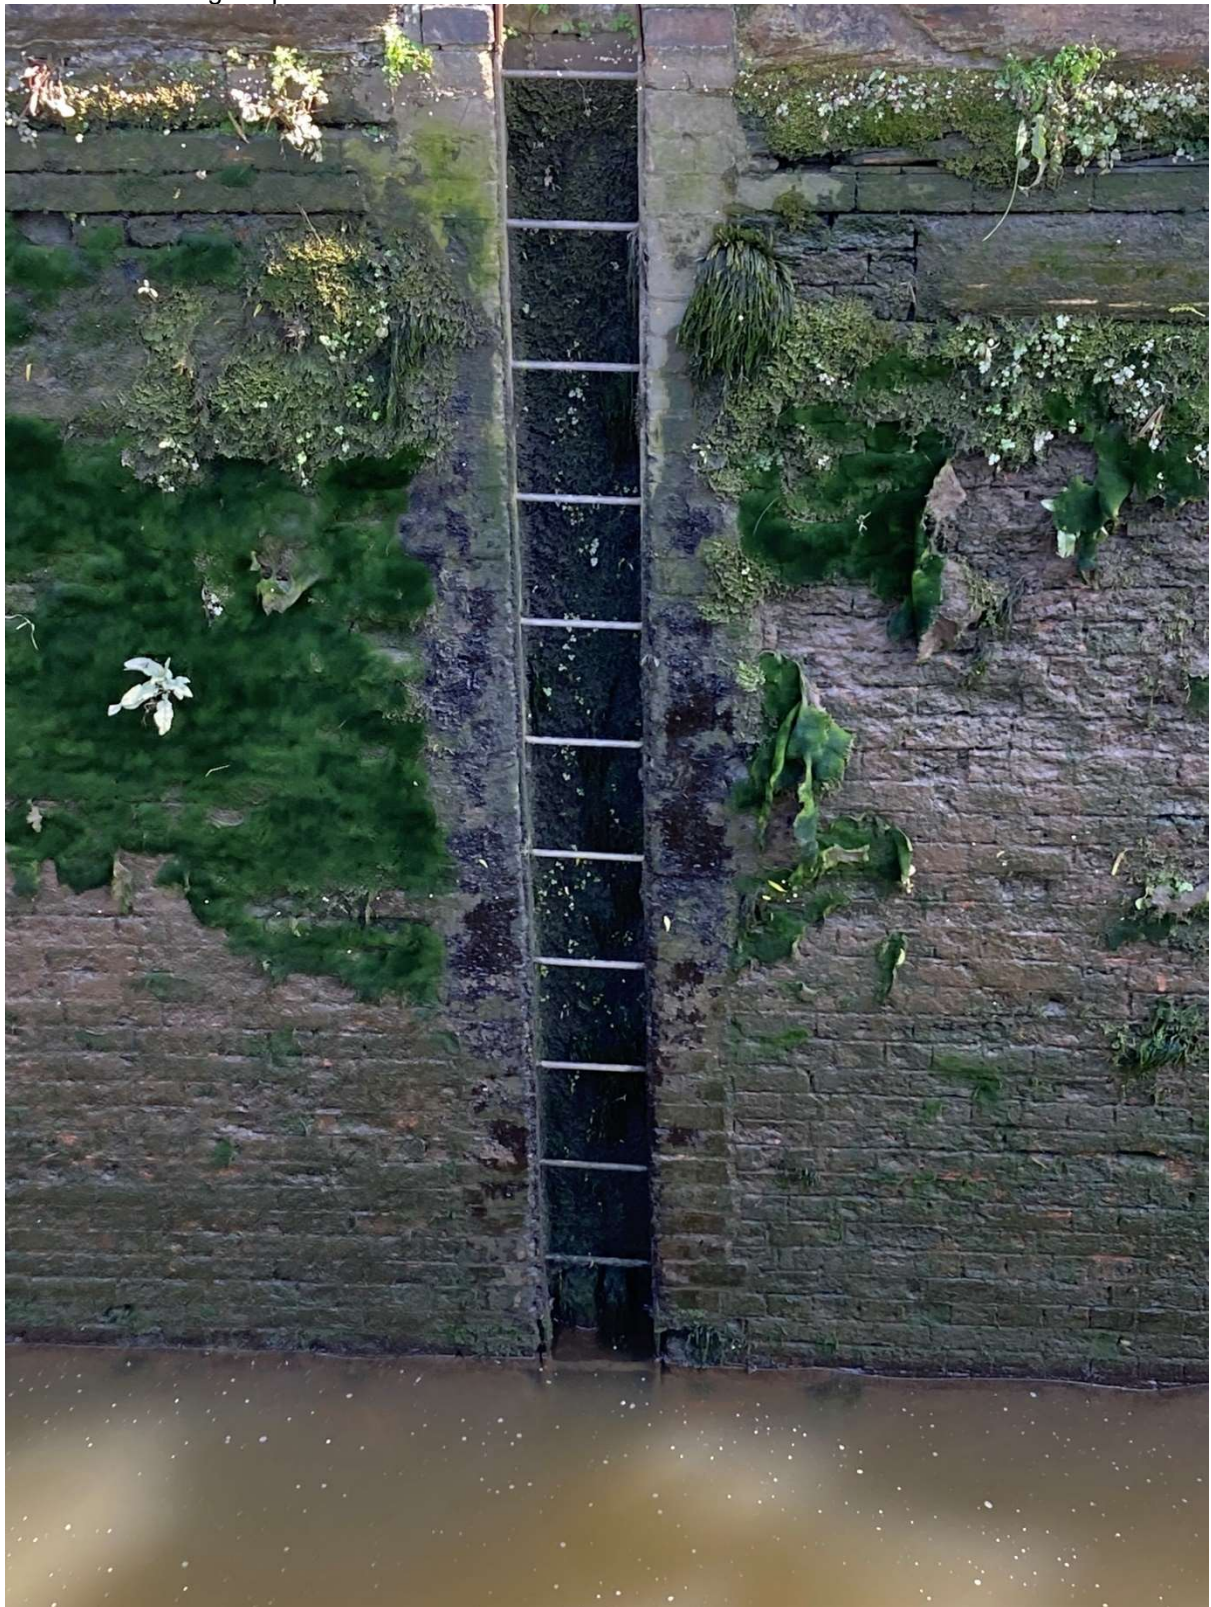
- The existing ladders do not comply with the Mandatory Standard for Navigation Standards.
- Ladder recesses are not wide enough. Widening of the ladder recess will involve some cutting of the stone copings.
- Stringers do not connect to handrails.
- There are some loose bricks in the towpath side ladder recess which require re-laying.
- Ladders are too short.

Plate 47 – existing towpath lock ladder

- Ladders should be replaced in their entirety to comply with current Mandatory Standard for Navigation Standards.
- Replace both ladders with new ladders as per Trust standard details for new lock ladders & hoops drawing numbers STD-CRT-ZZ-ZZ-03-DR-C-06 & STD-CRT-ZZ-ZZ-03-DR-C-07.
- Construct ladder recess in chamber walls in accordance with Canal & River Trust Civil Engineering Specification version 1.1 Part U Brickwork, Blockwork and Masonry.

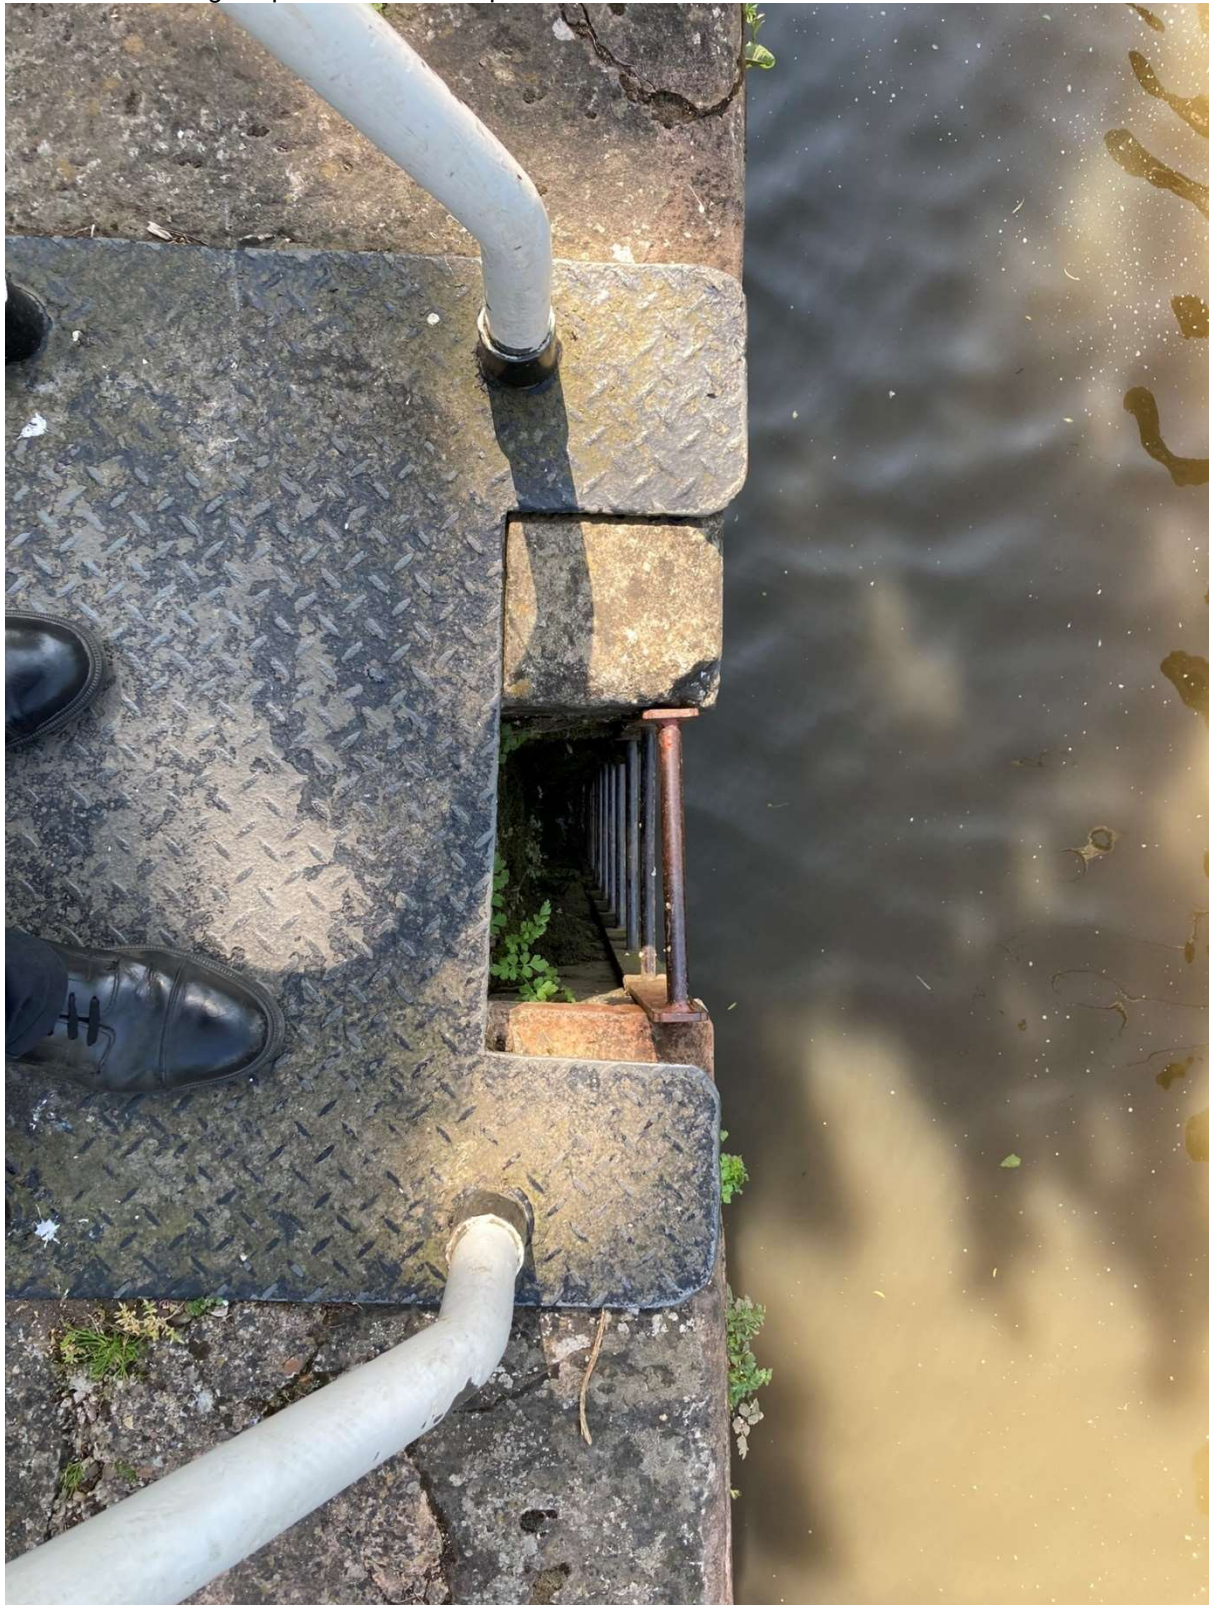
Plate 48 – existing towpath lock ladder top

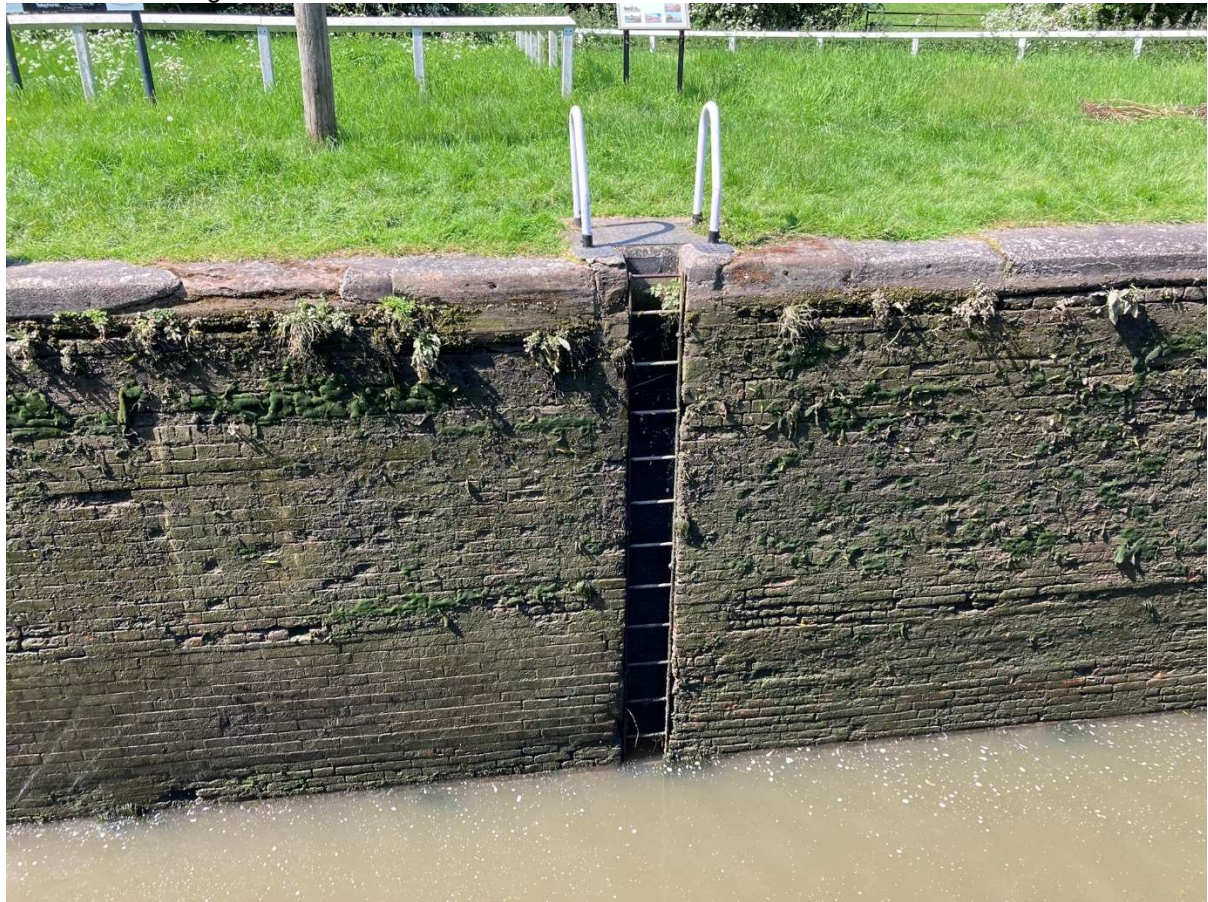
Plate 49 – existing offside lock ladder

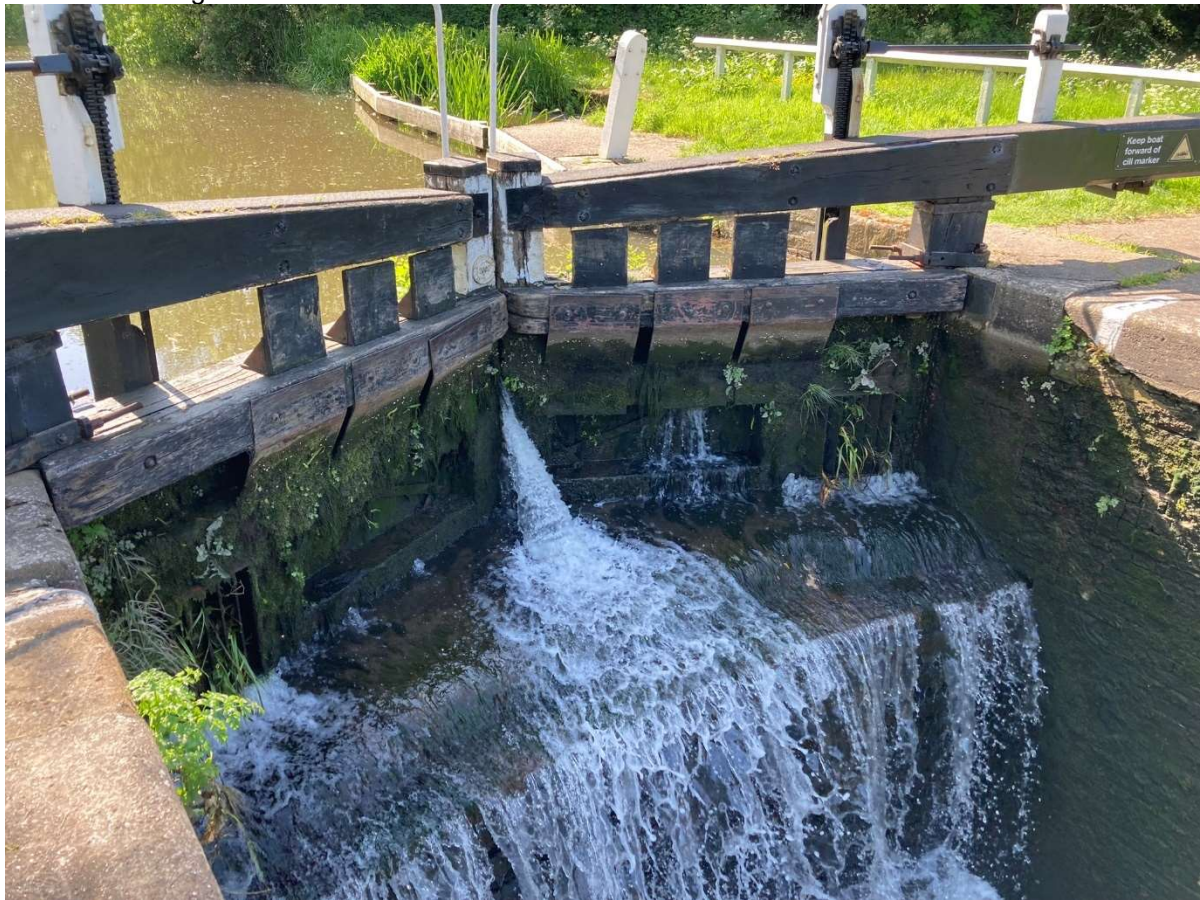
- Extensive leakage at the cills was observed, in particular near to the quoins.

Plate 50 – leakage at cills

- Replace the cills at the same time as the lock gates are replaced.
- Seal any leakage through quoins / masonry with cementitious grout such as "Fosroc – Conbextra HF" (or similar approved).
- Seal gap between new cills and existing concrete forbay with concrete.

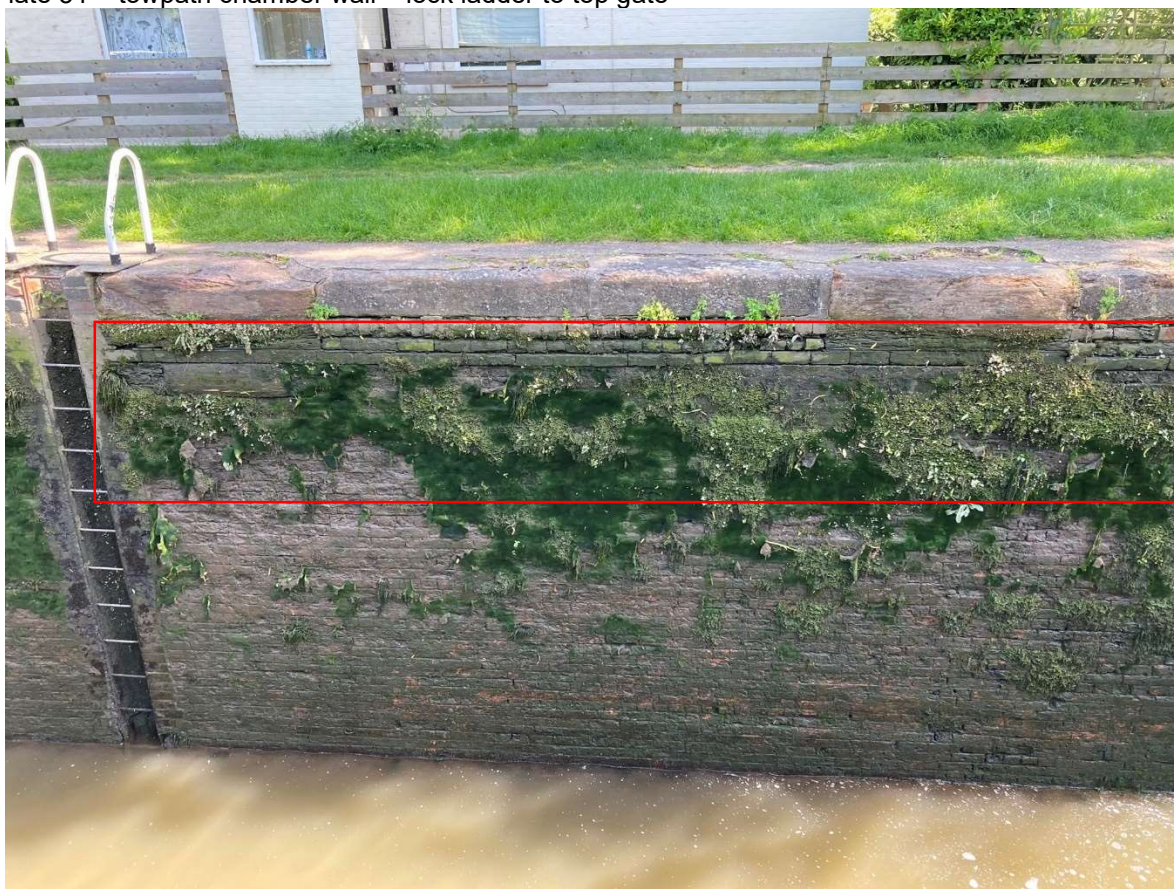
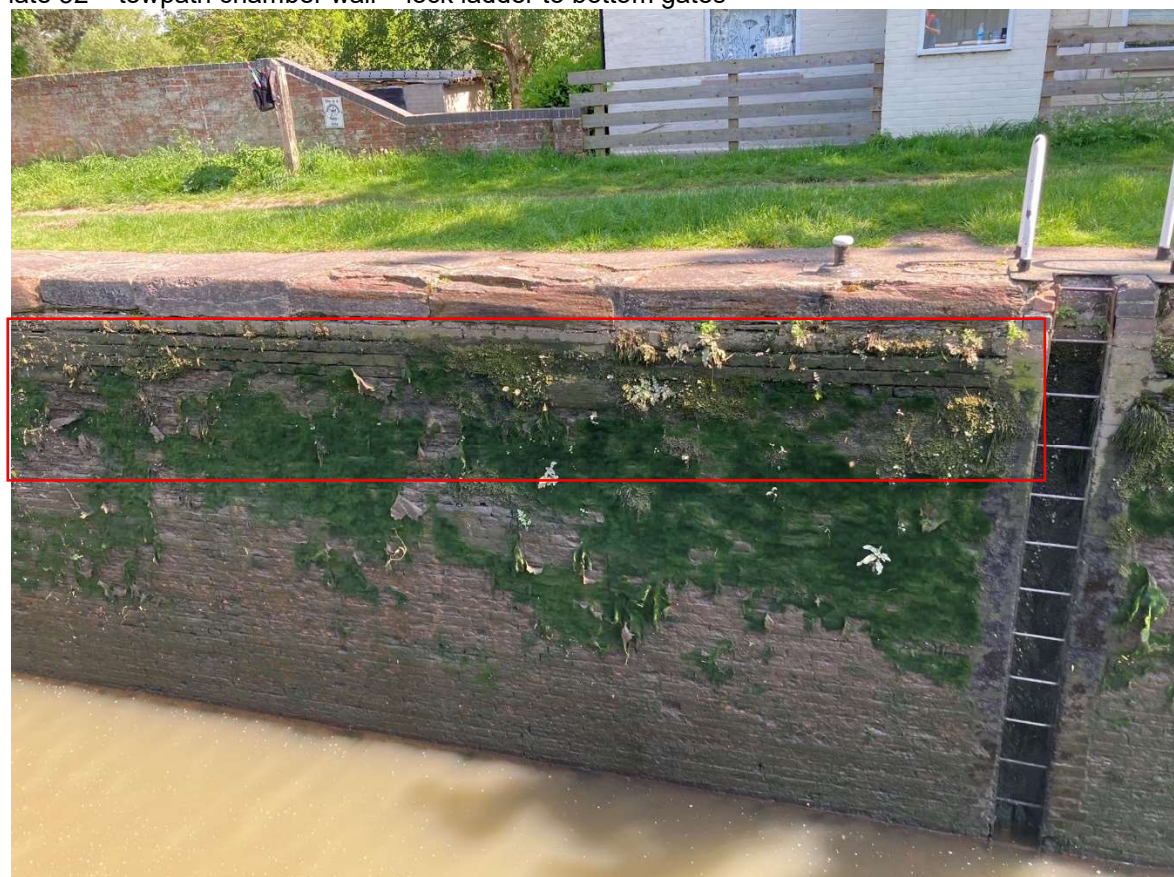
- Localised areas of mortar loss noted along full length of the towpath side chamber wall. Loss appears worst in the upper 1m of brickwork immediately beneath the lock side copings.
- There may be areas of brickwork which require replacement estimated at 3m<sup>2</sup>.
- Approximately 10m<sup>2</sup> of the TP chamber wall will require repointing including the bed joint beneath the copings.

Plate 51 – towpath chamber wall – lock ladder to top gate

Plate 52 – towpath chamber wall – lock ladder to bottom gates

- Pressure wash the lock chambers wall to remove any loose mortar and vegetation.
- Contact Asset Engineer immediately if after cleaning, scope of repair has changed.
- Prepare brickwork for repointing.
- Repoint the brickwork. Replace any spalled or damaged bricks
- Where brickwork requires replacement, new brickwork to be constructed in accordance with drawing STD-CRT-ZZ-ZZ-03-DR-C-03 Refacing Brickwork.
- All works to be completed in accordance with Canal & River Trust Civil Engineering Specification version 1.1 Part U Brickwork, Blockwork and Masonry.

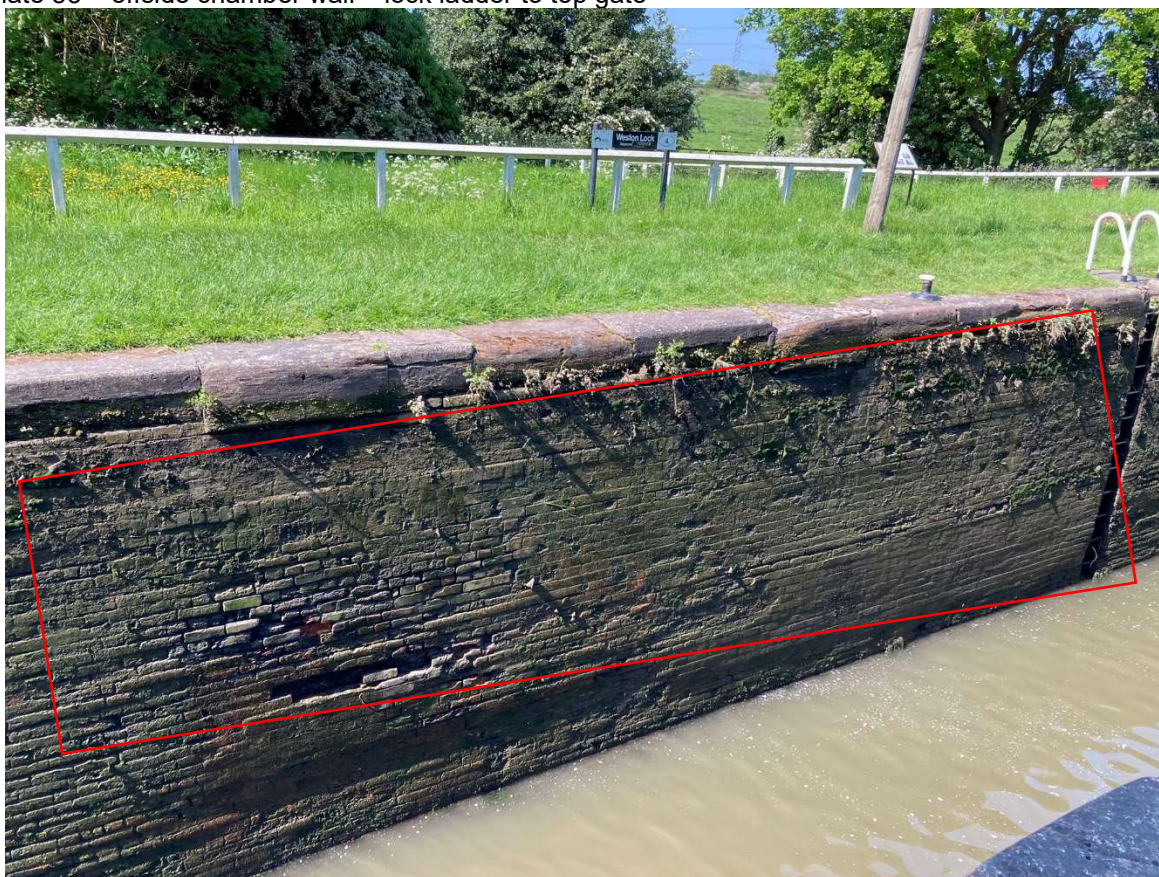
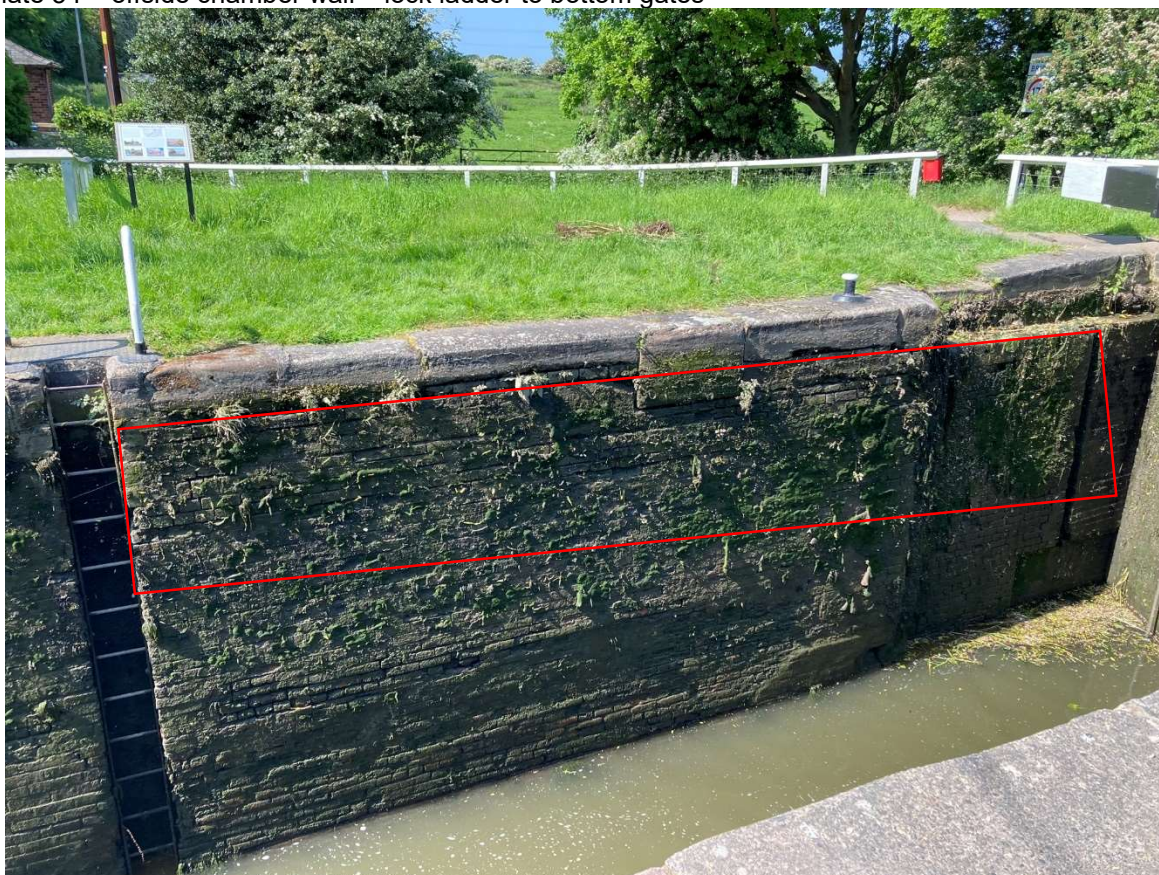
- Large areas of mortar loss along the entire length of the offside chamber wall. Of note it was felt that mortar loss was mainly bad within the bottom gate recess and the upper 1m of wall immediately beneath the lock top coping
- There are areas of brickwork which require replacement estimated at 6m<sup>2</sup>.
- Approximately 10m<sup>2</sup> of the chamber wall will require repointing including the bed joint beneath the copings.

Plate 53 – offside chamber wall – lock ladder to top gate

Plate 54 – offside chamber wall – lock ladder to bottom gates

- Pressure wash the lock chambers wall to remove any loose mortar and vegetation.
- Contact Asset Engineer immediately if after cleaning, scope of repair has changed.
- Prepare brickwork for repointing.
- Repoint the brickwork. Replace any spalled or damaged bricks
- Where brickwork requires replacement, new brickwork to be constructed in accordance with drawing STD-CRT-ZZ-ZZ-03-DR-C-03 Refacing Brickwork.
- All works to be completed in accordance with Canal & River Trust Civil Engineering Specification version 1.1 Part U Brickwork, Blockwork and Masonry.
