## CDM 2.0 Pre-Construction and Works Information Package

### SECTION ONE Pre-Construction Information

| General Data | | | |
|---|---|---|---|
| Waterway | Trent & Mersey Canal | | |
| Functional Location | TM-146-003 | | |

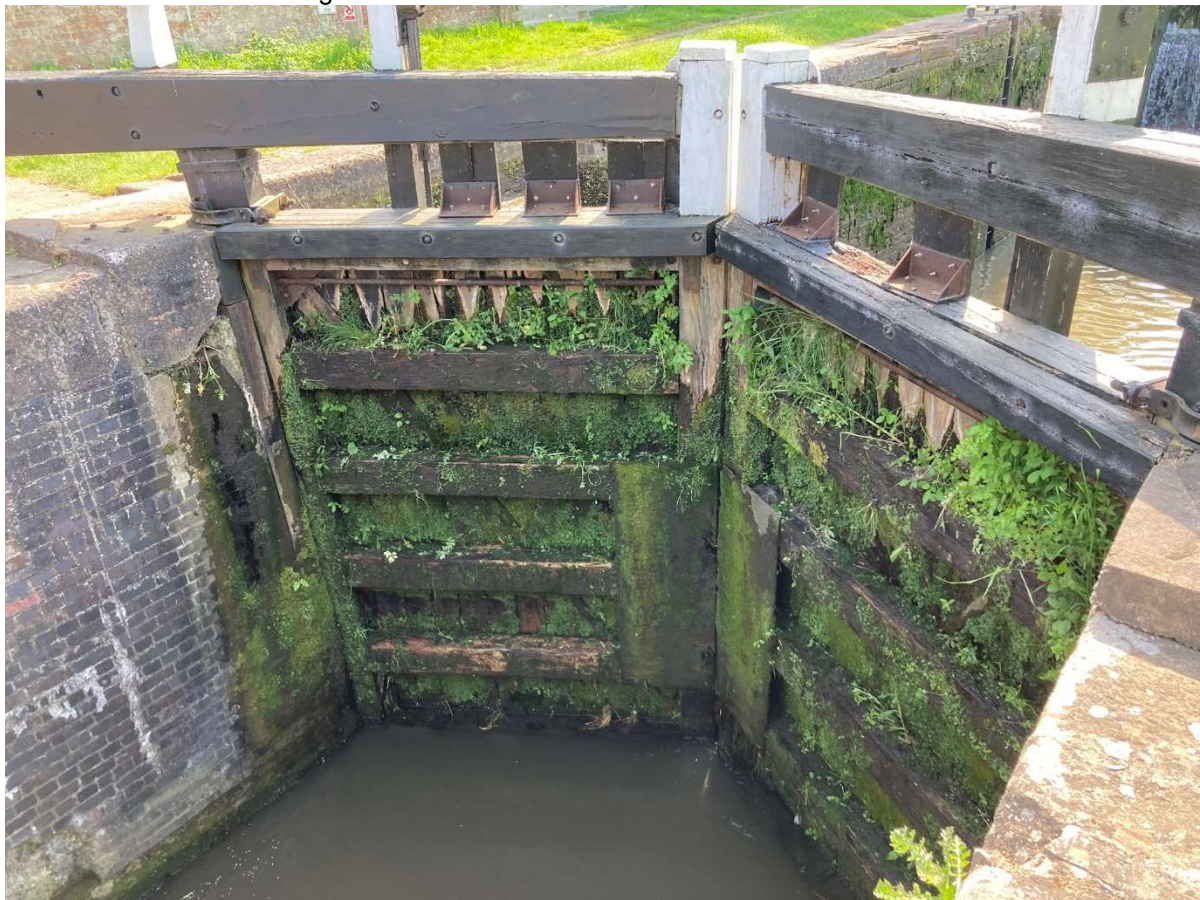
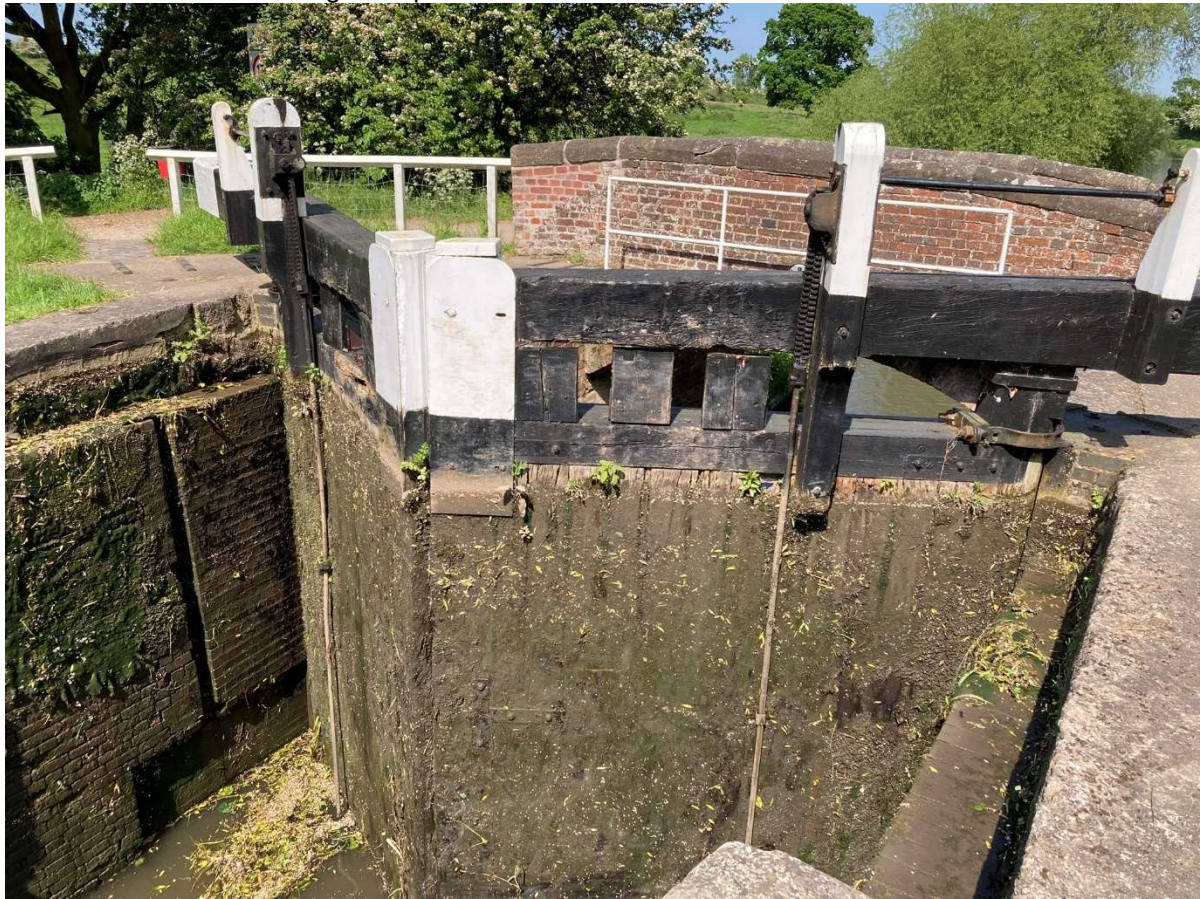
- Gates inspected and assessed as grade 4 – gates require replacement within 5 years.
- Leakage from gates losing the “fit” position due to wear / alignment of gate cups.
- Boil at cill and leakage through mitres
- Offside gate reported as swinging open.
- Estimated 30m<sup>3</sup> of debris in the bottom of the lock chamber

Plate 55 –Bottom end lock gates downstream face

Plate 56 – Bottom end lock gates upstream face

- Replace the lock gates and balance beams with new gates to the Trent & Mersy canal style and measurements for this location.
- New gates to include all gate furniture & fixings (ironwork, sluice gates, paddle gear).
- Replace timber cills.
- Replace gate cups.
- Seal any leakage through quoins / masonry with cementitious grout such as “Fosroc – Conbextra HF” (or similar approved)
- Remove debris from invert of lock chamber.

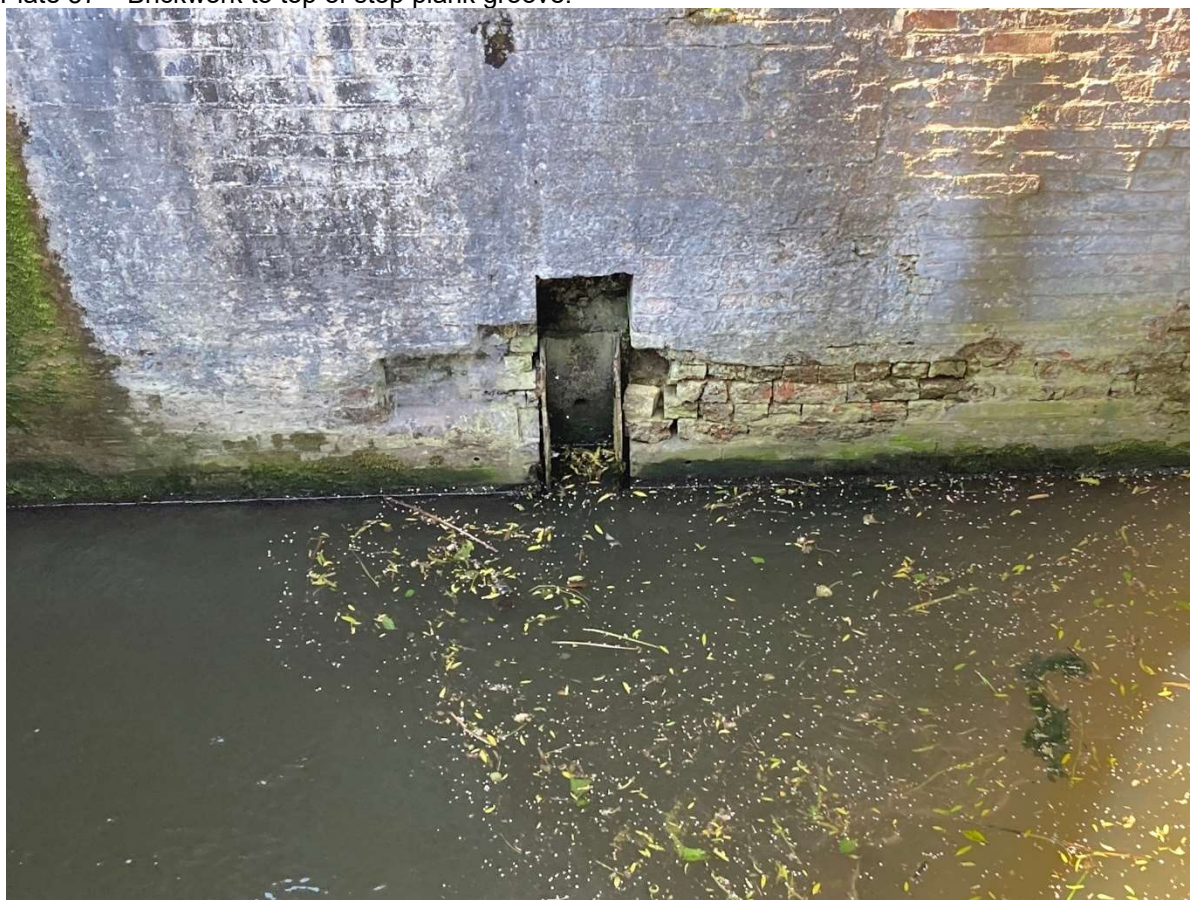
- There is approximately 0.75m<sup>2</sup> of brickwork to be repaired around the top of the stop plank groove on the offside approach wall at the downstream end of the lock.
- The brickwork is loose / spalled.

Plate 57 – Brickwork to top of stop plank groove.

- Remove any loose or damaged bricks.
- Replace brickwork with bricks to match the originals in size and colour.

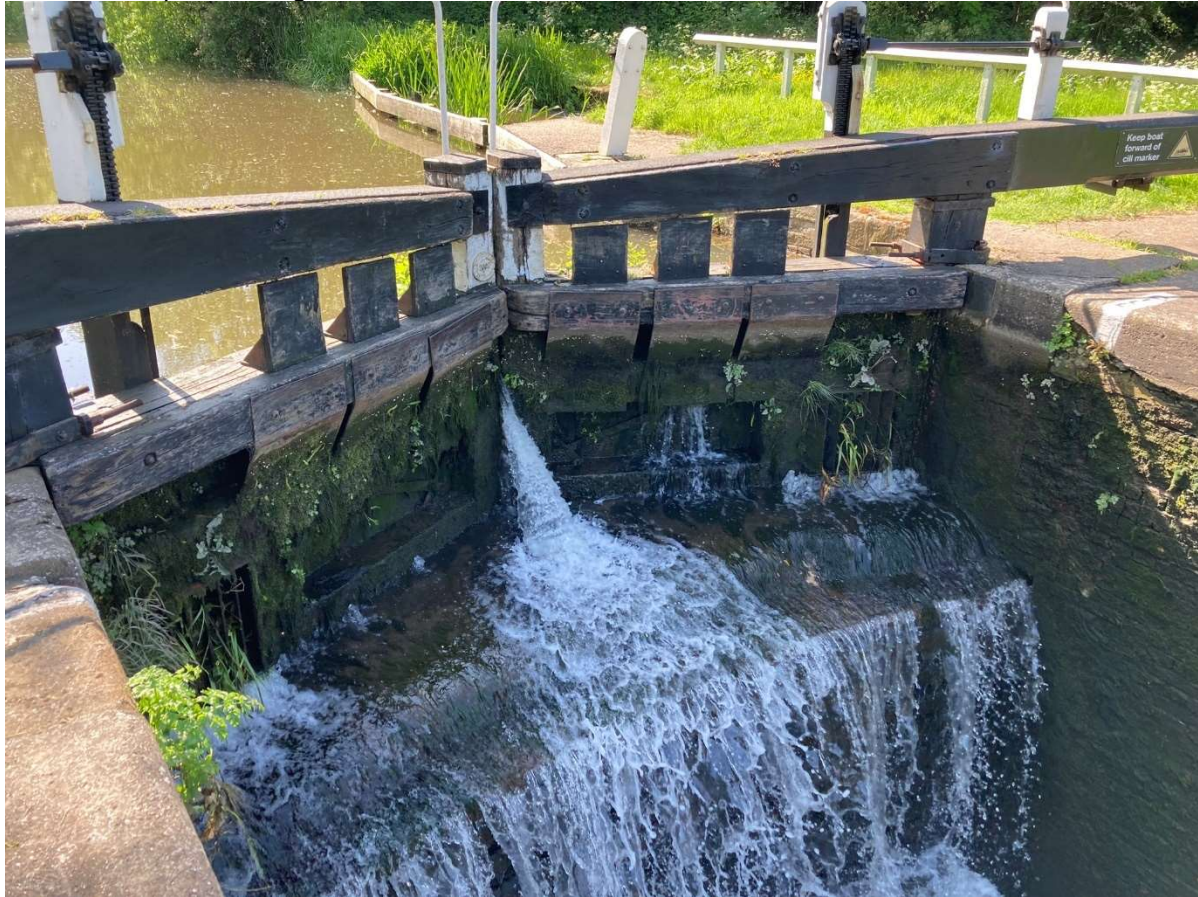
- Gates inspected and assessed as grade 3 – gates require replacement within 10 years.
- Leakage from gates losing the “fit” position due to wear / alignment of gate cups.

Plate 58 – Top end lock gates

- Replace the lock gates and balance beams with new gates to the Trent & Mersey canal style and measurements for this location.
- New gates to include all gate furniture & fixings (ironwork, sluice gates, paddle gear).
- Replace timber cills.
- Replace gate cups.
- Seal any leakage through quoins / masonry with cementitious grout such as “Fosroc – Conbextra HF” (or similar approved)

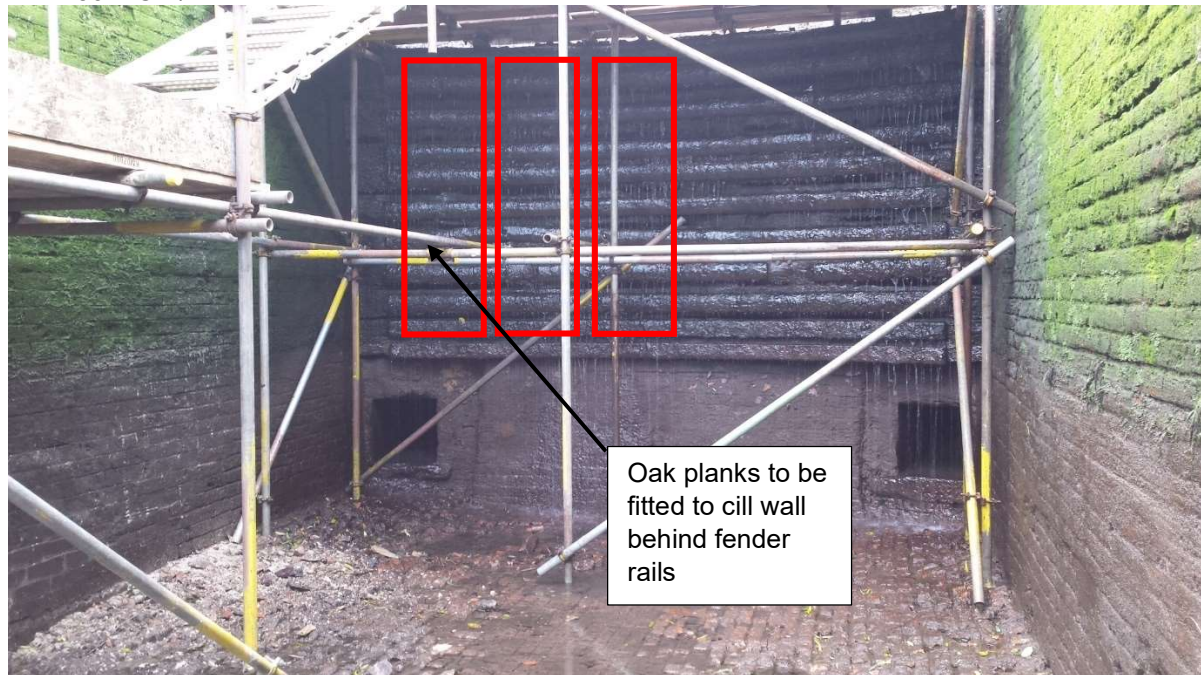
- The cill fender rails are fitted horizontally across the face of the cill wall and can pose a snagging risk to craft where there are voids between the rails.
- The voids are due to missing / failed timber fenders at the face of the wall.
- As part of the investigation into a recent boat sinking at Stenson Lock, the face of the cill (ribbed metal at present) was raised by the Chief Operating Officer as a potential contributory factor. At present the investigation is ongoing for that case.

Plate 59 – Cill / chamber wall with horizontal fender rails

- Oak planks to BS EN 338 grade class D40.
- M20 200mm coach screws for fixing timbers & original fender rails - A4 316 Stainless Steel.
- If timber planks are fixed to masonry instead of timber, use M20 stainless threaded bat fixed with Hilti HY-270 resin or similar approved.
