Repton School  
Window Repairs to  
Rear (South) Elevation  
of Foremark Hall  
Milton

# Window 11

Scale: 1:10 @ A3  
Date: January 2026  
Drawn By: CP Checked By:  
Drawing No. 2025-860-11

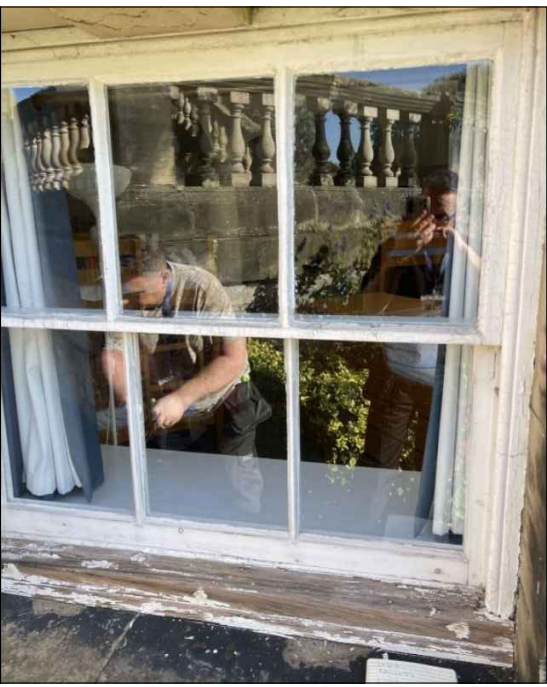
PHOTO

| Level: | LGF |
| Window number: | 11 |
| Description: | 3/3 sliding sash |
| Provenance: | Probably 19 <sup>th</sup> Century, lower sash and cill have been replaced with different profile |
| Condition: | Poor |

| Replace parts: | Lower sash (1)<br>Cill (2)<br>2 no. weight boards (3) |
| Replace glass: | 3. no panes of lower sash (4) |
| Timber repair: | Apply proprietary epoxy resin filler as required |
| Overhaul: | Disassemble as necessary, service opening mechanism, reassemble so as to open freely<br>Remove 2 no. opening restrictor blocks (5) |
| Putty: | Rake out substandard putty and replace with proprietary putty replacement sealant |
| Ironmongery: | Retain existing<br>Add proprietary opening restrictor with key release |
| Decoration: | Sand to stable surface, repaint with primer/undercoat and top coat, paint to overlap slightly on to glass |
| Perimeter seal: | Apply proprietary oil-based mastic sealant |
