### DAILY RECORD SHEET

| <b>Employer:</b> Benniman Construction Group Ltd | | <b>Site:</b> Dove Valley Park – Plot 11 | |
| <b>Contractor:</b> Collins Earthworks Ltd | | <b>Engineer:</b> GS | |

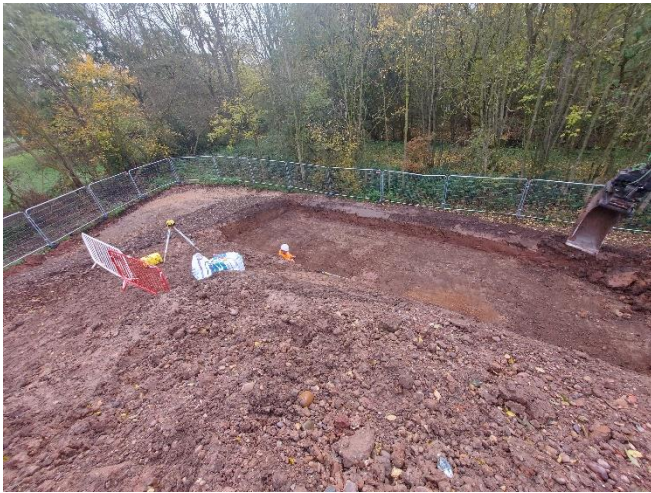
AB9/AB10 - Formation of retaining wall foundation currently being prepared.

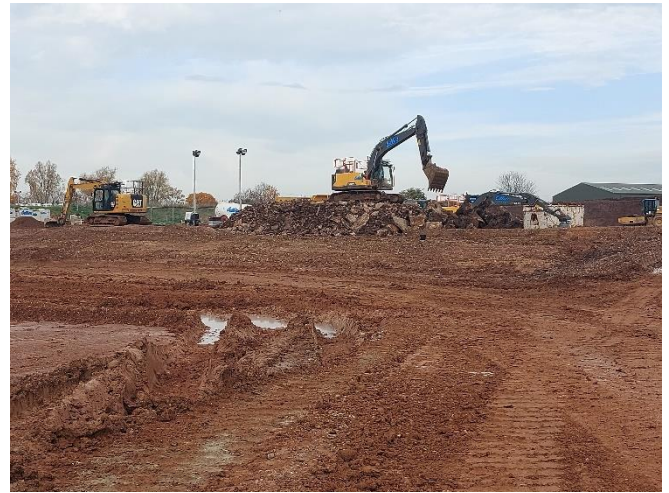
Screening of material from Marl Pit is in progress for larger objects.

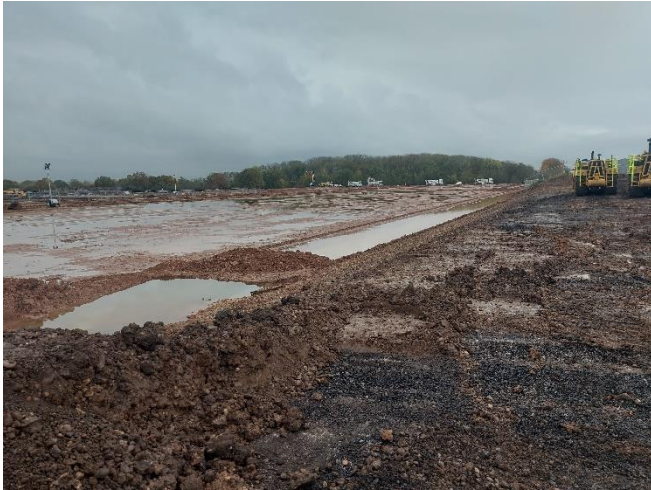
P3 towards South – Ponding water within the development platform.

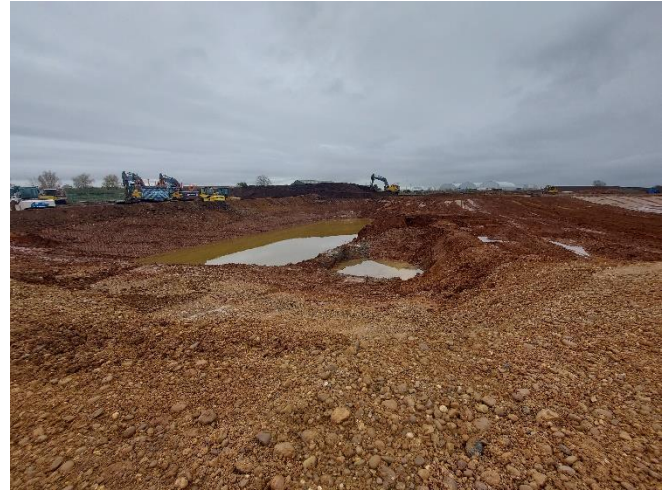
M6 towards North – Infilled Pond in the northern part of site is fully excavated – ponding water is noticed.

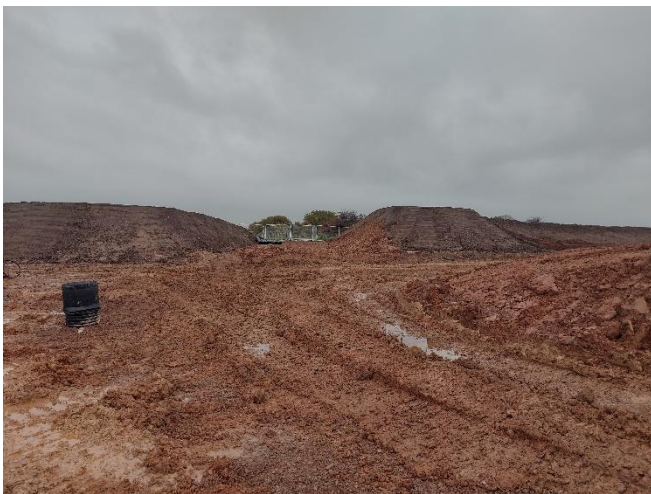
H9 towards East (H10) – Landscape bund is partly removed to install the drainage – to be reinstated.

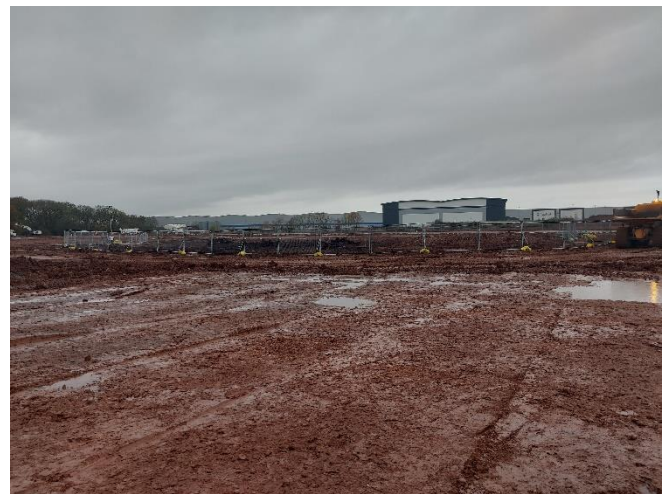
R11 towards S9 – Marl pit area has been fenced off following the discovery of asbestos and other potential contaminants.

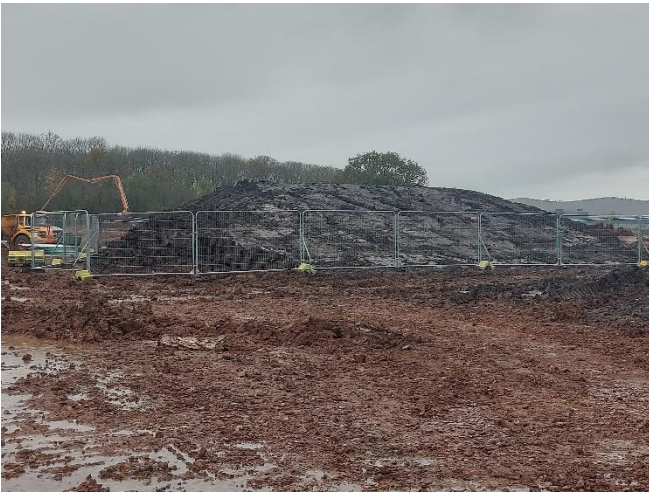
S12 towards U11 – Potentially contaminated subsoil material from the Marl Pit has been stockpiled, isolated, and securely fenced off following the discovery of asbestos and other suspected contaminants.

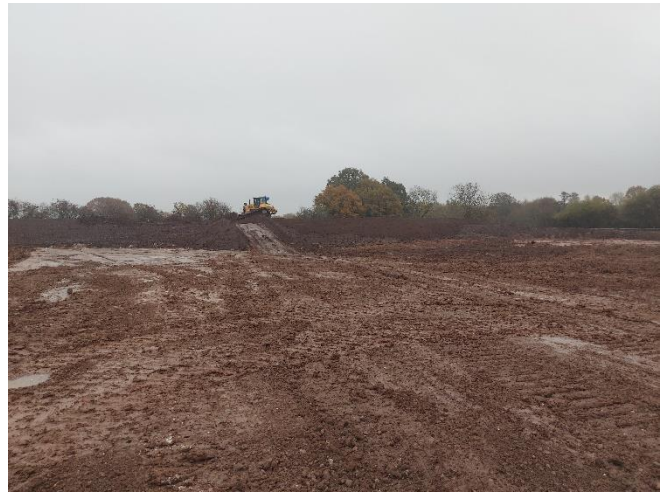
Landscape bund construction is currently underway at grids V17/W18 following a 2-week hold period.

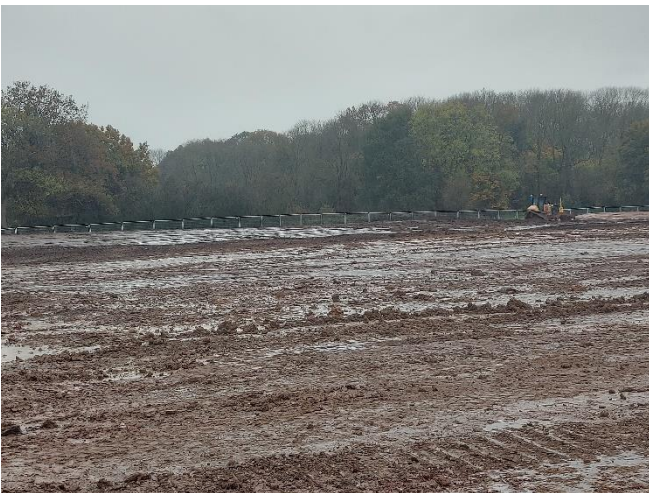
X12 towards Z12/Z13 – Landscape bund construction currently on pause after 4 layers.

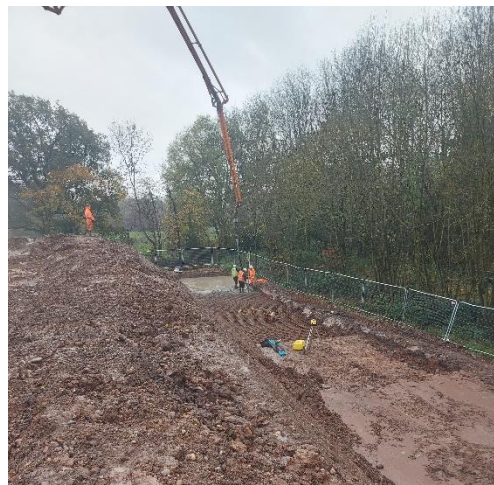
AB8 towards AB9/AB10 - Retaining wall foundation is currently being cast at grids AB9/AB10.

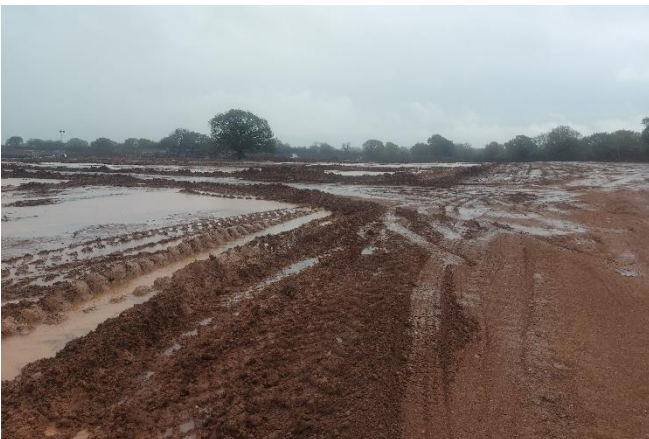
Z5 towards East – Ponding water across the development following the morning rain.

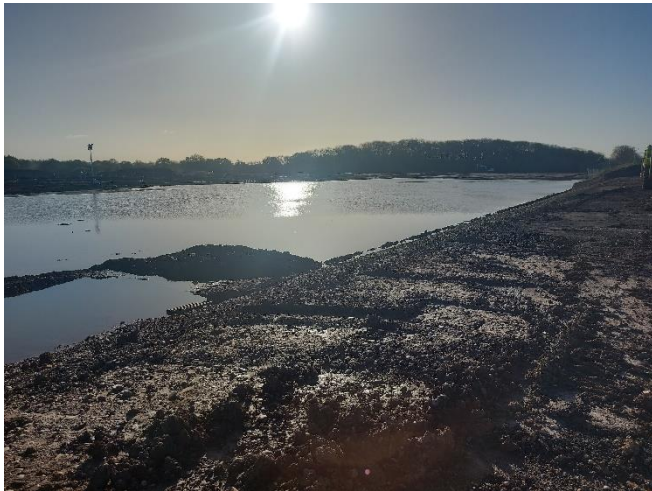
P3 towards South – Ponding water within the development platform.

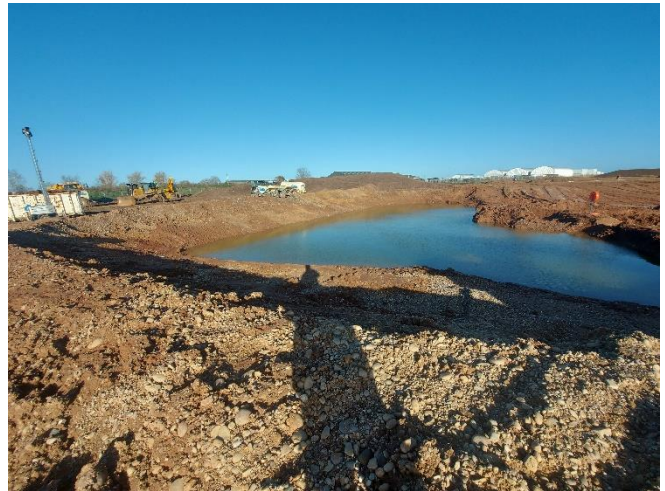
M6 towards North – Infilled Pond / burrow pit in the northern part of site is fully excavated – ponding water is currently being pumped out.

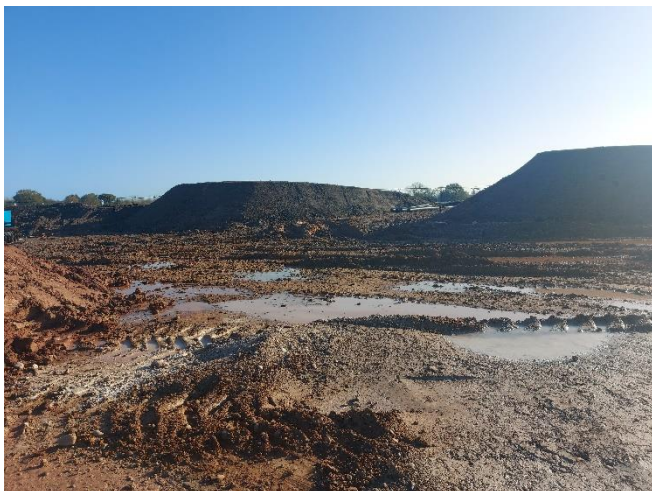
G8 towards East (F10/G10) – Partly removed landscape bund to install the drainage.

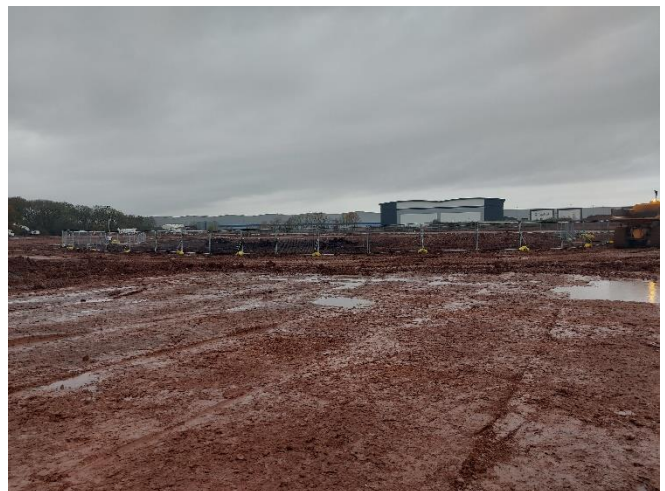
R11 towards S9 – Marl pit area has been fenced off following the discovery of asbestos and other potential contaminants.

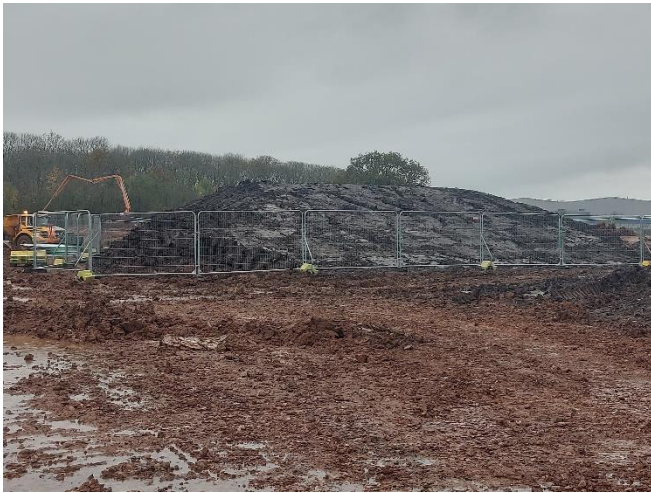
S12 towards U11 – Potentially contaminated subsoil material from the Marl Pit has been stockpiled, isolated, and securely fenced off following the discovery of asbestos and other suspected contaminants.

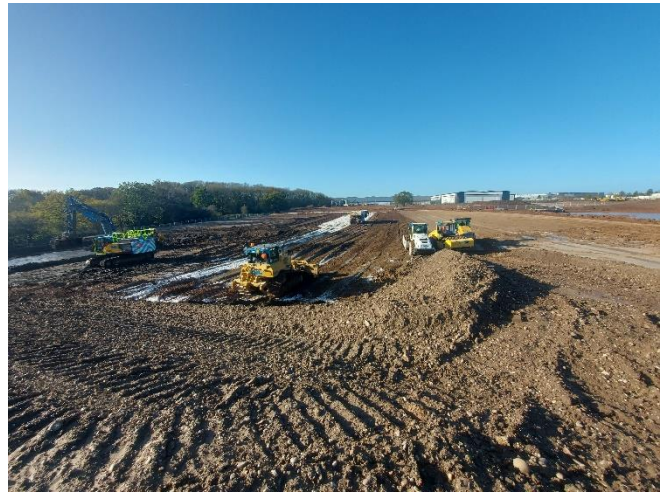
U17 towards West - Lime stabilisation underway in fill areas at grids V11–V14, W11–W15 and X11–X13.

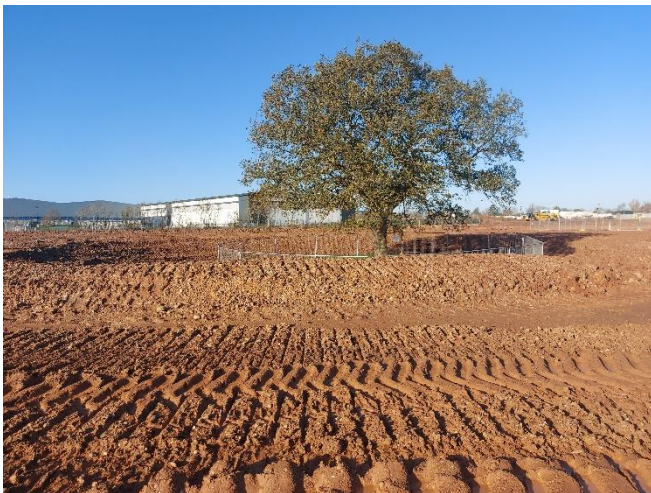
X10 towards west – Tree to be relocated to near grids N10.

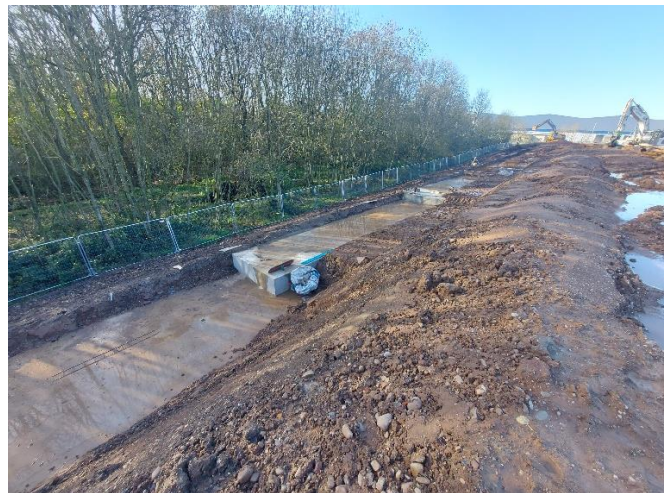
AB7 towards east - Retaining Wall 3 foundation partially cast at grids AB9-AB10.

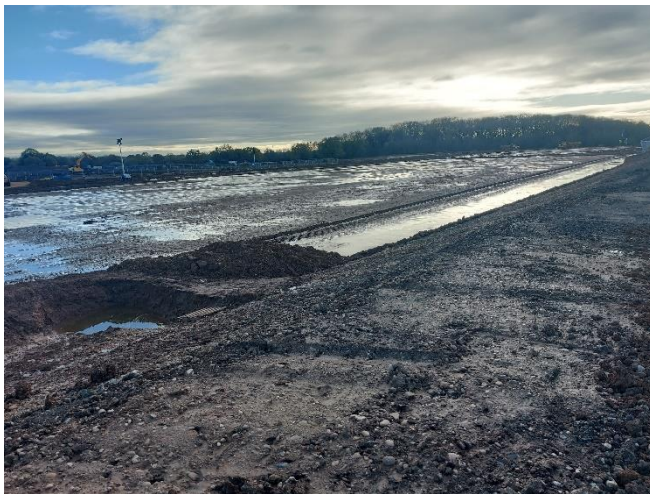
P3 towards South – Ponding water within the development platform.

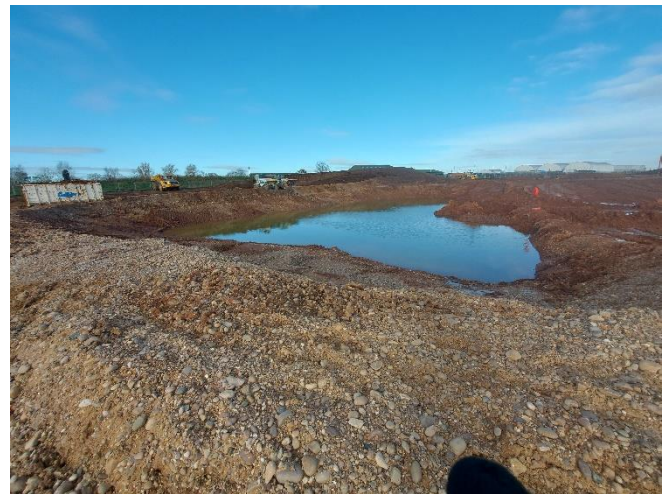
M6 towards North – Infilled Pond / burrow pit in the northern part of site is fully excavated – ponding water is currently being pumped out.

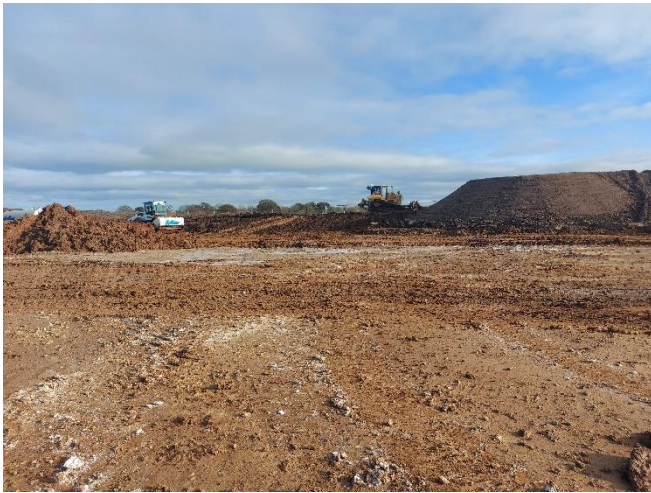
G9 towards East (F10) –Partly removed landscape bund to install the drainage currently being reinstated.

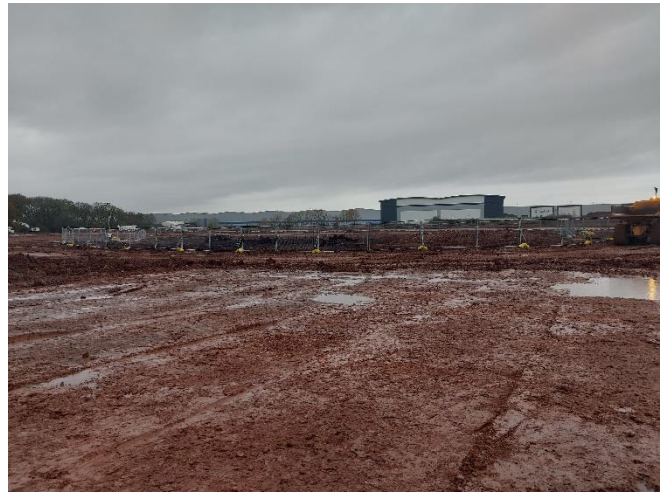
R11 towards S9 – Marl pit area has been fenced off following the discovery of asbestos and other potential contaminants.

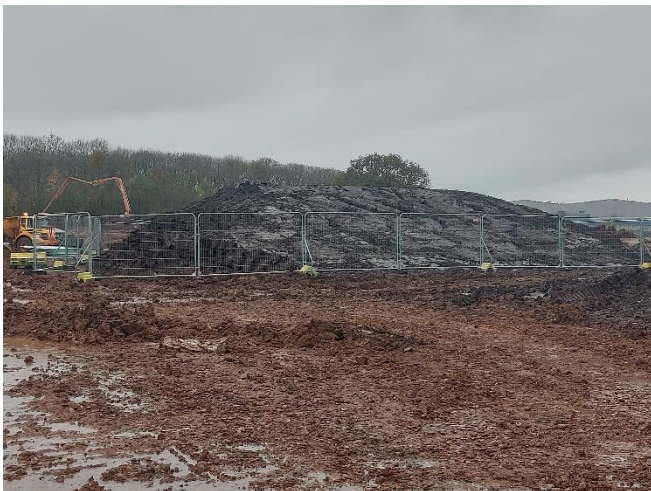
S12 towards U11 – Potentially contaminated subsoil material from the Marl Pit has been stockpiled, isolated, and securely fenced off following the discovery of asbestos and other suspected contaminants.

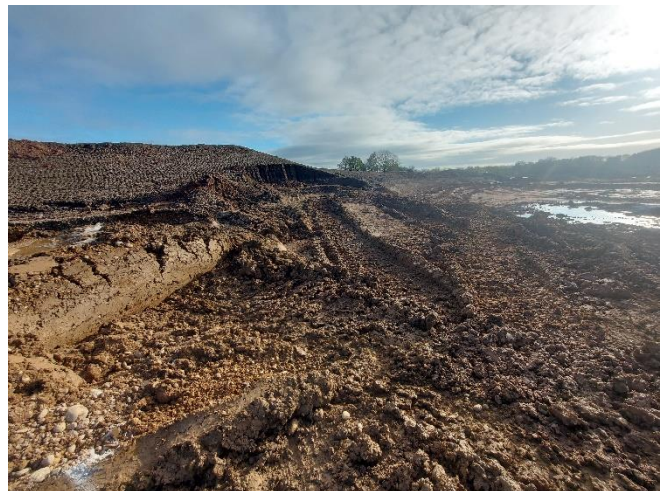
M9 towards east - Landscape bund partially removed at grid M10 to facilitate tree positioning.

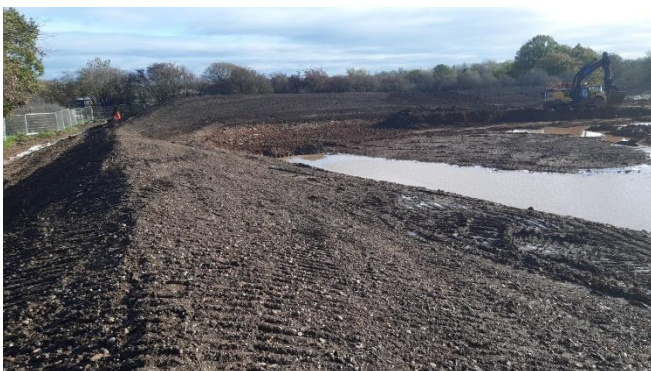
R13 towards S14/S15 – Pond excavation in progress at grids S14–S15.

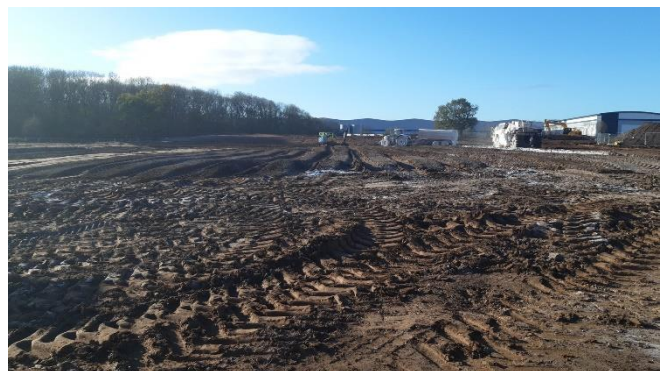
V14 towards West – Lime stabilisation underway in fill areas at grids W11–W15, X11–X13, and V11–V14.

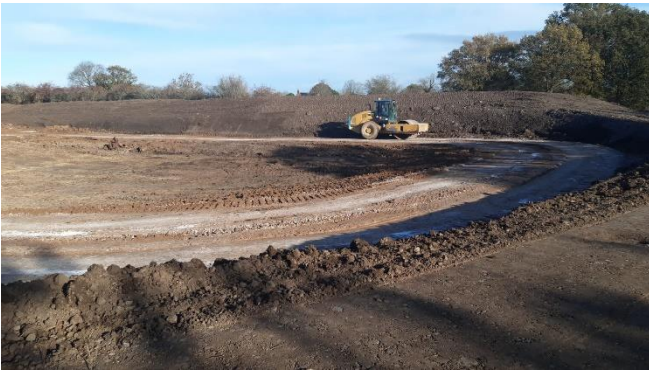
X15 towards east - Fill placement for pond ongoing at grids W15-W17.

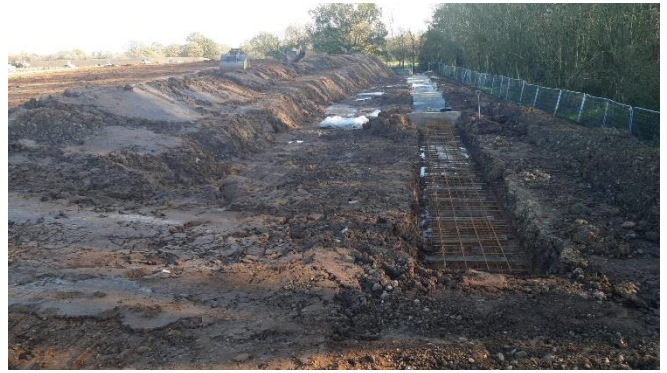
AB7 towards east - Retaining Wall 3 foundation partially cast; remaining sections at grids AB7-AB8 and AA10 scheduled for casting today.

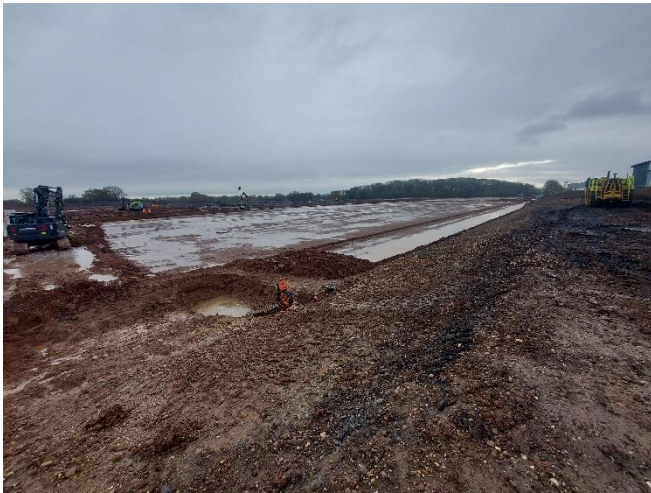
P3 towards South – Ponding water within the development platform.

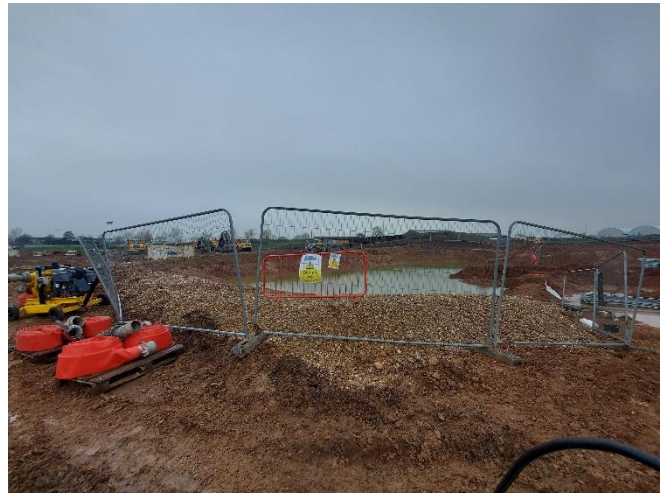
M7 towards northwest – Burrow pit in the northern part of the site has been securely fenced to mitigate risks associated with deep water and potential falls from height.

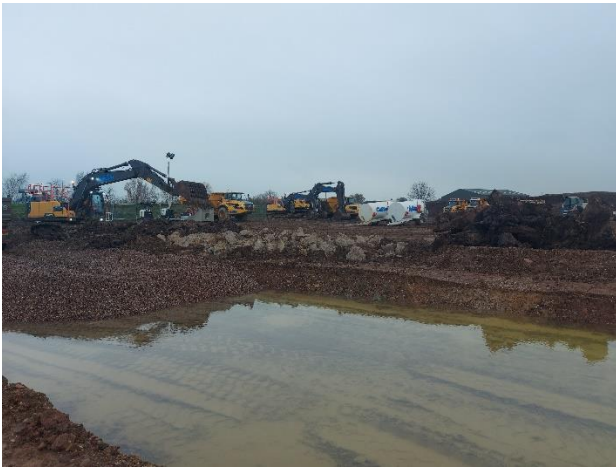
N5 towards northwest – Screening of large objects from material excavated from deeper area of Marl Pit is ongoing.

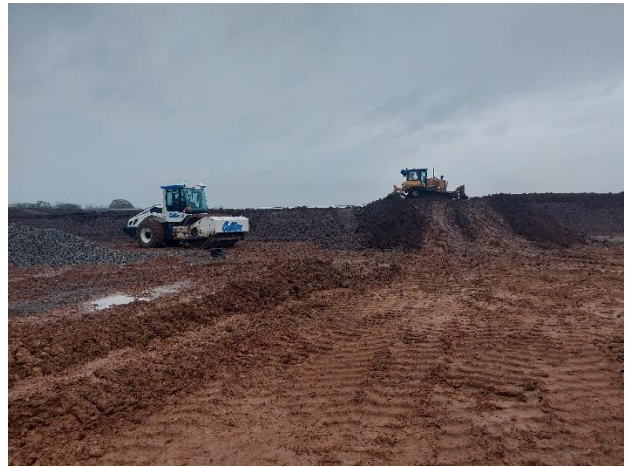
F8 towards east - Landscape locally excavated for drainage works at grids F10/G10 currently being reinstated, almost nearing completion.

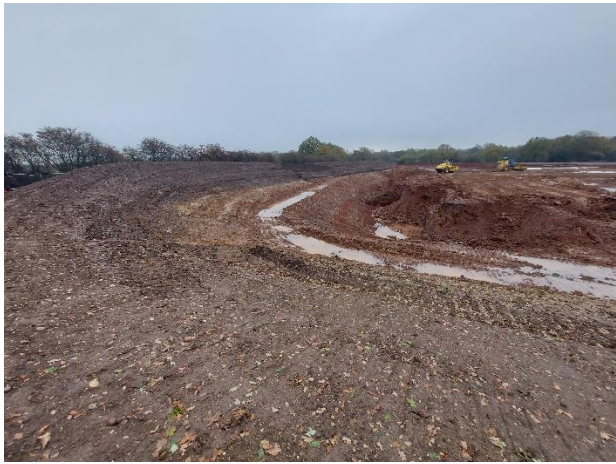
R9 towards southeast – Pond excavation progressed deeper at grids S14-S15.

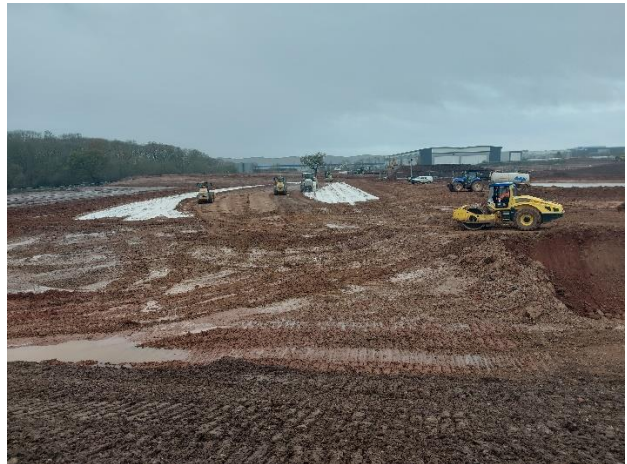
T16 towards west - Lime stabilisation underway in fill areas at grids W11–W15, X11–X13, and V11–V14.

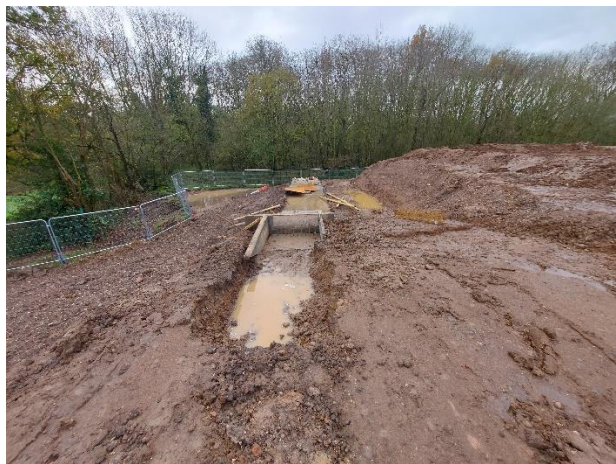
Z10 towards south – Final remaining section of the Retaining Wall 3 foundation yet to be completed in grid Z10 to AA10.

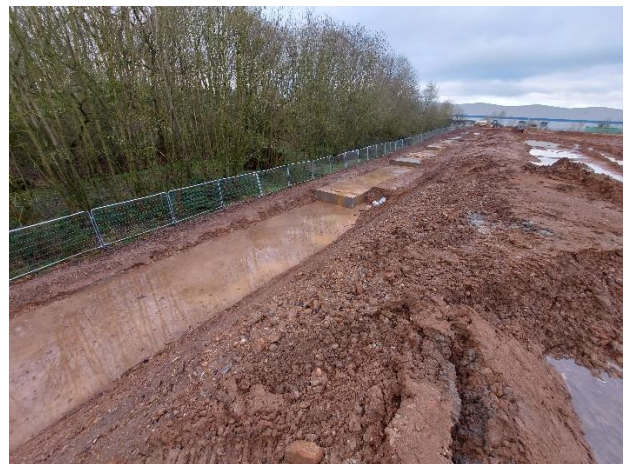
AB10 towards west – Completed foundation section of Retaining Wall 3.

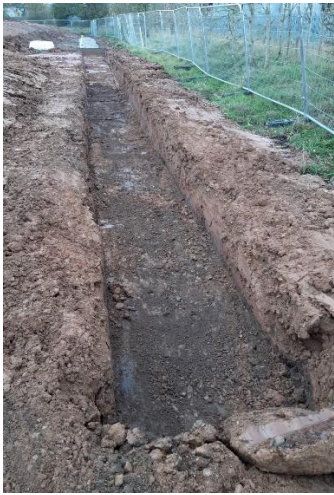
X3 towards south –Retaining Wall 2 foundation approximately 50% cast.

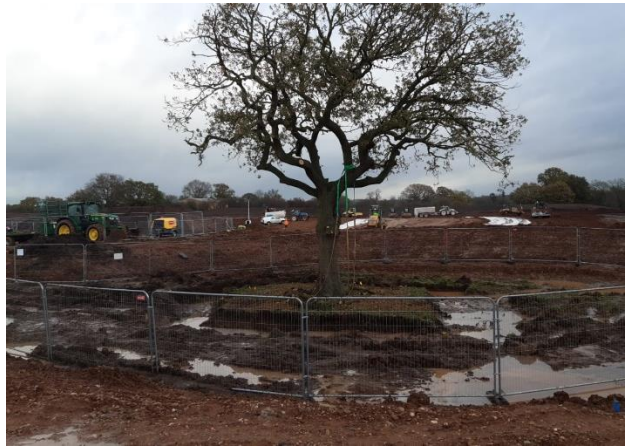
X8 towards east – Preparation works ongoing for tree removal at grid X9.

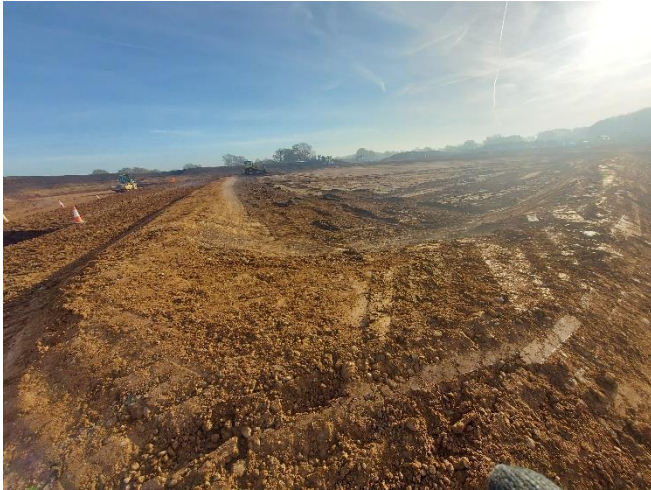
P6 towards south - An area being prepared at grids P7-P8 and Q7-Q8 to place the excavated material in bunds for screening.

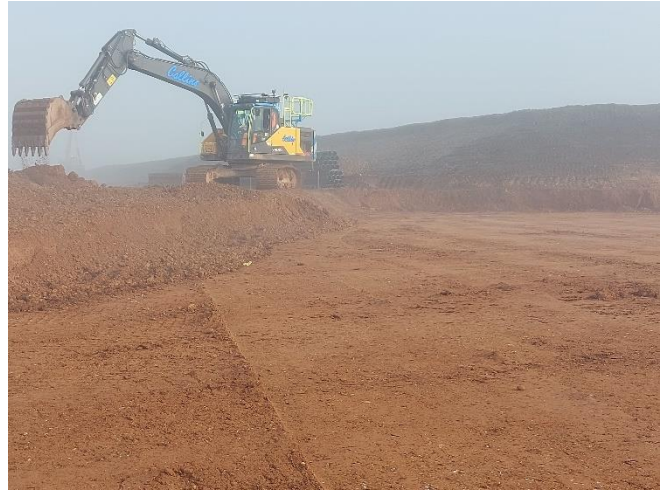
N8 towards east - Excavation for roundabout at grids N9-N10 is ongoing.

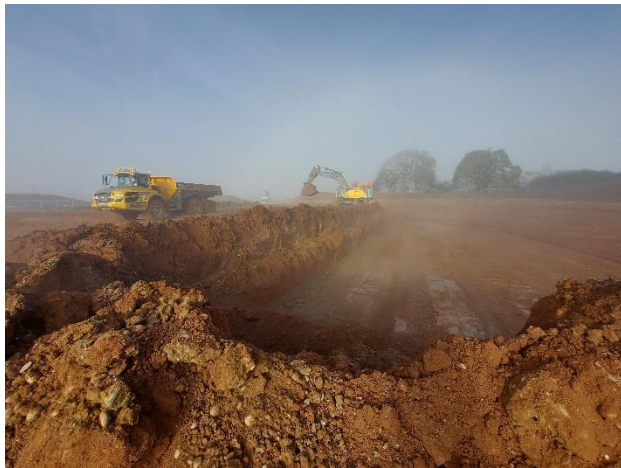
U15 towards north - Pond excavation continues at grids S14-S15 and T14-T15.

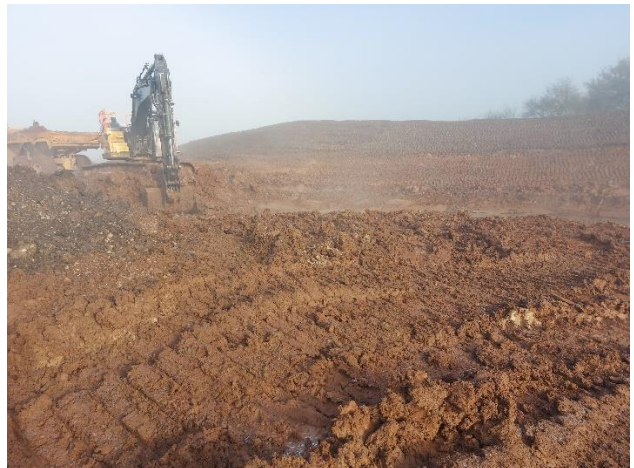
T12 towards north - Excavation at grids S11-S12 is ongoing.

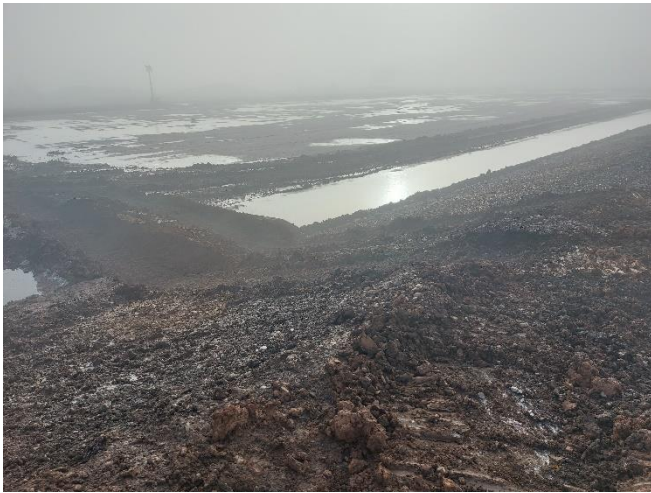
P3 towards South – Ponding water within the development platform – frozen at certain locations.

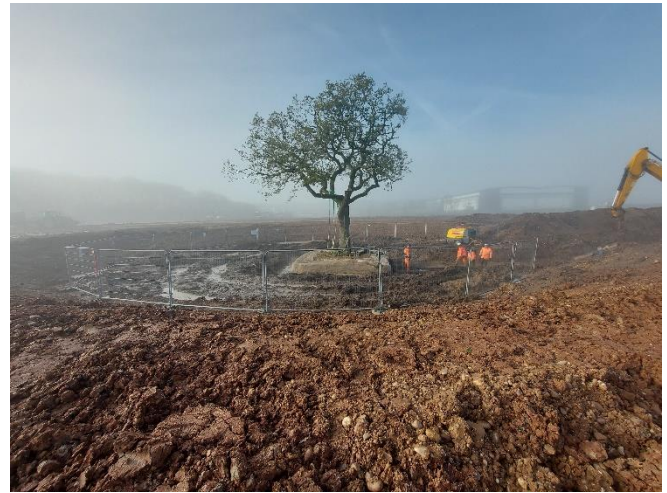
W10 towards west - Oak tree removal works are ongoing at grid W9.

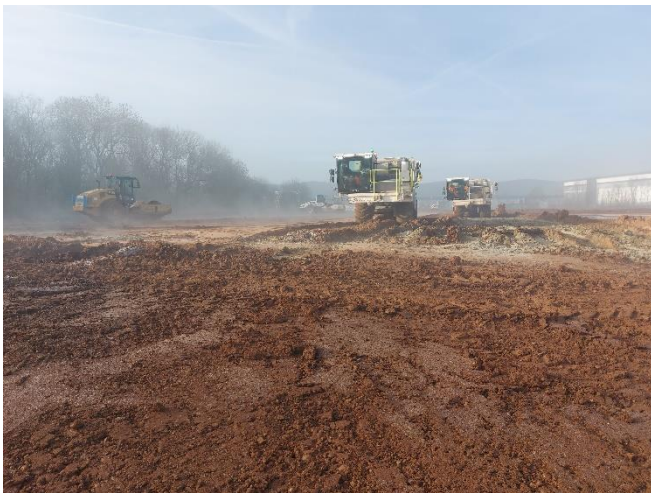
Z10 towards northwest - Cement stabilization is ongoing at grids Z7-Z10 and AA7-AA10

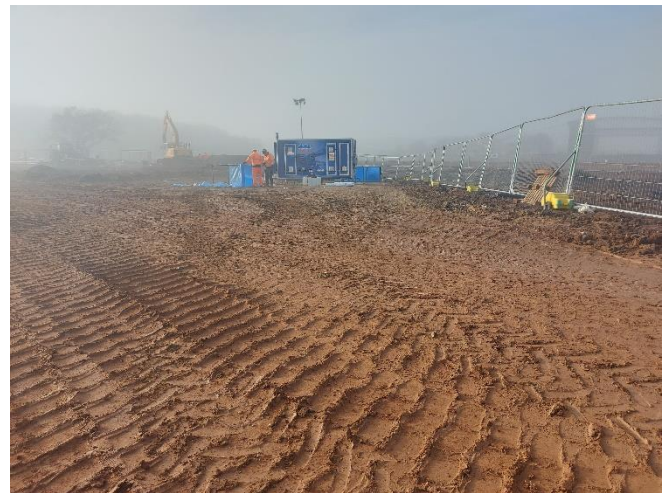
T10 towards east – Decontamination unit is being set up at grid J8-J9 for Marl Pit personnel entry.

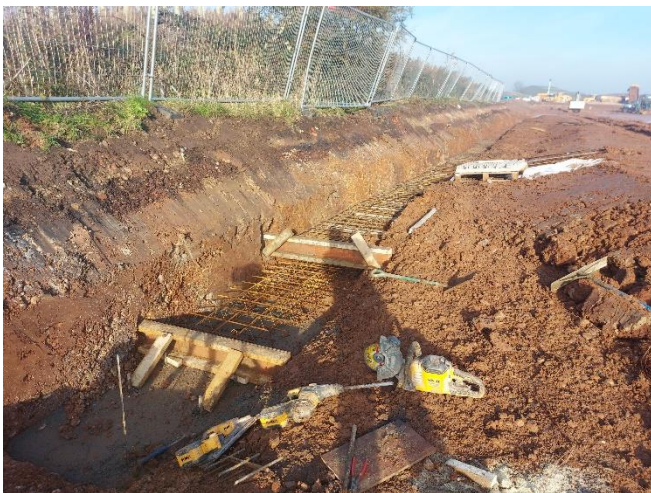
V3 towards north –Retaining Wall 1 foundation yet to be casted – reinforcement is being placed.

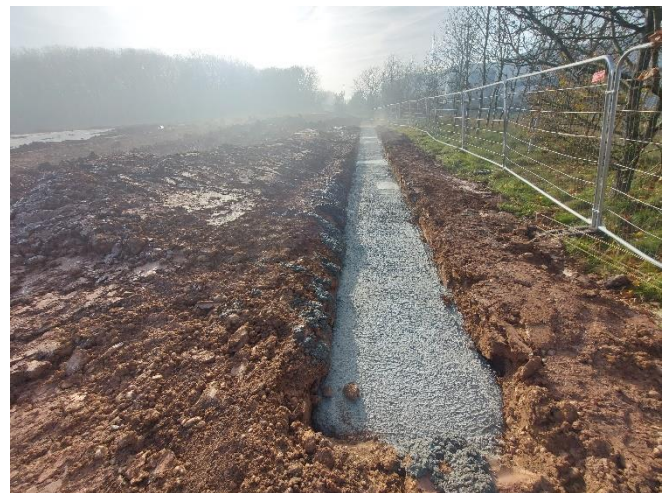
Z3 towards south – Retaining Wall RW2, foundation casting has been completed.

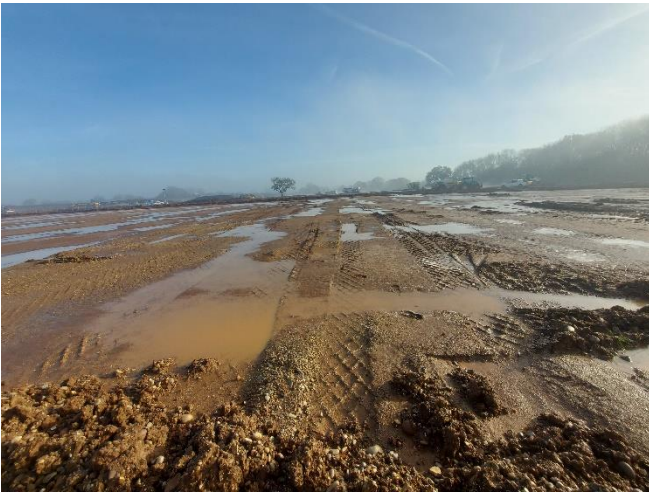
Z4 towards east – Ponding water observed across the development platform, mostly frozen.

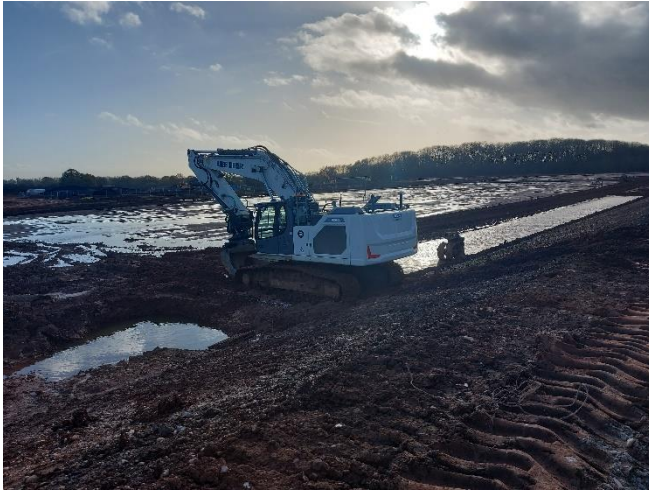
P3 towards South – Ponding water within the development platform.

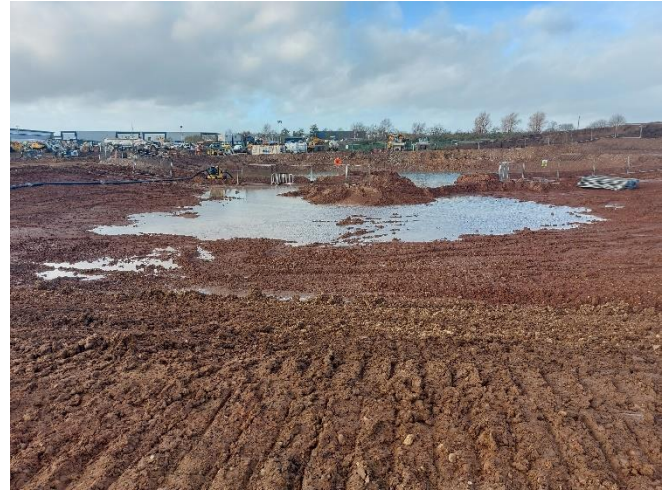
K9 towards West – Water yet to be pumped from the burrow pit to the excavated pond S14-S15 to W16.

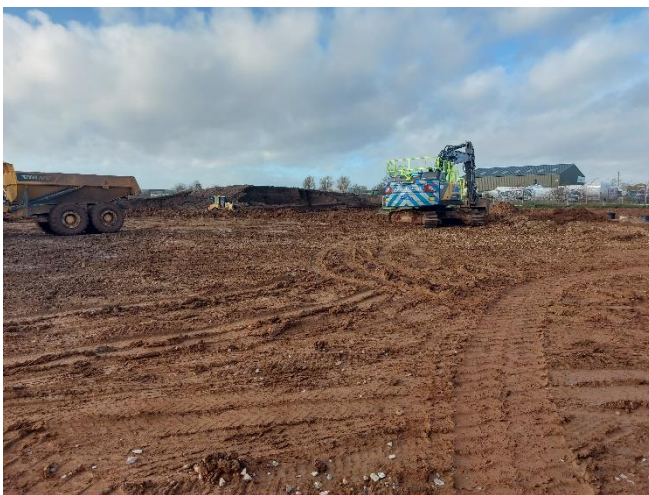
J9 towards North – Reducing level to the north of burrow pit in progress and excavated material being placed as fill at grids X10-X11 and Y10-Y11.

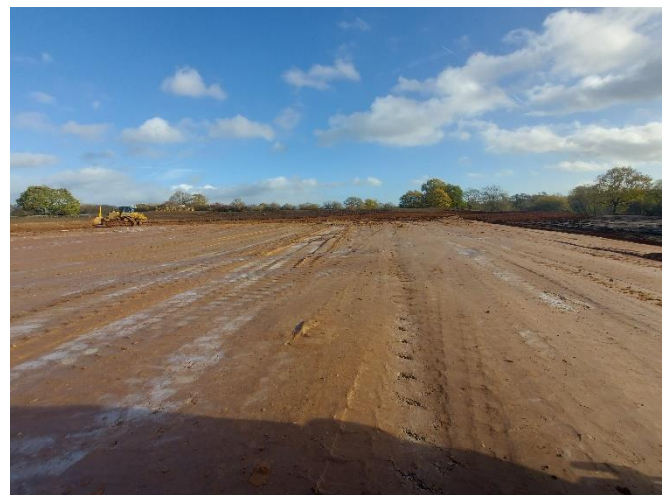
W11 towards East – Fill placement has been completed at grids V12-V14, W12-W14 and X12-X13.

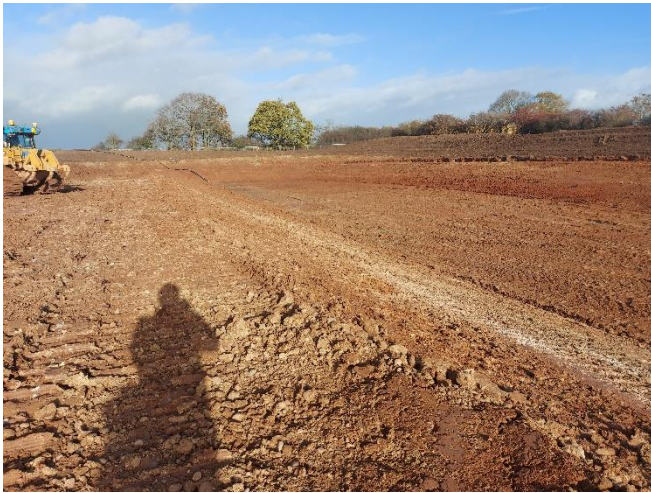
U14 towards Northeast – Pond excavation has been completed.

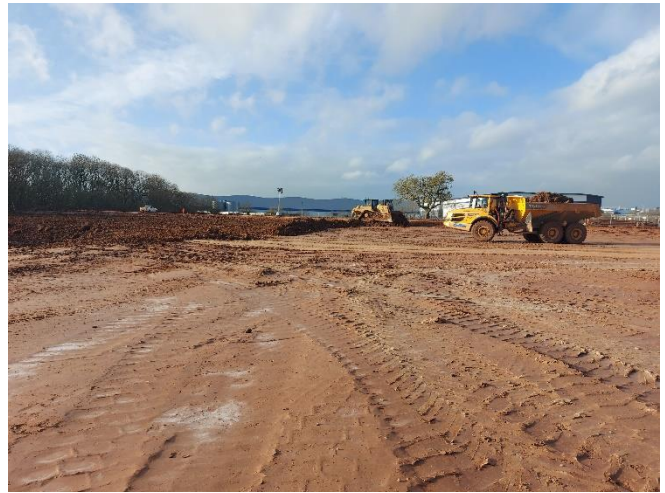
X12 towards West – Fill placement is ongoing at grids X10-X11 and Y10-Y11.

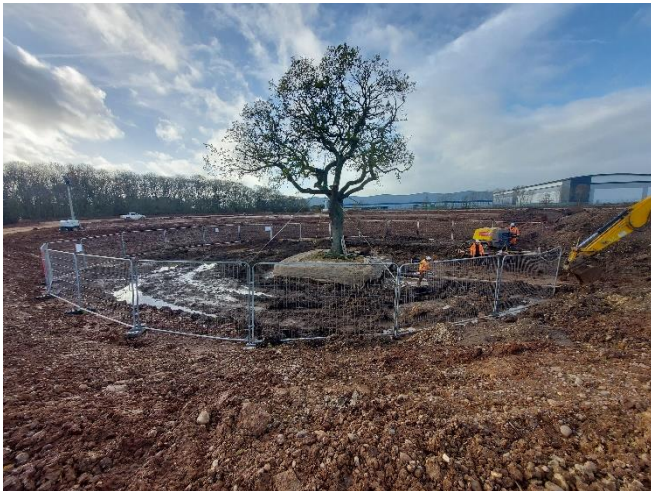
X10 towards West – Tree removal is still ongoing.

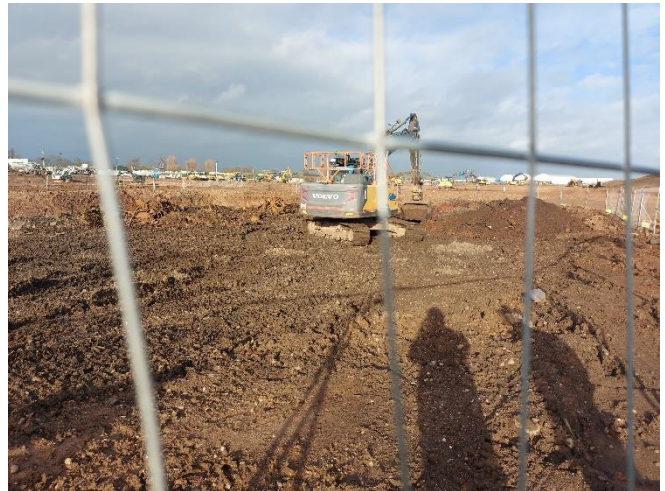
U9 towards North – Marl Pit excavation has resumed.

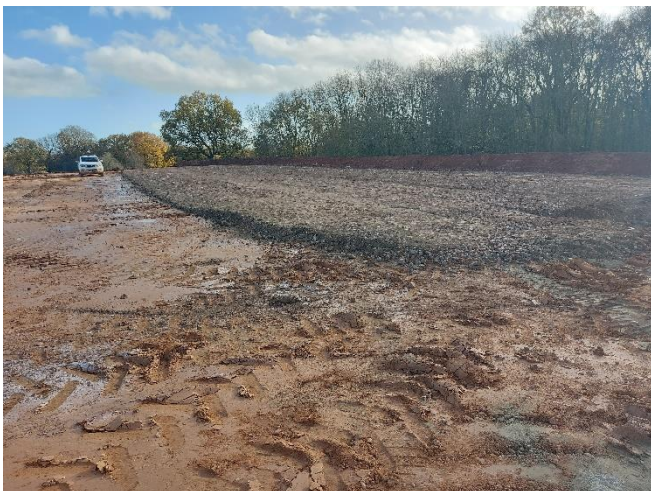
AA7 towards East – Working platform completed for crane operations to install Retaining Wall RW3.

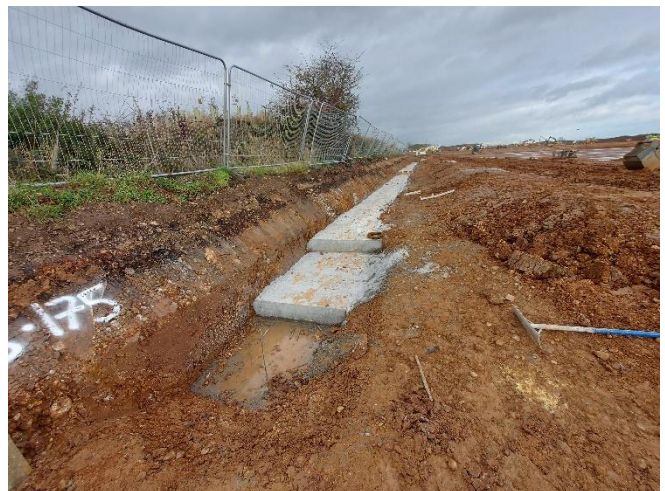
V3 towards North – Retaining Wall RW3 foundation has been completed.

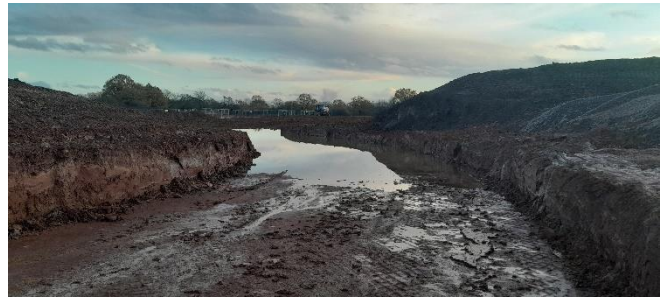
Grid R11 towards Southeast – Surface water conditions.

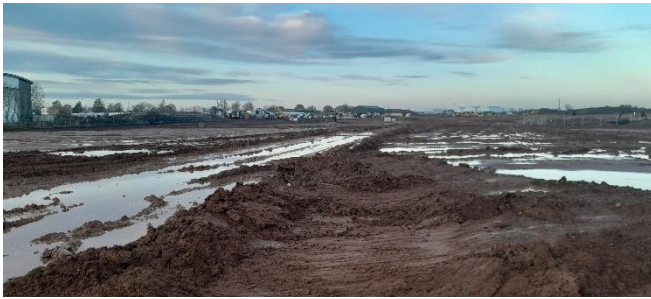
Grid X7 towards North – Surface water conditions.

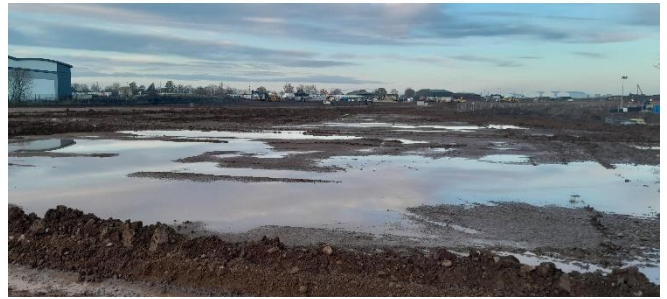
Grid V7 towards North – Surface water conditions.

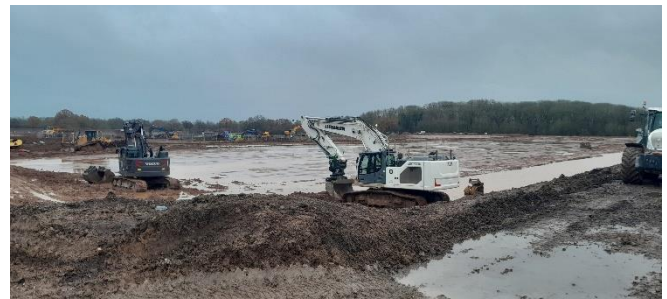
Grid P;4 towards South-southeast – Surface water conditions.

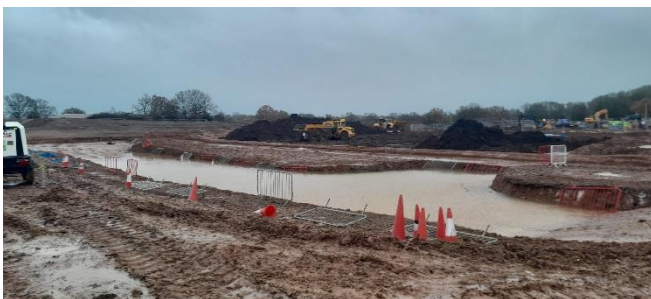
Grid M;6 towards South-southeast – Surface water conditions.

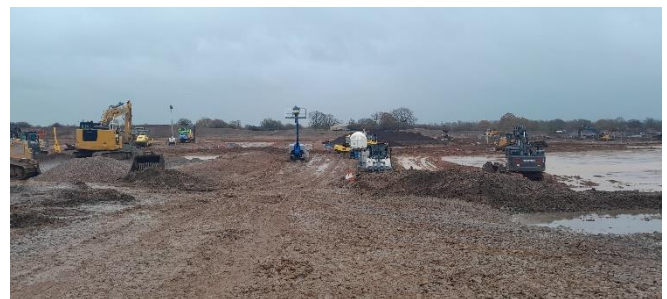
Grid N;3 towards East-southeast – Surface water conditions.

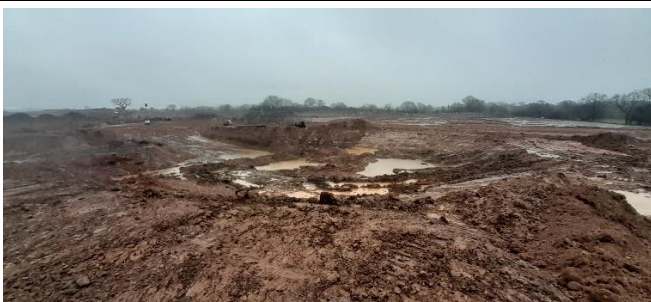
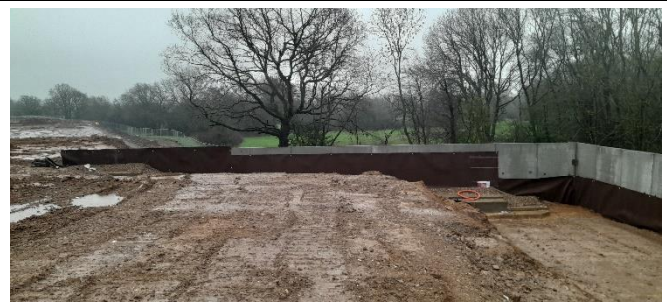
| <p>Looking (Northeast) towards Grid Y;9 – Area of tree excavation/removal.</p> | <p>Grid AA;9 towards Southeast– Retaining wall (RW1) with membrane installed and prepared for backfill.</p> |

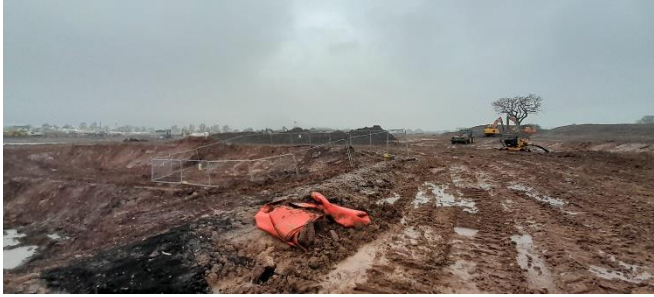
| <p>Grid S;9 towards North-northeast – Northern end of 'Marl Pit', stockpile of less-hazardous material removed from 'Marl Pit' beyond (Q;7-9) and relocated tree (N;10)</p> | <p>Looking (Southeast) towards Grid N;10 – Tree relocation</p> |
