## EUROPEAN TURFGRASS SPECIALISTS

### Cromwell Orchard: Mickleover

**Date: 10<sup>th</sup> April 2026**

## Introduction

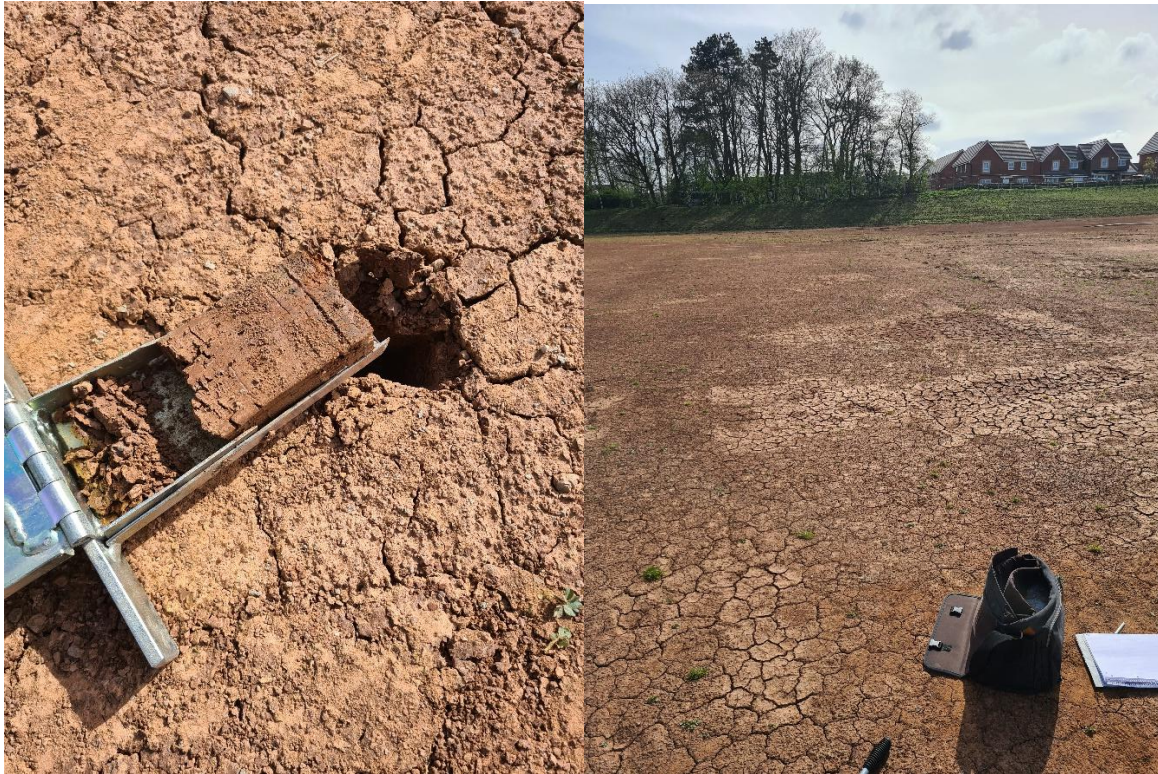
Figure 2. Surface and subsurface characteristics of test pit 1

The area surrounding Test Pit 1 supported only intermittent grass cover, with occasional weeds present. Overall sward cover was low (up to approximately 1%). Loose stones were visible at the surface. Surface cracking was also observed; this appears consistent with recent scraping activity undertaken during the winter period.

No thatch or organic material was observed within the profile, suggesting that the upper layer comprises former sub-base material rather than established topsoil. The soil exhibited a reddish-brown colouration, with the upper approximately 90 mm relatively uniform and darker in tone. The material felt plastic to the touch, and stones were present within the profile at depth (typically 10–20 mm in diameter). Moisture content measured 24.7%. Two penetrometer readings indicated relatively high resistance, with penetration limited to approximately 75 mm at 200 psi and 300 psi respectively, confirming that the material is compact.

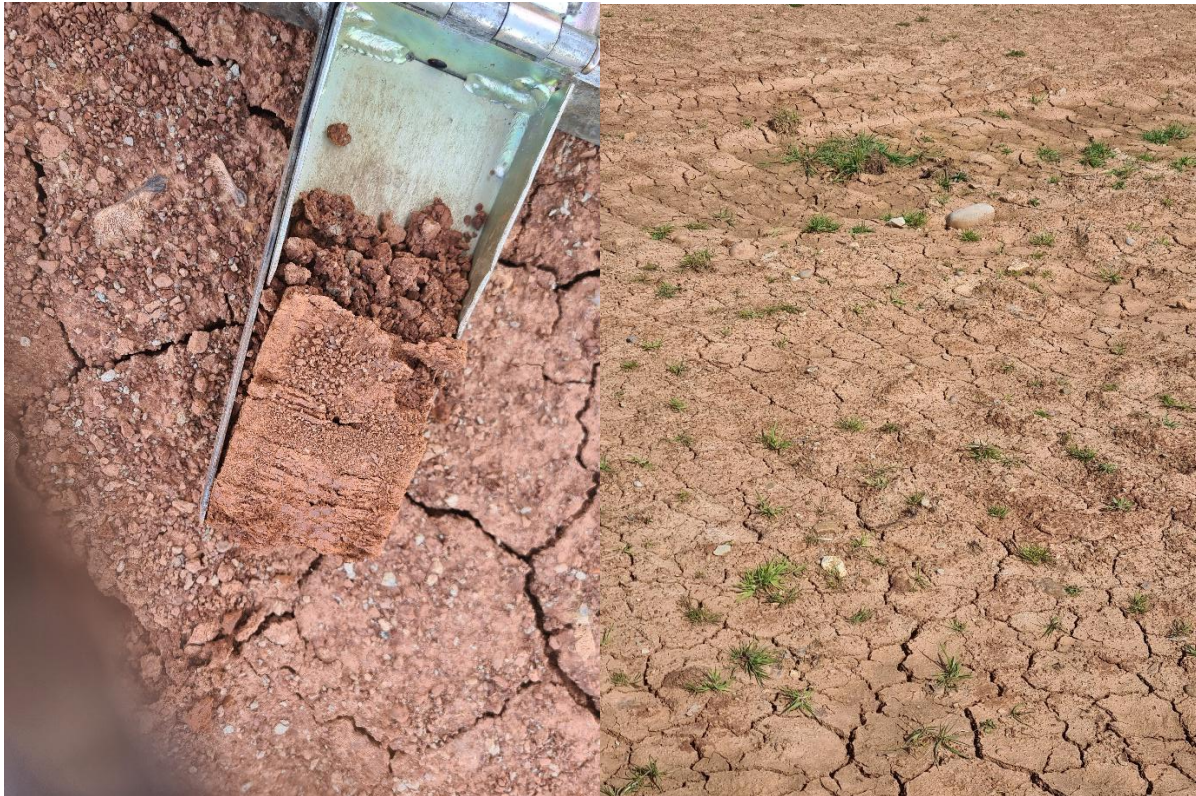
Figure 3. Surface and subsurface characteristics of test pit 2

Vegetation at this location consisted of isolated plantlets spreading into open areas. These plants are exploiting moisture retained within surface cracks and are establishing roots in the absence of competition. Less than 2% sward cover was observed around Test Pit 2. Several large stones were present, including rounded stones exceeding 10 cm in diameter. Localised rutting was also noted, associated with winter works undertaken during preparation of the sub-base. Overall, the surface was slightly uneven.

No organic material or thatch was evident within the soil profile. The profile was notably drier than at Test Pit 1, with a moisture content of 16.5%. The sub-base was highly compact, and stones of varying size were present throughout. Penetrometer testing confirmed significant resistance, with penetration limited to approximately 30 mm at 200 psi and 50 mm at 300 psi, again highlighting compaction. The material was very firm and tended to crumble when handled. A steep embankment is located adjacent to this area.

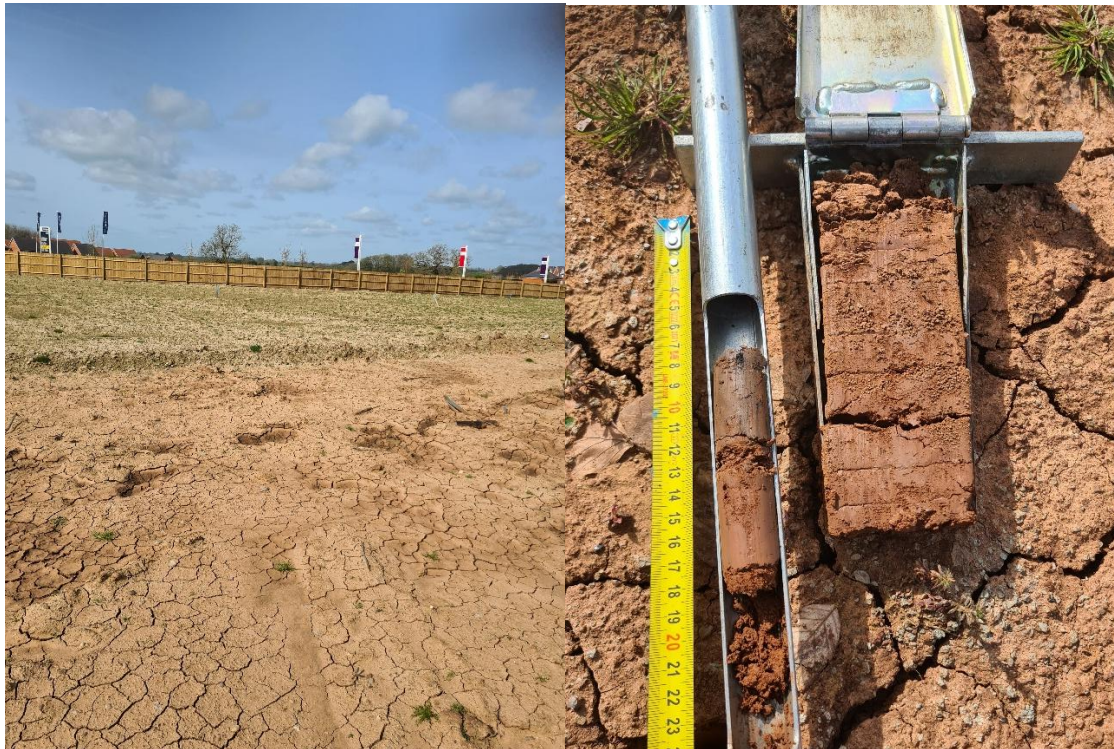
Figure 4. Surface and subsurface characteristics of test pit 3

Surface conditions at this location were notably uneven and soft underfoot. Isolated metal strips and other debris were observed within the sub-base. Standing water was present in lower-lying areas, and footprints were evident, indicating localised softness and poor surface stability. Turfgrass and weed growth was more vigorous here than in other areas inspected. Small grey stones were also noted at the surface. The edge of the constructed platform forms a distinct ledge, with a different material present behind it; this interface should be considered within any remedial works, as it effectively defines the perimeter and levels for the wider project.

Penetrometer testing at this location indicated low resistance, with no notable compaction recorded at either 200 psi or 300 psi to a depth of 300 mm. The profile was therefore easier to excavate, which is consistent with the higher moisture content measured (26.7%). The soil appeared broadly uniform through the inspected depth and may become progressively more clay-rich at greater depth.

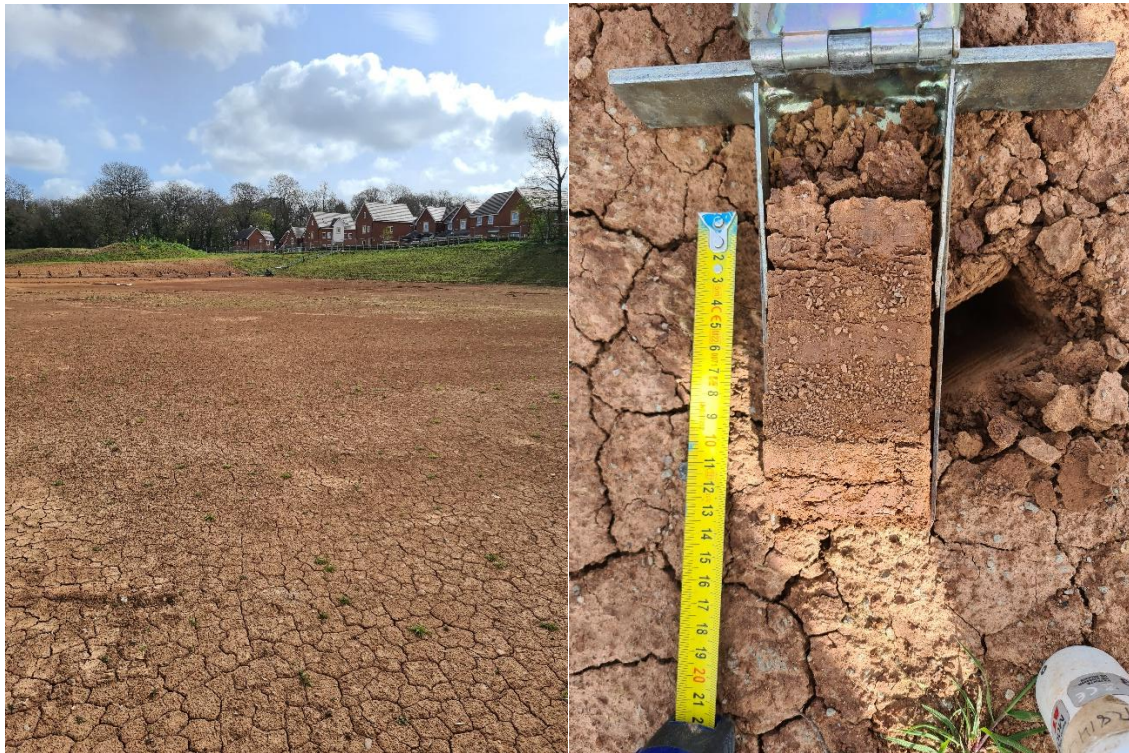
Figure 5. Surface and subsurface characteristics of test pit 4

Surface cracking was evident, and vegetation occurred only intermittently. Small, loose grey gravel was present across the surface, together with occasional larger stones.

No thatch or organic material was observed within the profile. Overall, the soil profile at Test Pit 4 was comparable to that recorded at Test Pit 3. Moisture content was 20.7%, indicating slightly drier conditions than at Test Pit 3. Penetrometer readings at both 200 psi and 300 psi showed no notable compaction to a depth of 300 mm. Small stones and gravel were present at the surface and throughout the profile, with occasional larger aggregates (>50 mm) encountered intermittently. The soil comprised a plastic, red-brown, clay-based material.

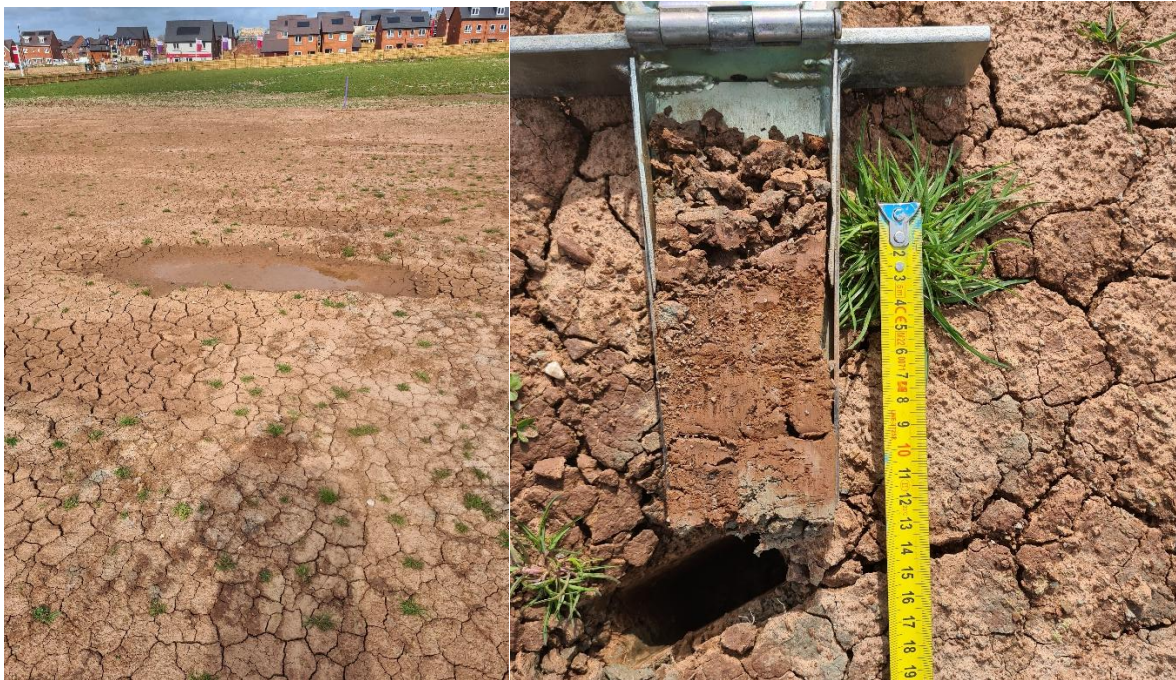
Figure 6. Surface and subsurface characteristics of test pit 5

Standing water was again observed in a low-lying area around Test Pit 5. Intermittent grey mottling was also noted at the surface, suggesting prolonged surface wetness in the past and/or that material formerly present at greater depth has been brought closer to the surface.

The upper 10–20 mm of the profile was extremely hard and friable, consistent with drying and oxidation following exposure to air; this layer is considered likely to comprise former subsoil rather than established topsoil. Below this, the material became noticeably softer and moister and retained its structure more readily. Stones were encountered intermittently at the surface and throughout the profile, with variable particle sizes present. A grey horizon was again evident at approximately 100 mm depth.

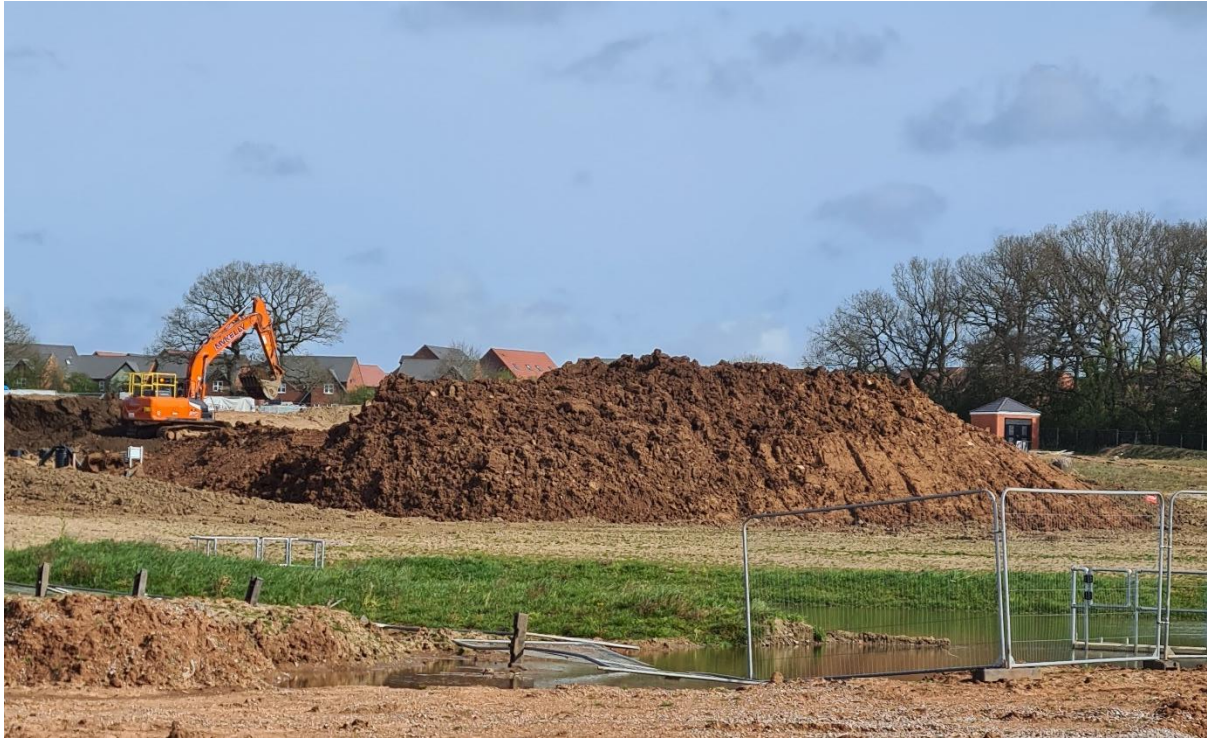
Figure 7. Characteristics of soil pile

A stockpiled soil material stored on site was inspected. The material was not friable or readily workable and comprised large, cohesive clods, consistent with a clay or silty-loam subsoil rather than suitable topsoil. On this basis, the stockpile is not recommended for reuse within the pitch construction, and an alternative imported topsoil source should be identified. A laboratory sample was not taken, as the material was considered unsuitable and further testing was not warranted.

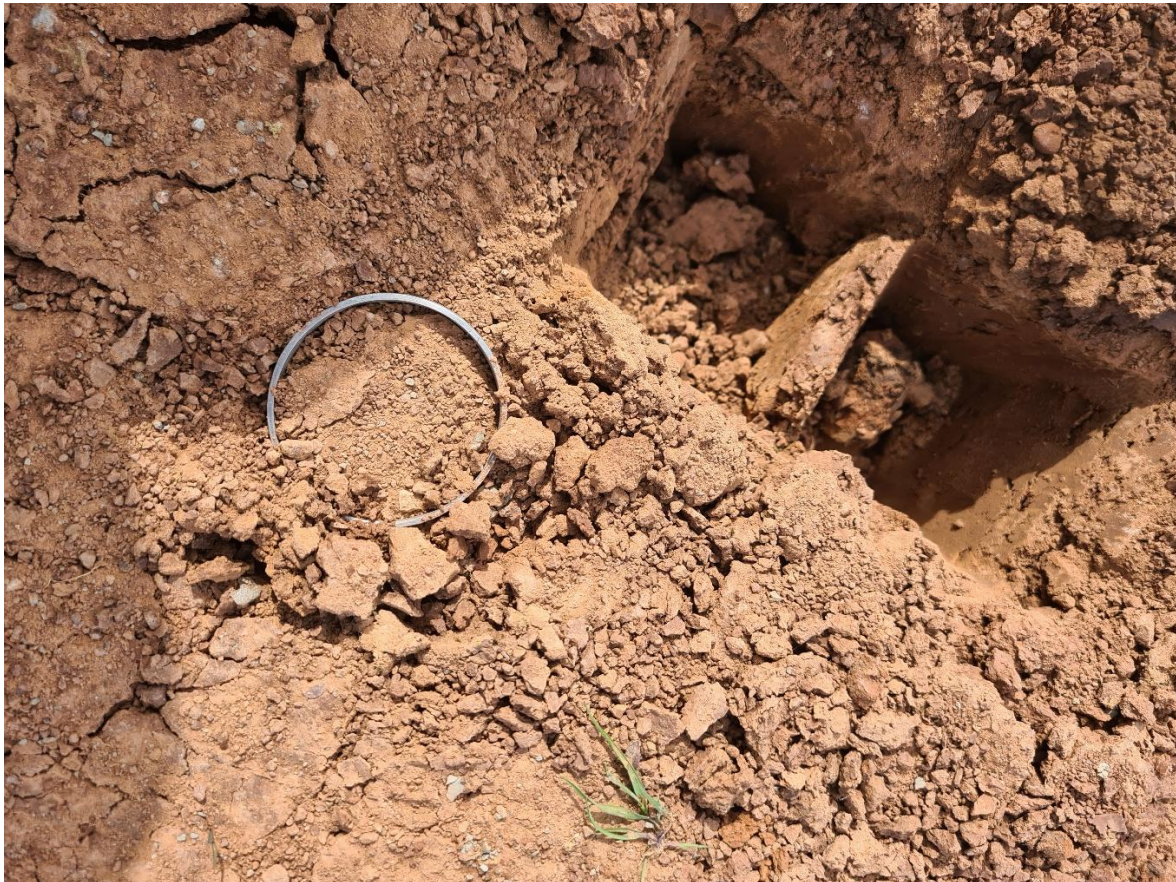
Figure 8: Cylinder located in soil prior to collection and sending off to the Laboratory for testing

The soil sample collected from Pit 1 was classified as a **silty clay**, comprising approximately 4% gravel, 14.2% sand, 41.1% silt and 44.7% clay. While the sand fraction provides limited drainage potential, the combined silt and clay content places the material close to an outright clay classification, indicating that improvement works would be required for reliable use as a sports pitch rootzone. Percolation testing within the upper 75 mm of the profile recorded a saturated hydraulic conductivity of **0 mm/hr**, which is unacceptable for sports turf. Particle density was **2.685 g/cm<sup>3</sup>**, with bulk density values of **2.0 g/cm<sup>3</sup> (moist)** and **1.59 g/cm<sup>3</sup> (dry)**; these values may be used for material volume calculations during any future improvement works. Total porosity was **40.8%**, which is acceptable; however, air-filled porosity was extremely low at **1%**, while water-filled porosity was very high at **39.8%**. Water retention was also high at **26.3%**. Overall, the results indicate that although the soil retains water readily, it provides very limited aeration when wet, increasing the risk of surface instability and reduced turf performance during prolonged wet periods. The rate at which water moves through the profile is therefore a key constraint and should be addressed through an appropriate drainage installation strategy.

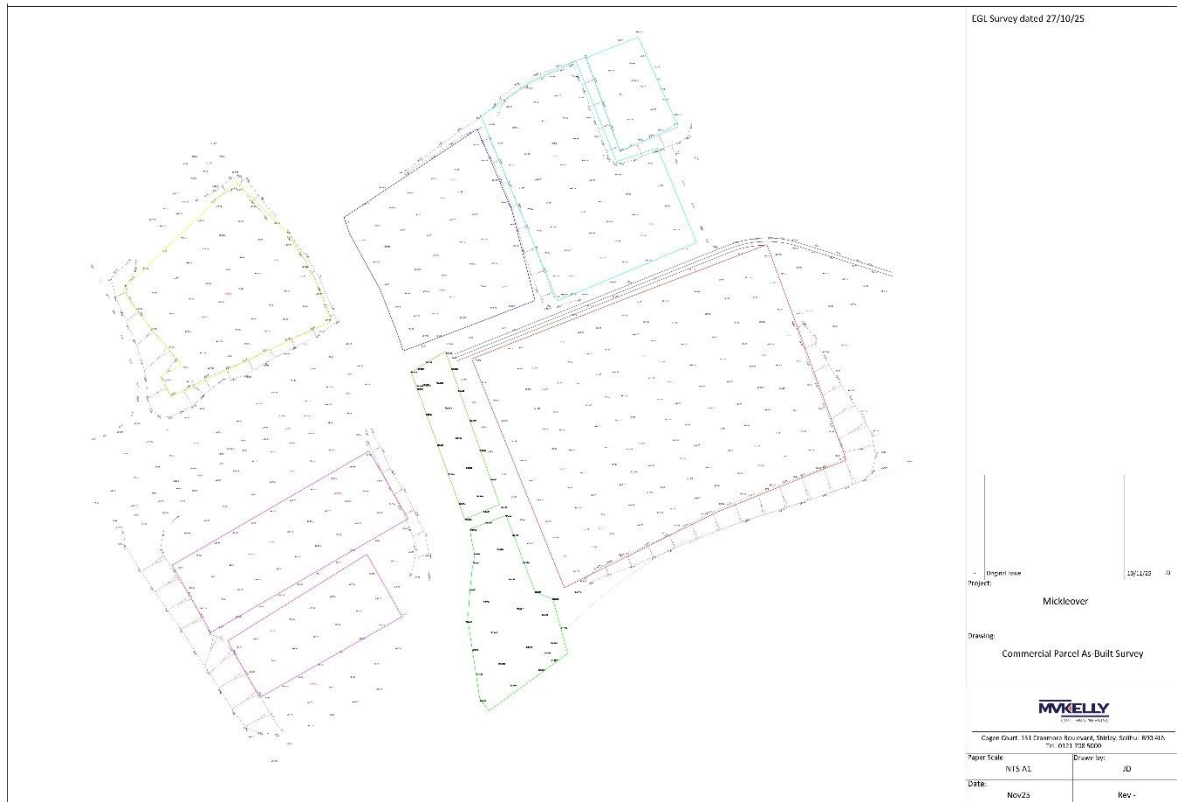
Figure 10. As laid topographical survey of the existing pitches subbase

The as-laid sub-base topography is presented in Figure 10 below. The site currently rises by approximately 1.0 m from the west to the east of the pitch area and falls by approximately 0.60 m from south to north. Overall, levels fall from south-east to north-west at approximately 1:100. These gradients are acceptable and fall within typical guidance (<1 in 80 in the direction of play and <1 in 50 across the direction of play). However, the surrounding banks do not meet the slope criteria required for safe and effective maintenance; a maximum allowance of 1 in 3 (33%) is recommended. This threshold is exceeded in the current design, and reshaping of the steep bank above the pitches will be required. Drainage provision at the toe of this bank should also be upgraded accordingly, to manage runoff and reduce the risk of water ingress onto the pitch surface.
