## Arboricultural Impact Assessment BS5837:2012

16 Milton Rd, Repton, Derby, DE65 6FZ

Project ref: AEL-19446

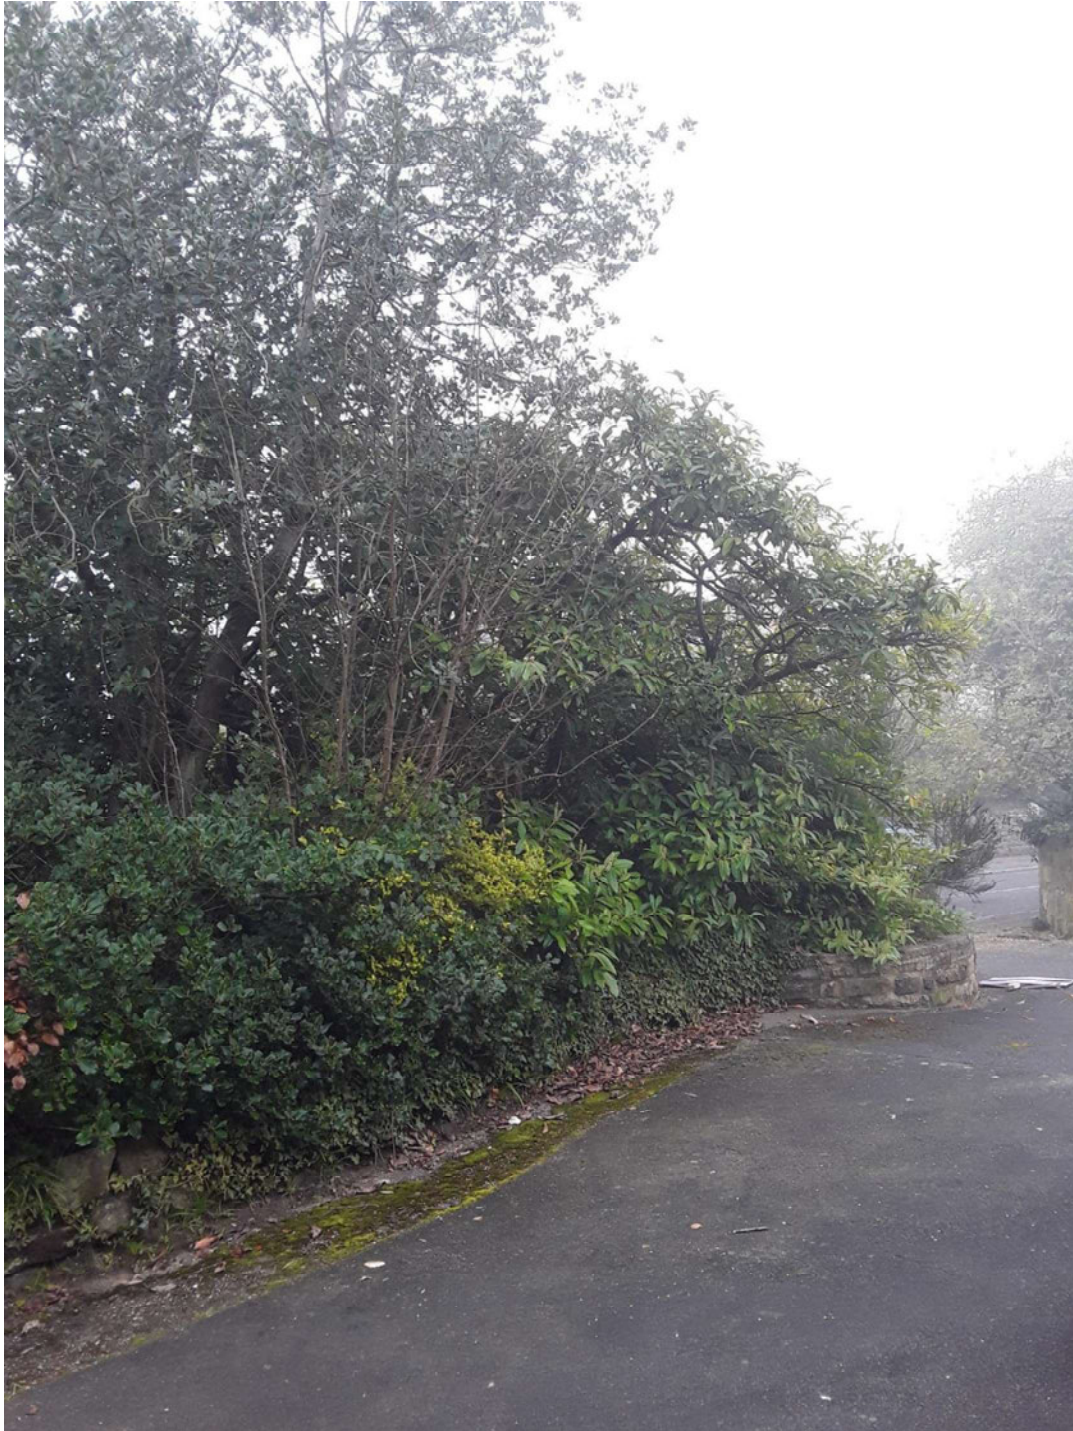
Image 1 – Showing G2 from the driveway

| Tree reference number | Species | Category grading | Works required | For Development | For Arboriculture |
|---|---|---|---|---|---|
| G2 | Mixed species<br>( <i>Mixed species</i> ) | C2 | Part removal of shrub bed | Yes | |

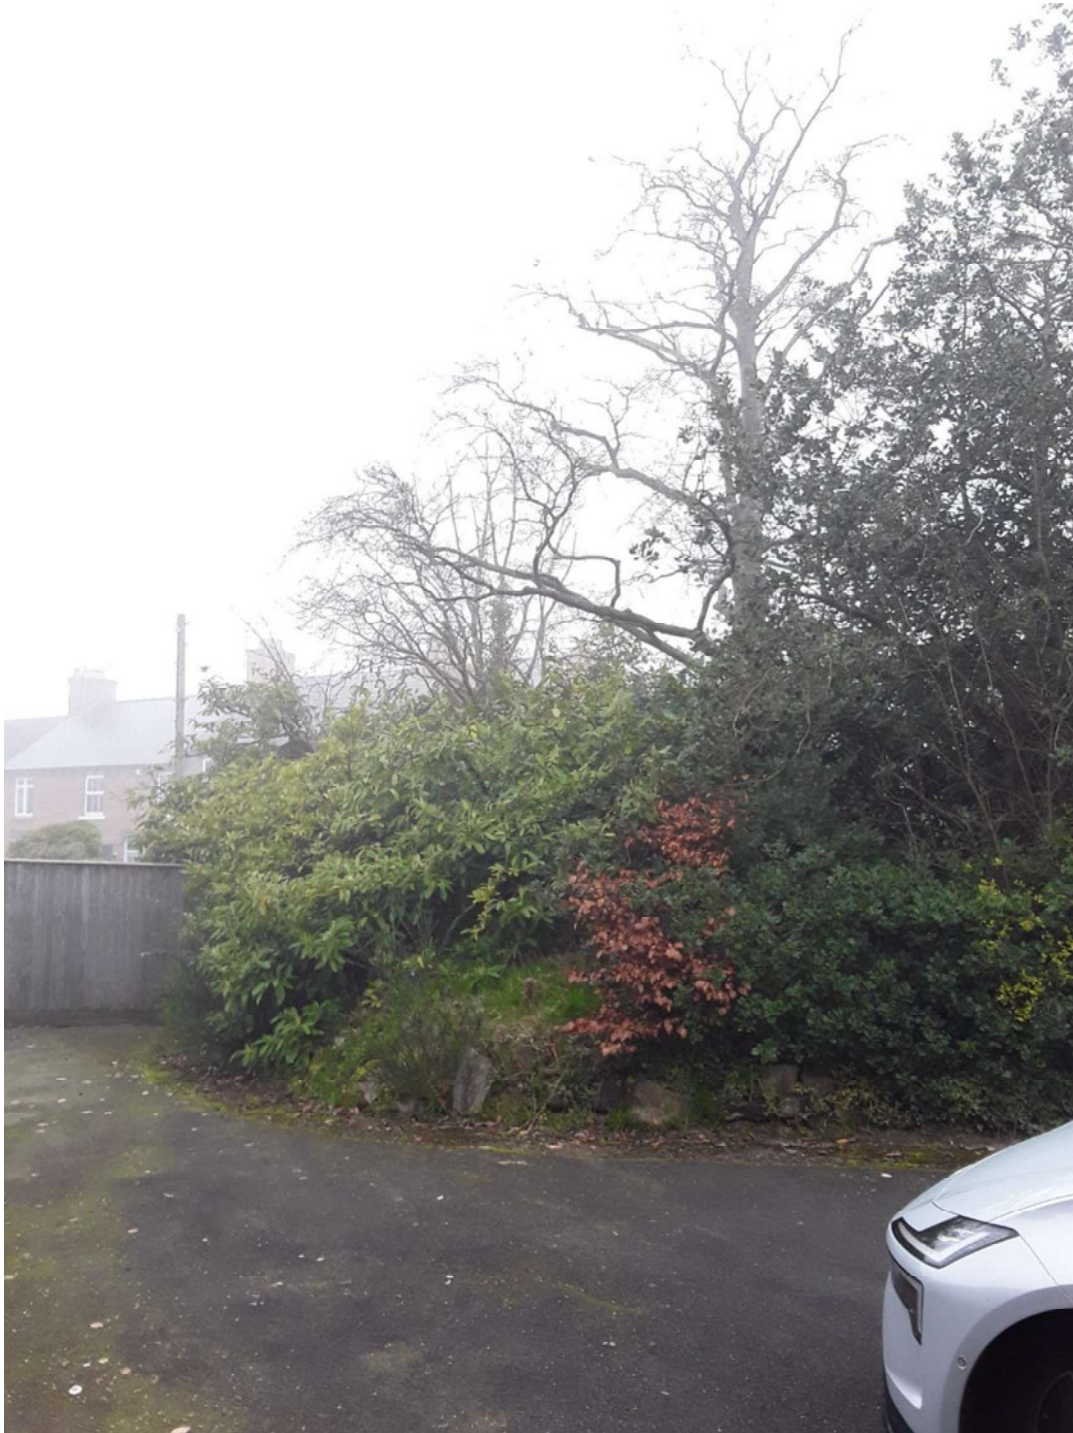
Image 2 – Showing G2 and the Beech tree and location of new gate area

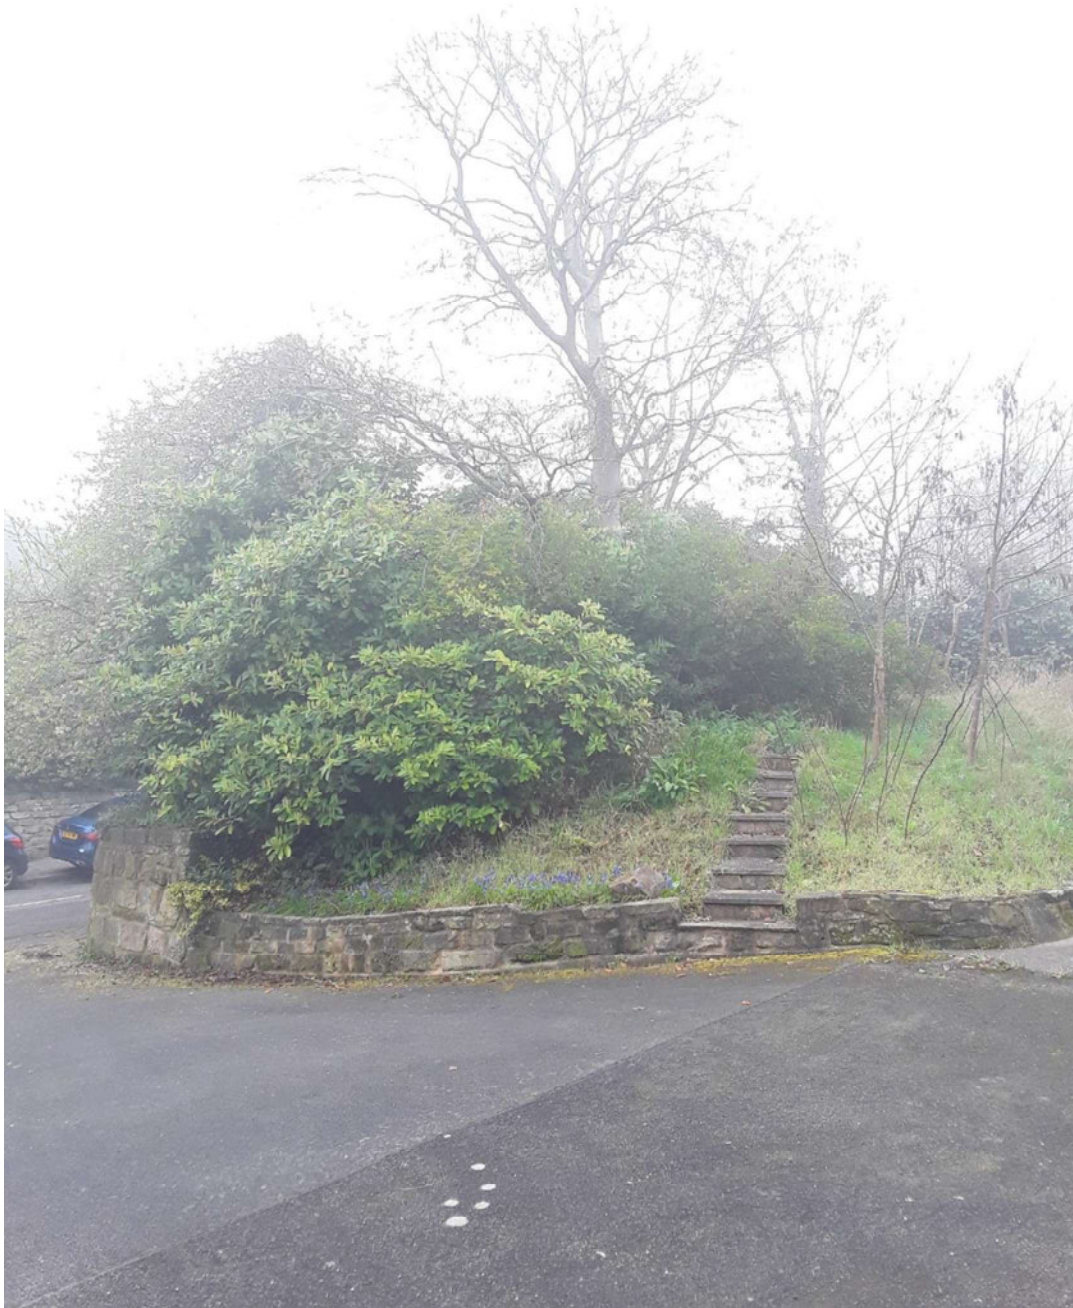
Image 3 – Showing G1 with shrubs to the front

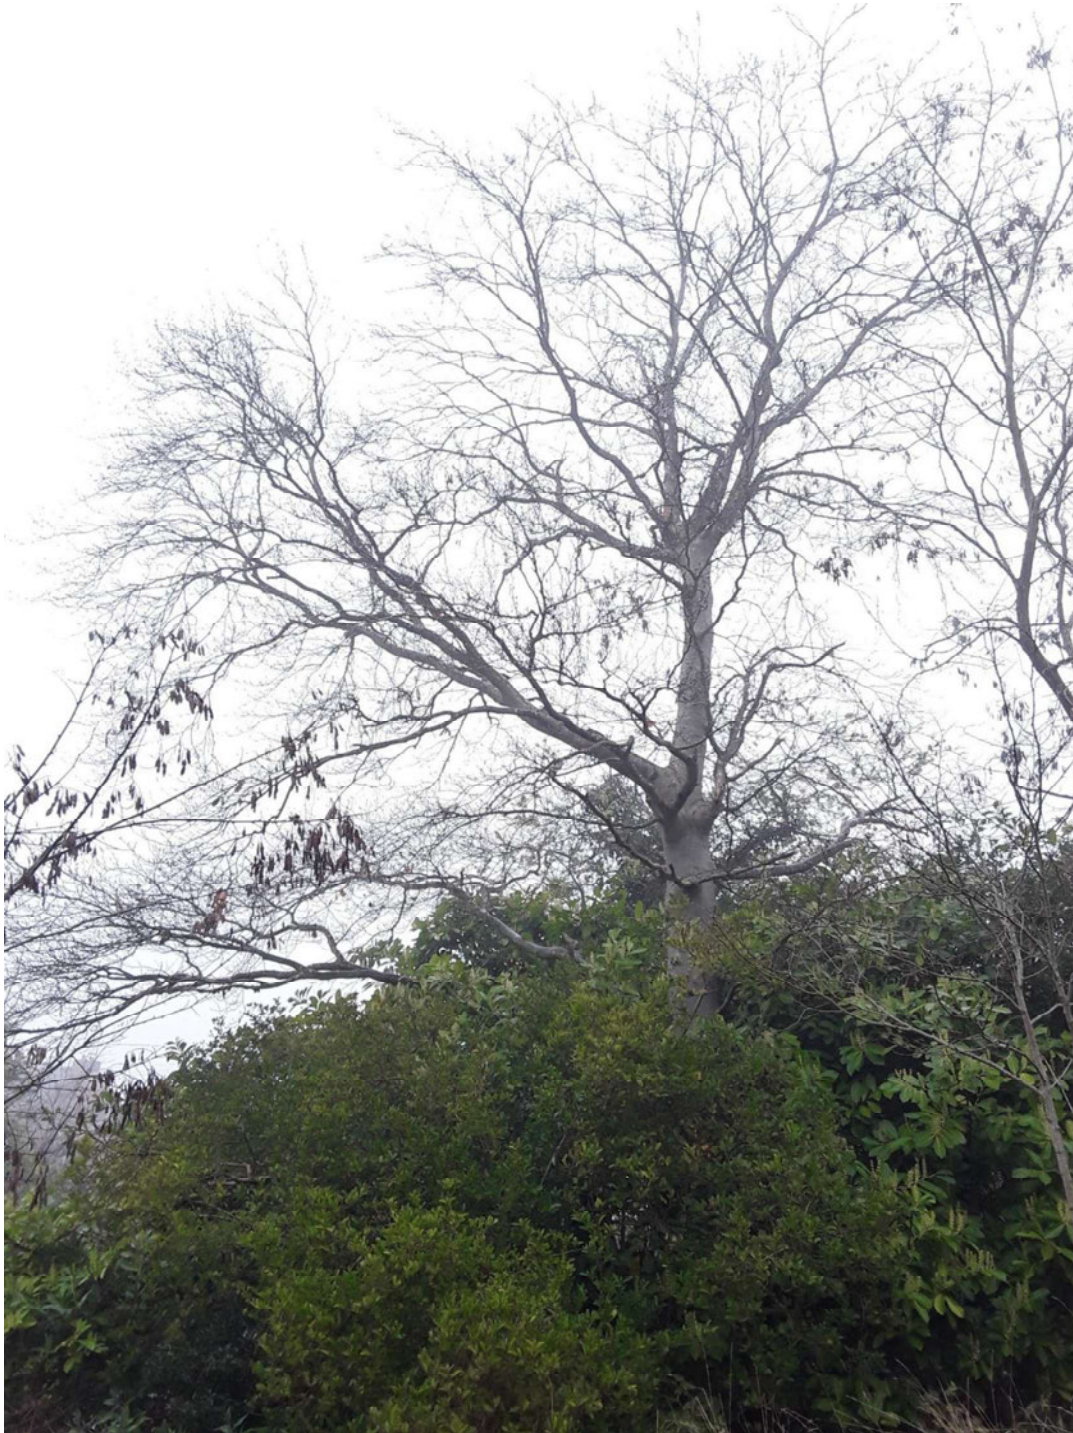
Image 4 – Showing T3 at the front

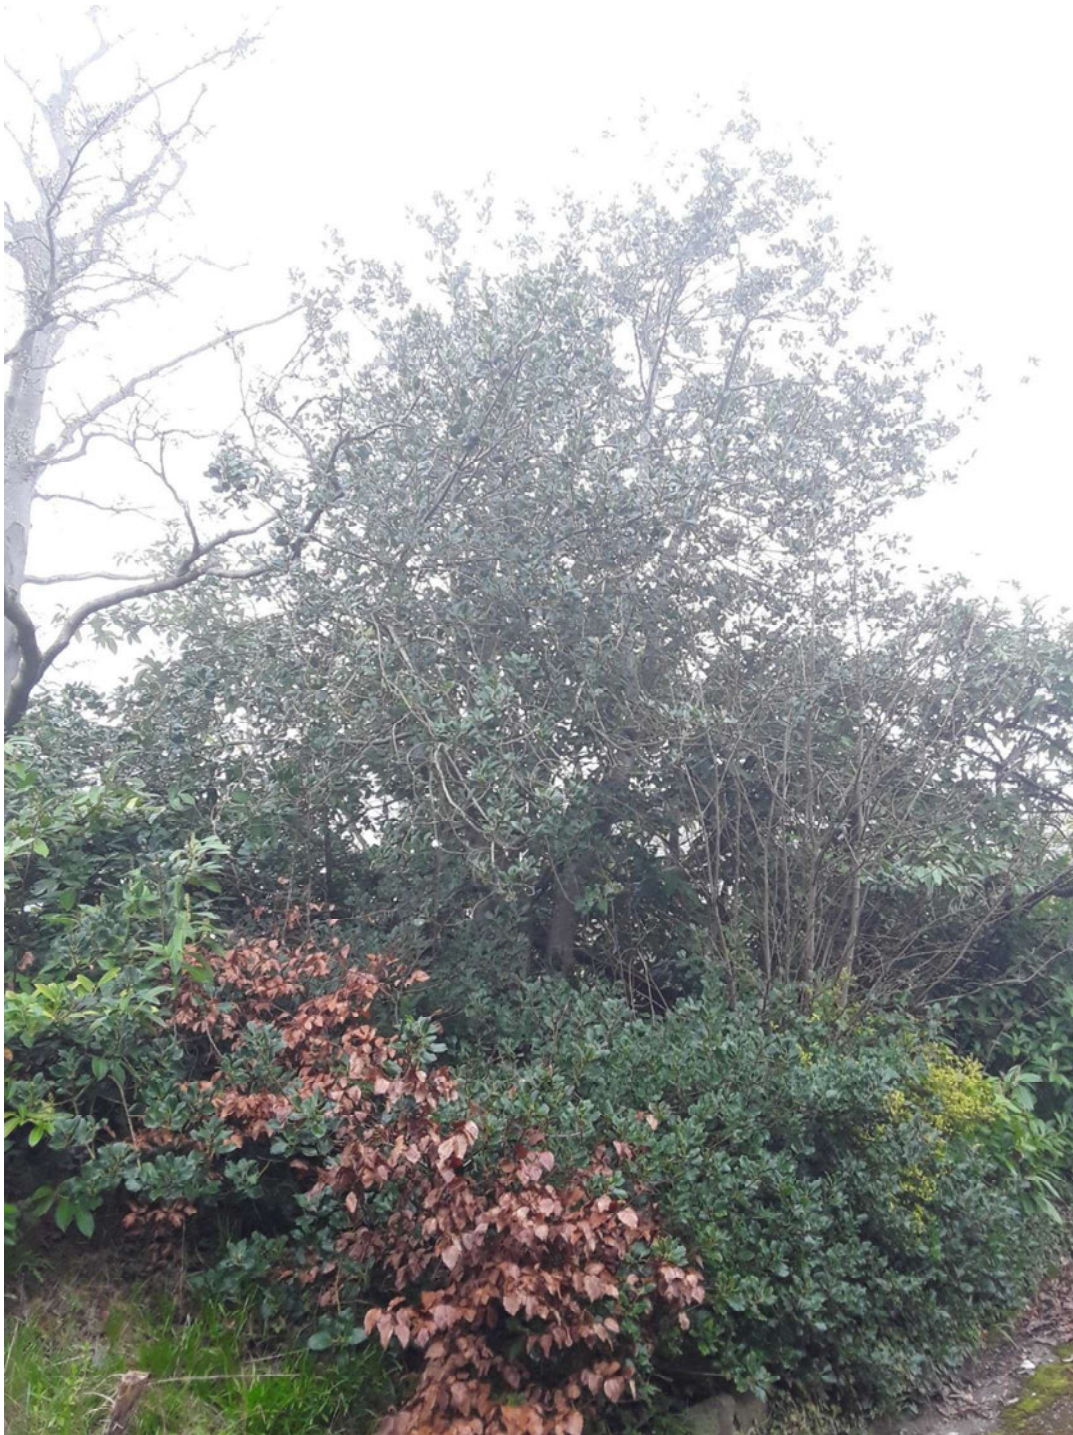
Image 5 – Showing T4 which will need to be removed

| Tree reference number | Species | Category grading | Works required | For Development | For Arboriculture |
|---|---|---|---|---|---|
| T4 | Holly<br>( <i>Ilex sp.</i> ) | B1 | Remove tree | Yes | |

It should be possible to replace T4 with two new trees at the front of the site.

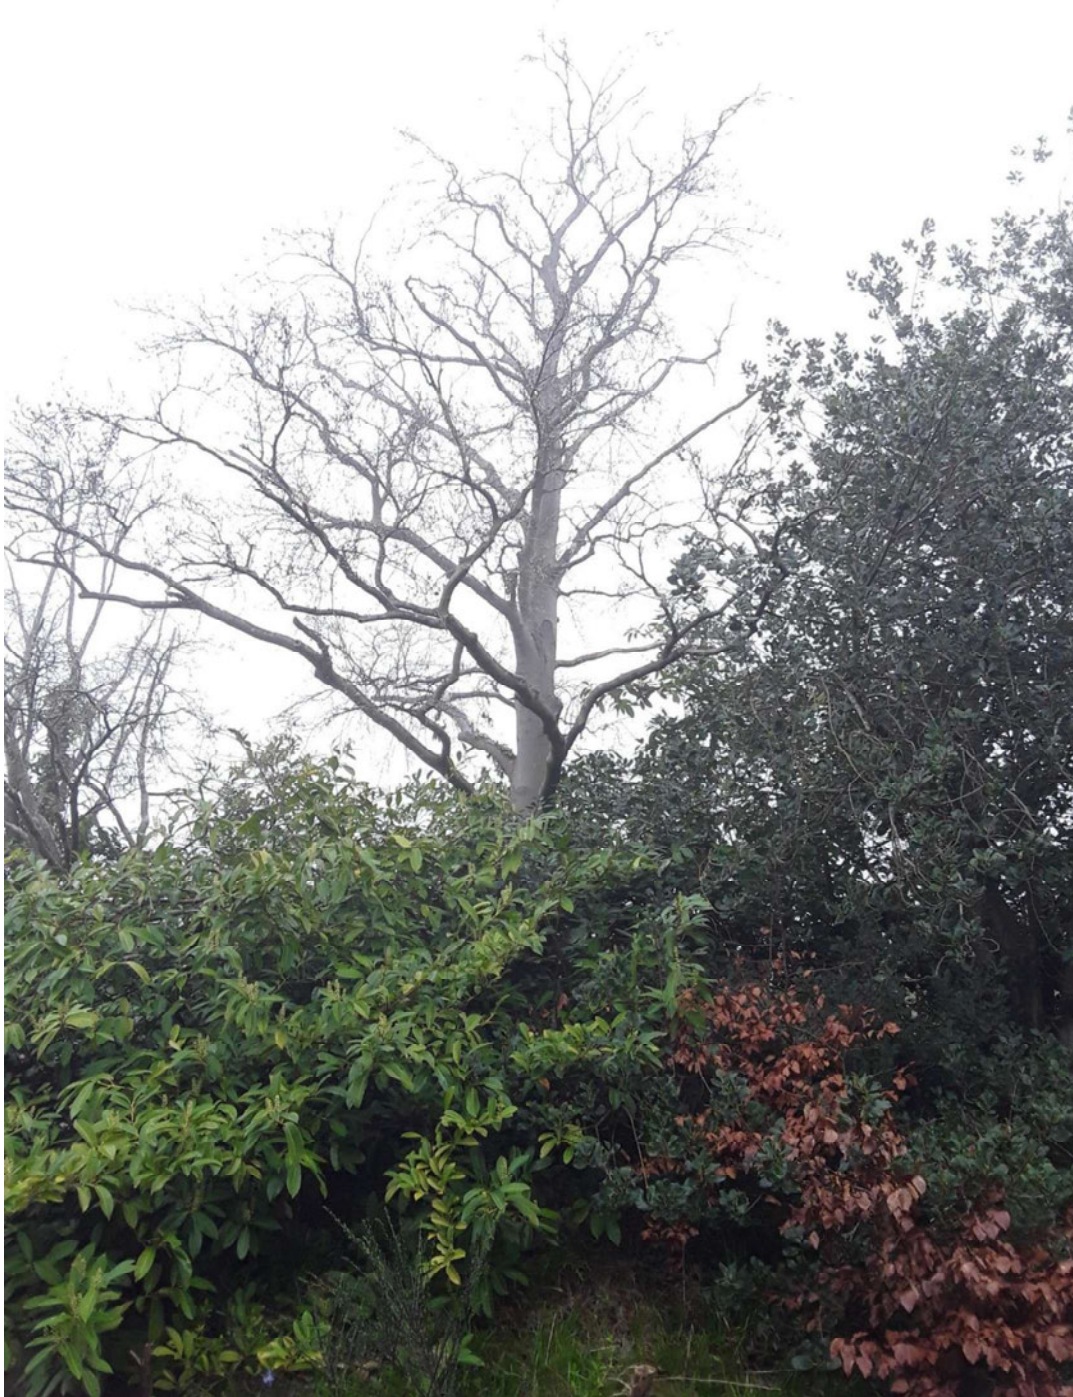
Image 6 – Showing T5 at the front of the property

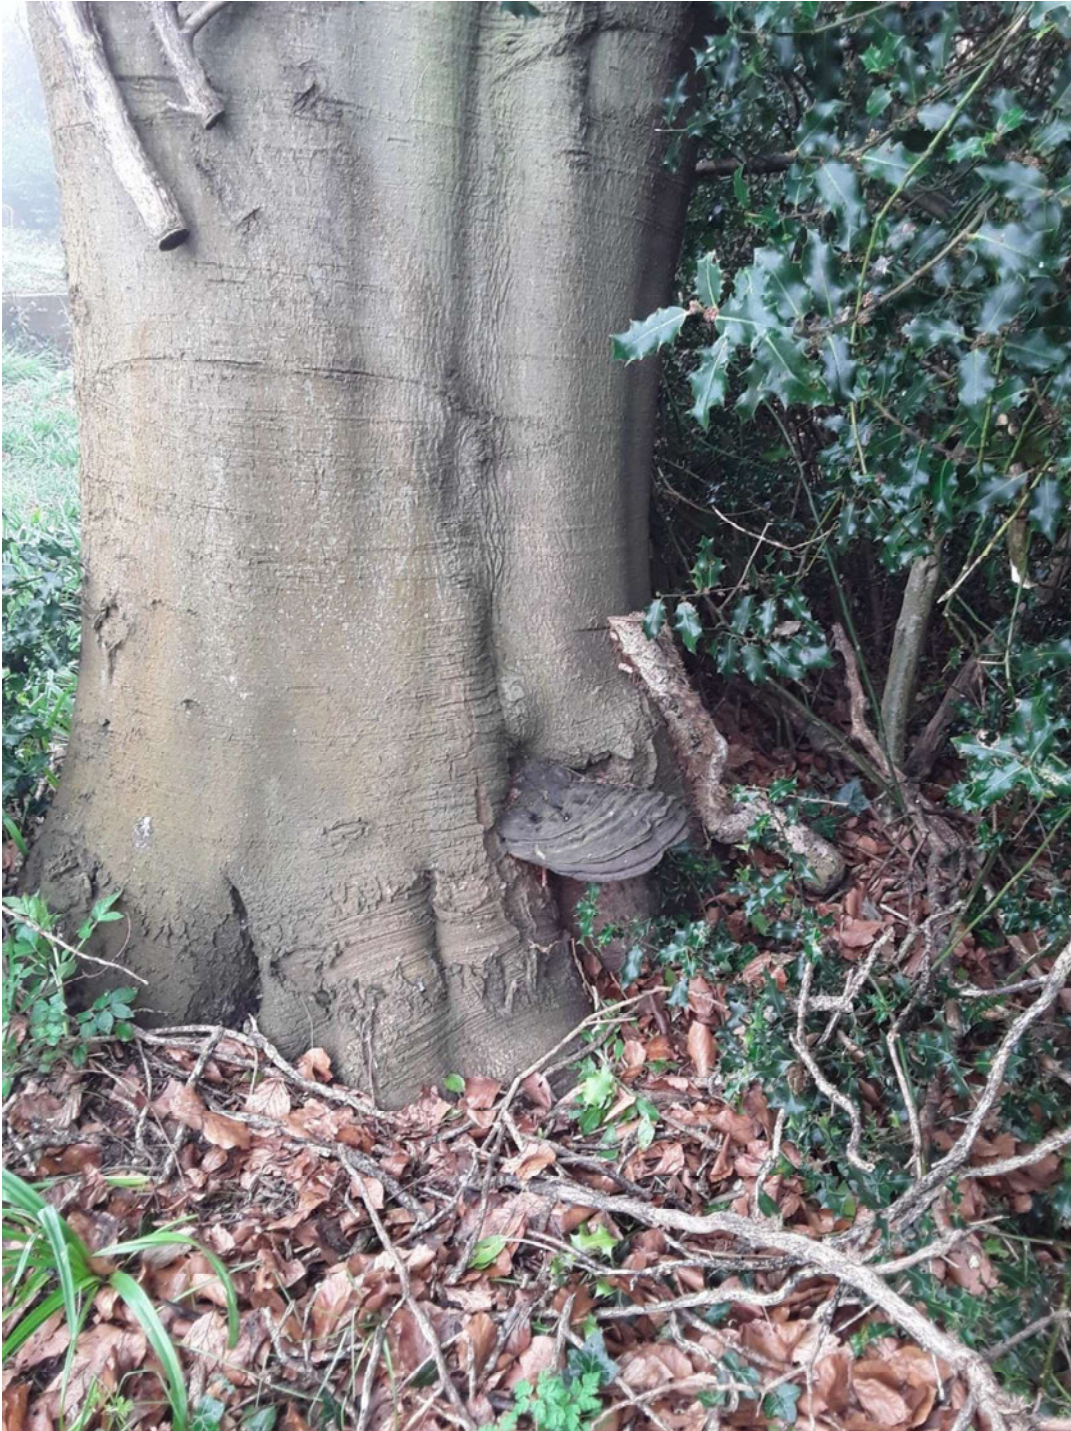
To the rear is a large Beech tree which is in decline and has a large Ganoderma bracket at the base of the tree. The tree is likely to fail in the future and is protected by a Tree Preservation Order. The tree will need to be removed within the next 10 – 15 years.

Image 7 – Showing Ganoderma bracket at the base of T6

Potential removal of Beech tree T06

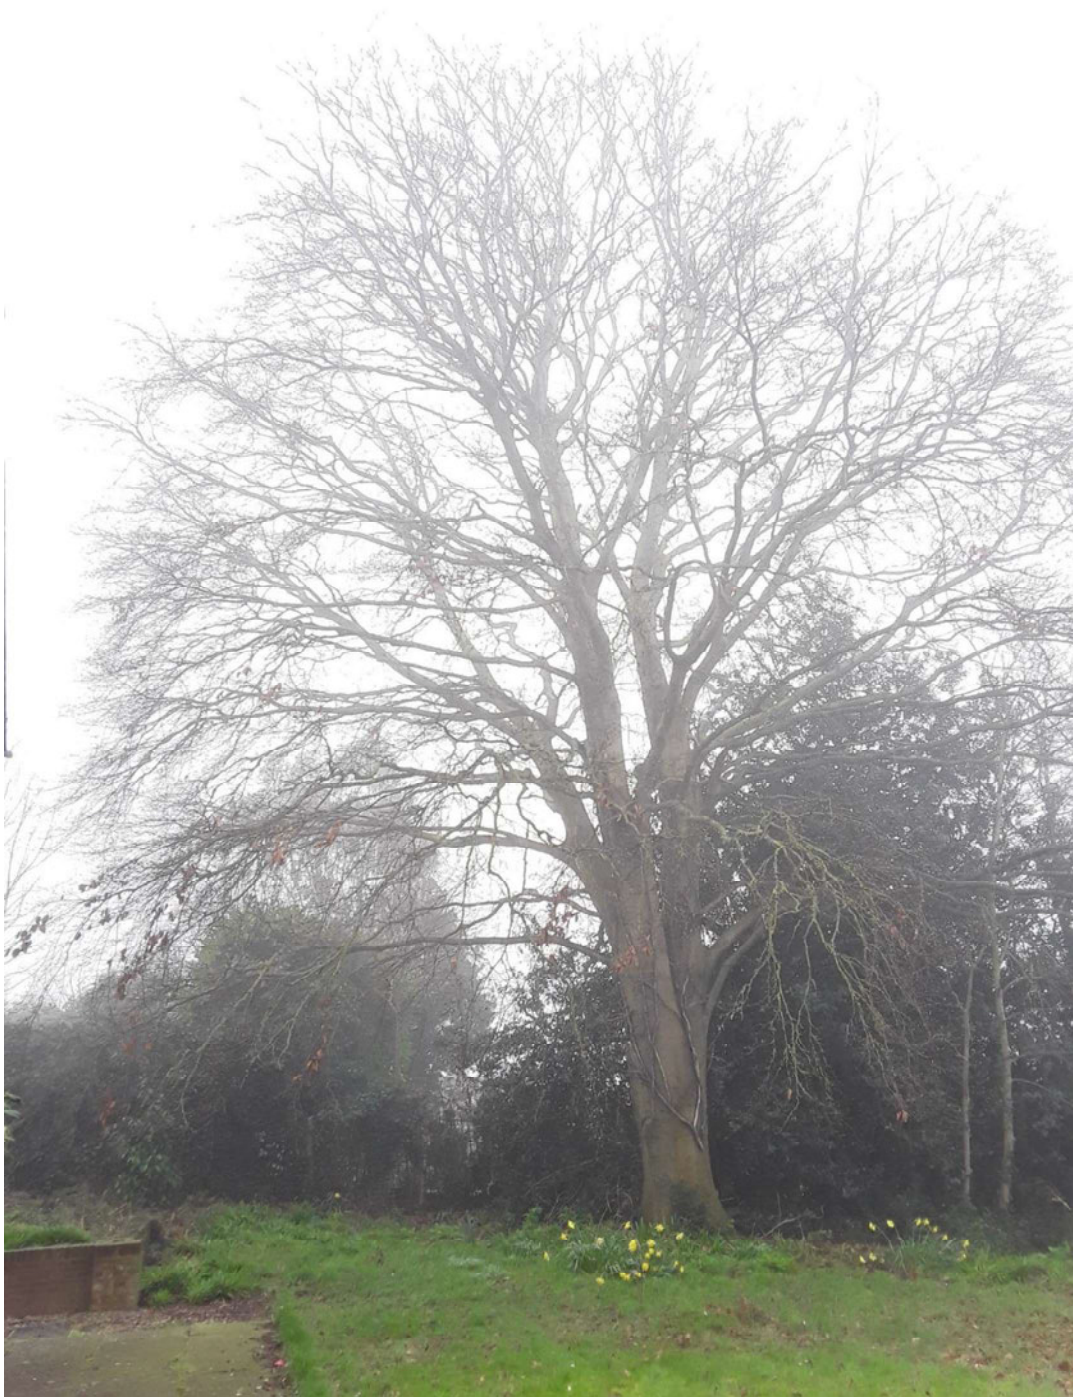
| T6 | Common<br>beech<br>( <i>Fagus<br/>sylvatica</i> ) | Height (m): 17<br>Stem Diam(mm): 960<br>Spread (m): 9.5N, 9E, 8S,<br>9.5W<br>Crown Clearance (m): 1<br>Lowest Branch (m): 3(E)<br>Life Stage: Mature<br>Rem. Contrib.: 10+ Years | Canopy in good health but<br>low and close to the house.<br>Significant Ganoderma<br>bracket at base of tree. Tree<br>forks at 3m to create three<br>main stems with included<br>bark areas<br><br>Fungus:<br>Ganoderma spp | C1 | Radius: 11.5m.<br>Area: 415 sq m. | Other Reference:<br>Physiological Condition:<br>Good<br>Structural Condition: Poor<br>Distance1: 8.622<br>Public Amenity Value: Low<br>Inspection Limitations:<br>None<br>Bat Habitat: None |

Image 8 – Showing T6

| Tree reference number | Species | Category grading | Works required | For Development | For Arboriculture |
|---|---|---|---|---|---|
| T6 | Common beech<br>( <i>Fagus sylvatica</i> ) | C1 | Crown lift 5m | Yes | Yes |
