## **BUILDING CONDITION SURVEY**

**BUILDING TO THE REAR**

**193 ACRESFORD ROAD,**

**OVERSEAL, SOUTH DERBYSHIRE**

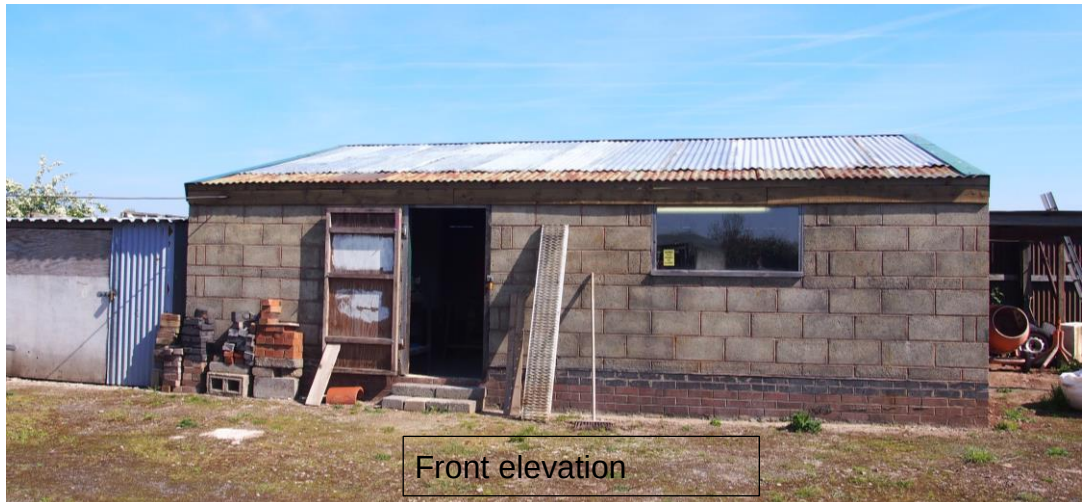
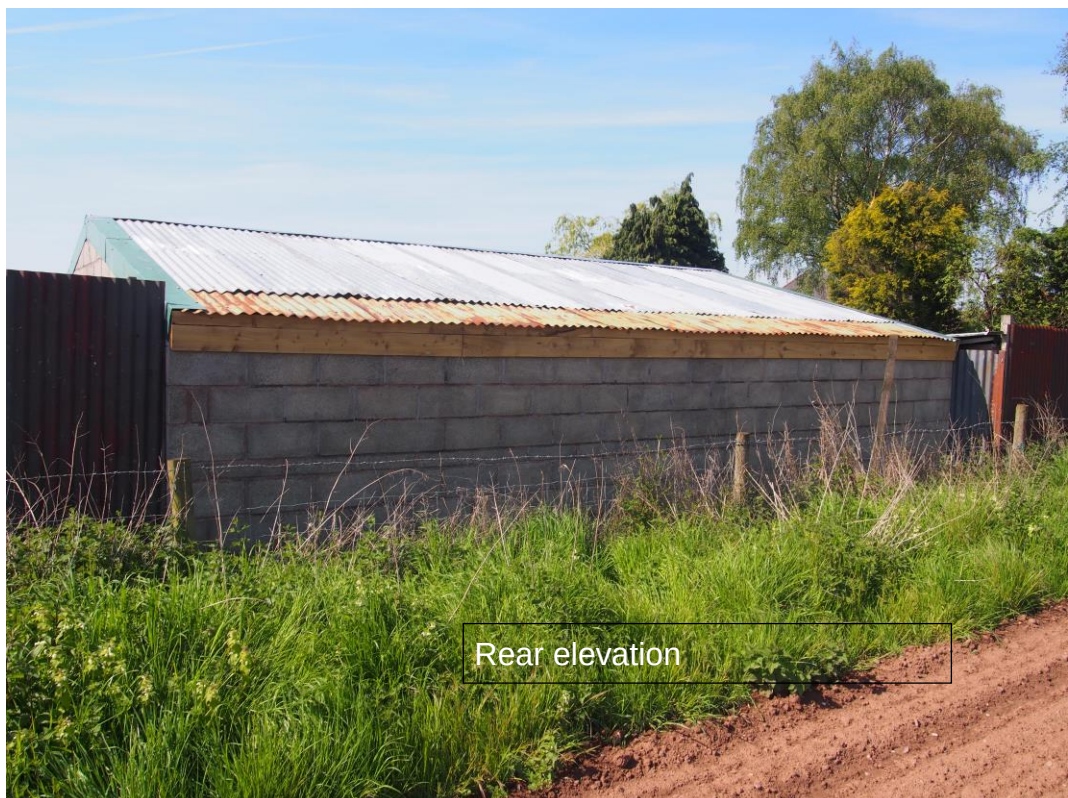
The main walls are constructed of concrete block and are 200mm in thickness to an eaves height of approx. 1.95m. The concrete blocks are set on lower level brickwork comprising two layers of blue engineering bricks and three courses of a traditional red brick. It is understood that the foundations to the building are of concrete as the top of the foundation can be seen. It is understood these are approx. 1m in depth. There is a damp-proof course to the walls above the concrete floor.

All of the block walls are in good condition being well pointed and there is no deterioration to any of the exterior blockwork. There were no signs of any movement to any of the walls and lintels have been provided over the openings.

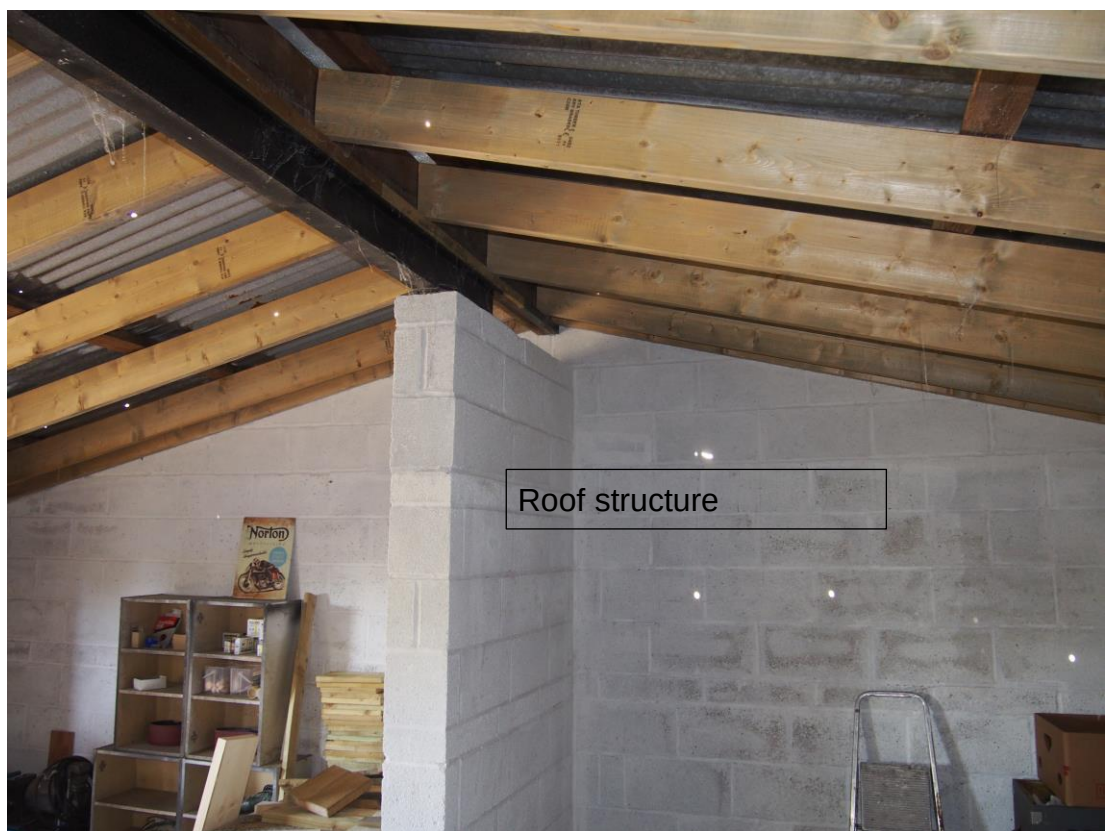
The roof is a shallow pitch roof and the roof structure is constructed of timber rafters resting on the timber external wall plates. The rafters are 117mm x

45mm at 600 centres and cover a span of approx. 3.4m. The rafters are treated timbers and support the steel sheeted roof. There is some surface rust to the sheeted roof however generally it is level and tight and there are no signs of any water ingress.

To the centre of the property there is a steel beam spanning the centre walls of 4.76m in length and with dimensions of 150mm x 85mm. This supports the ridge. The ridge height is approx. 2.92m. All of the timber work and supporting structure is in good condition throughout and there are no signs of any deflection. The roof is capable of withstanding additional weight and insulation without significant alteration or rebuilding.

A more aesthetically pleasing roof covering may be considered and dependent on loading the roof structure should not require replacement.
