**Report for**  
**Outbuilding at 160 Burton Road, Church Gresley,**  
**Swadlincote**  
**Protected Species Survey**

**Date of Report – 20<sup>th</sup> August 2019**

**Protected Species Survey at Outbuilding at 160 Burton Road**

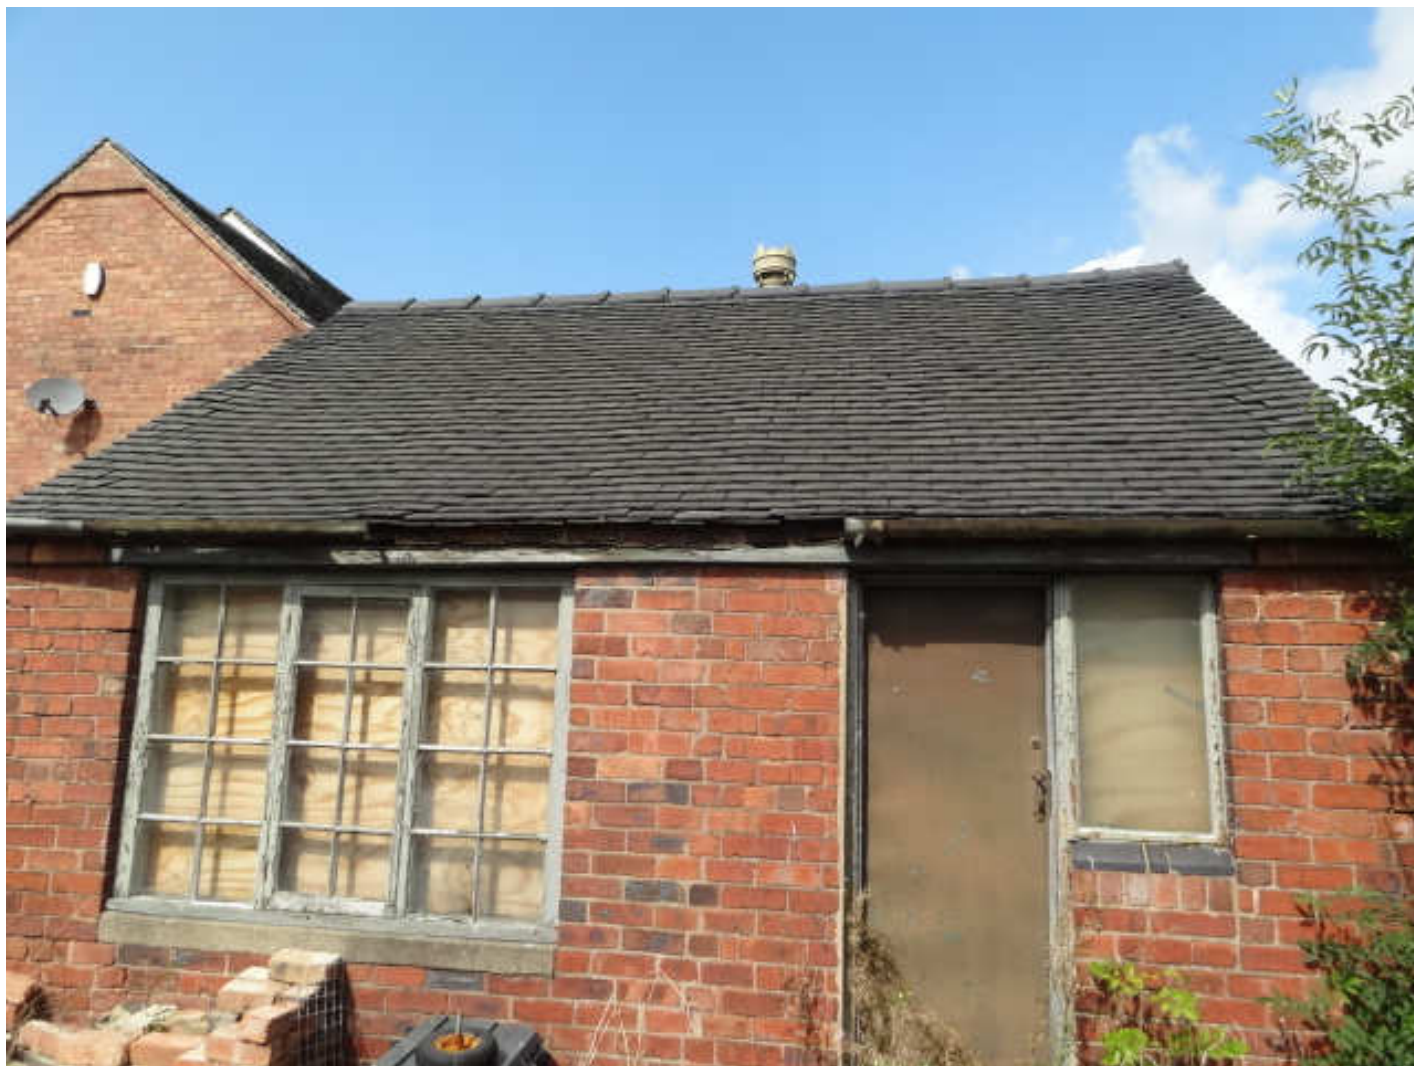
**Photo showing building, from front, (looking north)**

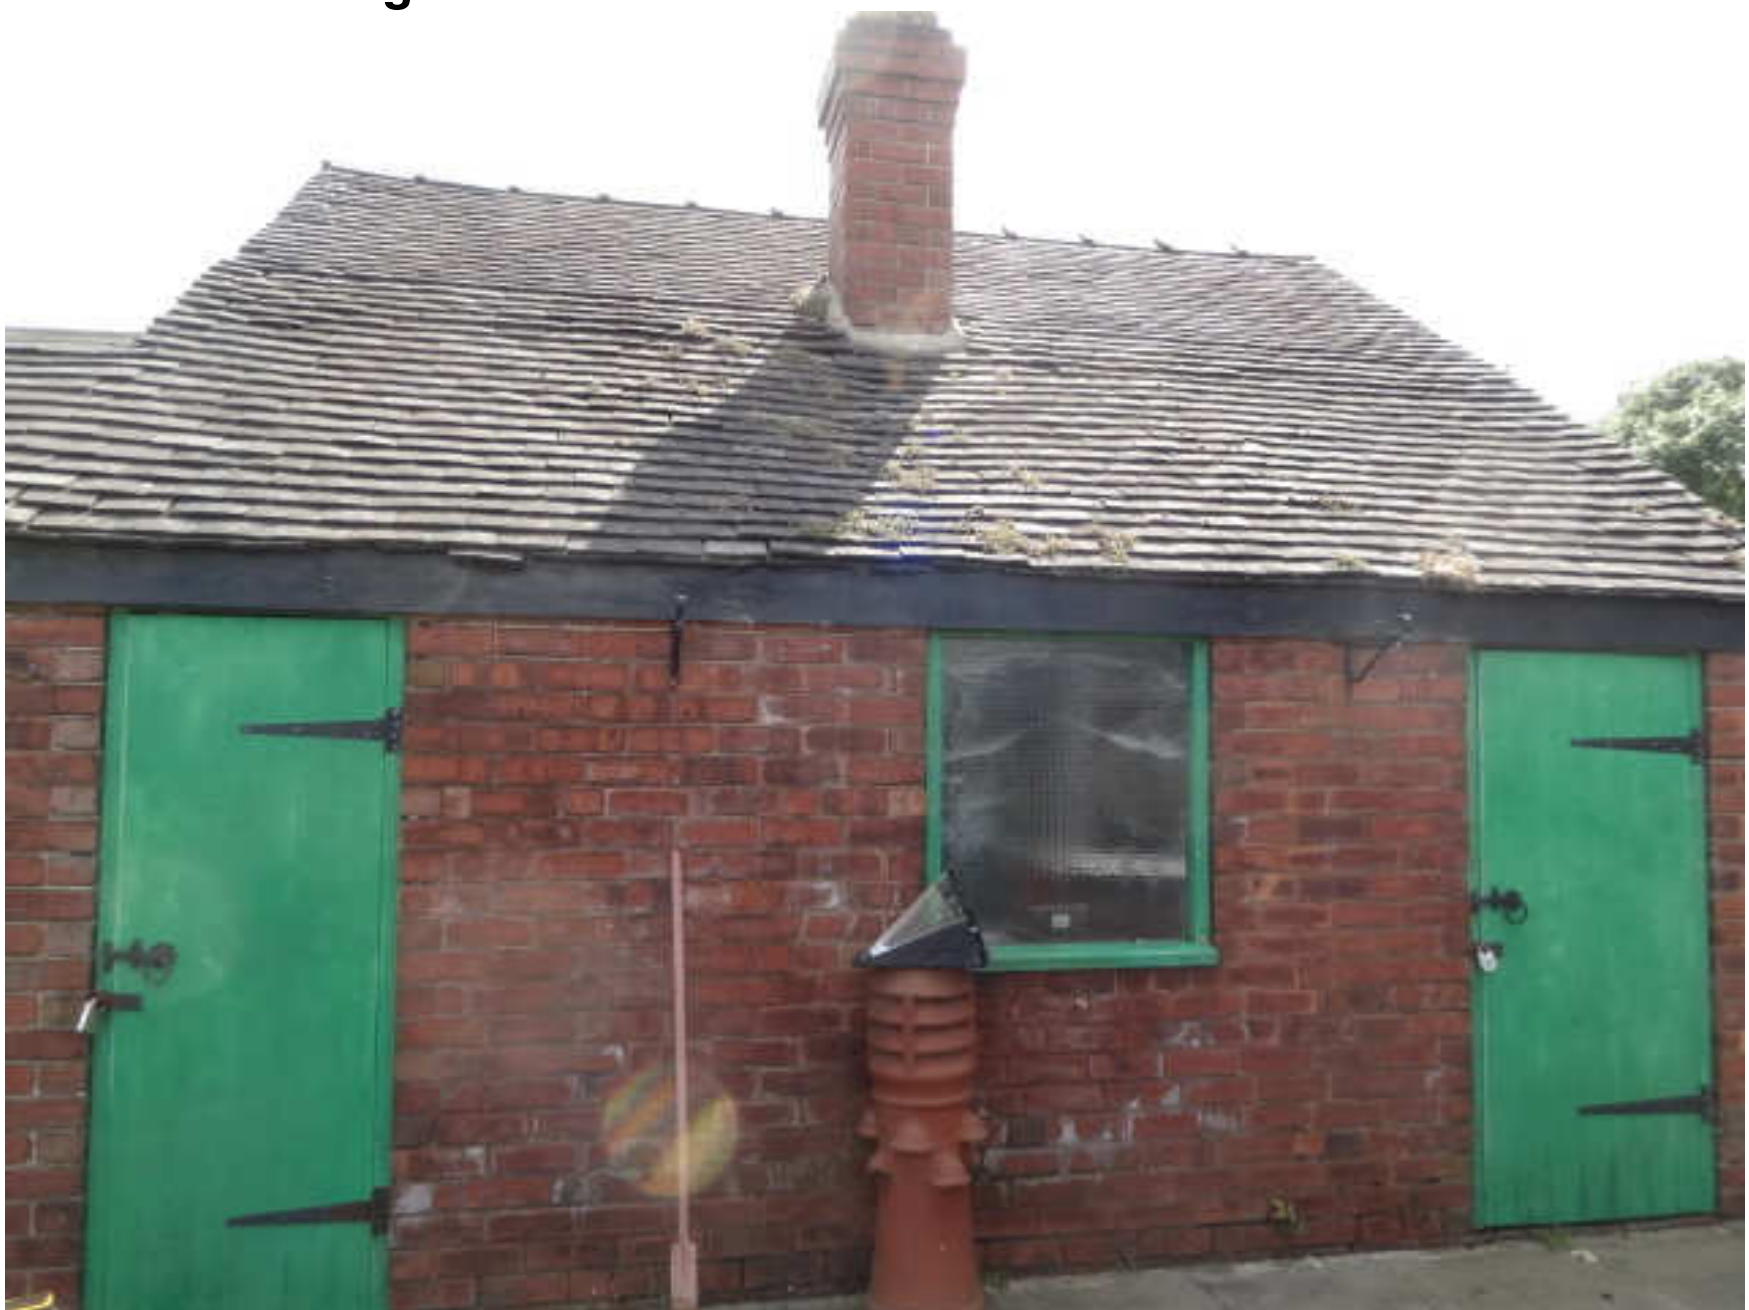
#### **Photo showing rear view of outbuilding, looking south**

The outbuilding had brick walls and a tile roof (clay peg 'Staffordshire blue' tiles). None of the tiles were missing and any small gaps were filled with spiders' webs throughout. There was no loft; the roof timbers were open for inspections. The roof timbers consisted of rafters, purlins and beams (sloping 'queen-post'); these beams had no joints or cavities associated with them. The roof timbers were covered in spiders' webs throughout;

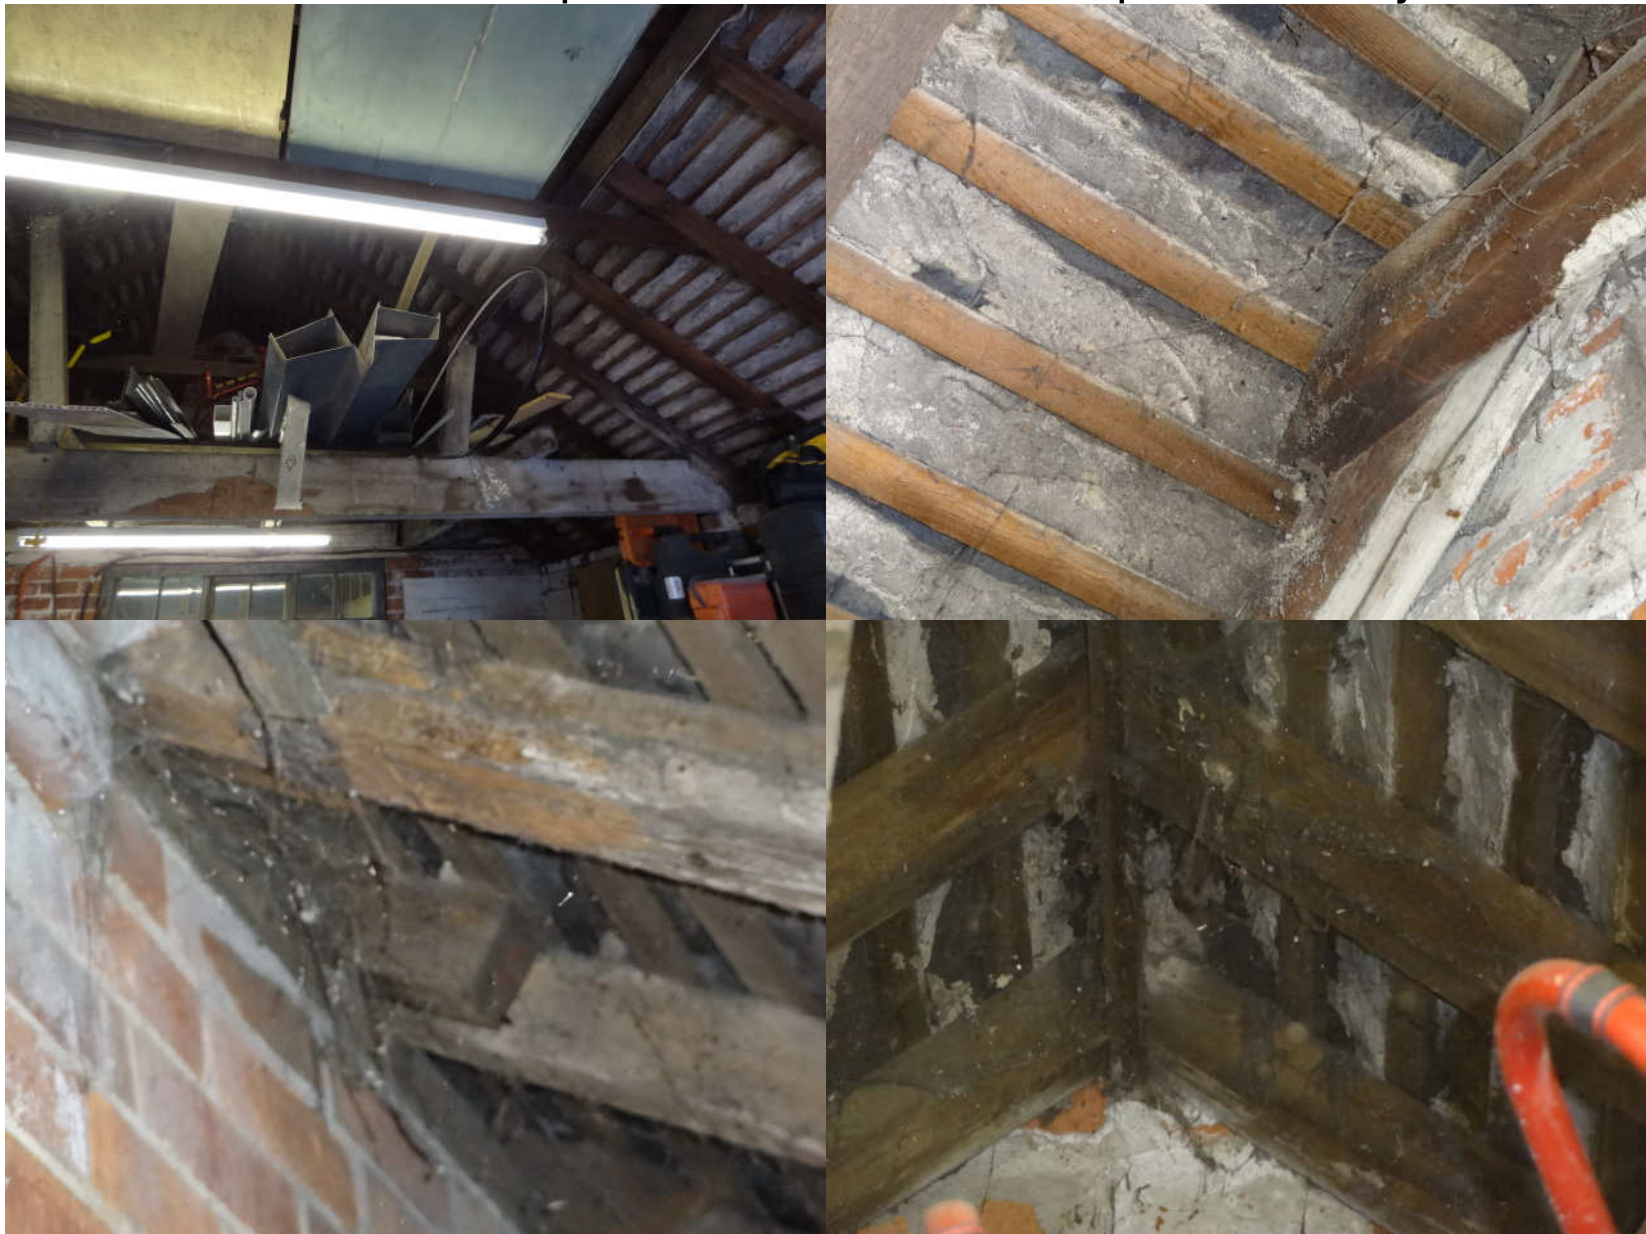
these webs filled the space between the timbers indicating that nothing had disturbed this space for some time. The roof tiles had no backing other than lime cement torching and so the reverse of the tiles was fully visible for inspection. There were no soffits or fascias. The eaves were covered in spiders' webs throughout. The roof had gables to east and west and there was a small lean-to shed on the eastern gable end. There were timber windows and doors, and there were no cavities associated with these. There was no flashing, only lime cement torching on the chimney joint, which had no gaps or cavities. The ridge tiles were all in place with some gaps; but these were all filled with spiders' webs. It was assessed as having negligible potential for roosting bats, due to it being unheated, under continual disturbance as a store/workshop, the lack of evidence of bats and the amount of spiders' webs in the roof space and any cavities.

**Photo showing roof timbers and spiders' webs in the roof space**

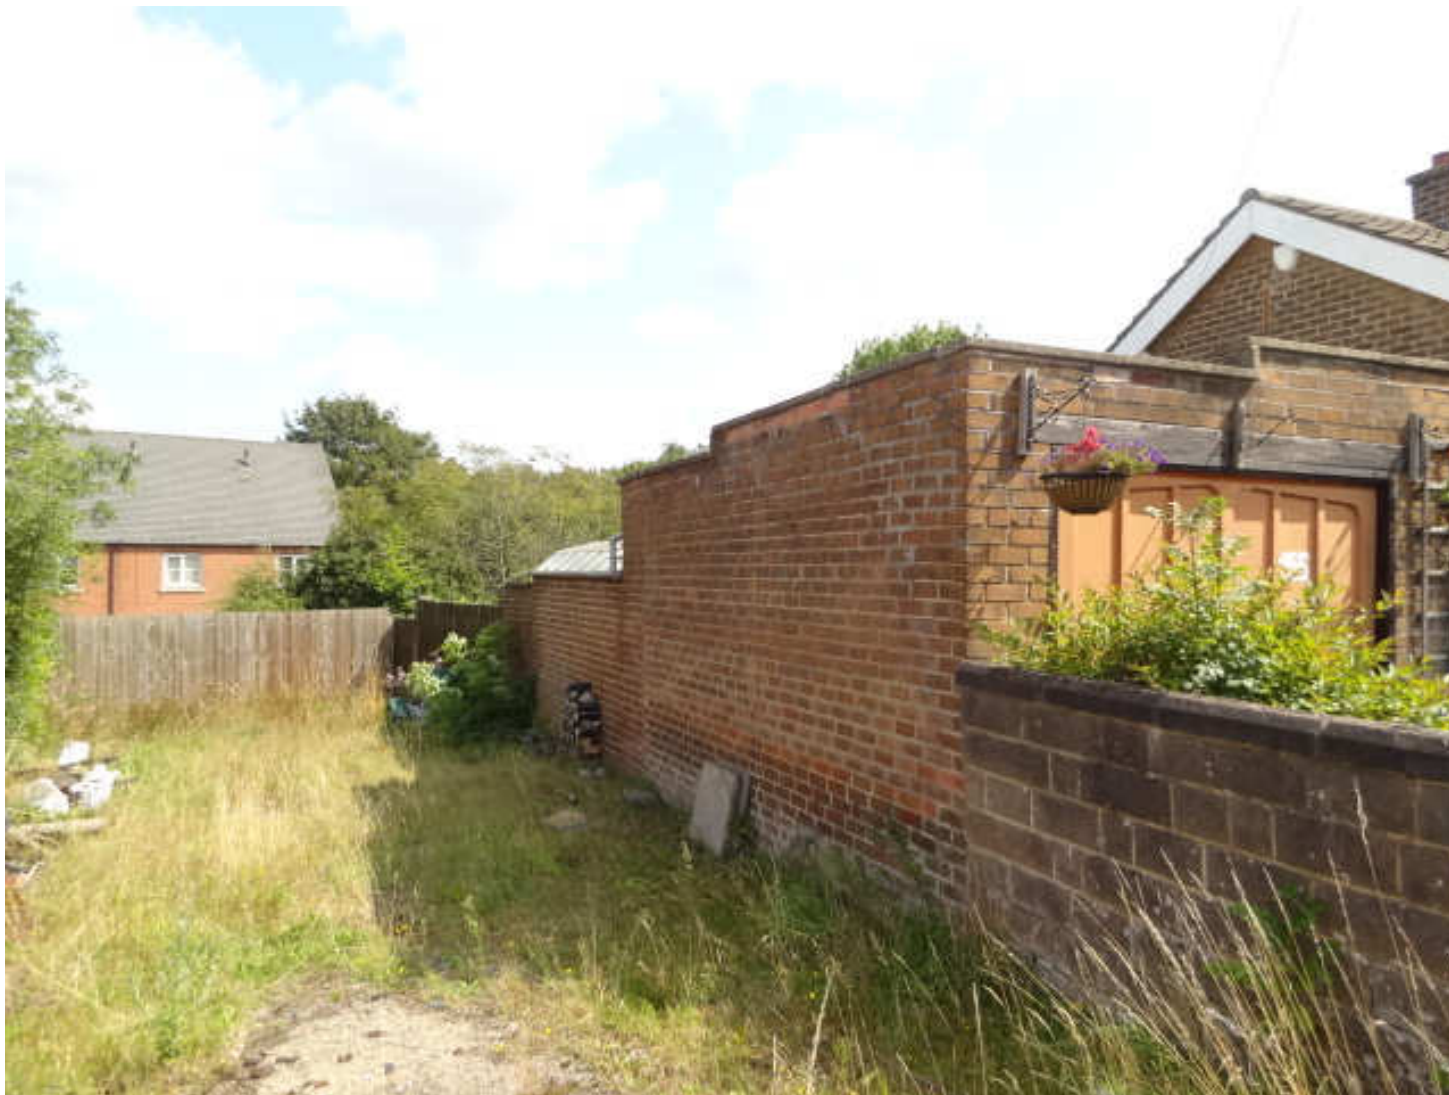
**Photo showing garage attached to 156 Burton Road**

The garage was attached to the bungalow at 156 Burton Road. It had brick walls (with a palisade/coping topping) and a fibre/cement sheeting roof. There were no potential bat roost entrances found. It was assessed as having negligible potential for roosting bats, due to the lack of evidence and lack of suitable potential roost entrances.
