## Technical Note

| Subject | Mine Workings Collapse Assessment – Newhall Junior School Temporary Accommodation | Date | 18 November 2024 |
| File Ref | 14228-CRH-XX-XX-TN-GE-0002_P2.docx | Pages | 16 |

### NEWHALL COMMUNITY JUNIOR SCHOOL TEMPORARY ACCOMMODATION – MINE WORKINGS COLLAPSE ASSESSMENT

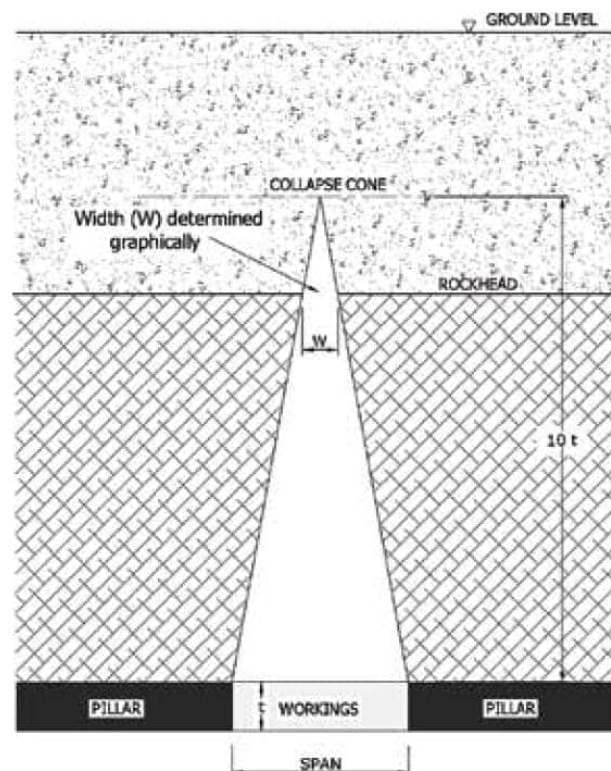
Figure 3 Extract from C758D showing geometry of conical collapse mechanism

- 4.3 An assessment of the potential migration of voids caused by the collapse of the roof of mine workings has been undertaken following guidance presented in CIRIA C758D and based on an assumed conical failure mechanism. The geometry of the cone of collapse is determined by the height of the mine working, the span of the mine working and the theoretical maximum height of void migration as illustrated by Figure 3.

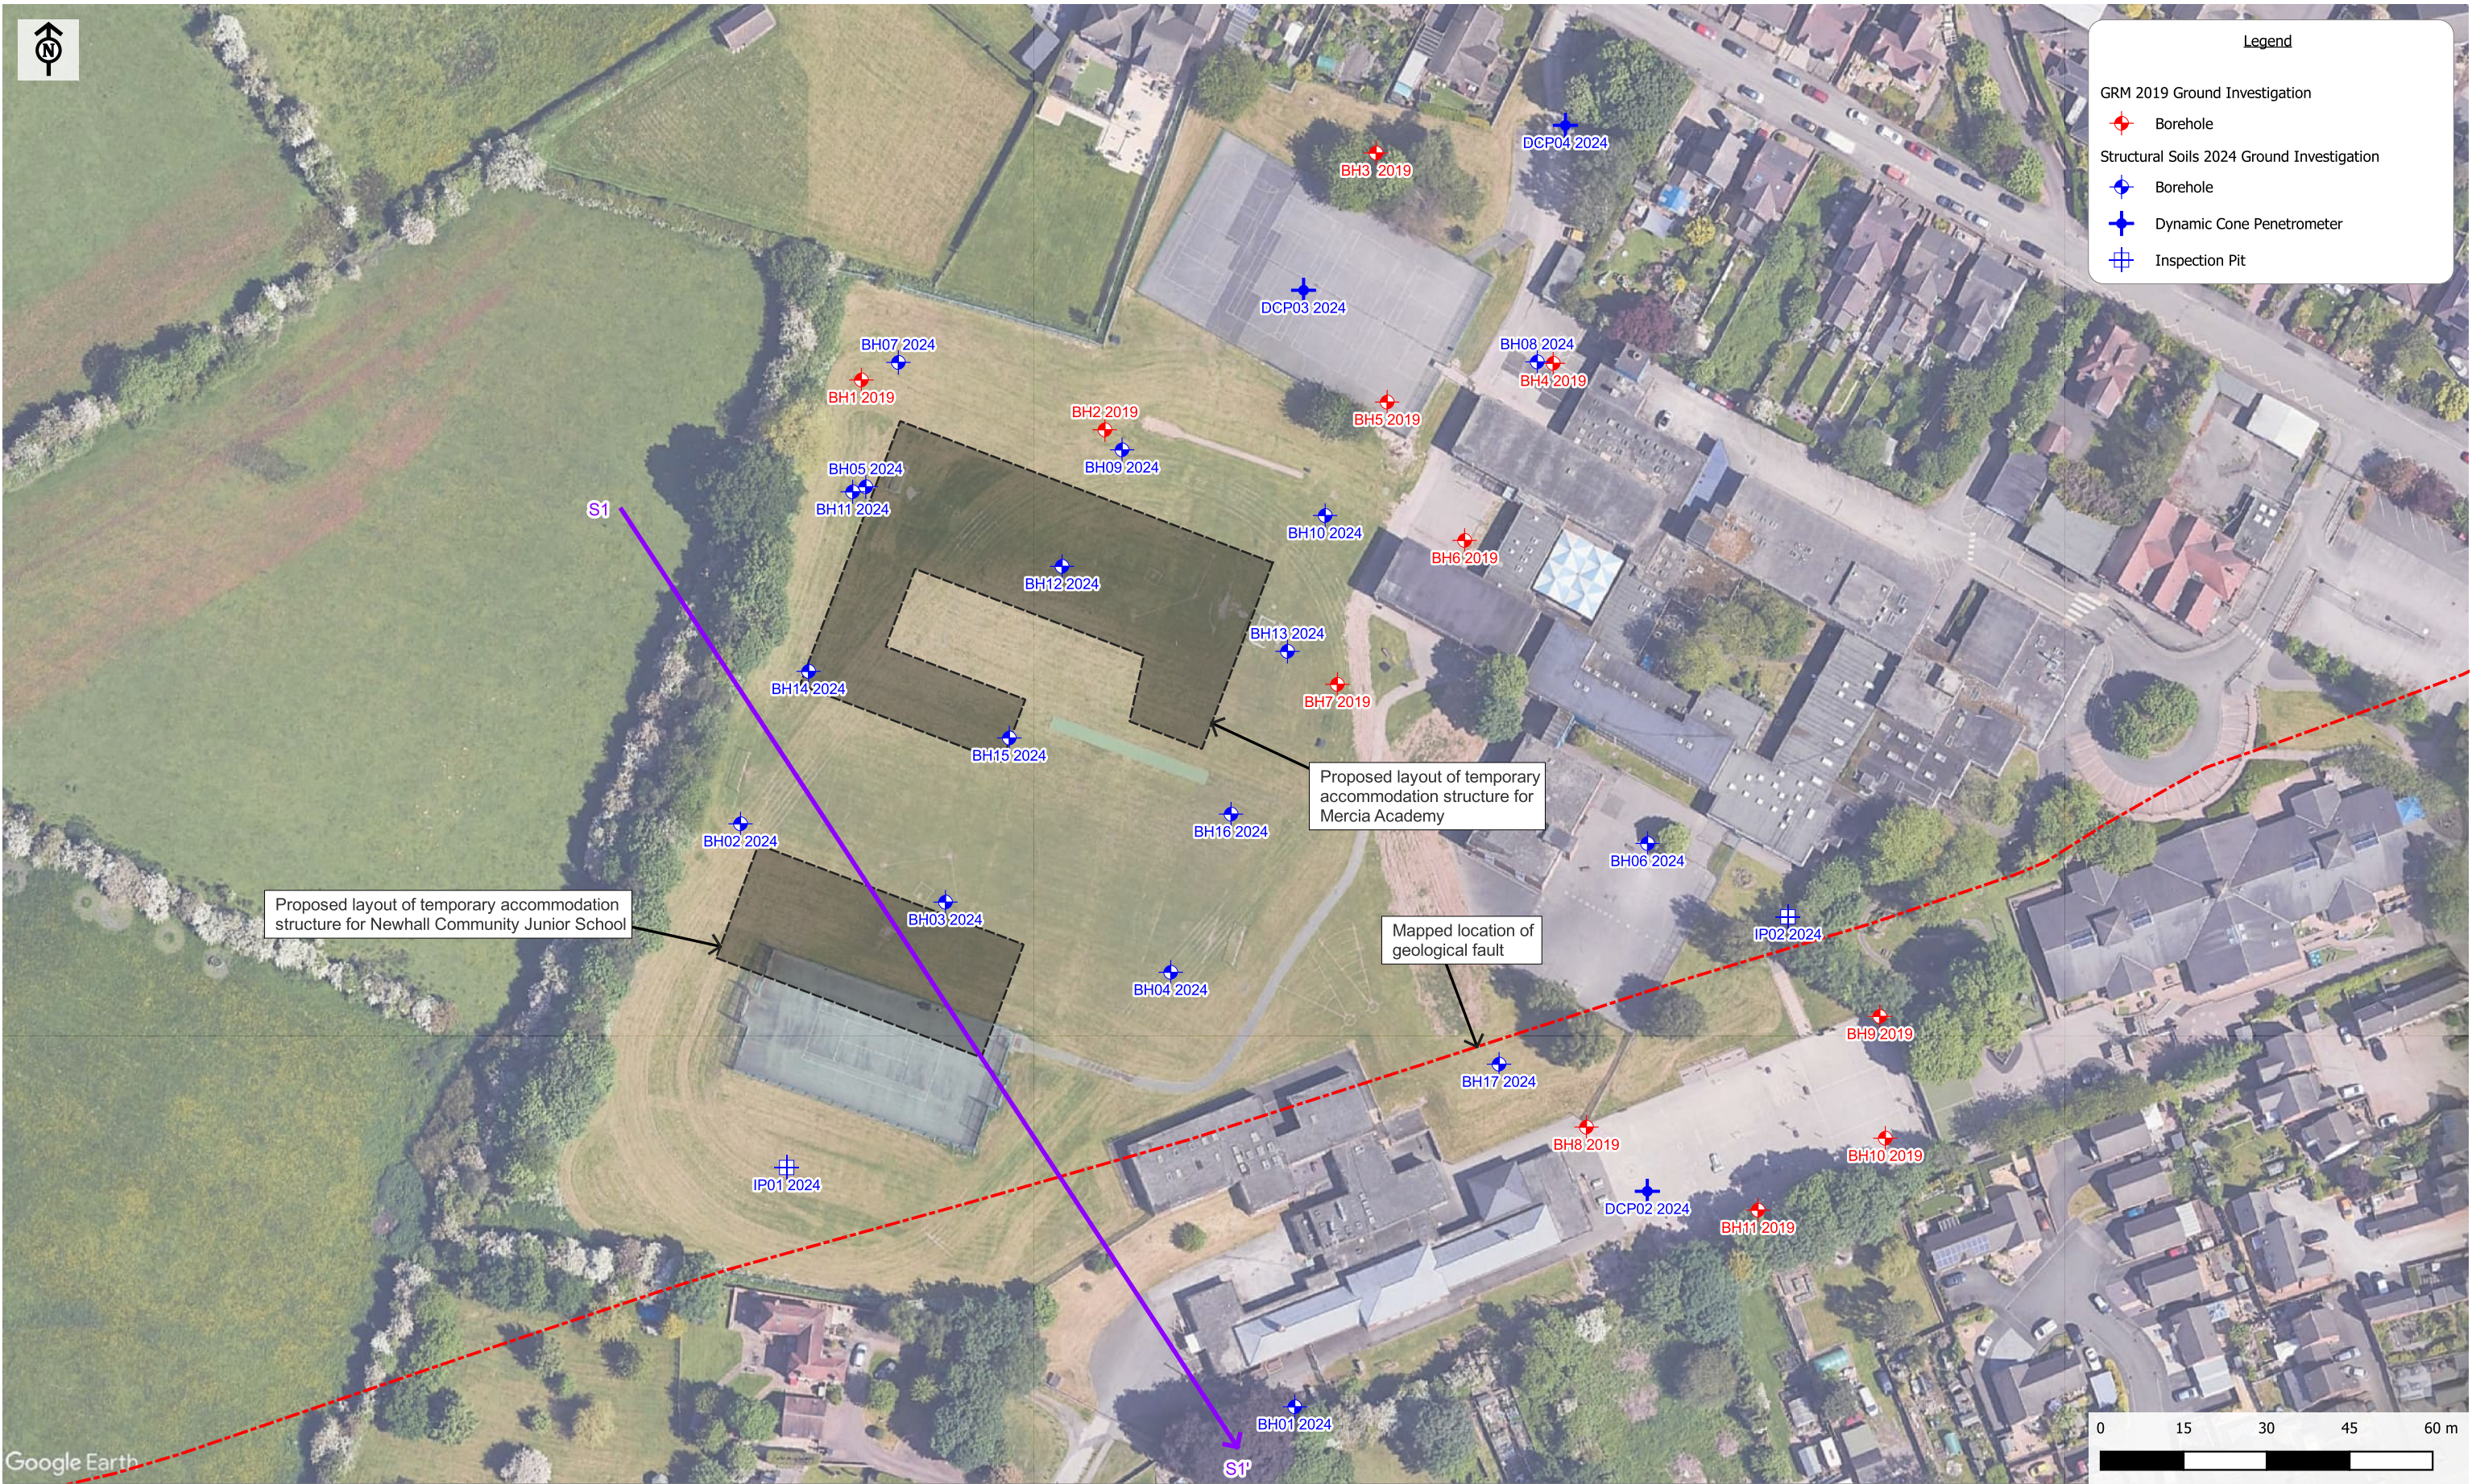
Figure A.1 – Exploratory hole location plan

3.16 A geological cross section as shown in Figure A.1, Appendix 1 displaying information from both phases of ground investigation is presented in Appendix 1.

3.19 The findings show clear evidence of a continuous coal seam, postulated to be the Over Main seam, with the top of the seam (determined by observation of intact coal or a suspected void)

recorded to vary from 13.20m to 30.80m bgl. The direction of dip is shown to be towards the southeast of the site and the dip angle generally varying from c.9° to c.10°.

- 3.21 The findings of the ground investigation indicate that the fault passes between BH06 2024 and BH17 2024 (as evidenced by an observed vertical displacement in the Over Main seam) which agrees well with the mapped location of the fault.

- 3.22 The mapped location of the geological fault has been overlaid onto Section 1 in Appendix A. It should be noted that the mapped location of the fault shown in Section 1 does not fall between BH06 2024 and BH17 2024 due to the projection of the cross section.

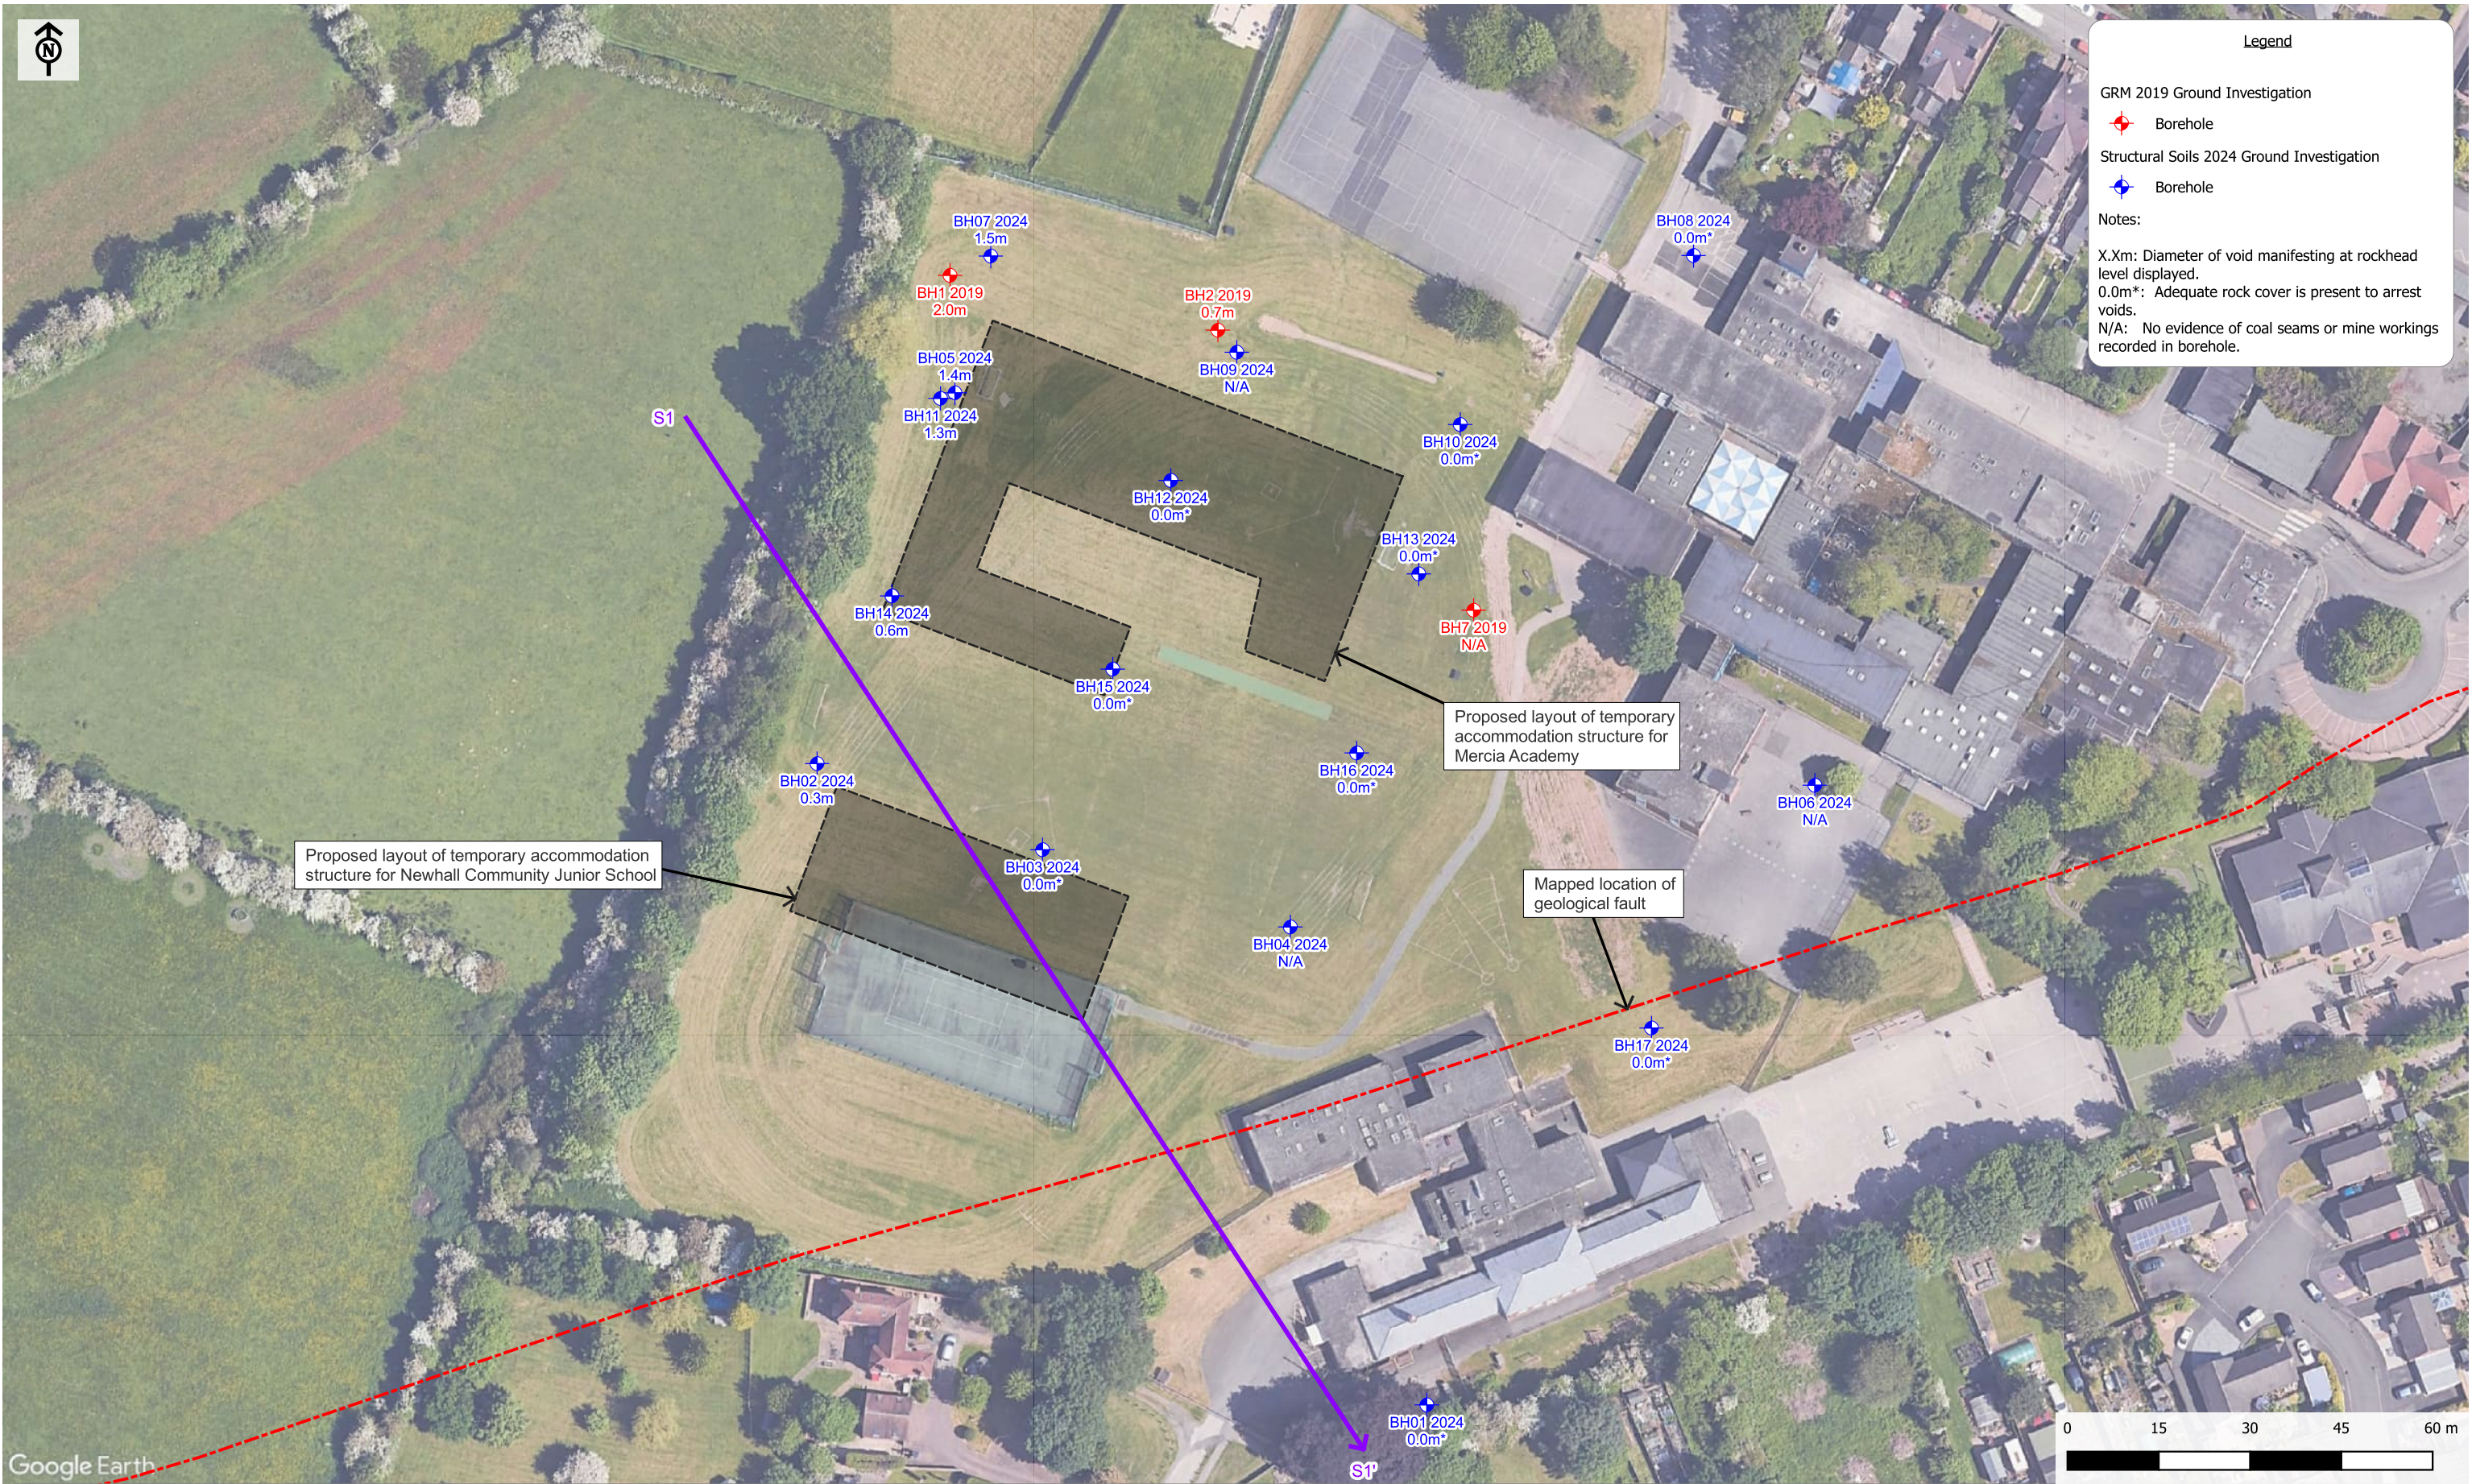
Figure A.1:  
Exploratory hole location plan

- 3.1 Two phases of ground investigation have been undertaken on the site between 2019 and 2024. A plan showing the location of the exploratory holes from both investigations in relation to the approximate footprints of the modular structures providing temporary accommodation provision for Mercia Academy and Newhall Community Junior School is shown in Figure A.1, Appendix 1.
