Tel: 01283 551249  
Web: [www.grm-uk.com](http://www.grm-uk.com)  
Ref: GRM/P8897/CMRA1.RevA  
Date: 12<sup>th</sup> August 2019

### **Coal Mining Risk Assessment for 6 Millfield Street, Woodville**

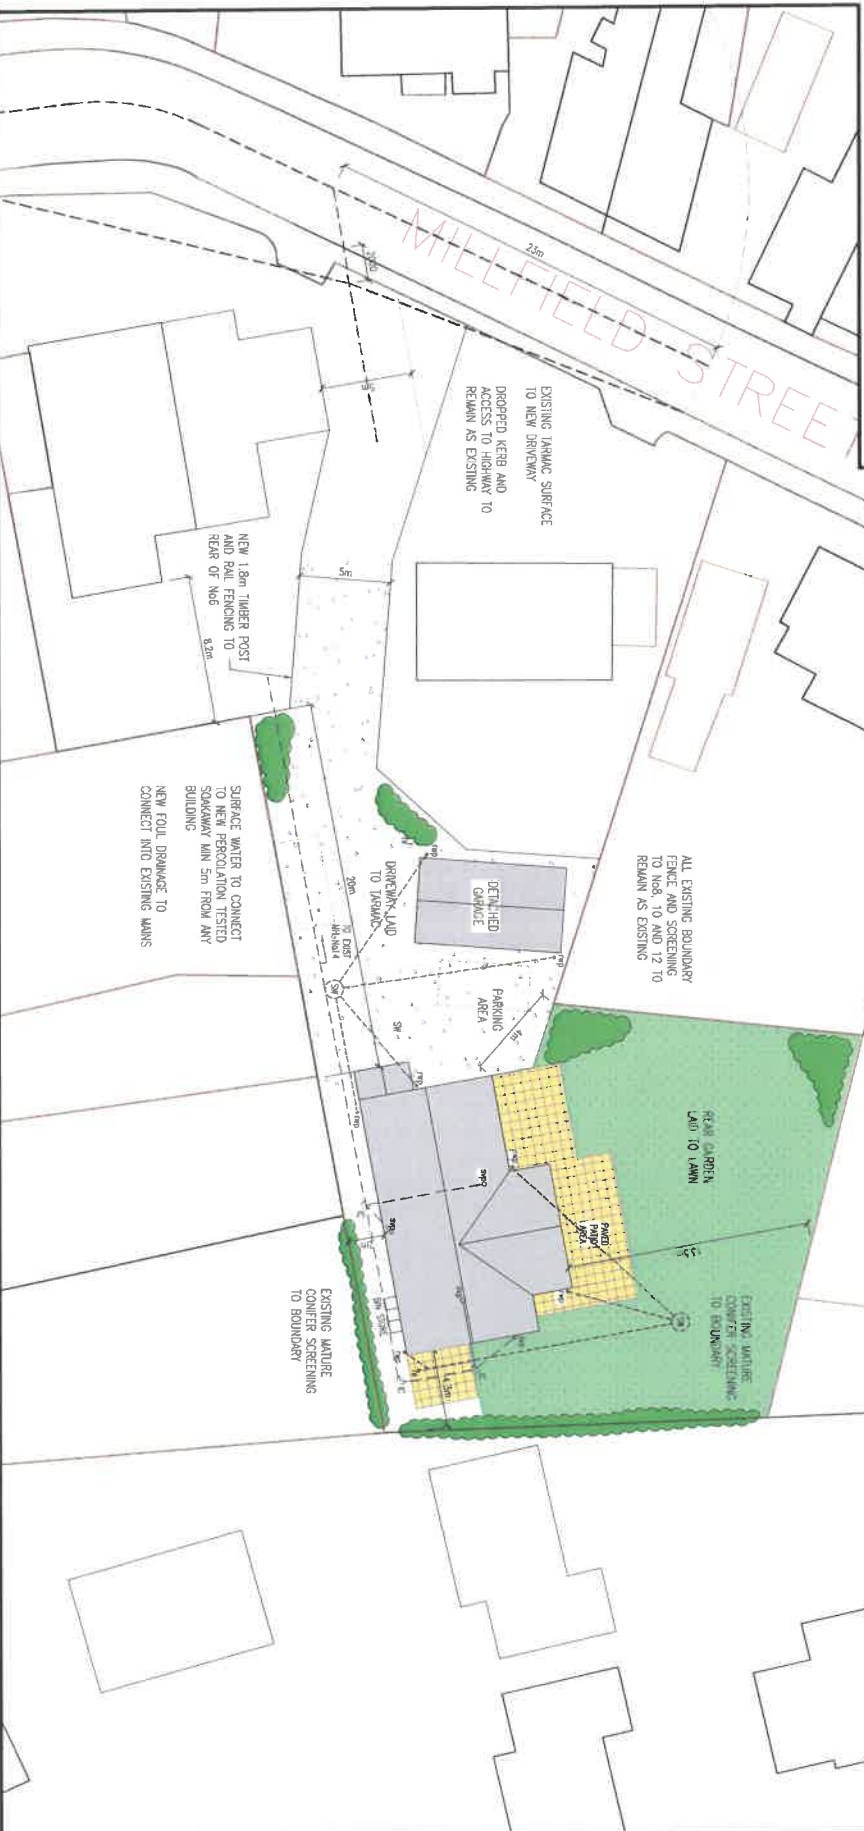
Proposed New Build Dwelling  
The proposed new build dwelling is a two-story house with a detached garage and rear garden. The plan shows the building footprint, parking area, and garden layout. The site is located on Millfield Street, Woodville.

We have been informed that you propose to develop the site with a single detached dwelling along with associated infrastructure and soft landscaping. A Proposed Development Plan is presented in Appendix A.
