# **BAT SURVEY REPORT**

Tutholme, Woodhouses  
Derbyshire

September 2019

| <b>Project:</b> | Residential Development |

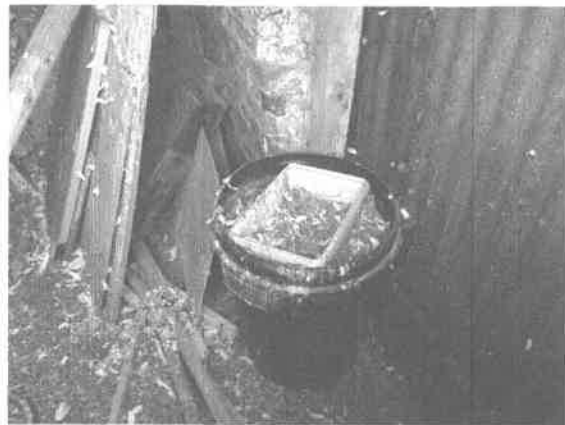
Image 8: Internal elements of Barn 2.

- 3.6 Barn 2 is also a brick structure with a pitched timber-framed roof that is covered with clay tiles. Access to the building was achieved via a stable door. Many of the roof tiles are slipped, damaged and missing, and there are a number of roosting features inside the building, including gaps between the timber beams, settlement cracks and crevices between the brickwork where the mortar has failed.

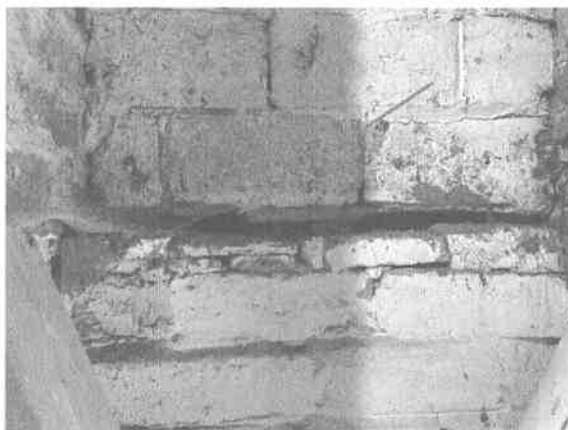
Image 9: Settlement crack in Barn 1.

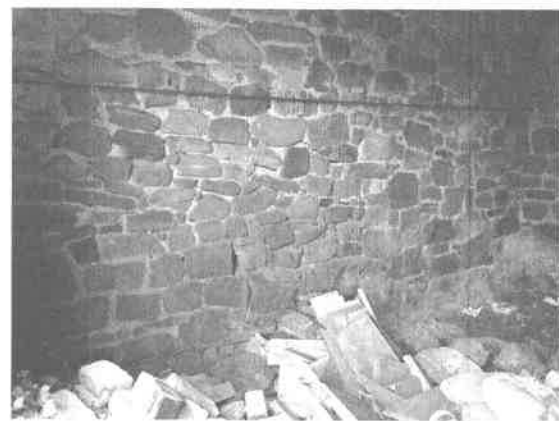
Image 10: Gaps between stone inside the lean-to structure.

- 3.7 The lean-to structure was built using a mixture of brick and local stone. The roof is timber-framed, pitched and it is covered with clay tiles. Many of the tiles are dislodged, damaged, raised or missing. During the survey a number of holes were observed in the stonework. No evidence of bats was found inside the lean-to structure.

- 4.3 While undertaking the daytime building inspection, numerous potential access and egress points were observed in Barns 1 and 2 and also the lean-to structure. All buildings are considered to support features with bat roosting potential. These included gaps, missing masonry, raised tiles and cracks in brickwork due to missing mortar. The majority of these features have suitability for small numbers of bats during summer months, however the gaps in the stonework of the rear wall of the lean-to have the potential to support hibernating bats.

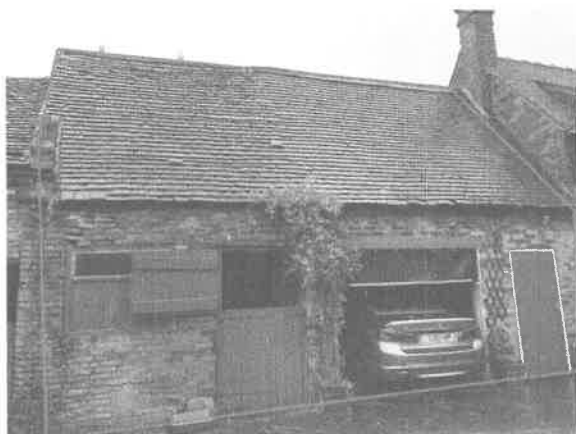
Image 1: North-west facing aspect of Barn 1.  
Note that that the building is subdivided. One half is used to park a motor vehicle (Section 1). Other us used by fan-tailed doves (Section 2)

- 3.3 Barn 1 is subdivided in two sections. Section 1 is used to park a motor vehicle and Section 2 is a former stable that is currently used by nesting doves. The barn is a solid brick building with a pitched timber roof that is clad with clay tiles and it is partially lined with modern breathable roof membrane.

- 3.4 Section 1 has a timber dividing wall, it is open to the elements and is used regularly to park a car. Potential Roosting Features (PRFs) include dislodged bricks, failed mortar bedding, raised tiles and gaps behind the guttering. There are small crevices above the door lintel, cracks in the timber beams and also settlement cracks in the walls. During the field visit, two small bat droppings were discovered in a spider web near to the parked car.

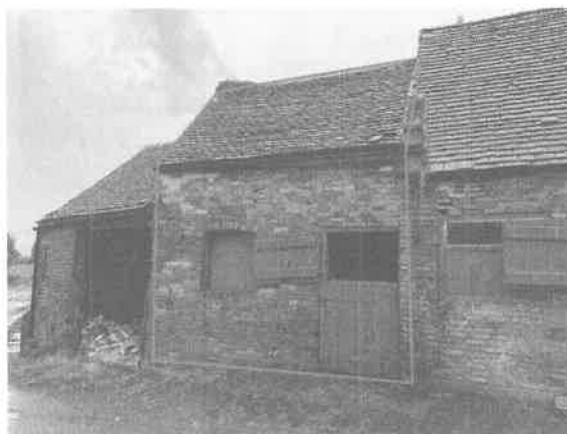
Image 2: North-west facing aspect of Barn

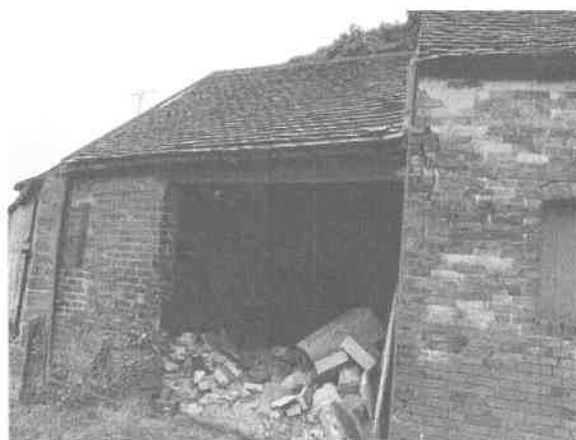
Image 3: North-west facing aspect of lean-to structure adjacent to Barn 2.

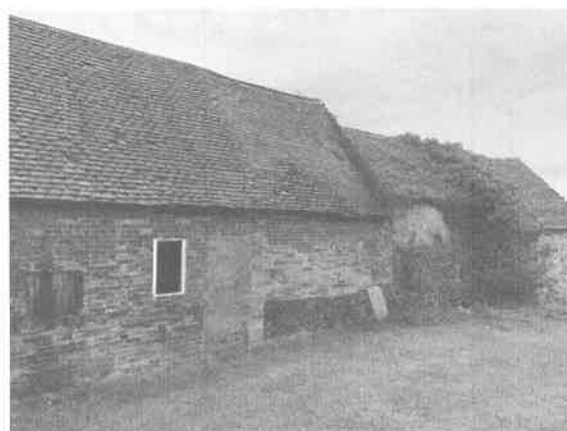
Image 4: South-east facing aspects of survey buildings.

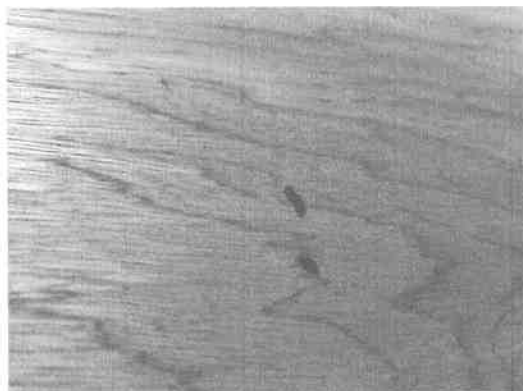
Image 5: Two bat droppings found in Barn 1 near parked motor vehicle.

- 4.4 Two bat droppings were discovered in Barn 1 during the daytime building inspection. Whilst bat droppings can be indicative of the presence of a bat roost, low numbers of scattered droppings in barns can also result from bat foraging behaviour. Following the daytime survey, three follow-up nocturnal bat surveys were subsequently undertaken to determine the presence or likely absence of roosting bats.

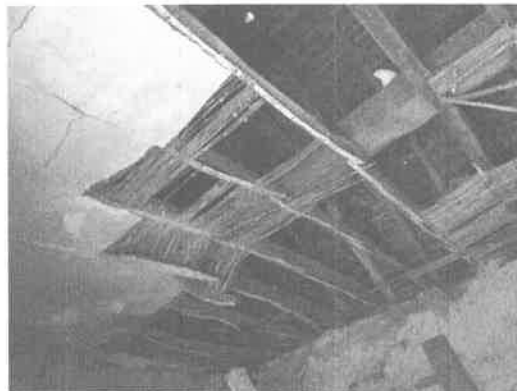
- 3.5 Section 2 can be entered via a stable door. It once contained a loft void but in recent years the ceiling has become progressively worse and has collapsed. Like Section 1, numerous gaps and cervices were noted during the survey and evidence of common British birds and fan-tailed doves was found. No evidence of bats was found in Section 2 of this building.

Image 6: Dilapidated ceiling in Barn 1 Section 2 of Barn 1.
