## **Preliminary bat roost assessment & Emergence Surveys**

| Site Location | Brookley Meadows Farm, Thurvaston, Ashbourne, DE6 5BL |
| Document reference | CE1247-01 |

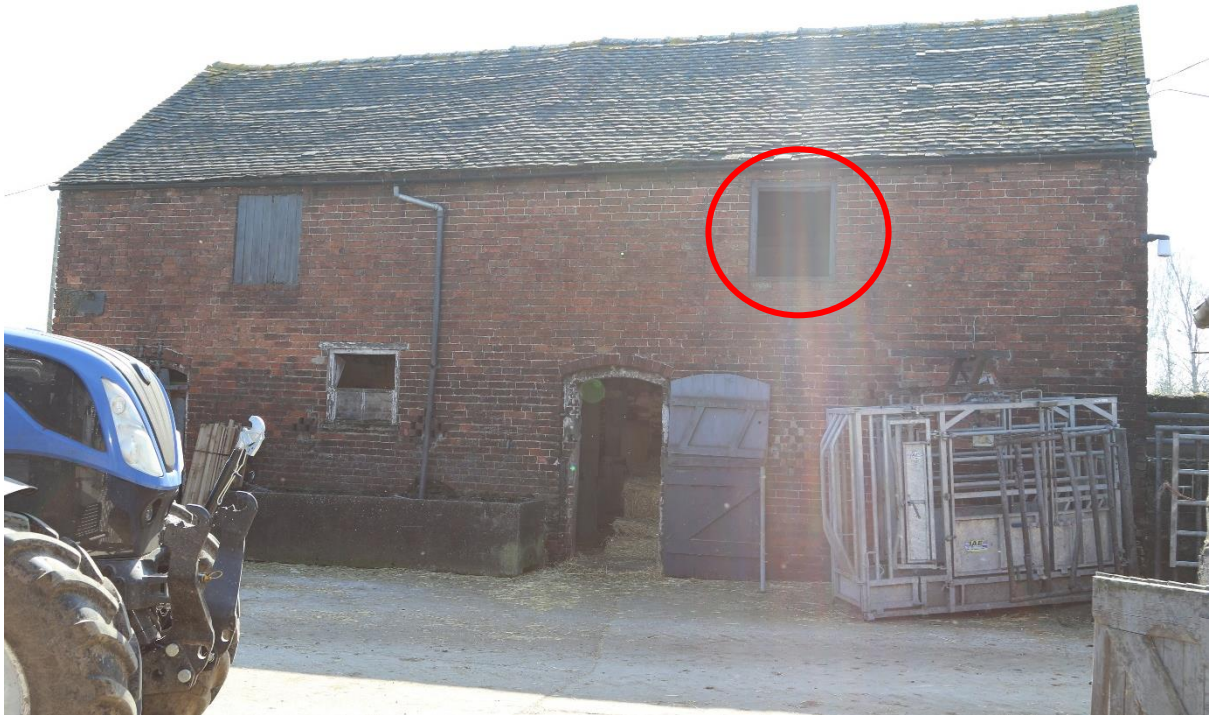
Several un glazed opening (Image 1, 5) across the ground and 1<sup>st</sup> floor areas offer access value to both bats and birds into the internal features of the building.

Image 1 – North facing elevation of the building which has demonstrated an opening within the 1<sup>st</sup> floor areas giving access to both bats & birds internally

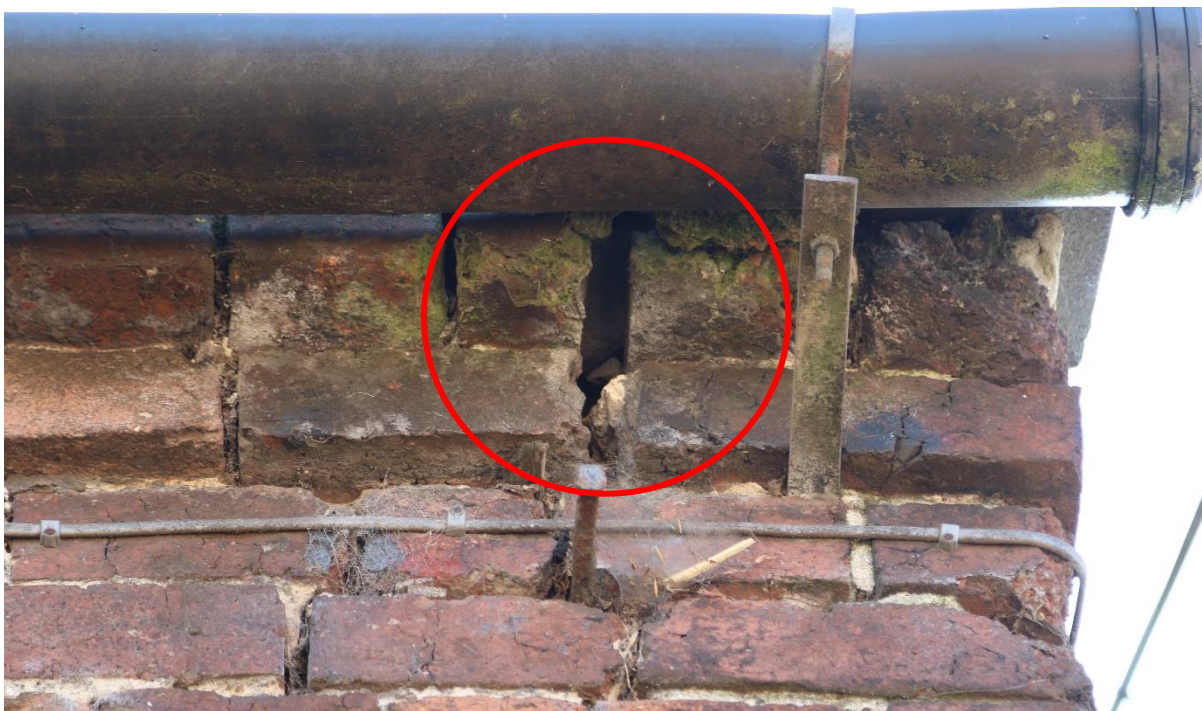
Several gaps between the stonework's and roof tiles could be seen within the North & South facing elevations (Image 2) which offer possible roosting values to crevice dwelling bats.

Image 2 – Gaps within the stonework's below the roof coverings which look to offer value to crevice dwelling bats as a suitable roosting habitat within

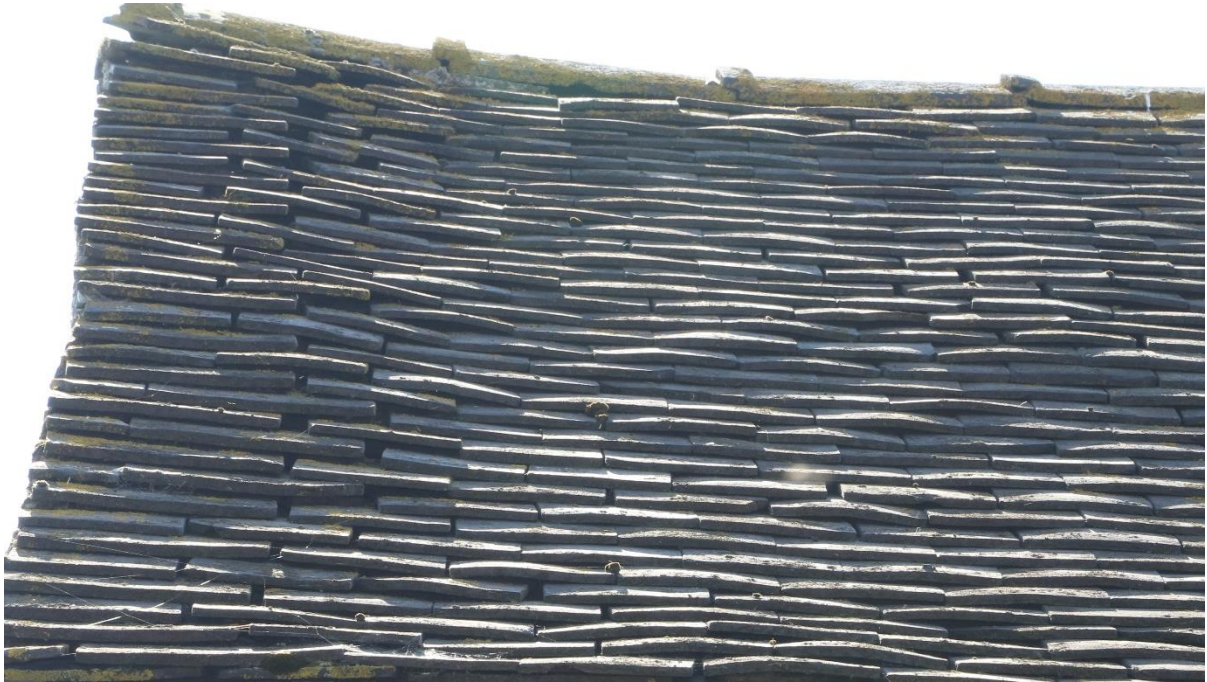
The roof coverings have demonstrated a level of movement & deterioration with multiple gaps throughout the North & South facing elevations (Image 3, 4, 6), in addition several gaps below the ridge tiles were observed which offer further roosting values to crevice dwelling bats.

Image 3 – North facing roof coverings which have demonstrated moderate levels of movement/deterioration which may offer access & roosting values to bats within. Also gaps below the ridge tiles which offers a suitable roost environment for crevice dwelling bats

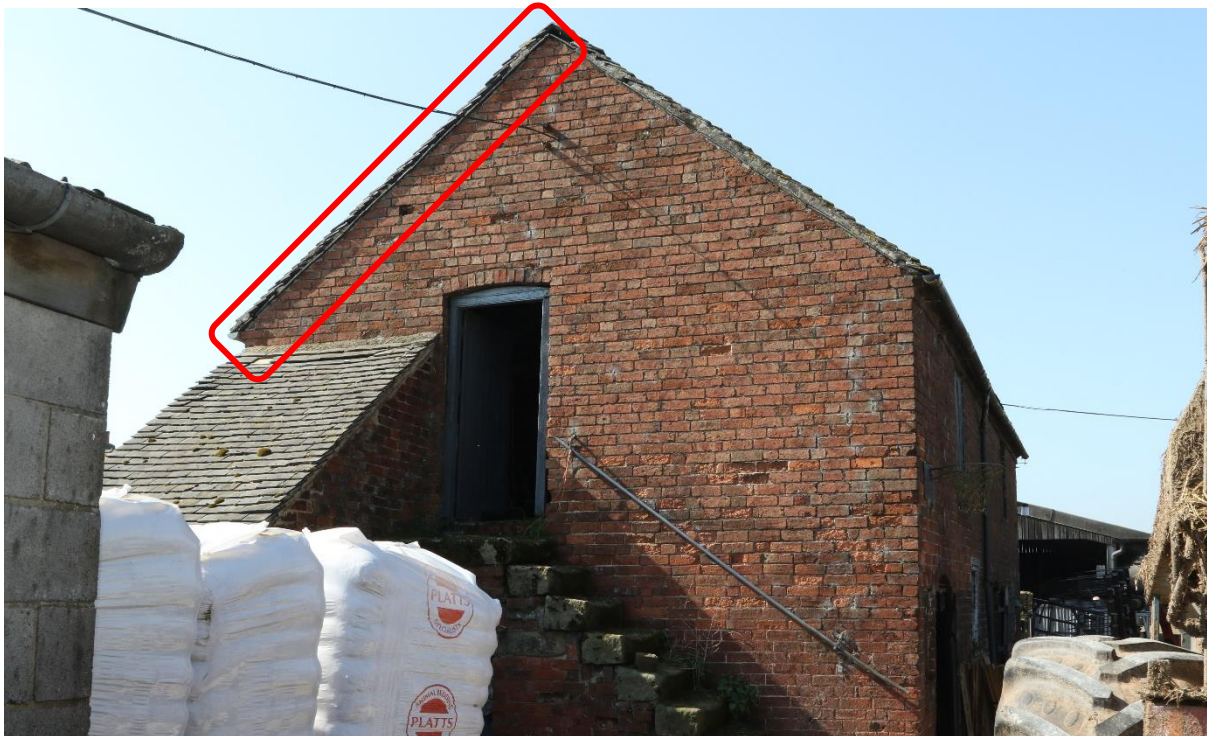
The East facing gable (Image 4) has demonstrated several gaps of moderated value between the stonework's and roof coverings including the ridge tiles.

Image 4 – East facing elevation which offers a number of accessible crevices between the stonework's and roof coverings

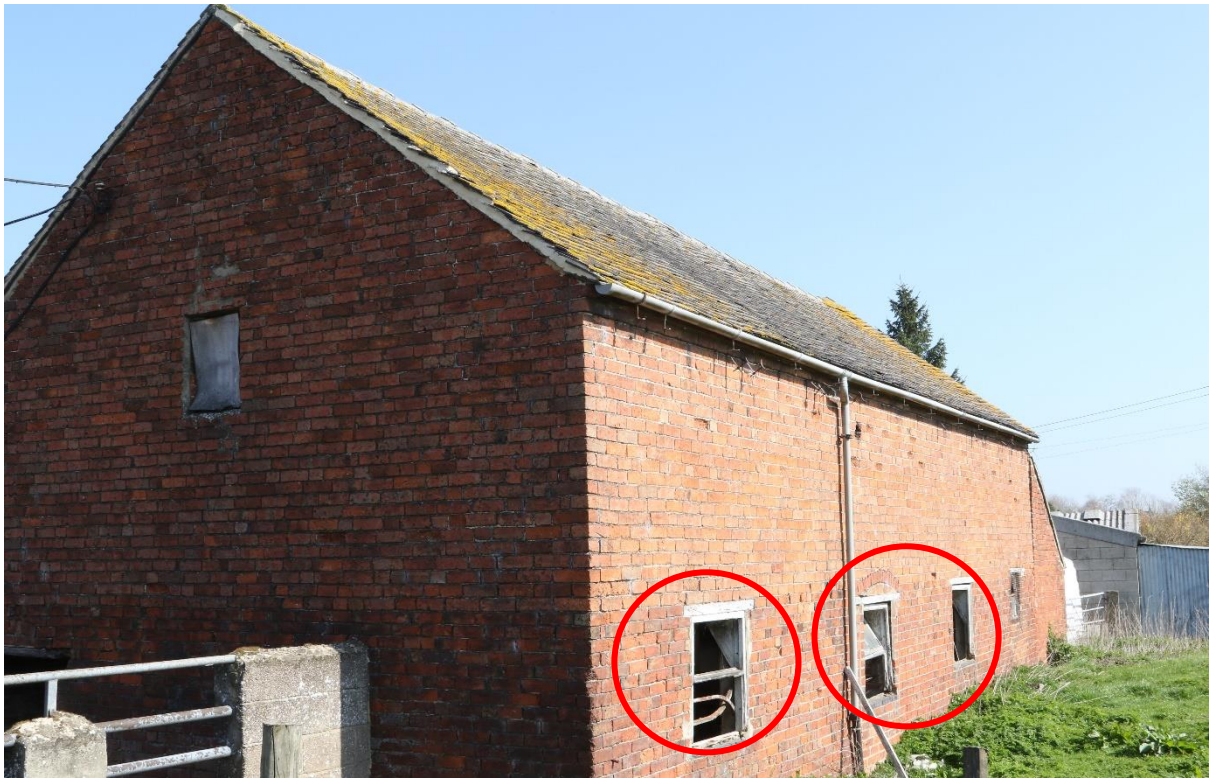
Image 5 – South & West facing elevations with several un glazed opening with access value to bats & birds

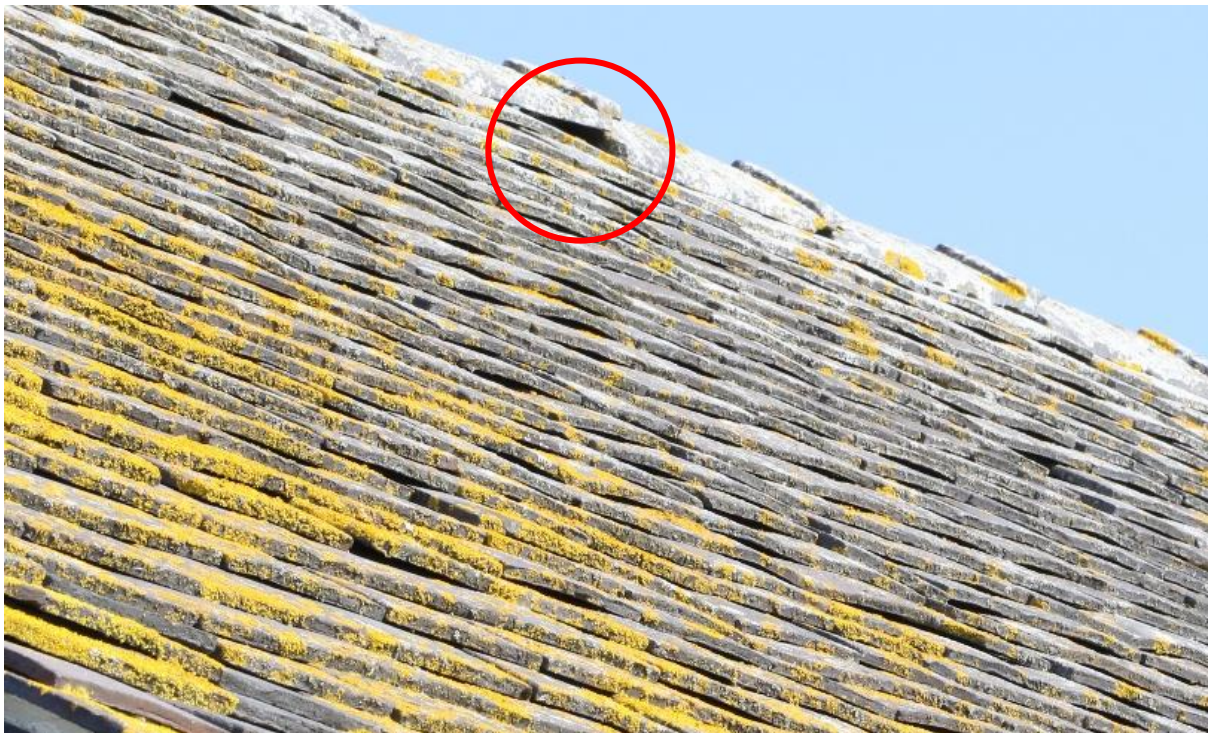
Image 6 – Gap below the ridge tiles within the South facing elevation which offers value to crevice dwelling bats within for roosting

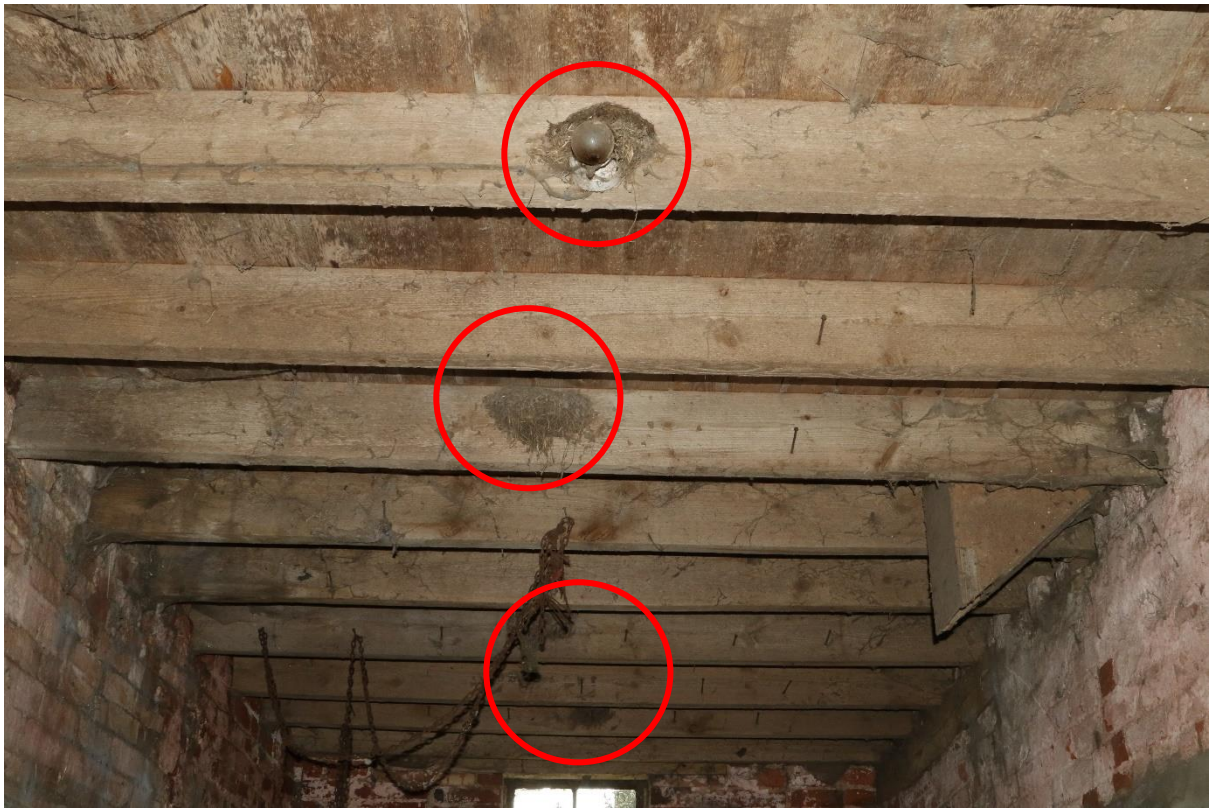
Several historical birds' nests were observed (Image 7) within the timbers to the ceiling when assessing the ground floor spaces, however no current activities from birds was noted.

Image 7 – Internal view from within the ground floor space where evidence of historical nesting birds has been identified

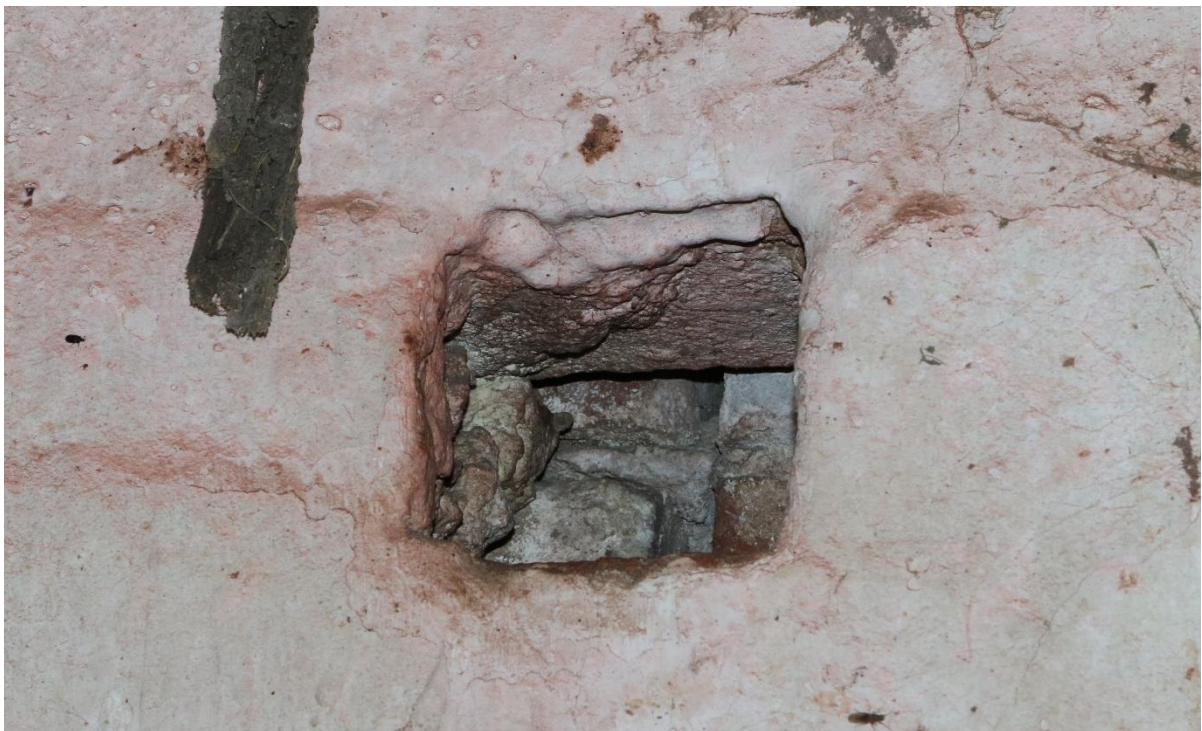
Image 8 – Internal stonework with a gap which offers access into a cavity areas of value to crevice dwelling bats

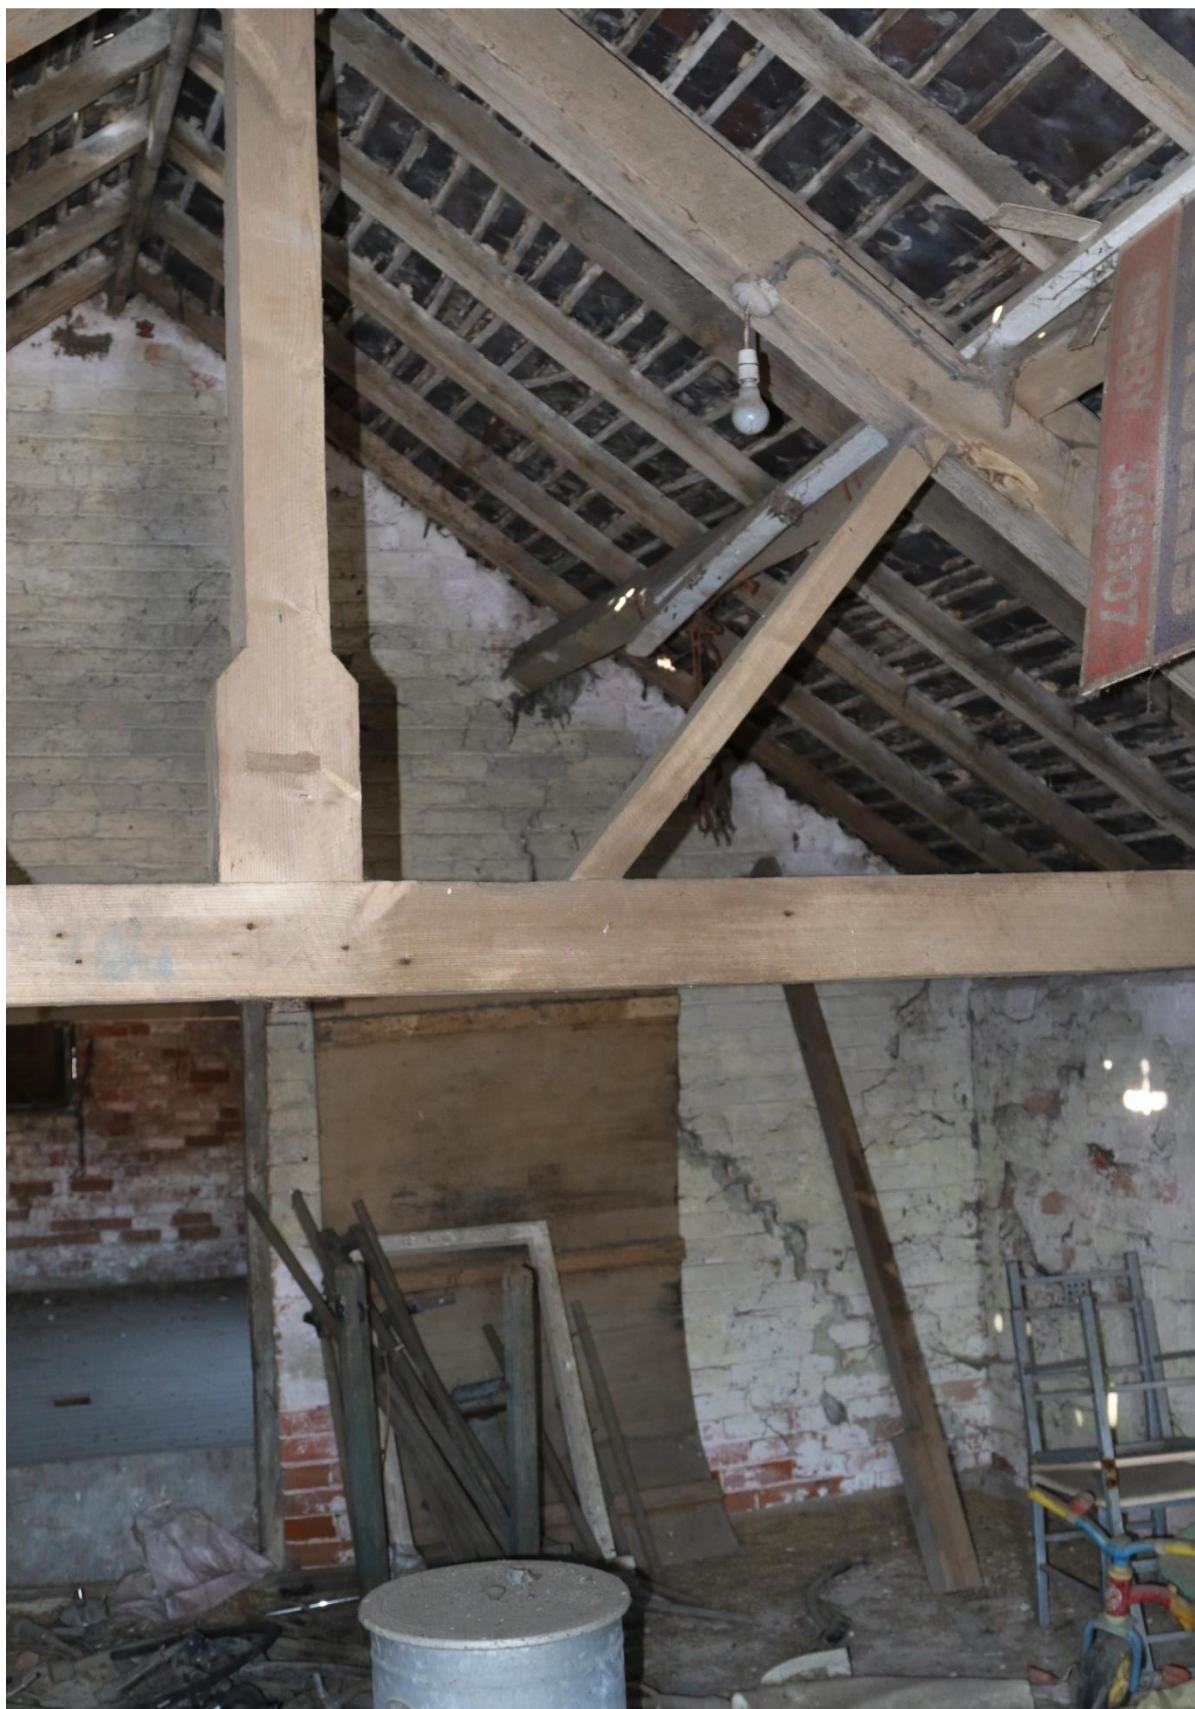
On entering the 1<sup>st</sup> floor areas it was noted that no membrane coverings are in place below the roof tiles (Image 9, 10) which offer several gaps with a good level of protruding daylight throughout.

Image 9 – View from within the 1<sup>st</sup> floor space which has demonstrated no membrane coverings below the roof tiles where several sections of protruding daylight was observed

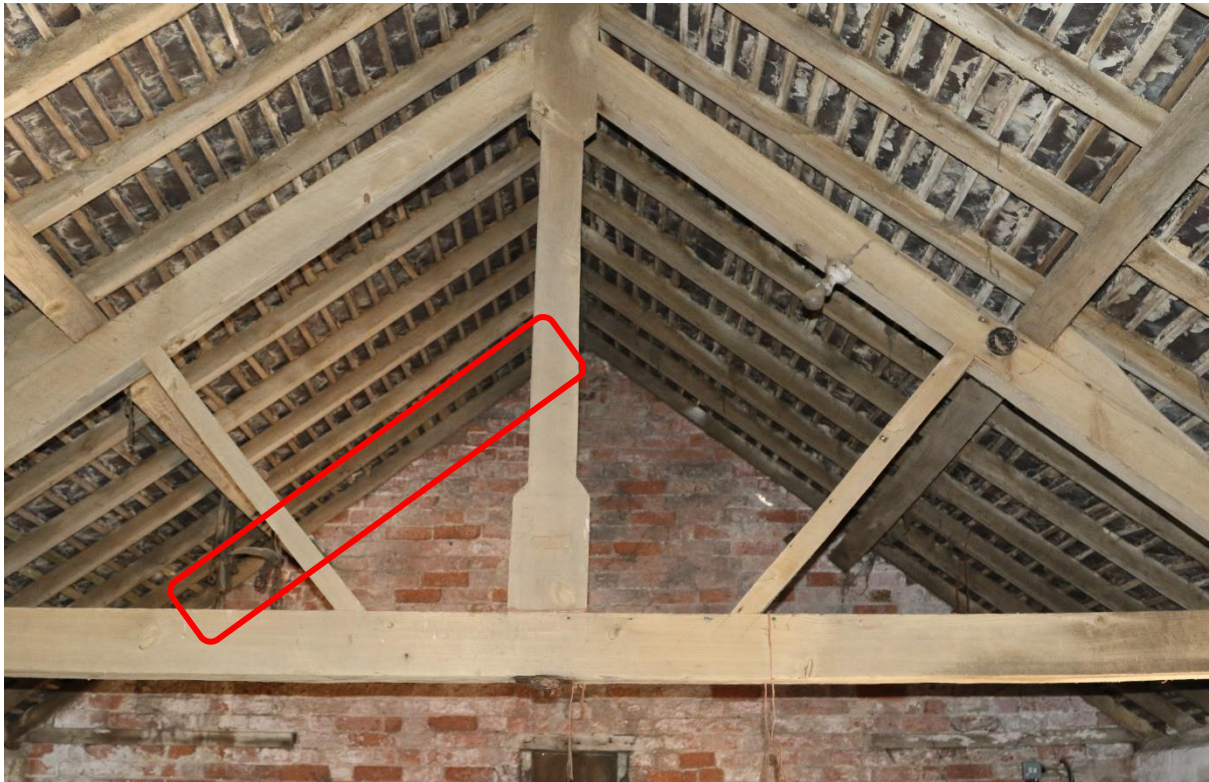
Several gaps between the stonework's and roof coverings of suitable value for roosting crevice dwelling bats (Image 10, 11) was noted throughout the 1<sup>st</sup> floor areas, where possible the use of an inspection camera was used where no further evidence of bats was noted, however due to access it was not possible to fully rule out.

Image 10 – View from within the 1<sup>st</sup> floor area to the far West of the building which has evidenced gaps between the roof coverings and stonework's which offers further value to crevice dwelling bats for roosting

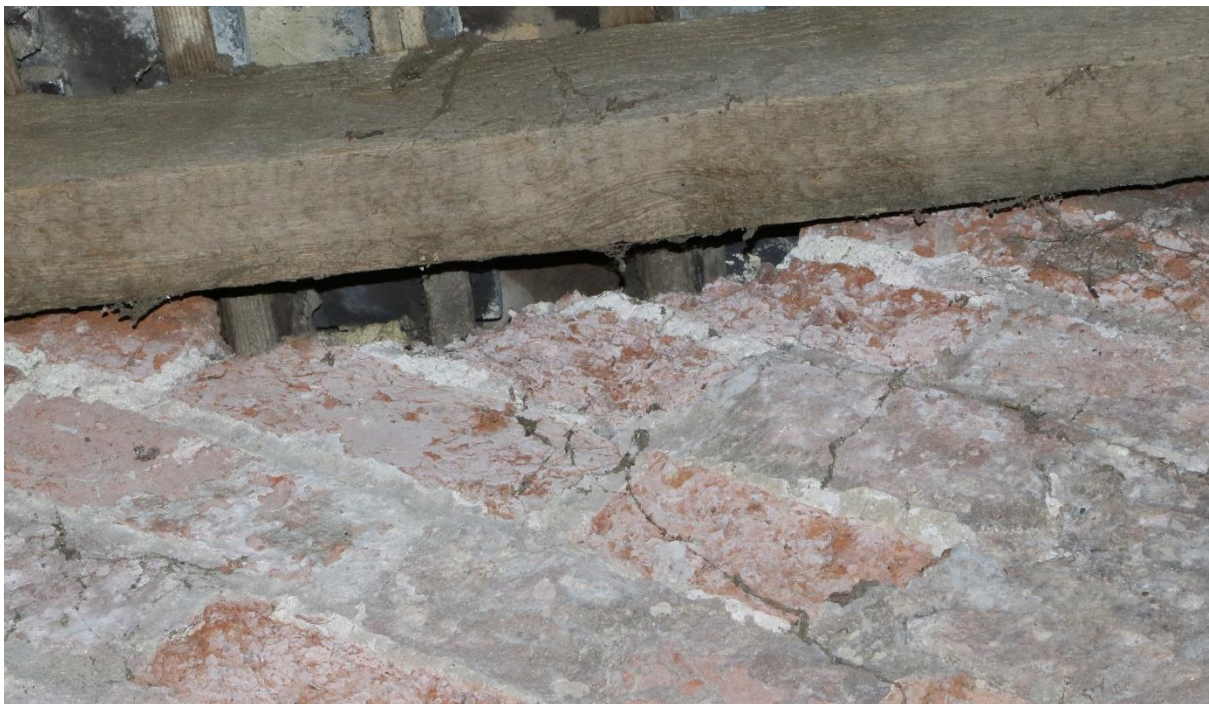
Image 11 – As image 10, gaps between the roof coverings and stonework's of value to crevice dwelling bats for roosting

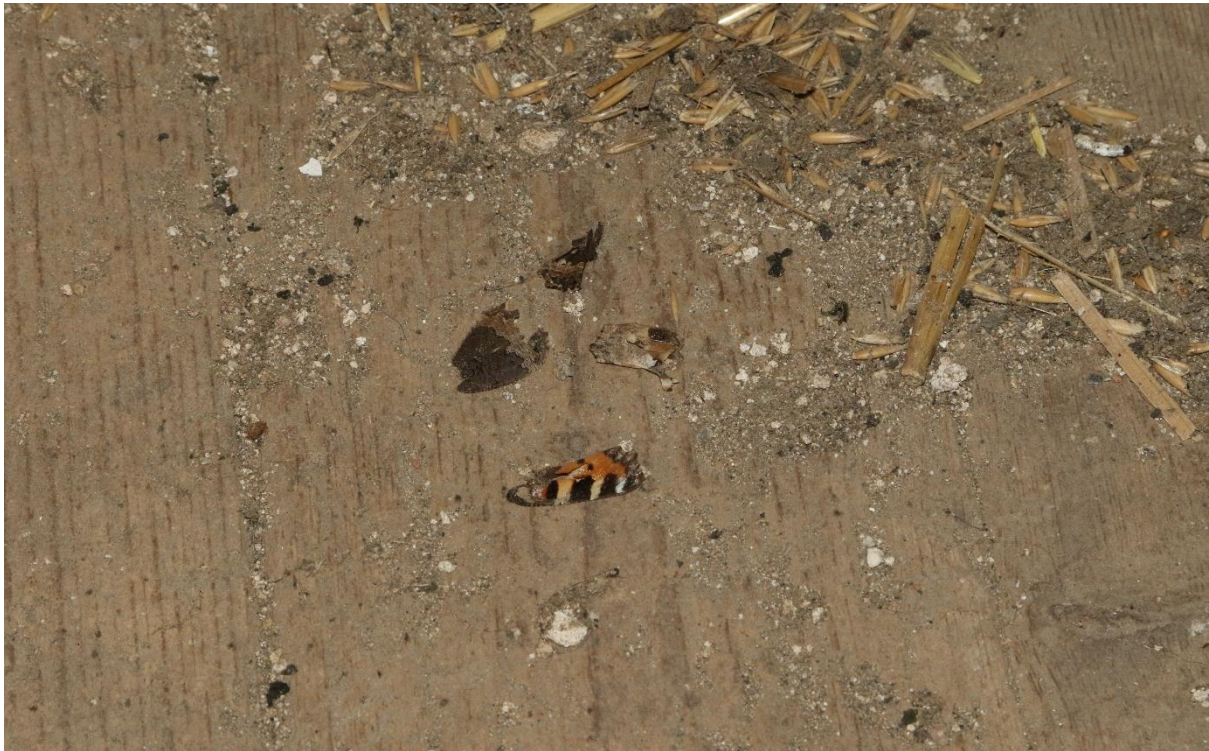
A small number of butterfly wings (Image 12) were identified across the 1<sup>st</sup> floor which can demonstrate possible feeding remains from Brown Long-eared bats.

Image 12 – Small number of butterfly wings located on the 1<sup>st</sup> floor area of the building which can be a common sign of feeding remains from Brown Long-eared bats

- 6.3** A small number of potential feeding remains from Brown Long-eared bats were observed within the 1<sup>st</sup> floor areas of the building but not confirmed. No evidence of bat droppings were noted.

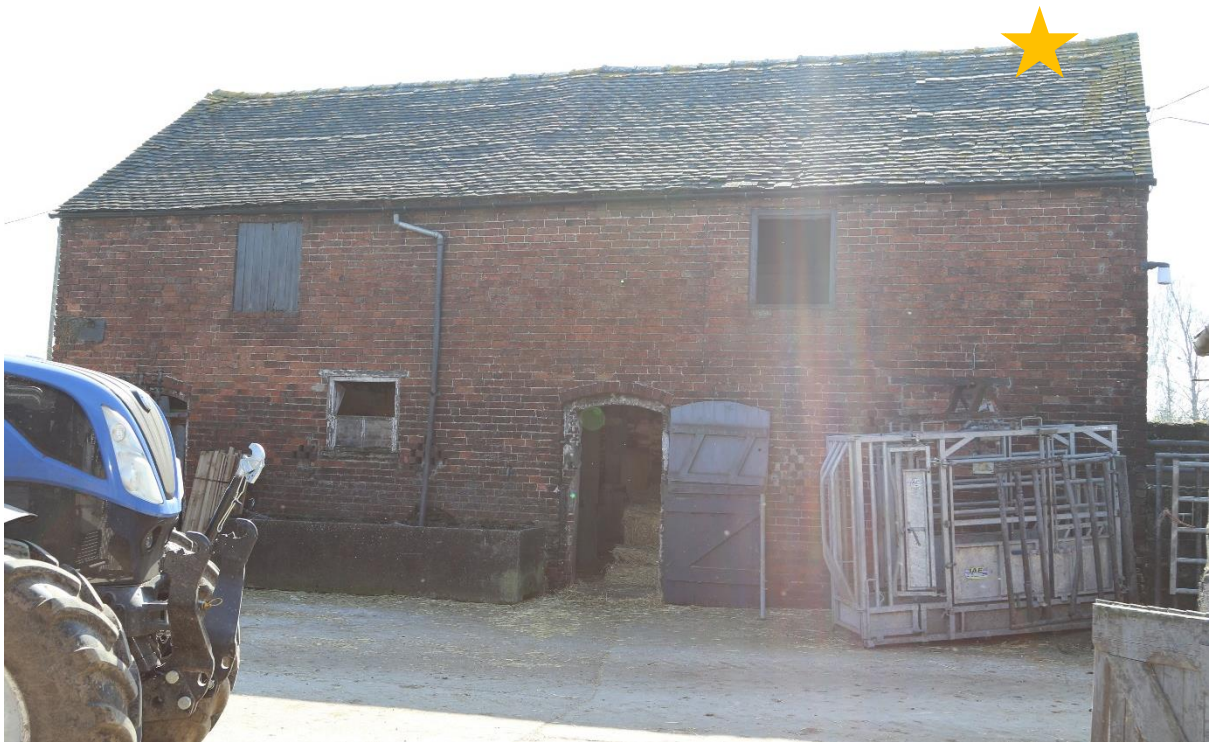
| Time | Species | Activity | Audio/Visual |
|---|---|---|---|
| 22:01 | C Pip | Emerged from ridge tile approx. 3 tiles across from West facing elevation. See image below | Audio/Visual |

Emergence point – 31<sup>st</sup> May 2019 - Common Pipistrelle x 1

- During three emergence surveys carried out on the building we have observed two day roosts for Common Pipistrelle. See images within appendix four and require an EPS Mitigation Licence to be implemented before all works progress.

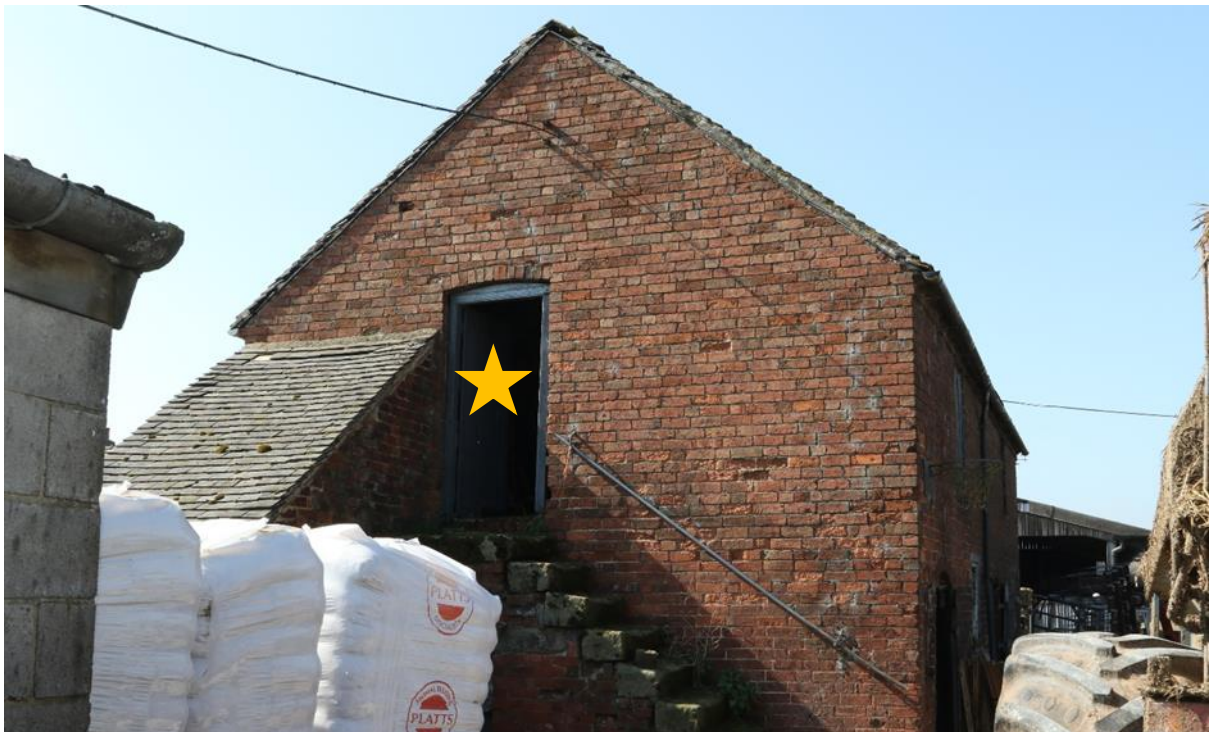
Emergence point – 31<sup>st</sup> May 2019 - Common Pipistrelle x 1

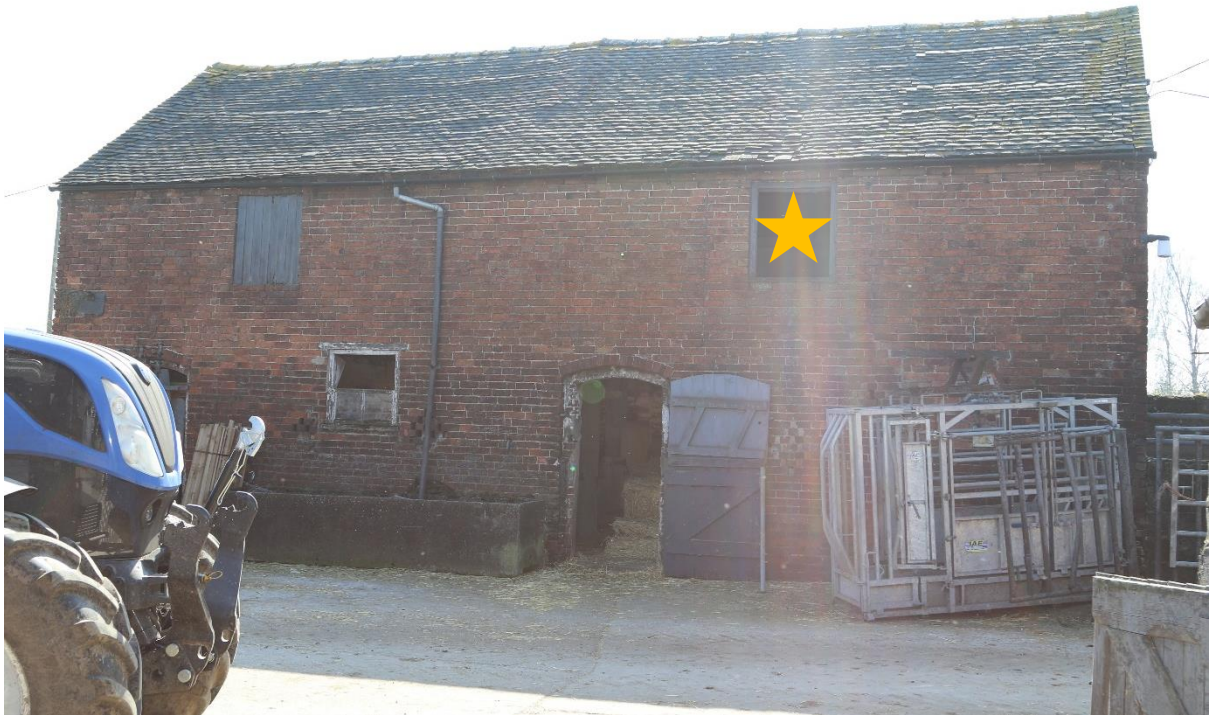
Emergence point – 18<sup>th</sup> June 2019 - Common Pipistrelle x 1

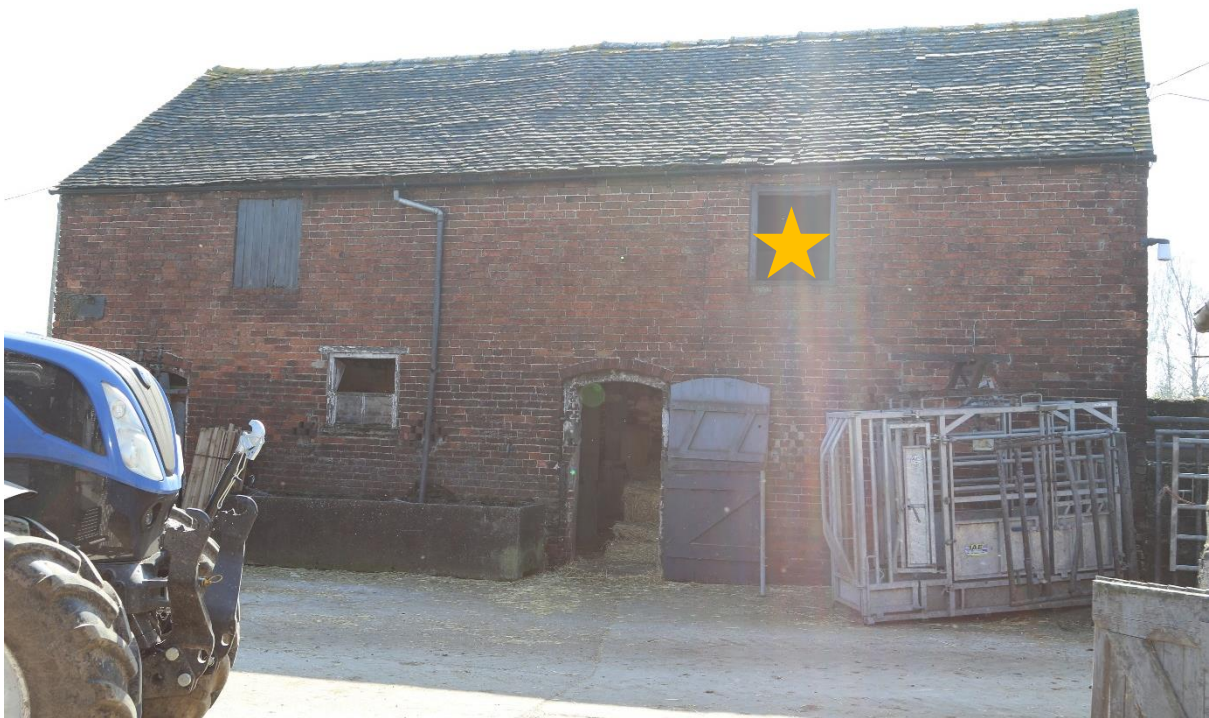
Emergence point – 19<sup>th</sup> July 2019 - Common Pipistrelle x 1

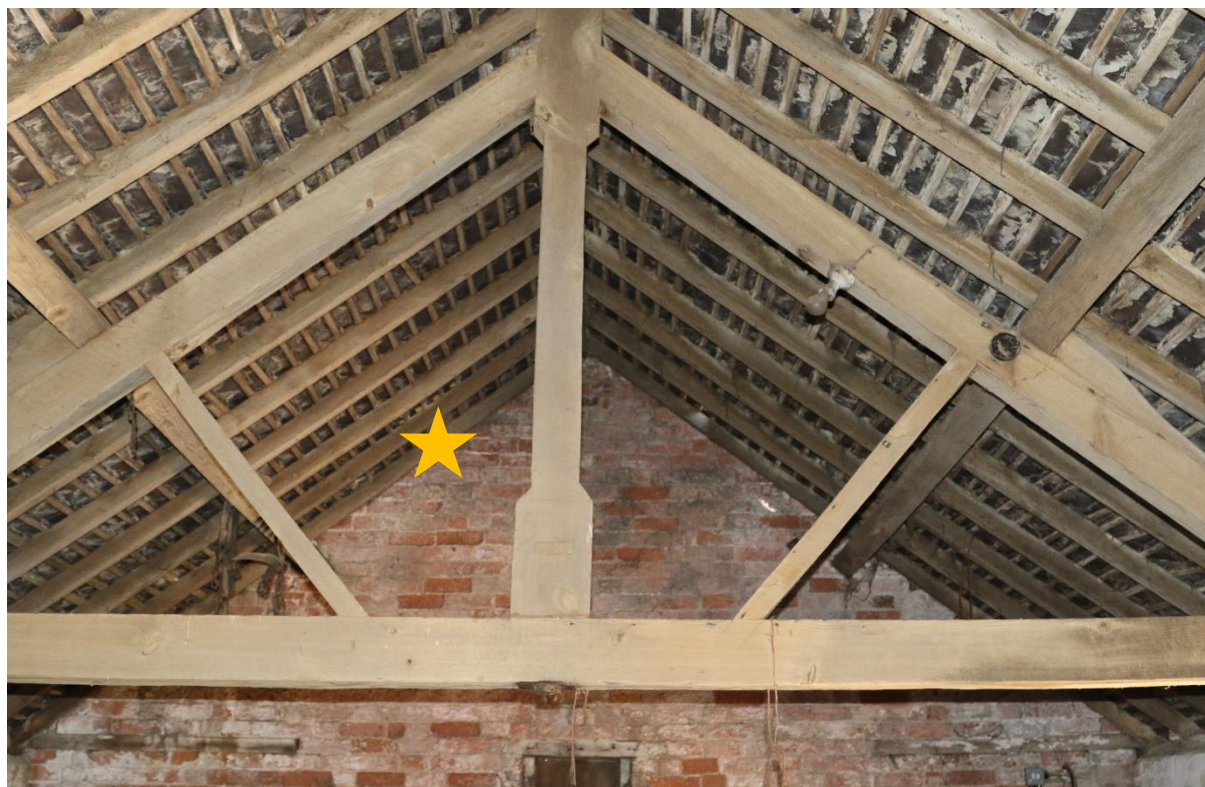
Internal location where single Common Pipistrelle emerged from on the 19<sup>th</sup> July which was observed emerging via window
