**GEOENVIRONMENTAL APPRAISAL**  
of land at  
**DARKLANDS LANE, SWADLINCOTE**

**Prepared on behalf of LNT Construction Limited  
& South Derbyshire District Council**

**Report 7034/1**

**August 2019**

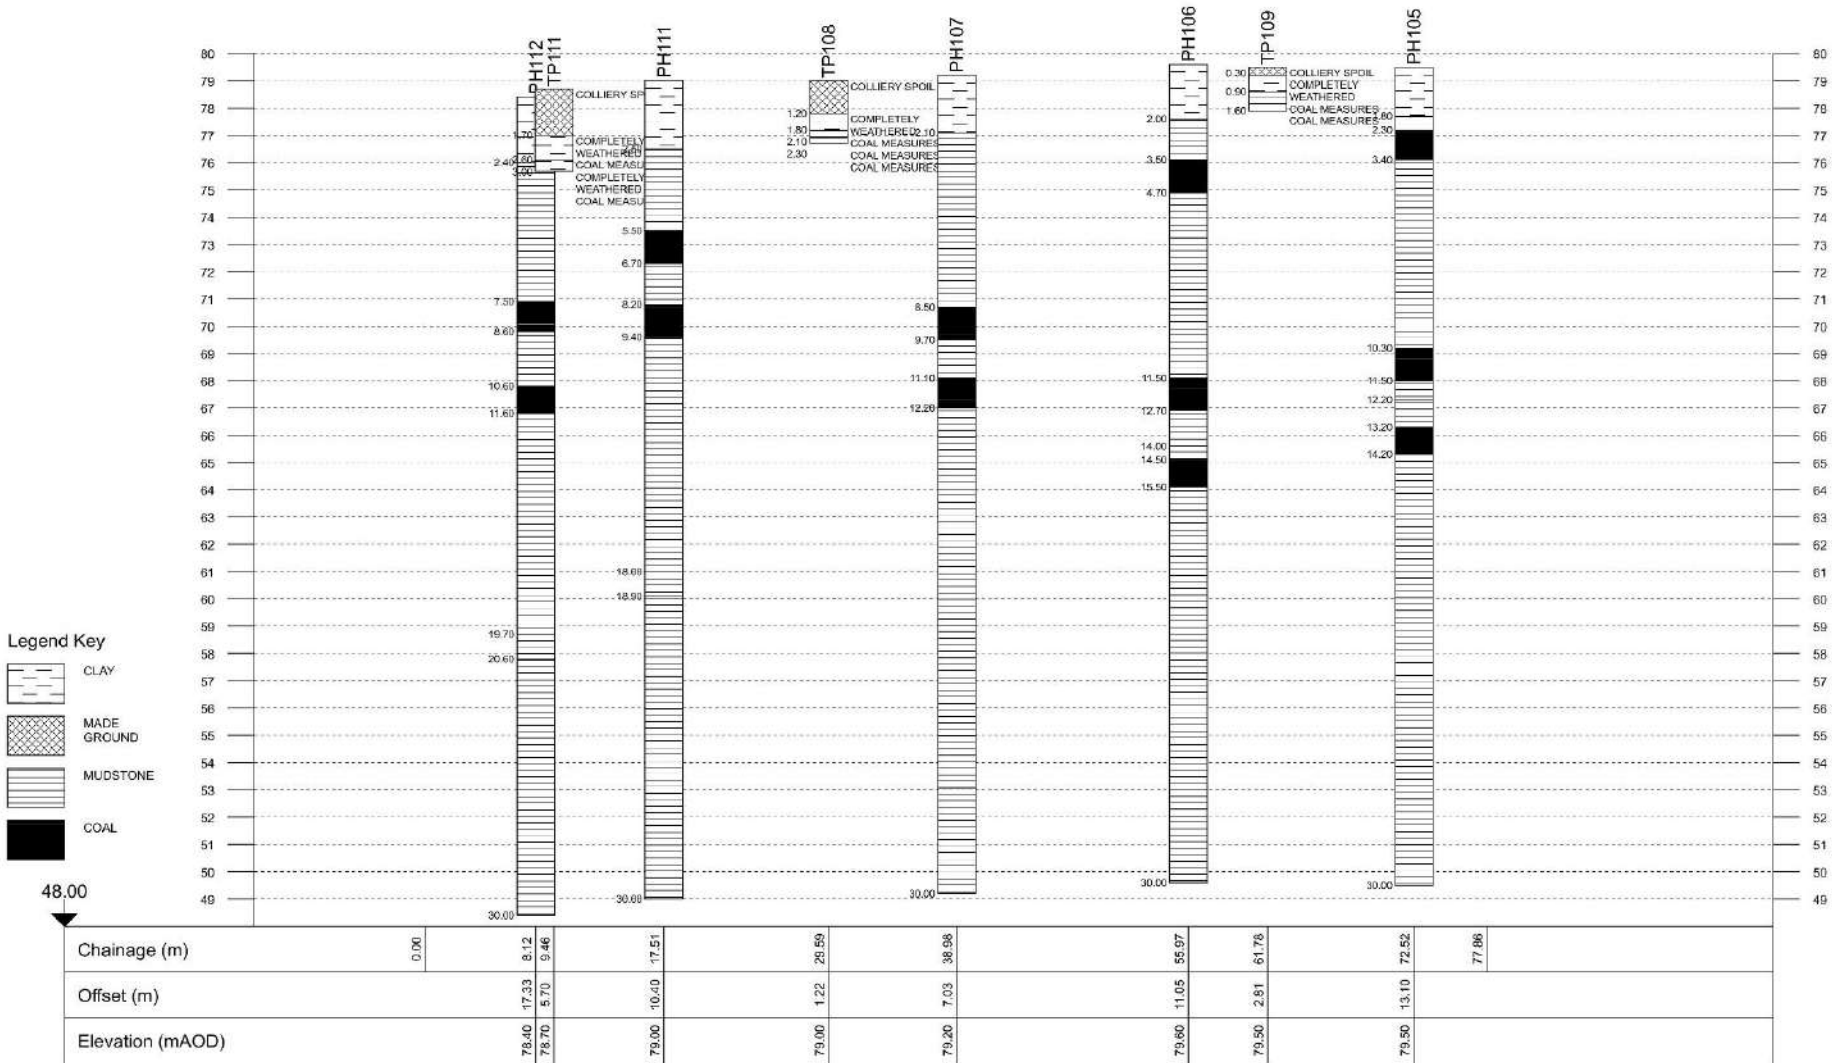
Title: Section line 4  
Vertical Scale: 1:250  
Horizontal Scale: 1:500  
Engineer: RJH

Project Id: 7034  
Project Title: Darklands Road  
Location: Swadlincote  
Client: LTN Construction Limited

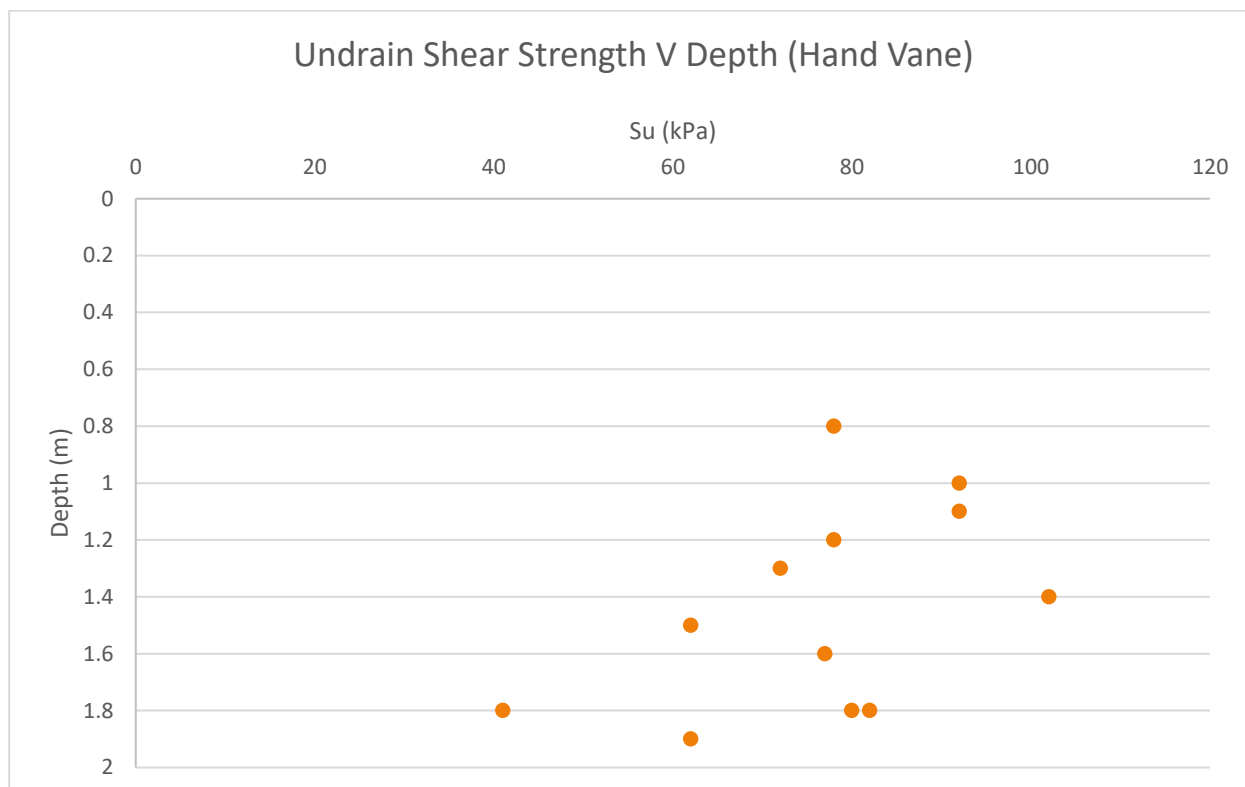
### Hand Shear Vane Testing

Hand shear vane testing was undertaken from larger blocks of clay excavated from the trial pits. The results are summarised within the plot below and illustrate that undrained shear strength ( $S_u$ ) with depth within the weathered Coal Measures deposits were above 60kPa.

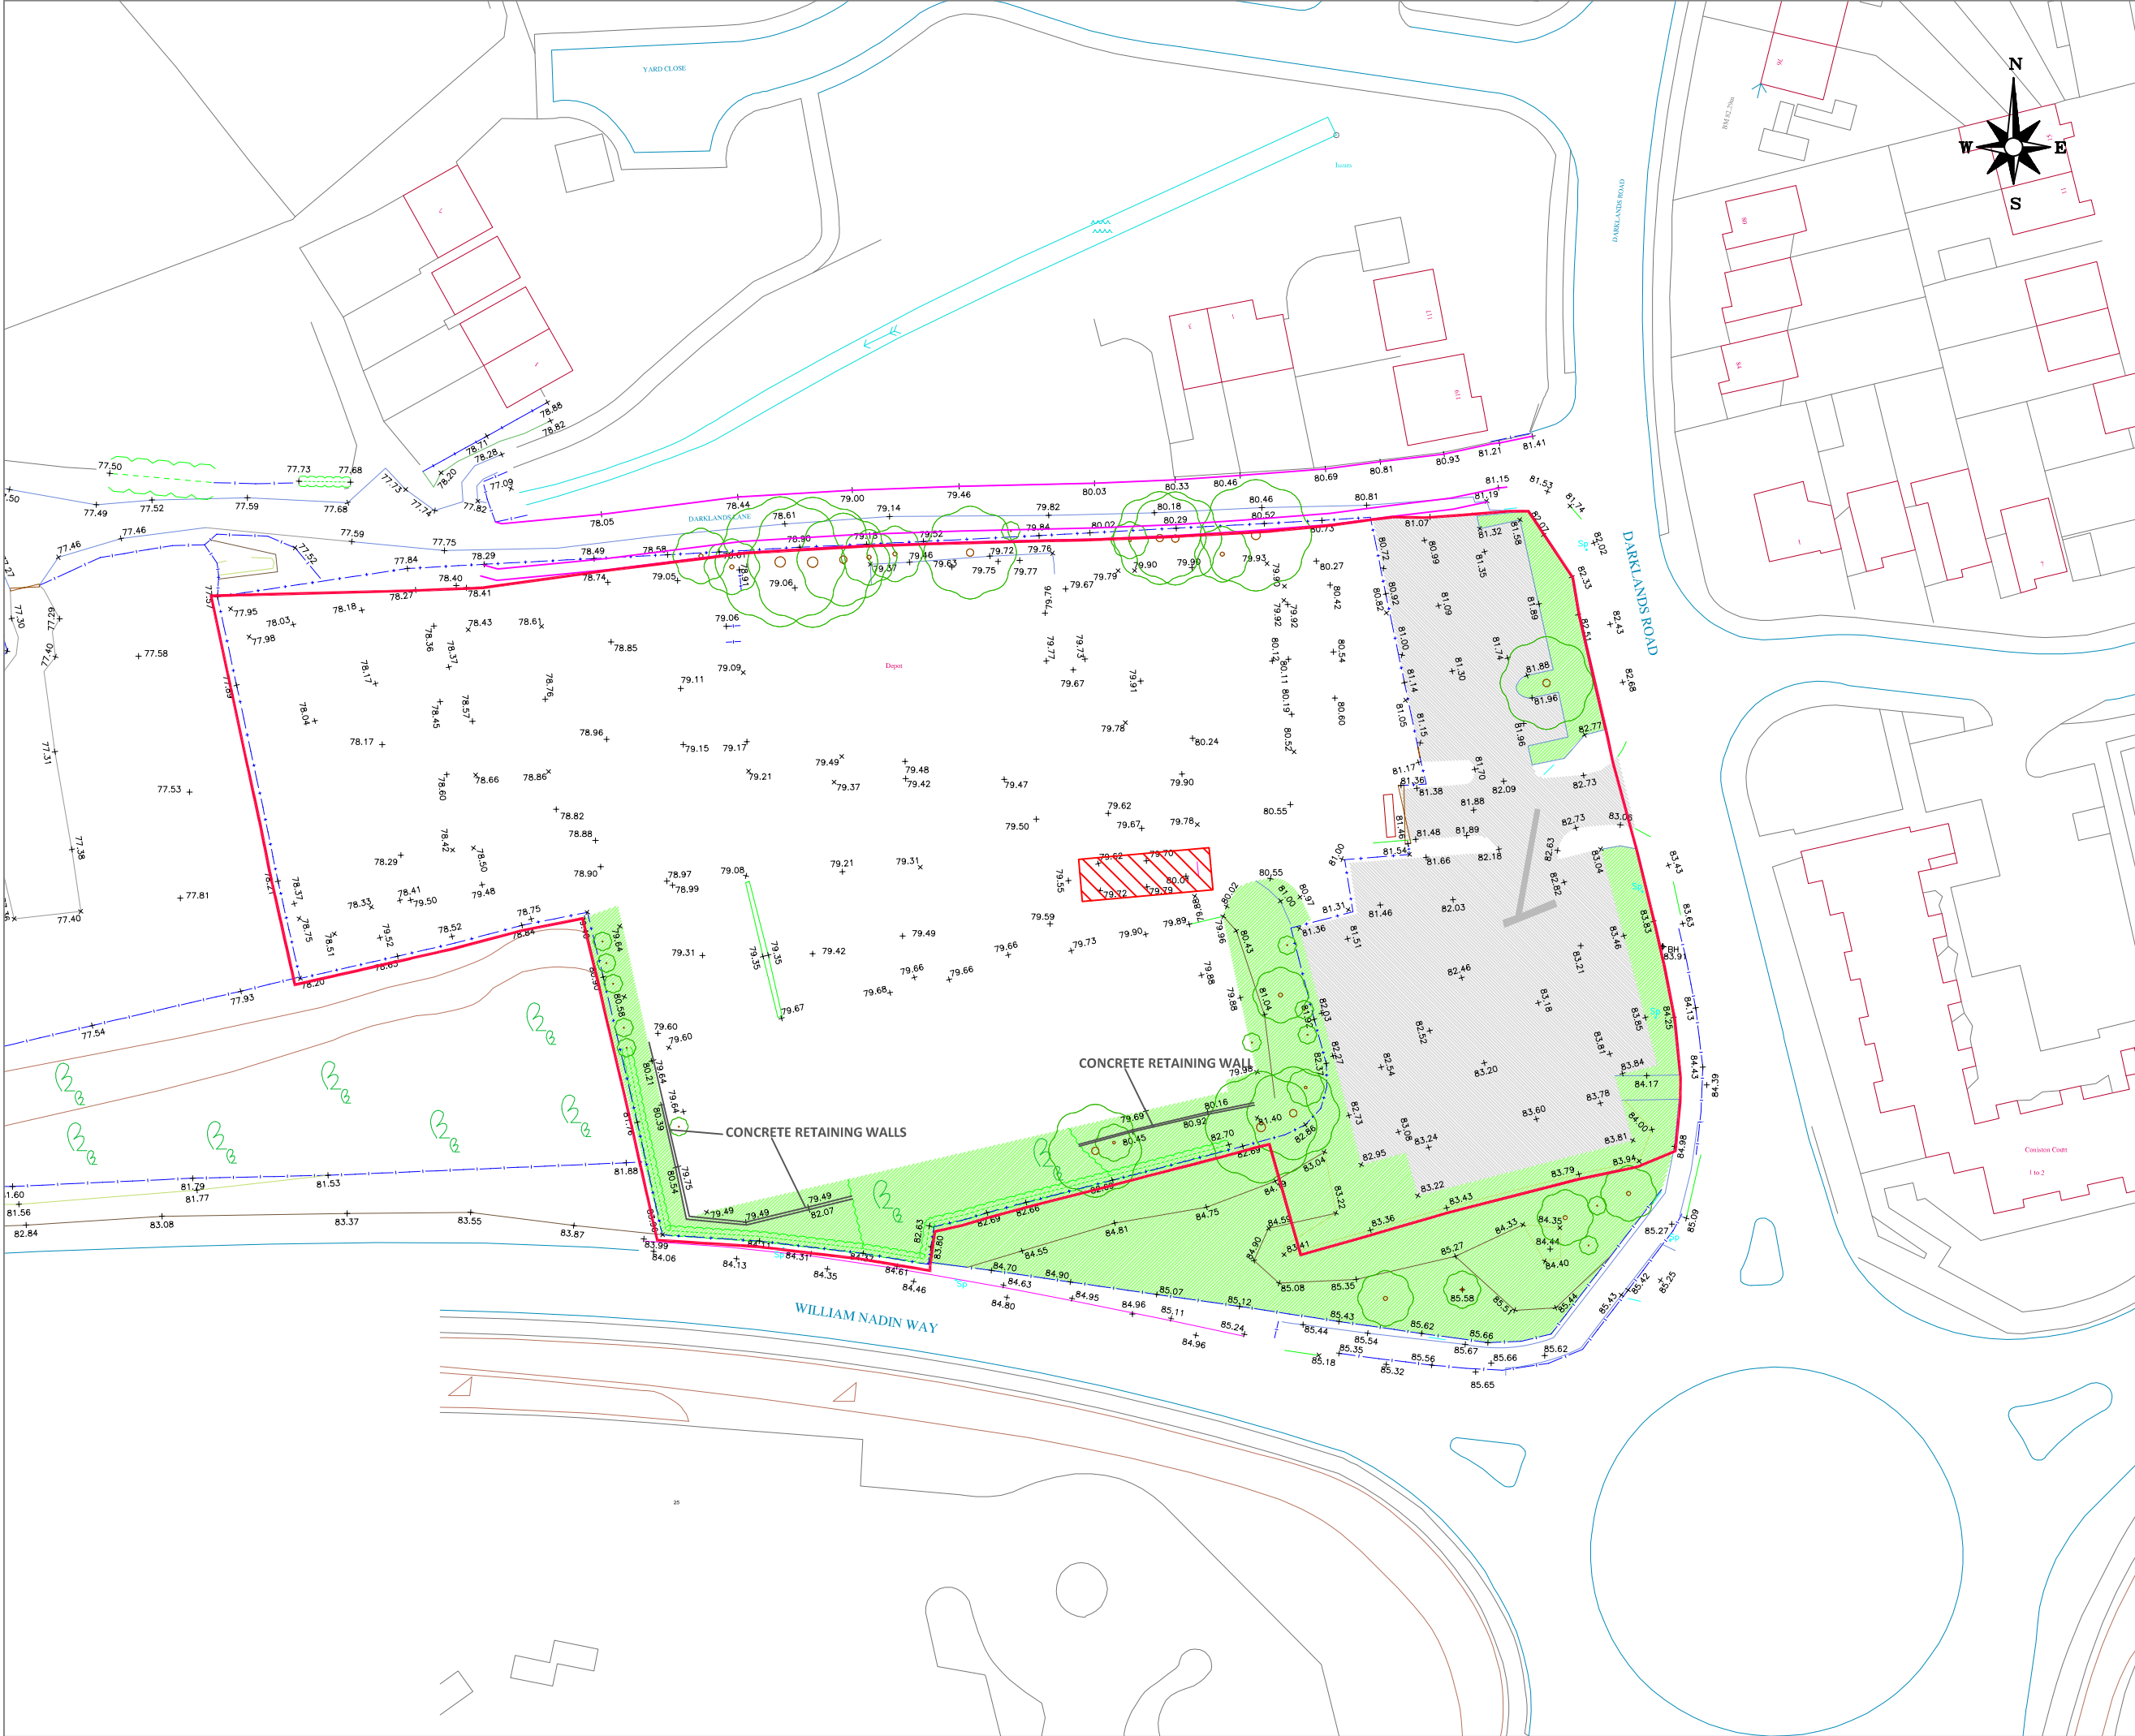
- GRASS & OVERGROWN AREAS
- TARMAC HARDSTAND
- FORMER FUEL STORAGE TANKS
- APPROXIMATE SITE BOUNDARY

The site had a small tank farm consisting of two diesel tanks with a small petrol tank. These were located in the centre of the site (see Drawing 7034/3) and also had vent pipes and service pumps associated with them. It was understood that the tanks were set within brick linings. It is thought that there may have been a potential leakage from the petrol tank.

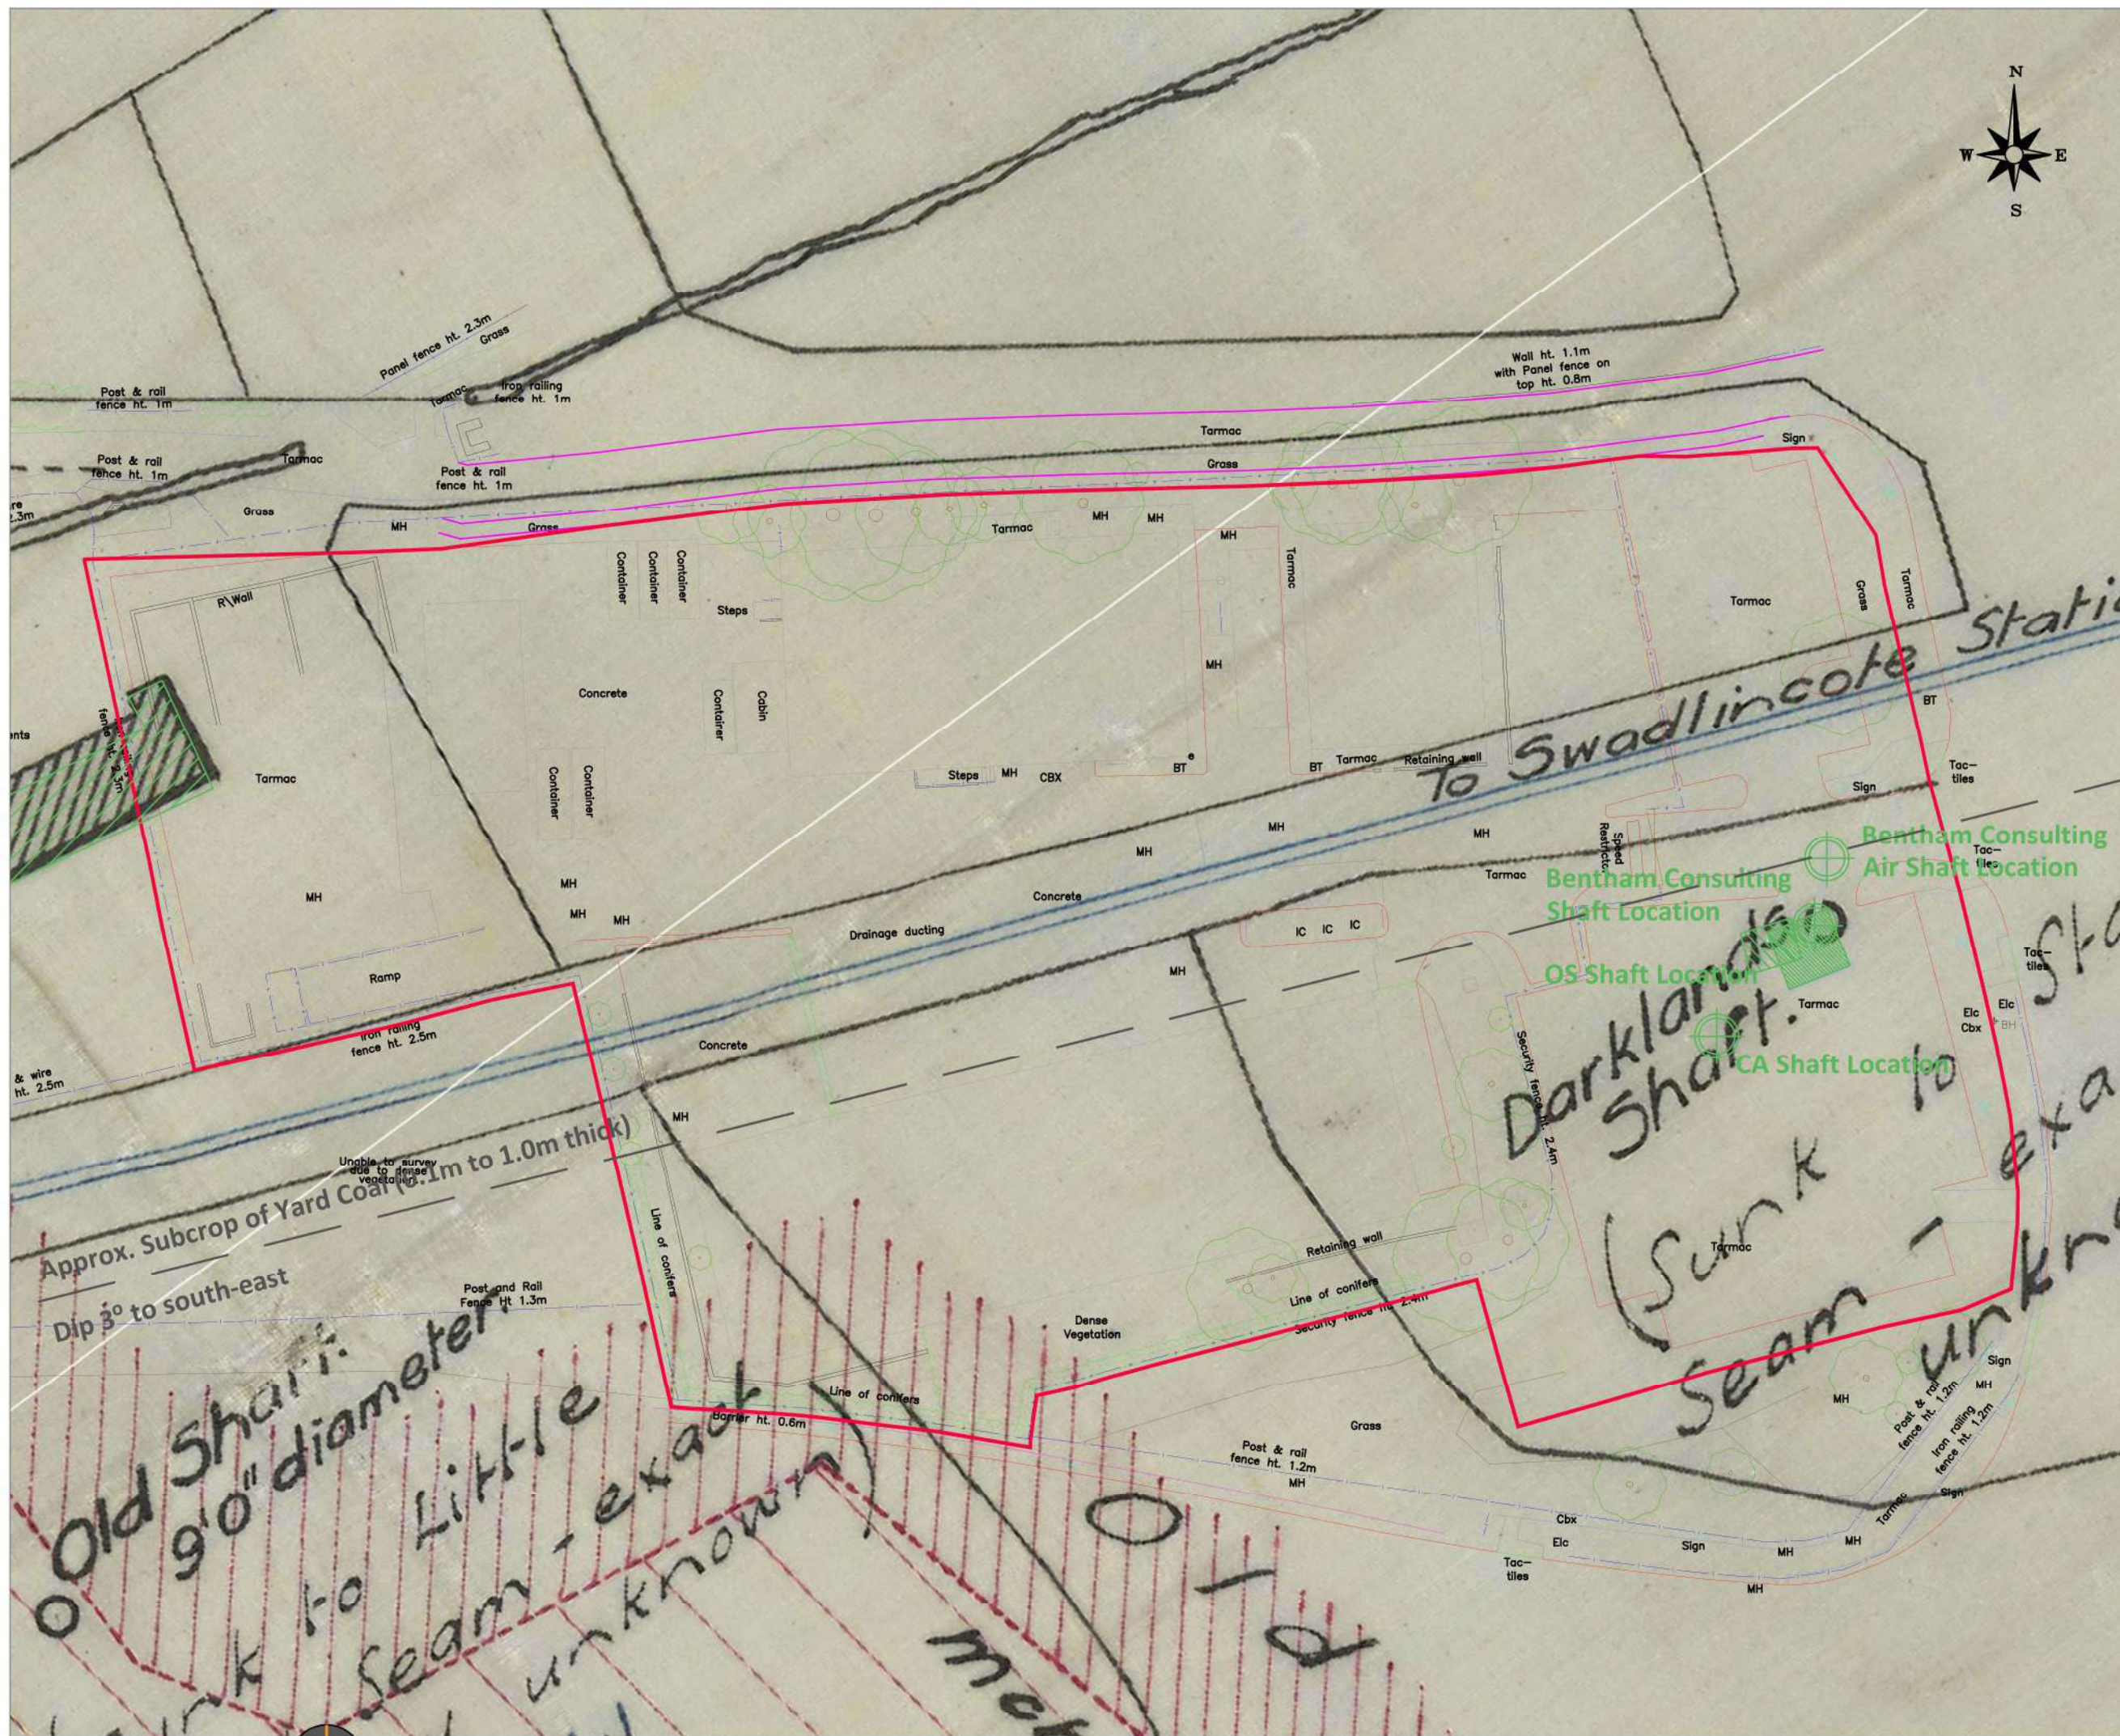
Based on CA Abandonment record 'Plan of the Little Coal Working at Swadlingcote (Old Colliery)'.

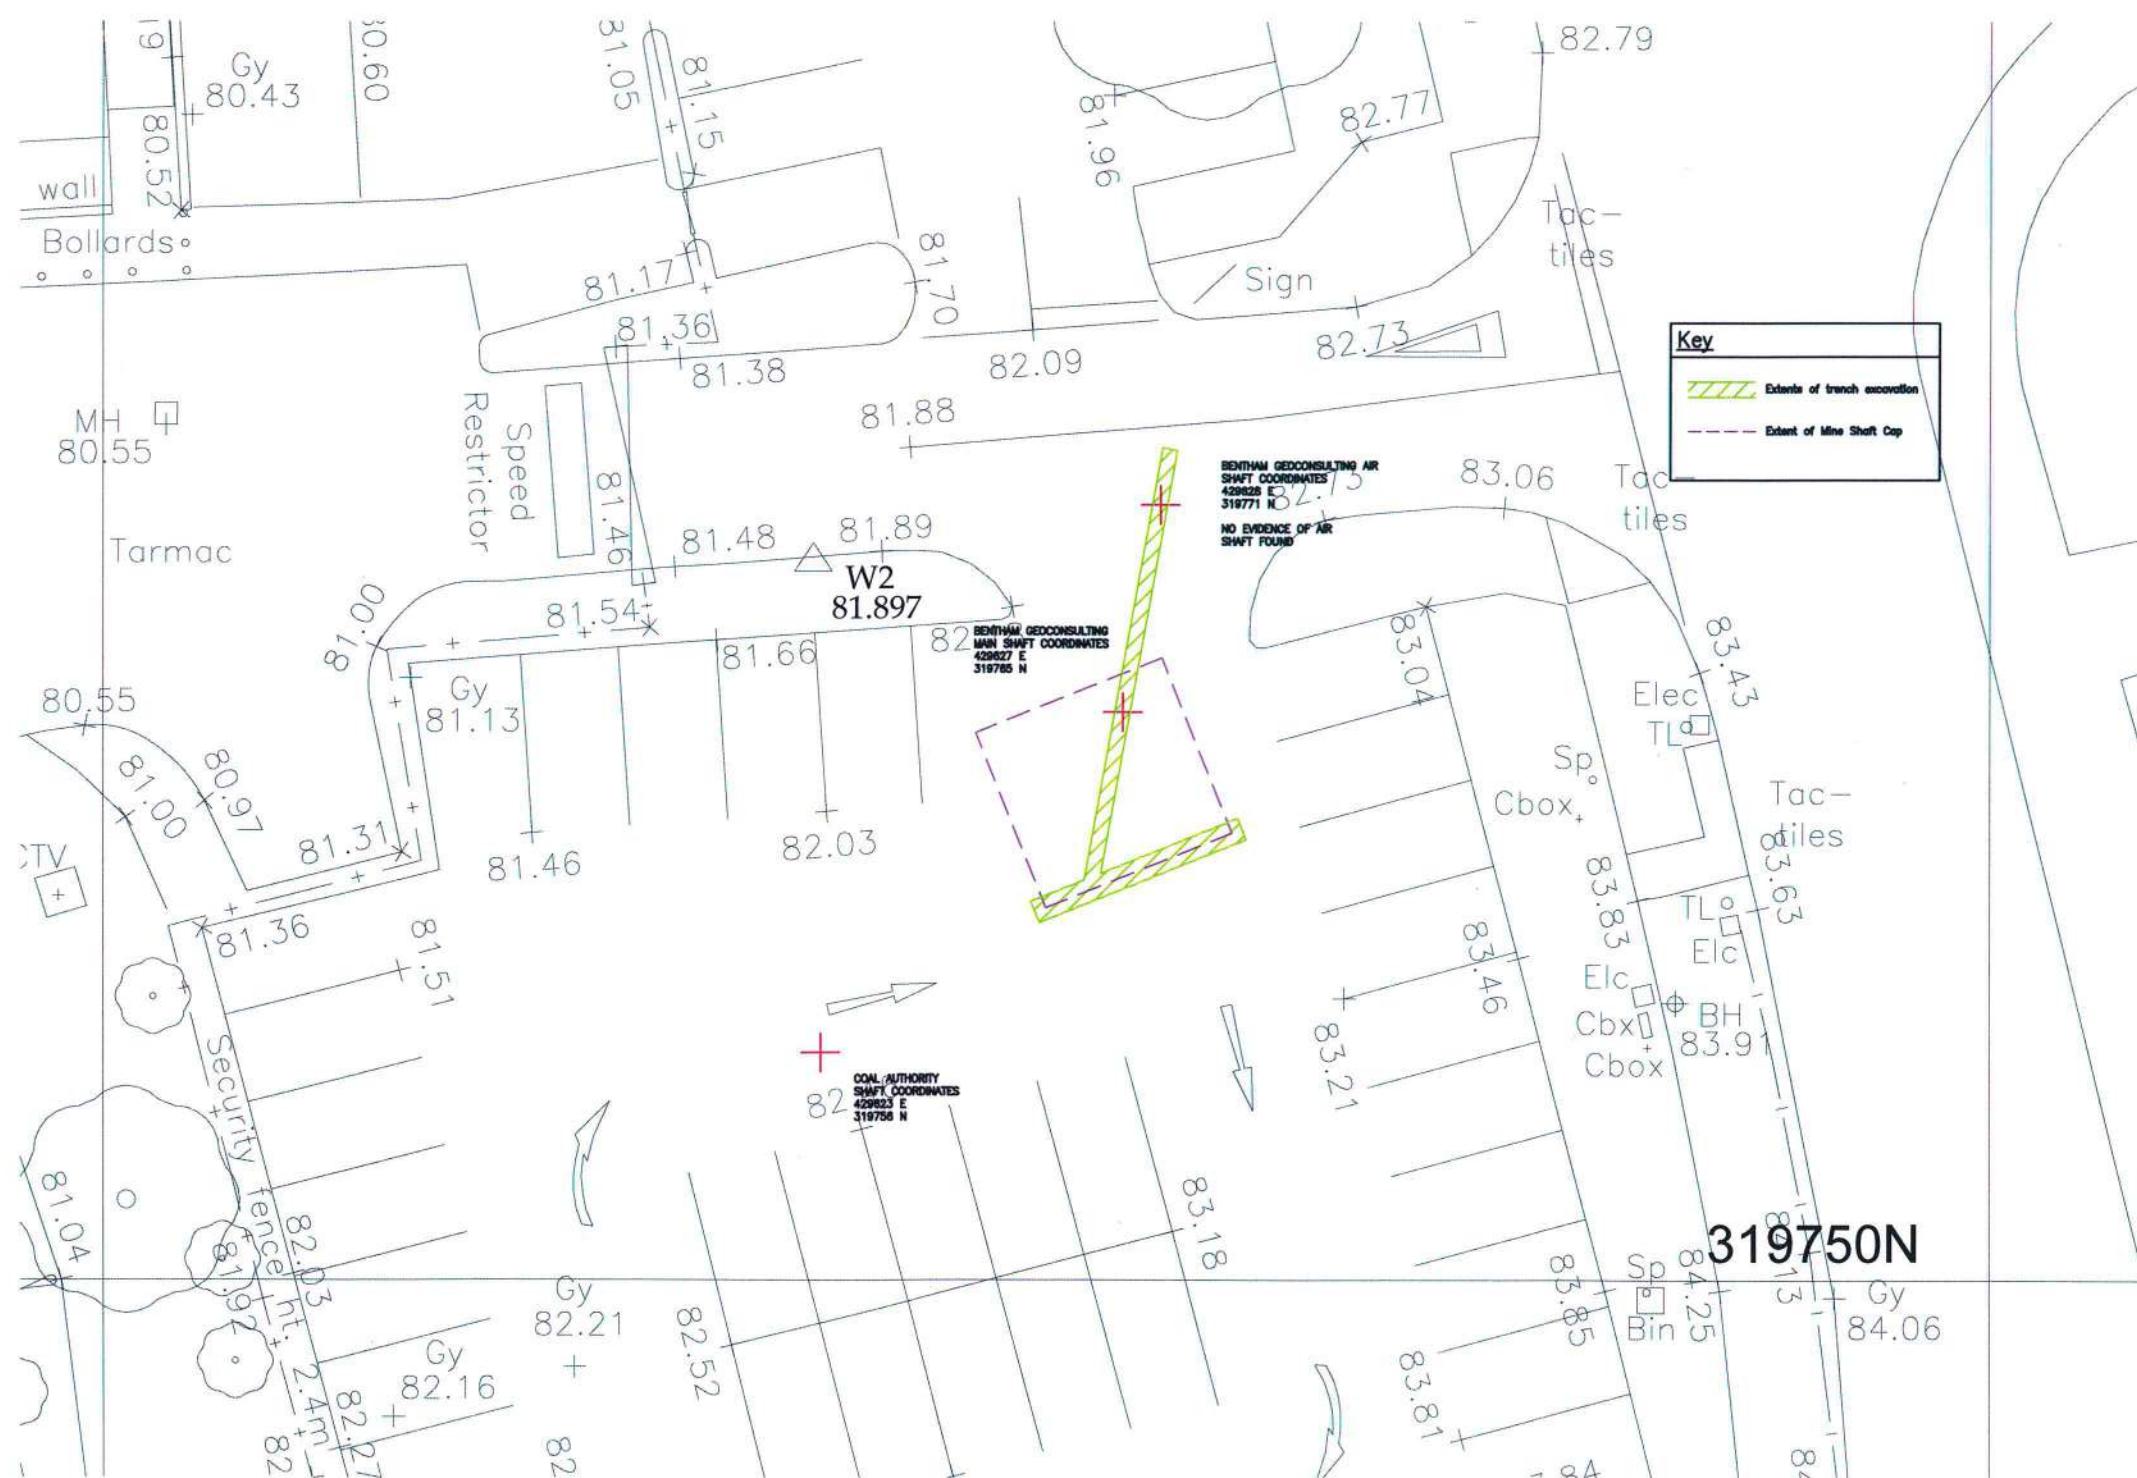
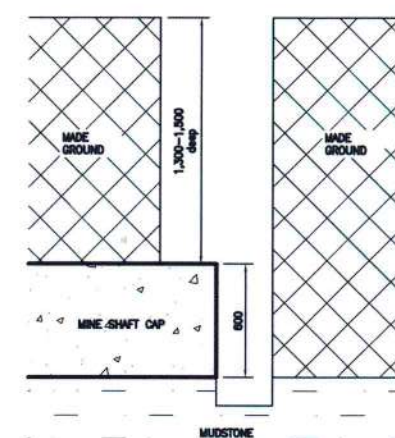
TYPICAL SECTION THROUGH EXCAVATION  
Scale 1:20

ADA Consulting investigated the shaft location February 2017; trenching identified the location of the 600mm thick concrete shaft cap which was founded on mudstone at around 1.5m depth. Drawing referenced 12343/951 is copies in Appendix C.

ADA Consulting investigated the shaft location February 2017; trenching identified the location of the 600mm thick concrete shaft cap which was founded on mudstone at around 1.5m depth. Drawing referenced 12343/951 is copies in Appendix C.
