**Bat Roost Assessment and Bird Survey for,  
Mr. O. Howard.  
Buildings at,  
Barn Farm,  
Wards Lane,  
Stanton by Bridge,  
DERBY,  
Derbyshire  
DE73 7HX.**

**Map Ref SK 3757 2732  
31<sup>st</sup> July 2018.**

**S. Christopher Smith MRICS MSc CEnv.**

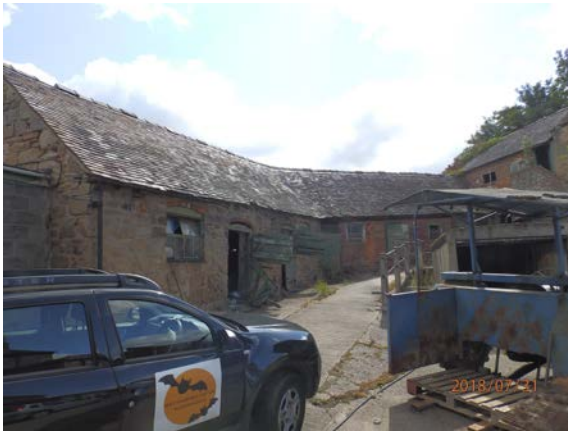
**Single storey stables.**

| Feature. | Evidence of bats. | Likelyhood of bats roosting. | Photograph. |
|---|---|---|---|
| Behind ridge board. | None. | Possible. There is access to the roof space for bats but the ridge tiles allow weather penetration. | A close-up photograph of the roof structure, showing wooden beams and tiles. A date stamp '2018/07/31' is visible in the bottom right corner of the image. |

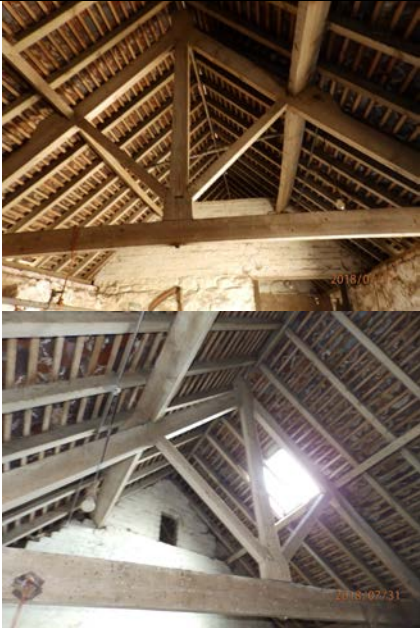
| In splits in timber rafters. | None. | None. Machine cut timbers. | |

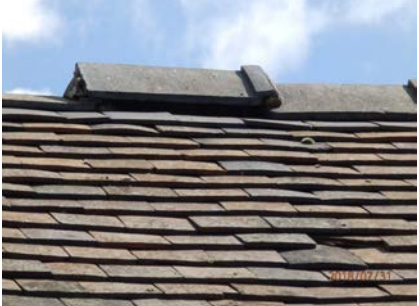
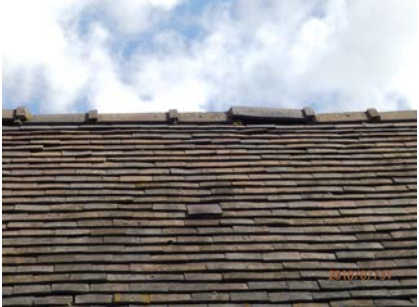
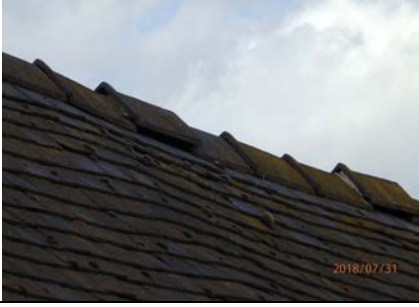
| Under ridge tiles. | None. | Possible. There is access to the underside of the ridge tiles for bats but the raised/ventilated ridge tiles make such areas prone to weather penetration. | |

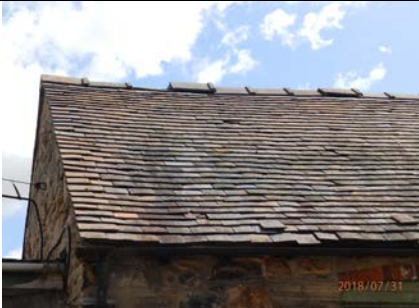
| Under loose or missing roof tiles. | None. | None. The plain tiles have no underfelt so no roosting only access points for bats. | |

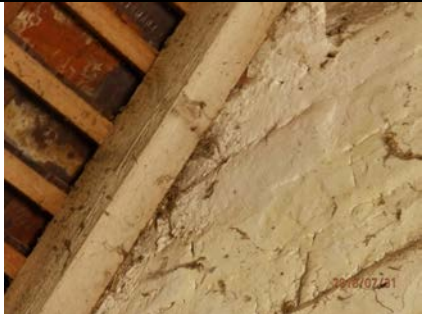
| | | | |
|---|---|---|---|
| Between the rear of the plain tiles and the top of the brickwork. | None. | Poor. There is access for bats in some areas but cobwebs and rubbish show there has been no use.. | |

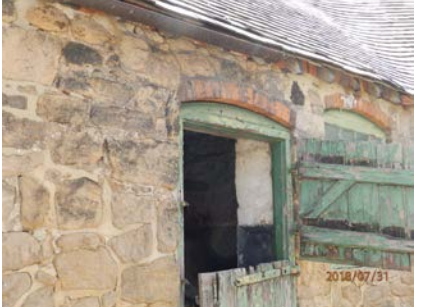
| | | | |
|---|---|---|---|
| In eaves. | None. | None. Corbel brickwork and stone with access for bats but no crevices for roosting. | |

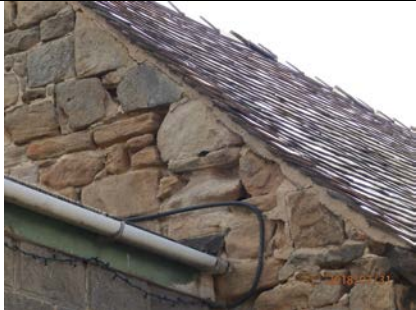
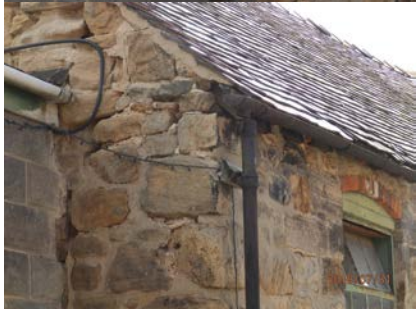
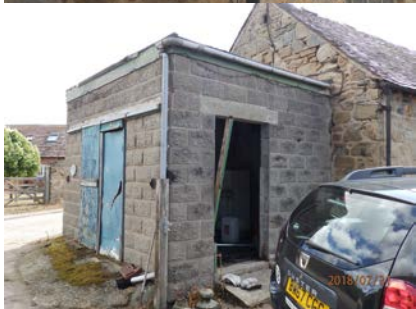
| | | | |
|---|---|---|---|
| In verge. | None. | None. There is no access for bats. | |

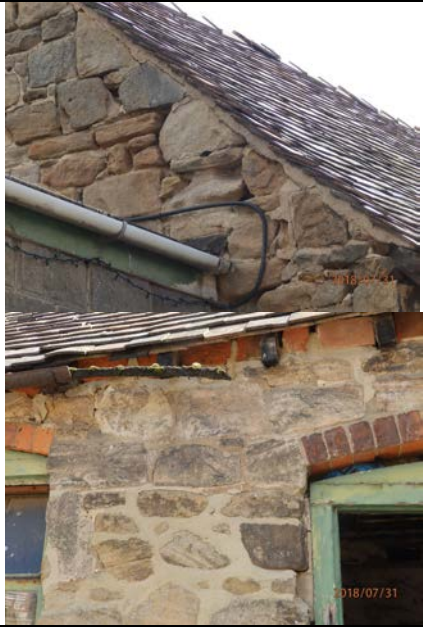
| In crevices in the stone walls | None. | Possible. There is access for bats to the crevices in the stone wall but these are not very large so would only support small numbers of bats.. | |

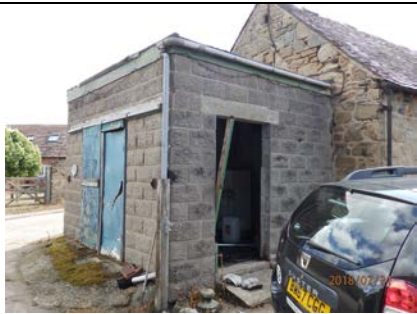
| In crevices in the stone walls | None. | Possible. There is access for bats to the crevices in the stone wall but these are not very large so would only support small numbers of bats.. | |
|---|---|---|---|
| In the flat roofed stone extension | None. | Poor. There is access for bats to the underside of the flat roof where bats could roost against the roof joists. | |

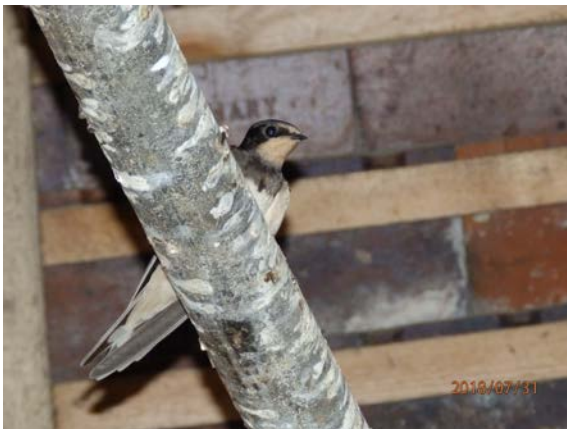
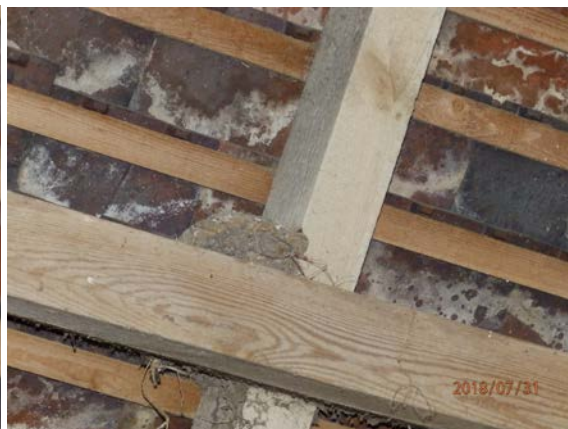
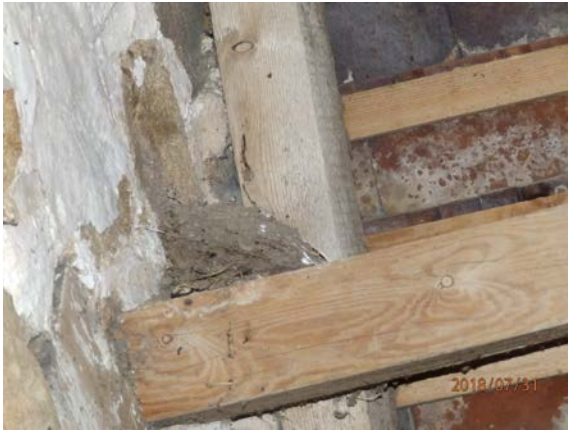
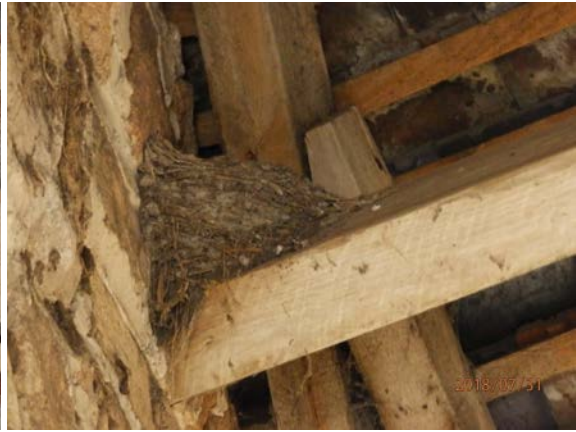
Swallows were seen flying in and out of the stables where there were nests.

Replacement nesting for Swallows is to be provided in the roof space of the eastern garage. This roof space is to be separated from the adjacent bat loft and a ceiling installed in the garage to stop bird droppings falling on the cars. Access for the swallows is to be provided by making an opening in the northern gable wall, 450mm x 450mm.

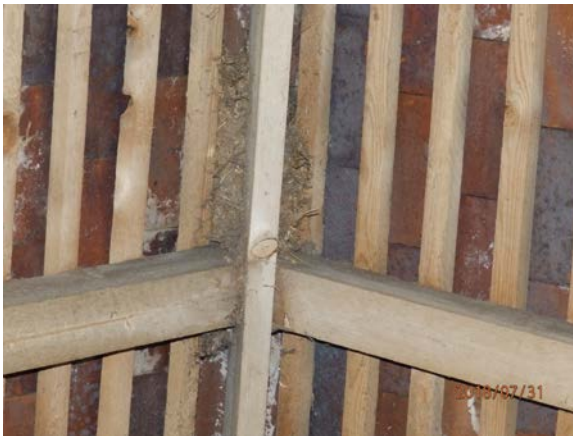
There are Sparrows nesting beneath the ridge tiles.

**Bird nesting; Definite.**

Sparrows are nesting under the ridge tiles. Replacement nesting for the Sparrows is to be provided by installing three Sparrow terrace nest boxes in the re-built brickwork at the eaves.

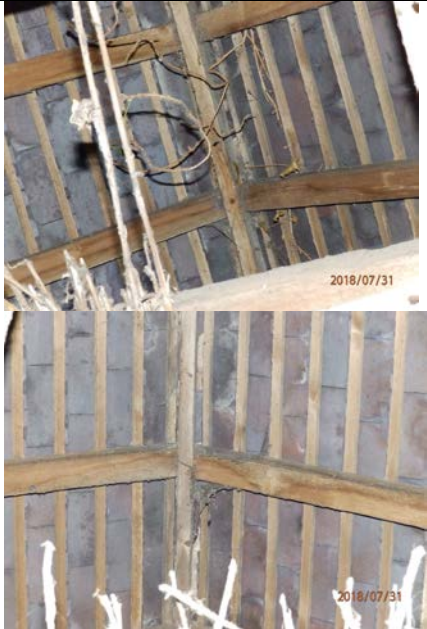
| Feature. | Evidence of bats. | Likelyhood of bats roosting. | Photograph. |
|---|---|---|---|
| Behind ridge board. | None. | Possible. There is access to the roof space for bats. | |

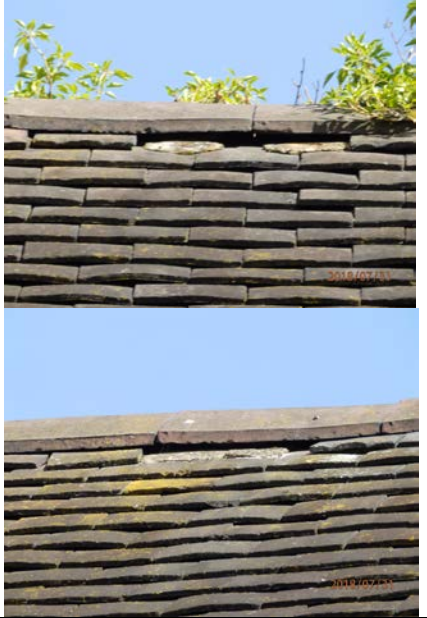
| Feature. | Evidence of bats. | Likelyhood of bats roosting. | Photograph. |
|---|---|---|---|
| Under ridge tiles. | None. | None. There is no access to the underside of the ridge tiles for bats | |

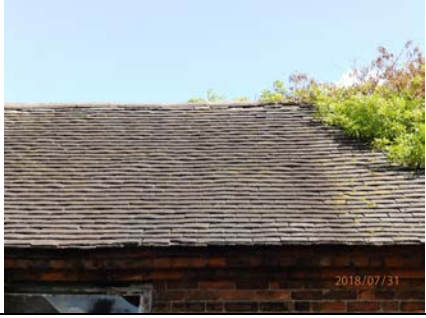
| | | | |
|---|---|---|---|
| Under loose or missing roof tiles. | None. | None. The plain tiles have no underfelt to provide a crevice for bats to roost in but there are access points for bats. | |

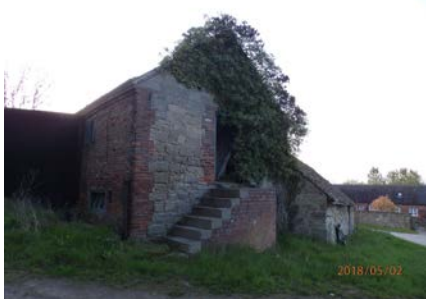
| | | | |
|---|---|---|---|
| In verge. | None. | None. There is no access for bats. | |

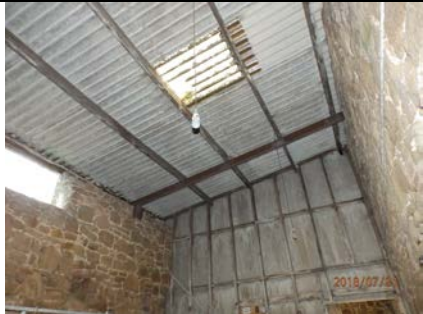
| Feature. | Evidence of bats. | Likelihood of bats roosting. | Photograph. |
|---|---|---|---|
| Behind ridge board. | None. | None. The roof is a monopitch with no ridge boards. | |

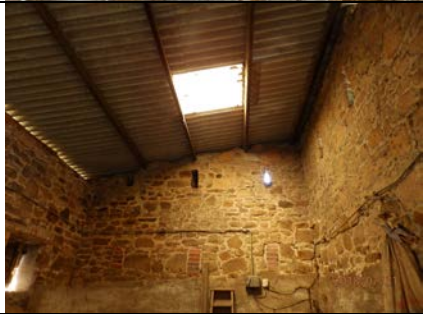
| Feature. | Evidence of bats. | Likelihood of bats roosting. | Photograph. |
|---|---|---|---|
| In splits in timber rafters. | None. | None. Machine cut timbers. | |

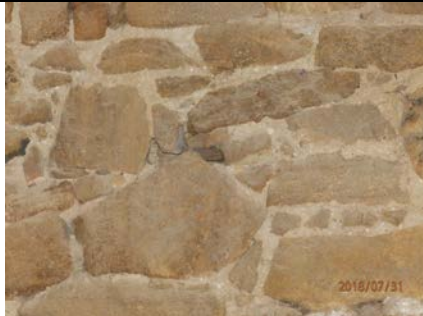
| Feature. | Evidence of bats. | Likelihood of bats roosting. | Photograph. |
|---|---|---|---|
| In crevices in the stone walls | None. | Possible. There is access for bats to the crevices but the space is small and would only support small numbers or individual bats. | |

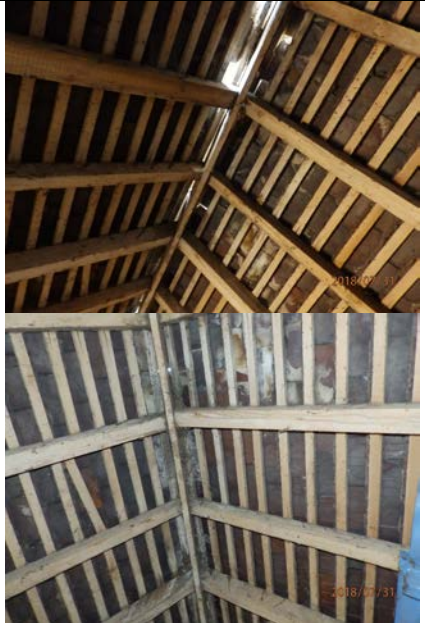
| Feature. | Evidence of bats. | Likelihood of bats roosting. | Photograph. |
|---|---|---|---|
| Behind ridge board. | Bat droppings. | Definite. There is access to the roof space for bats and in 2014 there were bat droppings and butterfly wing fragments on the floor. The gaps in the ridge tiles mean that there will be weather penetration. | |

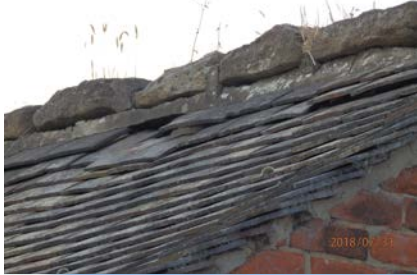
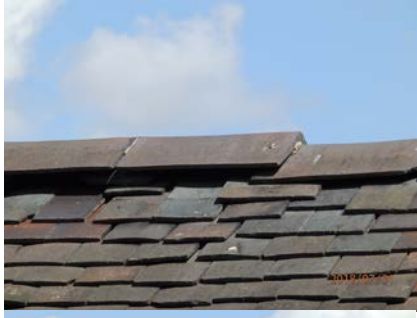
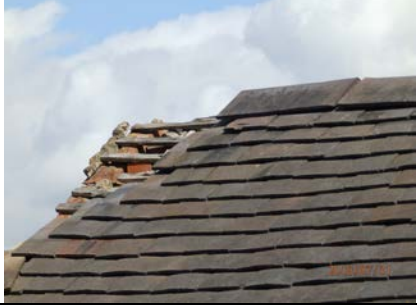
| Under ridge tiles. | None. | Possible. There is access to the underside of the ridge tiles for bats but there is also weather penetration. | |

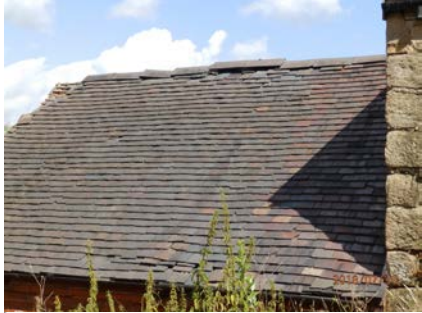
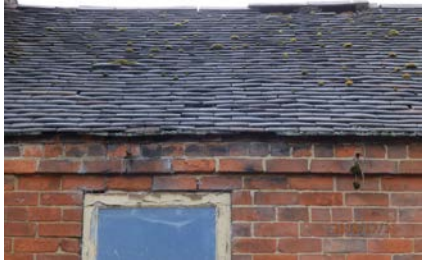
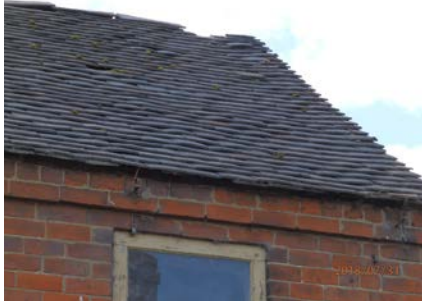
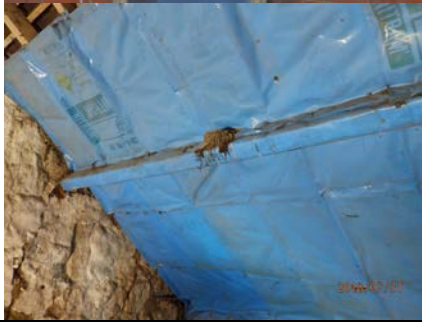
| Under loose or missing roof tiles. | None. | None. The plain tiles have access points for bats but the only underfelt is polythene sheet material that is not suitable for bats to roost against.. | |

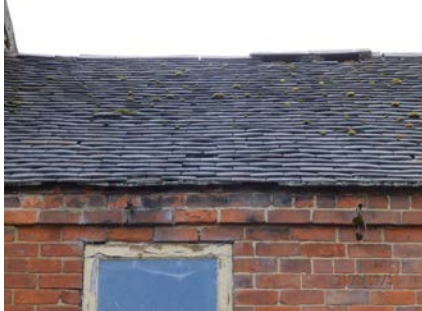
| In eaves. | None. | None. Corbel brick eaves with no access for bats. | |

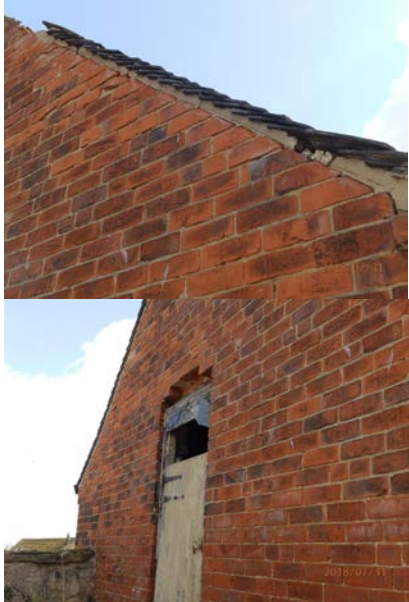
| In verge. | None. | Poor. There is access for bats but there is also weather penetration making use by bats unlikely except in periods of warm and dry weather. | |

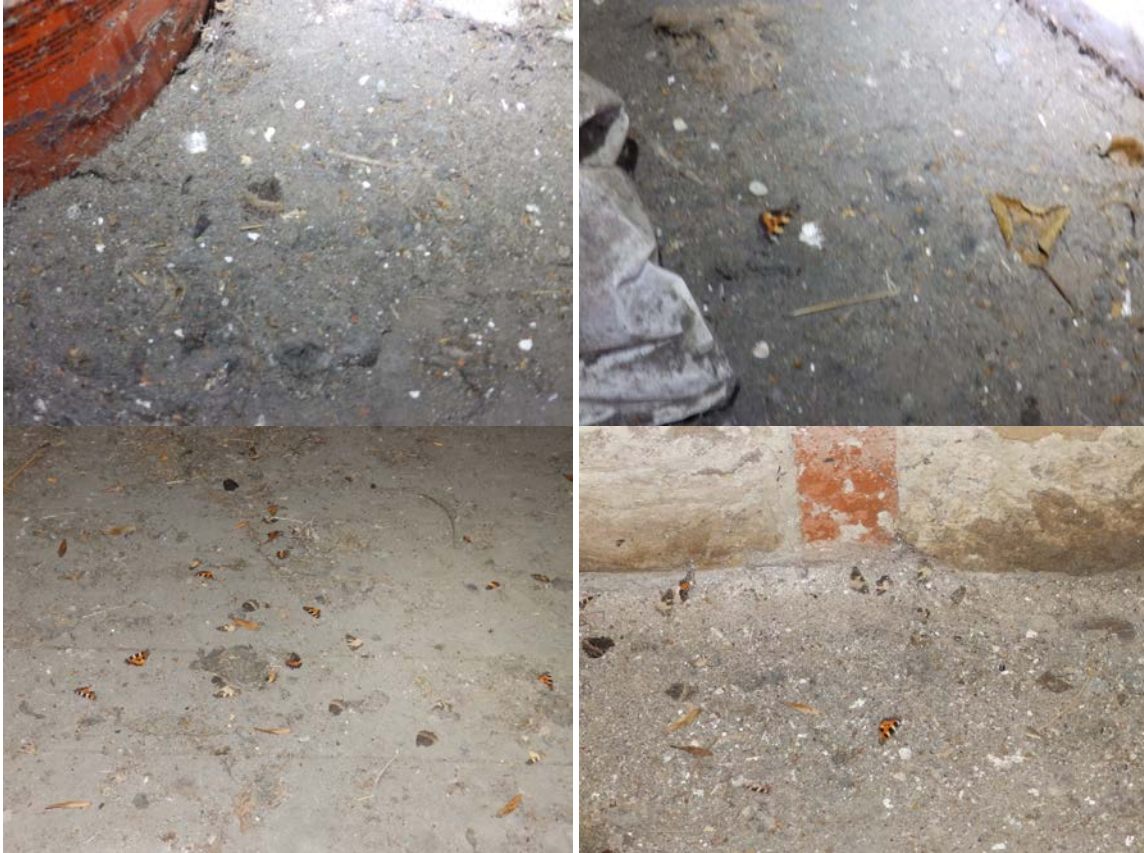
Medium sized, segmented bat droppings and butterfly and moth wings were found in the first floor area of the southern barns in 2014 and 2018.

The droppings and butterfly/moth wings were all found beneath the ridge board. The size and shape of the droppings and the presence of the butterfly/moth wings confirm this site as being a feeding perch for Brown Long Eared bats.

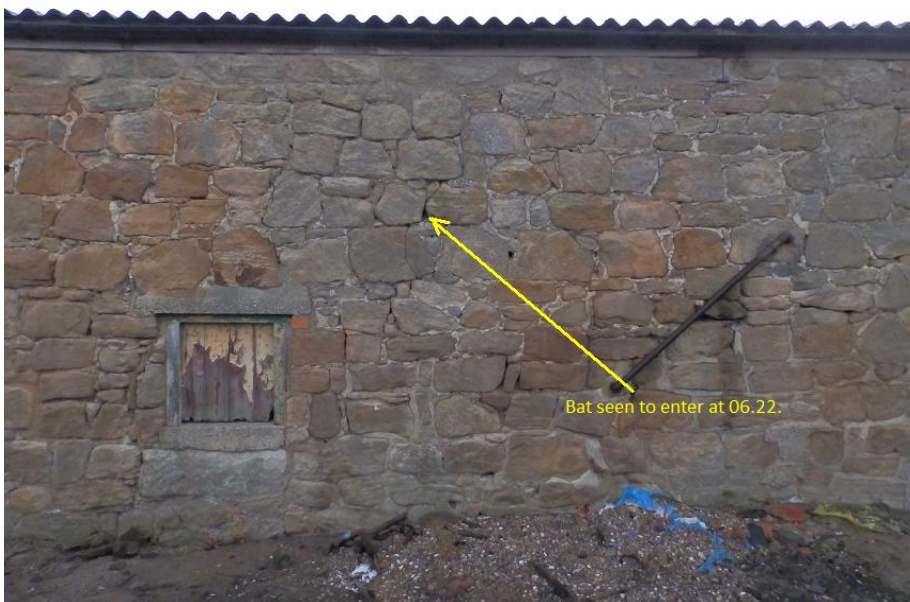
During the dawn survey of the 29<sup>th</sup> September 2014 a Common pipistrelle bat was seen to enter a crevice in the stonework on the south side of the 2 storey barn at 06.22. These crevices can be retained in any development of the buildings.

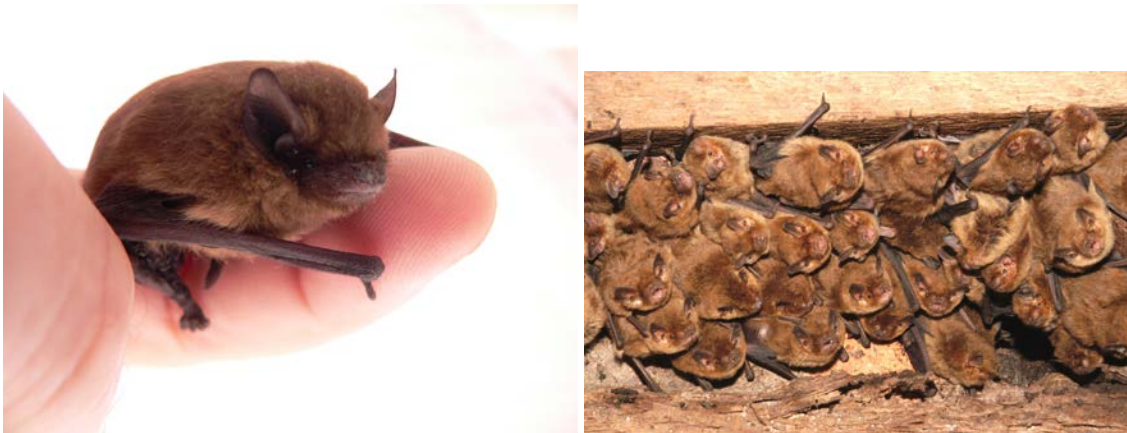
The common species of bats that are likely to roost in buildings of this nature and are evidenced from the regional records, are crevice dwelling bats, such as the Common Pipistrelle. These bats are small and can use accesses as little as 50mm x 20mm. When found in buildings they appear no bigger than a thumb and have dark brown fur.

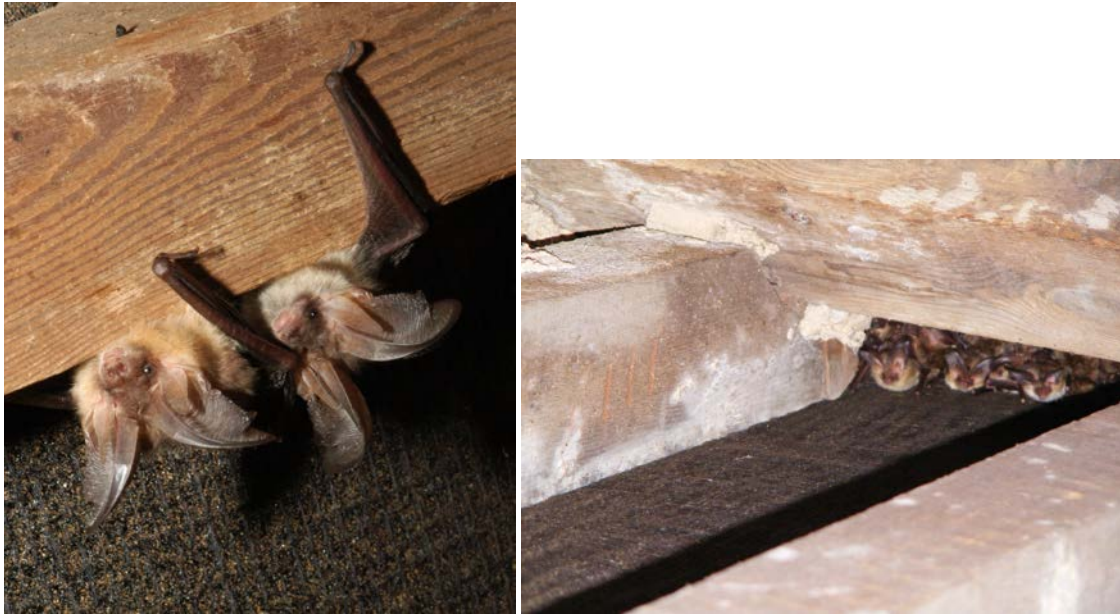
The other species of bat that may possibly be found on site is the Brown Long Eared bat. These are a medium sized bat, larger than a Pipistrelle with very long ears that meet in the centre of

the head. These bats may be found in crevices in the brickwork, behind ridge boards or in splits in the larger roof timbers.
