## **Preliminary bat roost assessment & Emergence Surveys**

| Site Location | Brookfield Farm, Schoolpiece Lane, Church Broughton, DE65 5DH |
| Document reference | BFF001 |

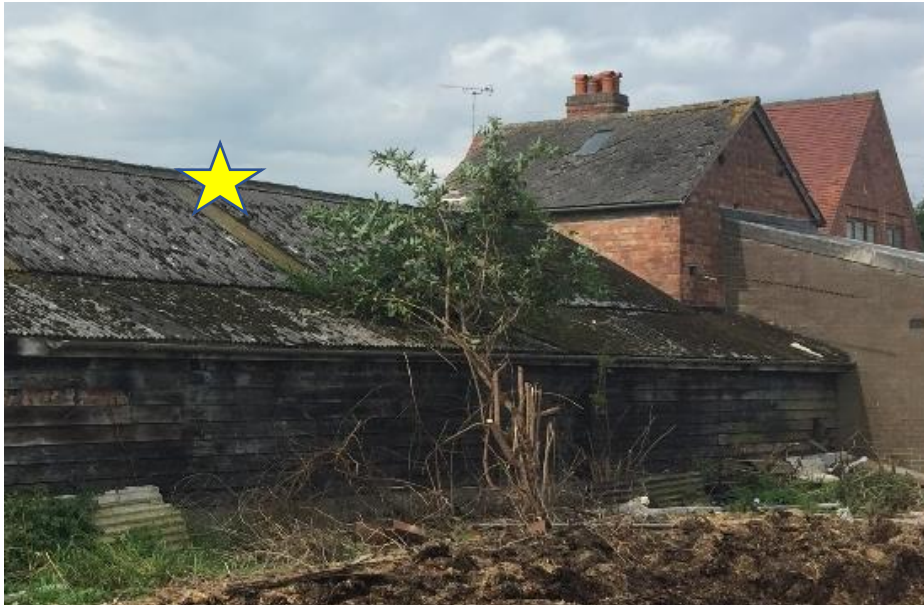
4<sup>th</sup> May & 22<sup>nd</sup> May 2018 – Common Pipistrelle (Maximum count of 1), Via gap between fabricated sheets and ridge cover

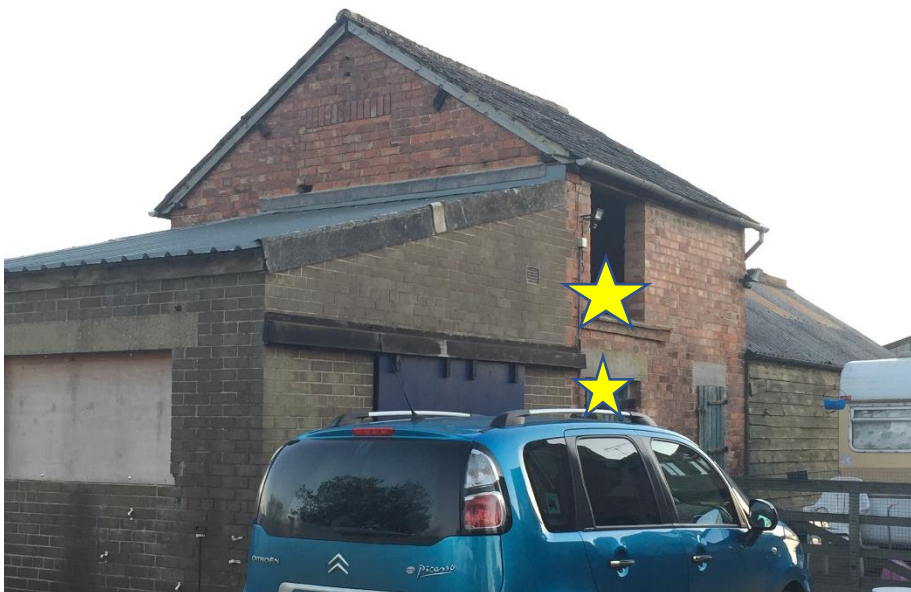
4<sup>th</sup> May, 22<sup>nd</sup> May & 10<sup>th</sup> June – Common Pipistrelle from within open section to 1<sup>st</sup> floor and above door below (Maximum count of 4). Several gaps within floor so possible of 1 roost within the building.

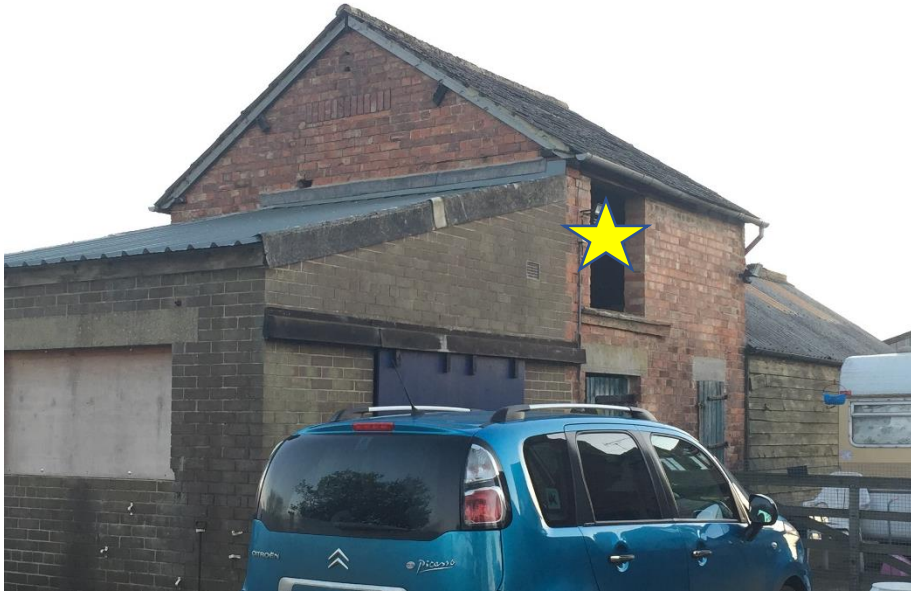
4<sup>th</sup> May – Brown Long-eared bat emerged into 1<sup>st</sup> floor area via open entrance at 21:22 and re-emerged at 21:25. Again entering the same location at 21:45 demonstrating signs of a feeding roost. 1<sup>st</sup> floor areas were re-inspected on the 10<sup>th</sup> of June where fresh signs of droppings were located to the floor area close to the wall to the left.

- 6.2** On the 4<sup>th</sup> May 2018 it was identified that a single Brown Long-eared bat was using the 1<sup>st</sup> floor area of the two-storey section for a possible feeding roost where further fresh droppings were noted to the floor area on the 10<sup>th</sup> June 2018.

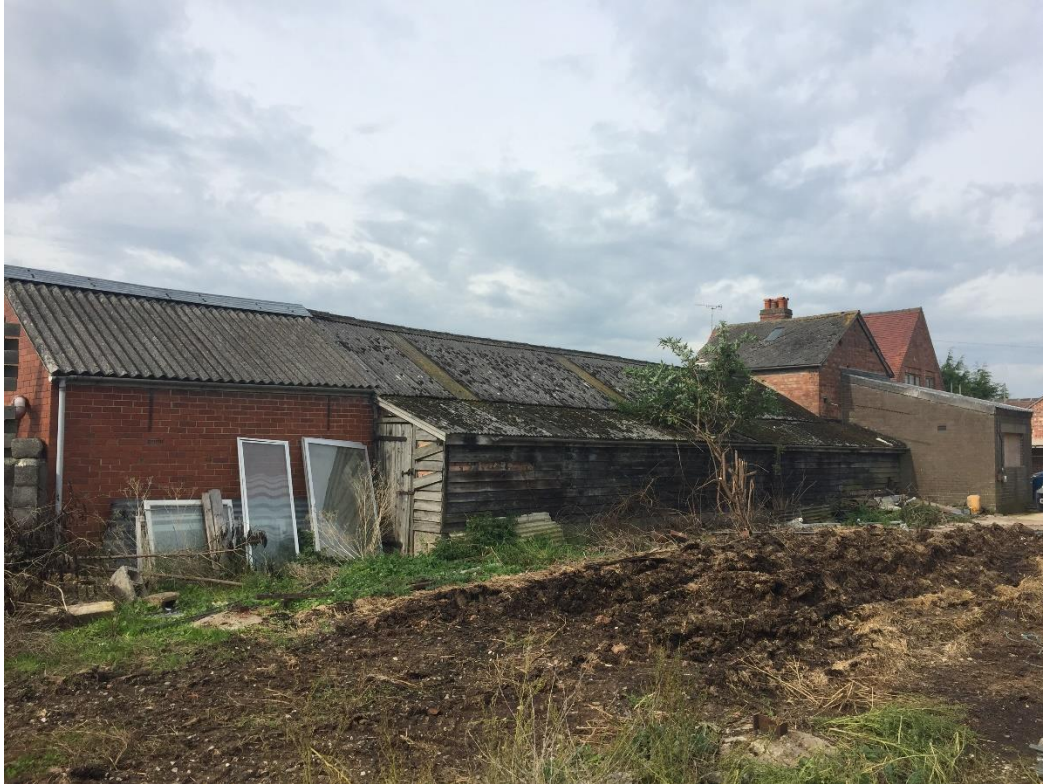
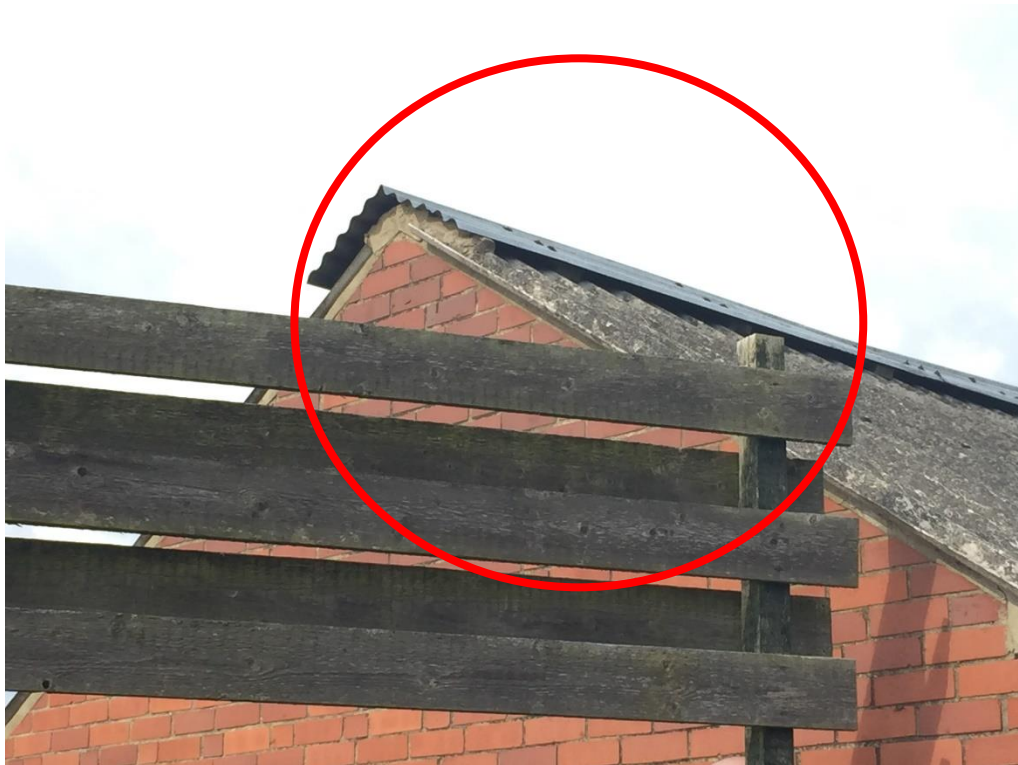
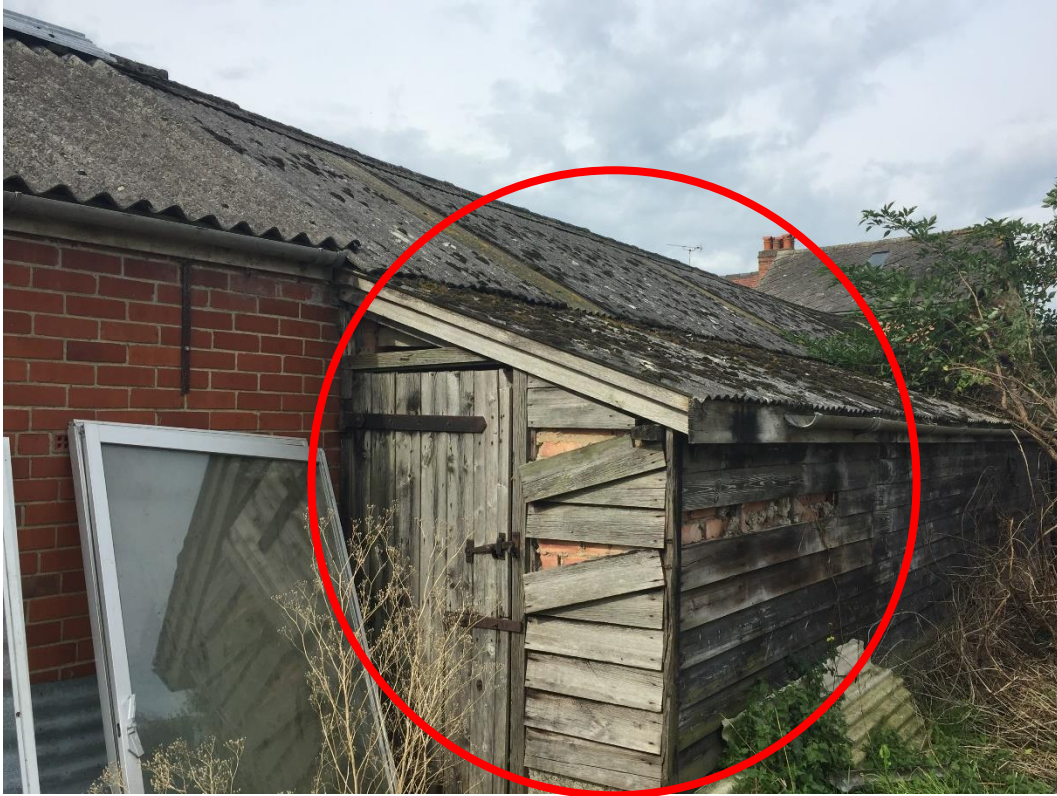
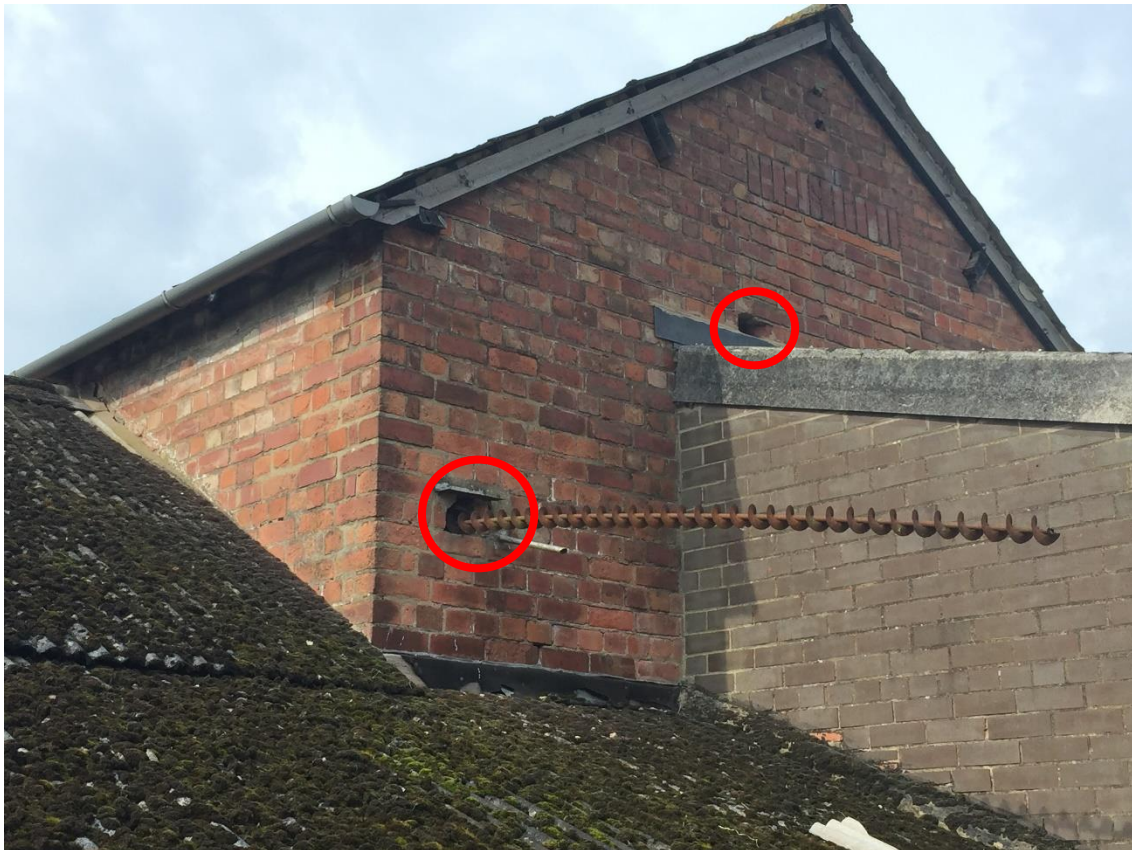
East facing elevation of the single-storey building constructed with a fabricated sheet roof and areas of brick and timber cladding in a deteriorated state in places giving access/roosting opportunities for bats

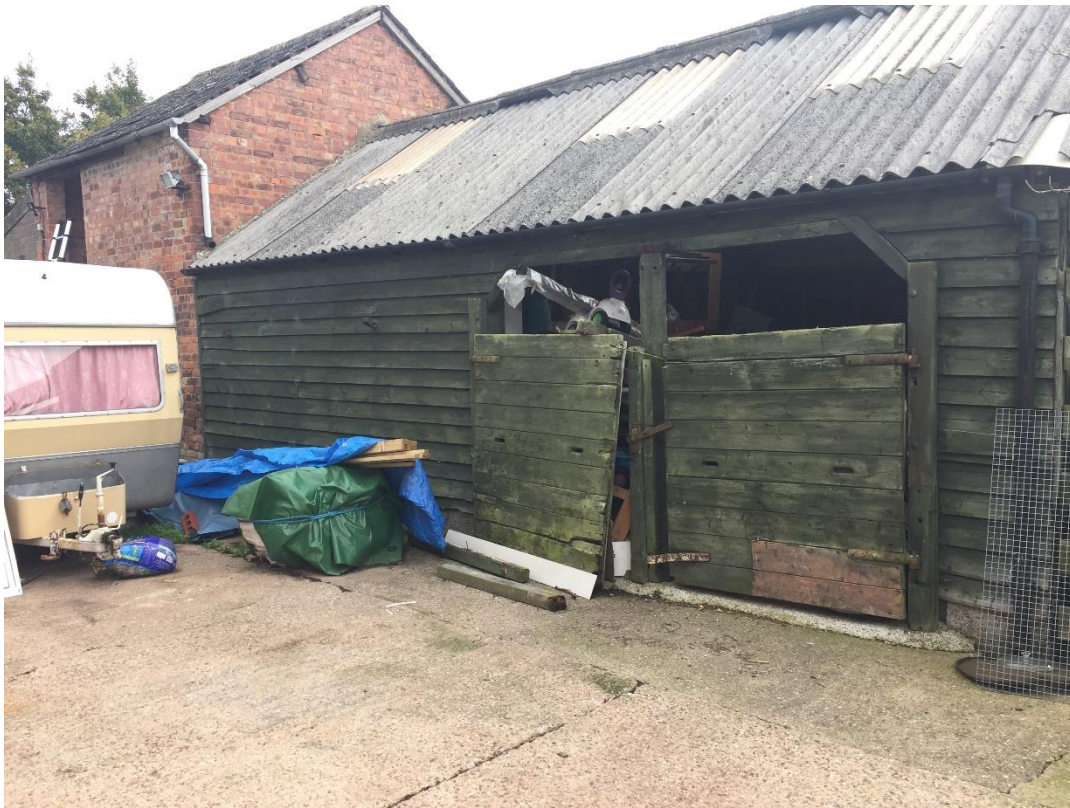
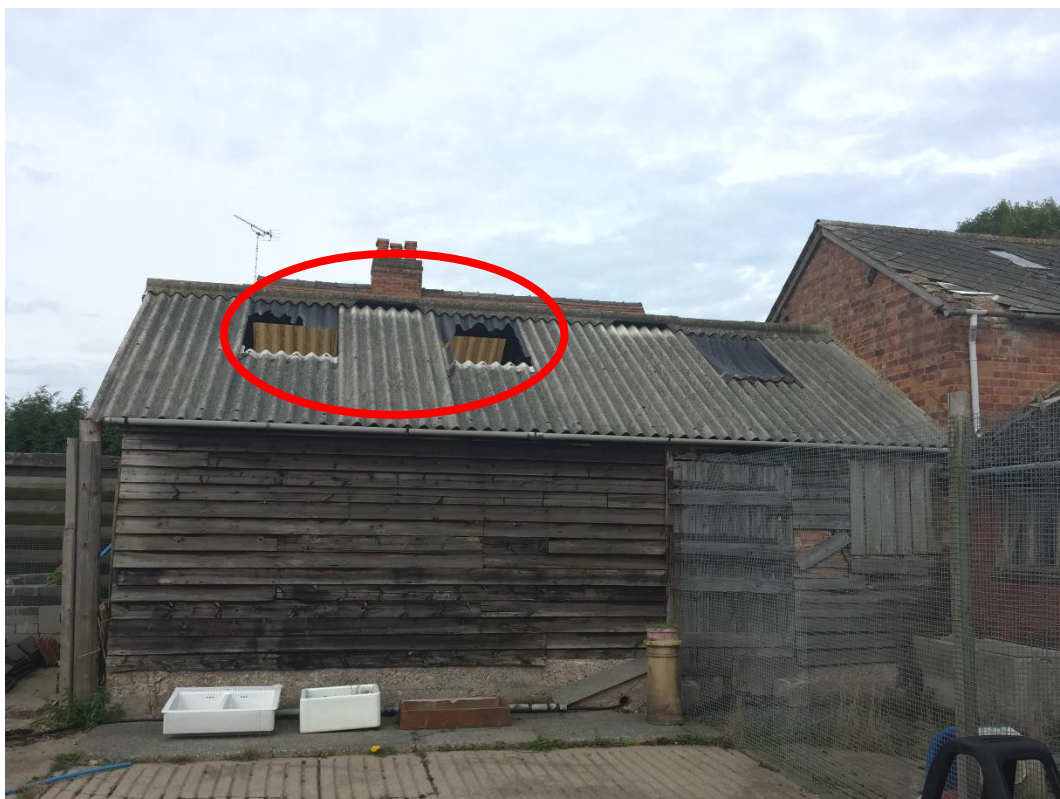
North facing elevation of the single-storey & two-storey building showing a considerable amount of deteriorated areas giving access/roosting opportunities for bats

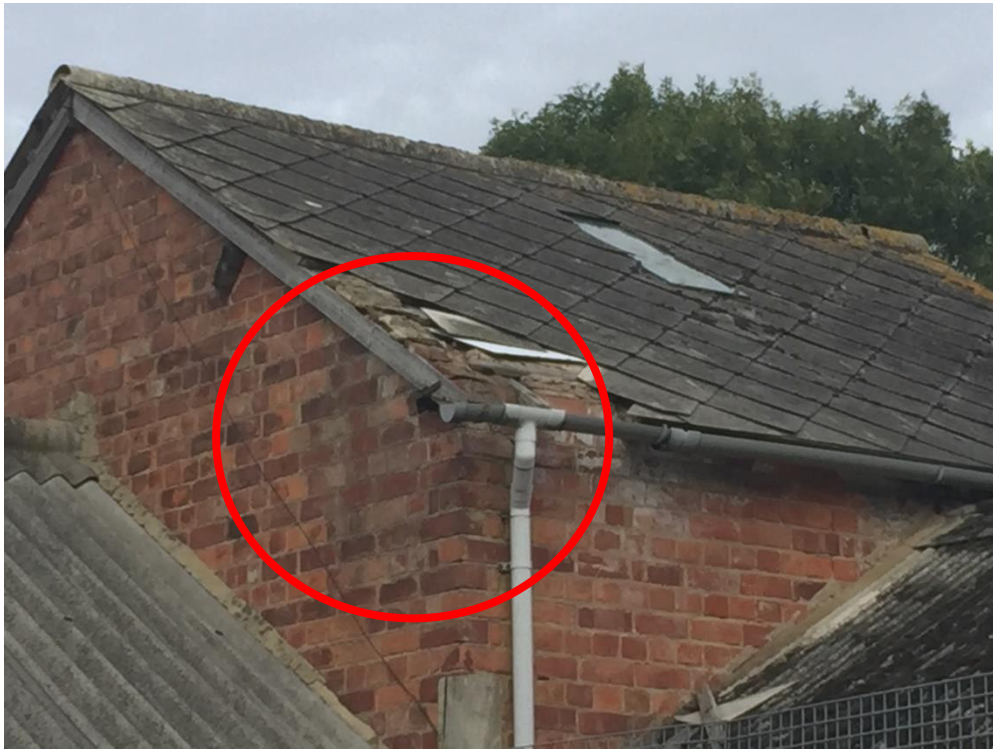
Damaged area of roofing cover to the two-storey area

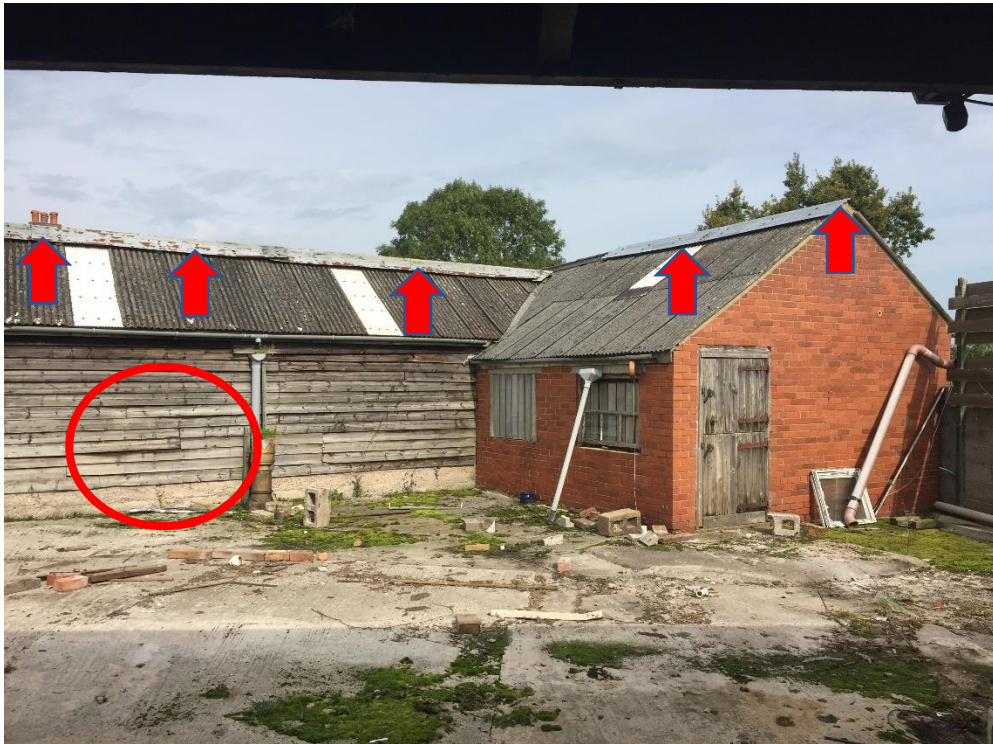
Below timber single-storey building to the South of the structure in a deteriorated state giving access/roosting opportunities for bats, gaps behind timber cladding/boarding's and around roof

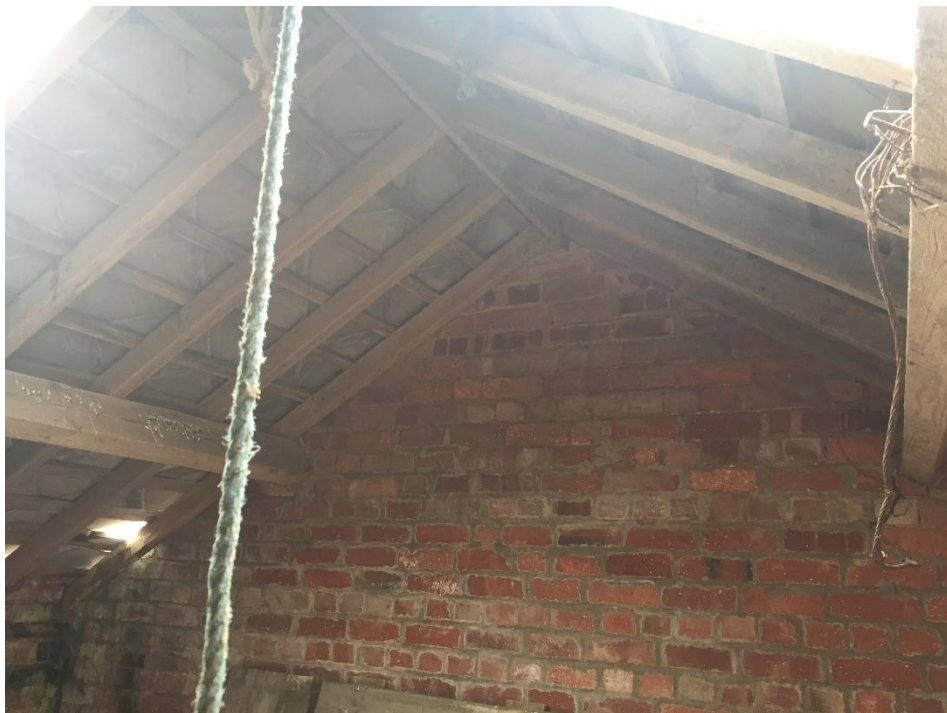
Below internal roof area to two-storey brick area where a small number of droppings similar to those of Brown long-eared bats were located below a timber beam. Open access to the building along with several areas of damage to the roof structure

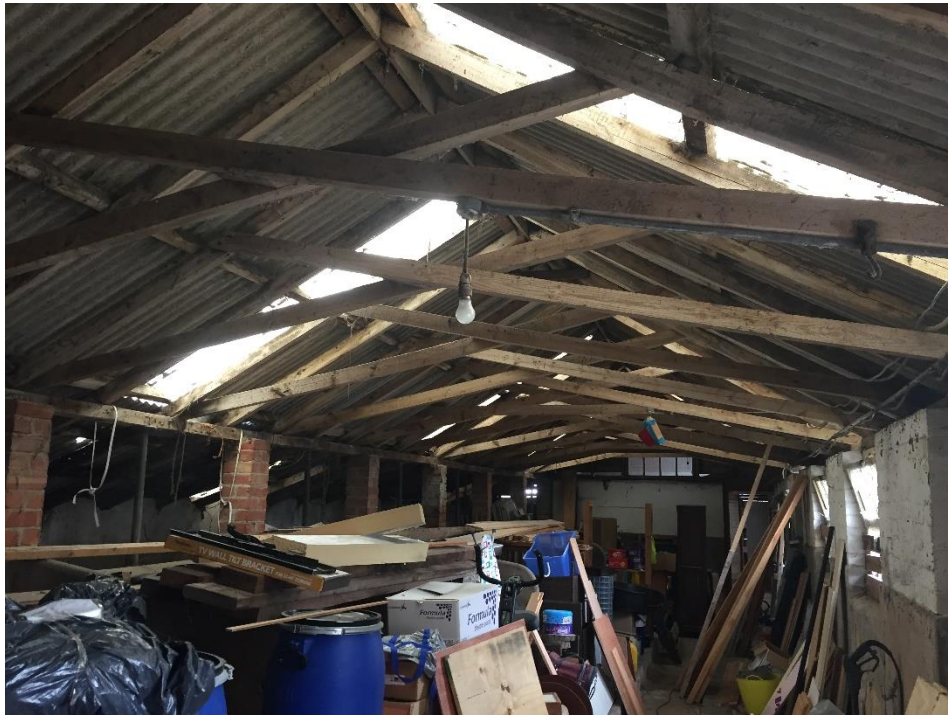
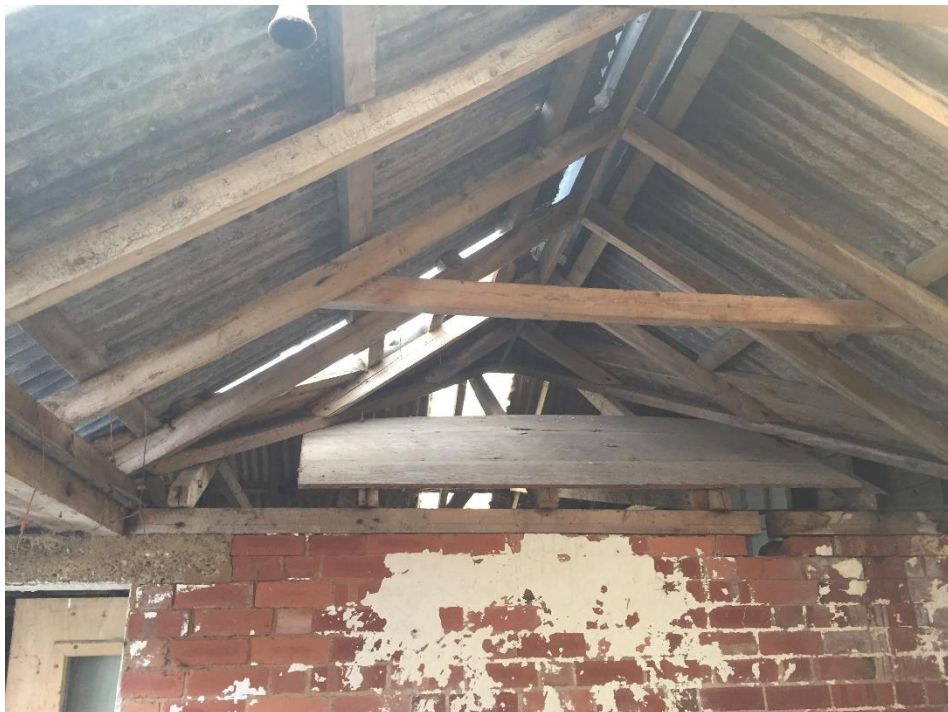
Internal views of the single-story areas which house limited areas within the roof structures for roosting, these areas are also visibly well-lit during the day time from natural light

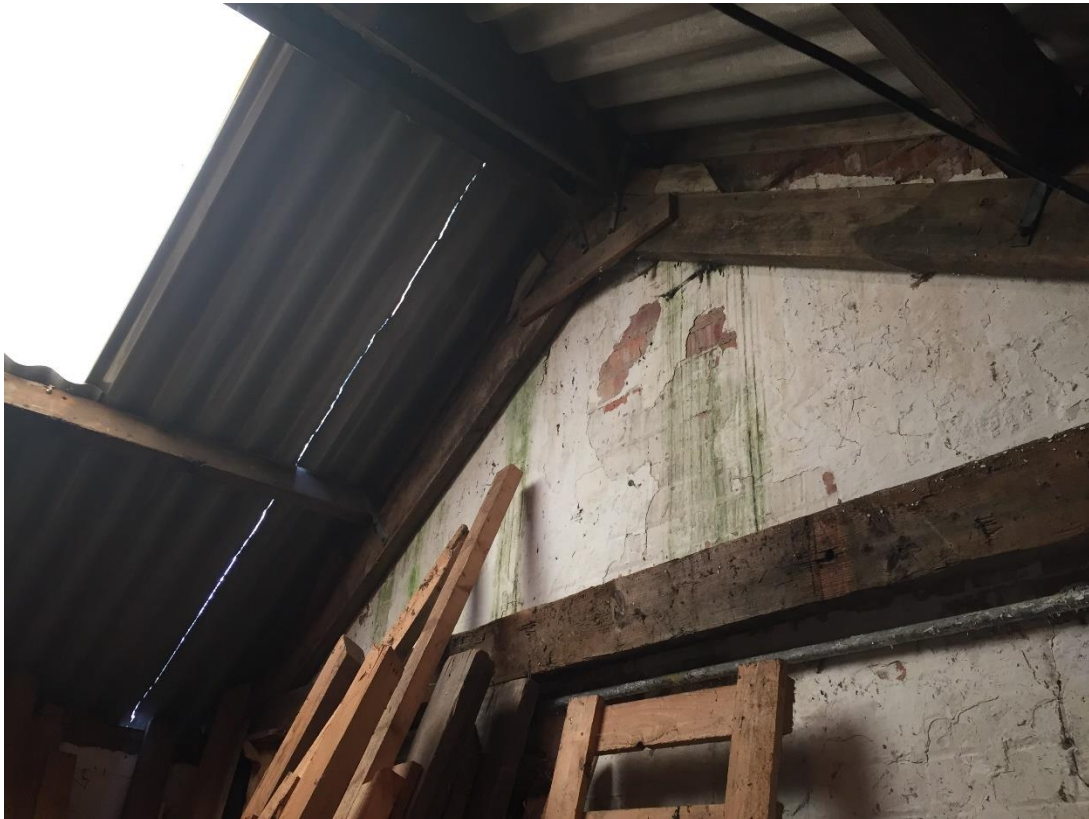
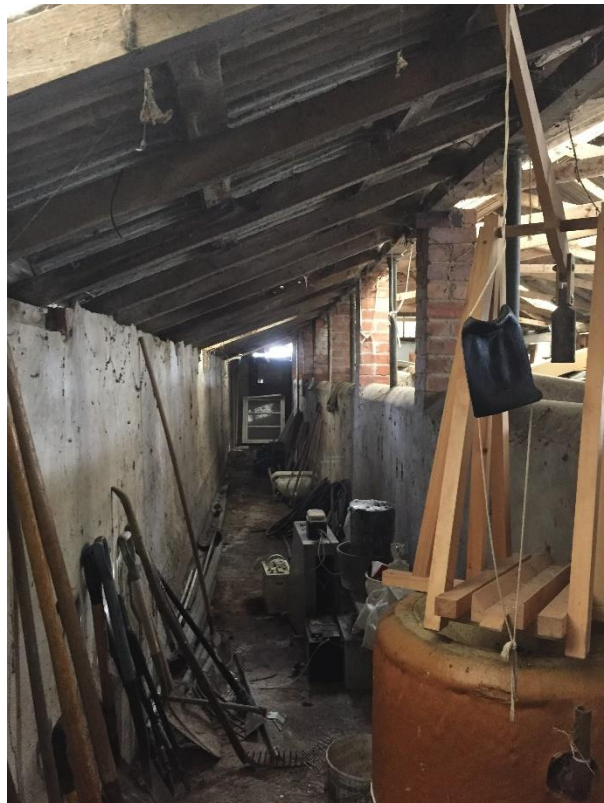
Internal views of the single-story areas which house limited areas within the roof structures for roosting, these areas are also visibly well-lit during the day time from natural light

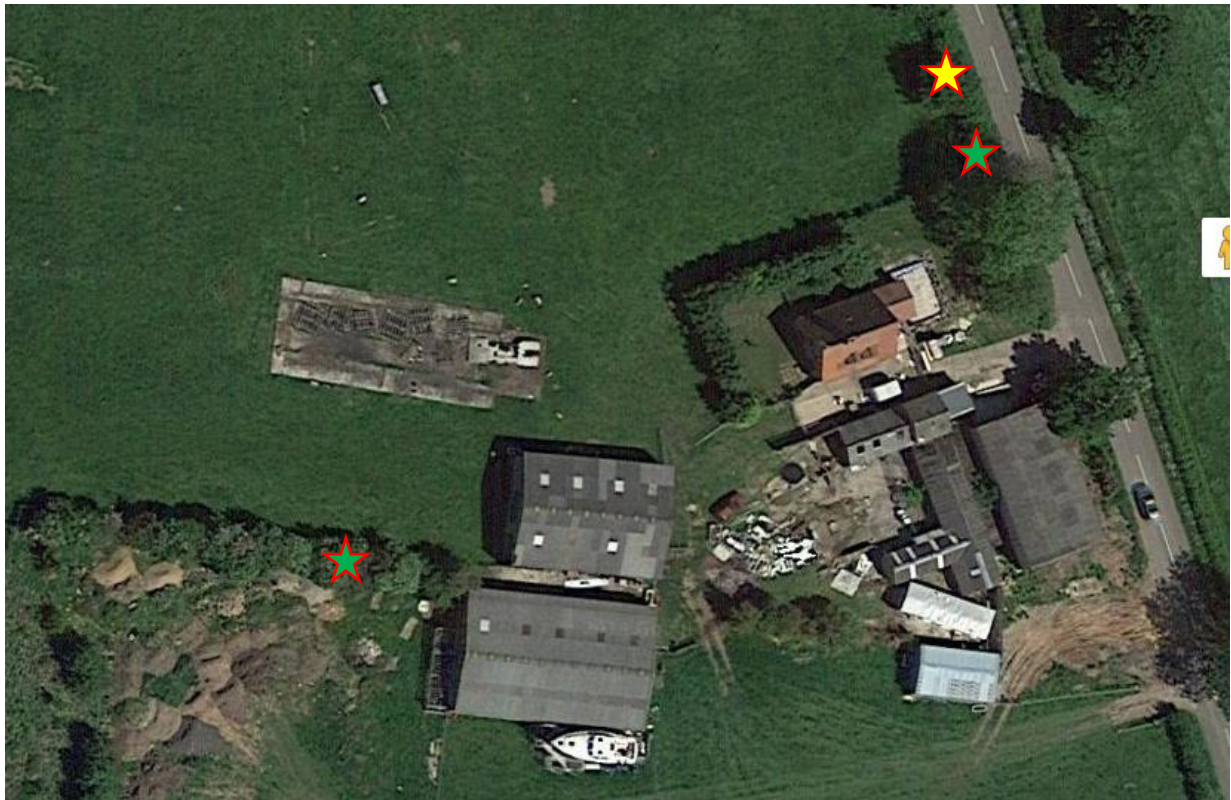
Below Mitigation plan for bat boxes within the site, to be installed before all mitigation works progress to the roof coverings. All boxes will remain as a permanent fixture to offer additional enhancement to the site.

- ★ Small Woodstone Bat Box x 2, these will act as a mitigation support and remain as a permanent fixture to offer additional enhancement for crevice dwelling bats.
- ★ Large Multi Chamber Woodstone Bat Box x 1, this will act as a mitigation support and remain as a permanent fixture to offer additional enhancement for void dwelling bat
