# **The Croft 4 Main Street Ambaston Derbyshire**

## **Bat Survey Report**

Client: Mr & Mrs Mulligan-Freeman

Issue Date: May 2020

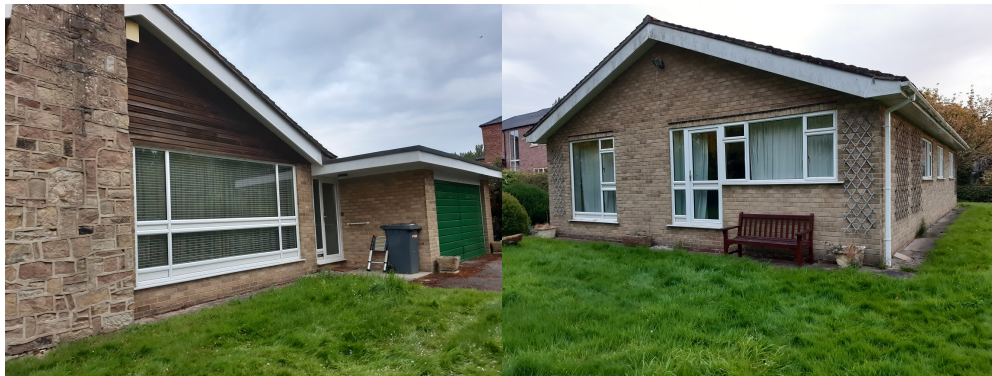
- 3.1 Building B1: This single storey residential building was of brick construction with a pitched roof featuring tightly fitted concrete tiles. It was in good condition having been well maintained although now unoccupied. The doors and large windows all featured UPVC frames and the soffits and fascias were also modern, uPVC and well-sealed.

- 3.2 An area featuring wooden hanging boards was present adjacent to the front door but again these were well sealed with no warping or gaps leading underneath or in at the sides. Adjacent to this area was a stone chimney stack with lead flashing around the chimney at roof level. This was well pointed with no gaps in mortar or leading underneath the flashing.

- 3.3 A garage was attached to the southern aspect of the house. Again, this was constructed from brick but featured a flat roof covered with felt. The uPVC soffits on the garage were in good condition and sealed with silicon along the edge of the wall sealing any gaps into the boxes.

- 3.4 No evidence of use by bats were noted externally on walls or windowsills.

**Photo: eastern and northern aspect of building B1 featuring attached garage, wooden boards and uPVC soffits**

- 4.1 No evidence of bats was found associated with B1 and B2 during either the building inspection or during the two nocturnal surveys. As such no further surveys are considered necessary and there are currently no statutory constraints to the removal of the buildings.

- 4.2 However, bats are transient in nature and presence can never be completely ruled out. Therefore, if bats or evidence of bats such as droppings are discovered during demolition then all work should stop immediately, and a consultant Ecologist contacted for further advice.

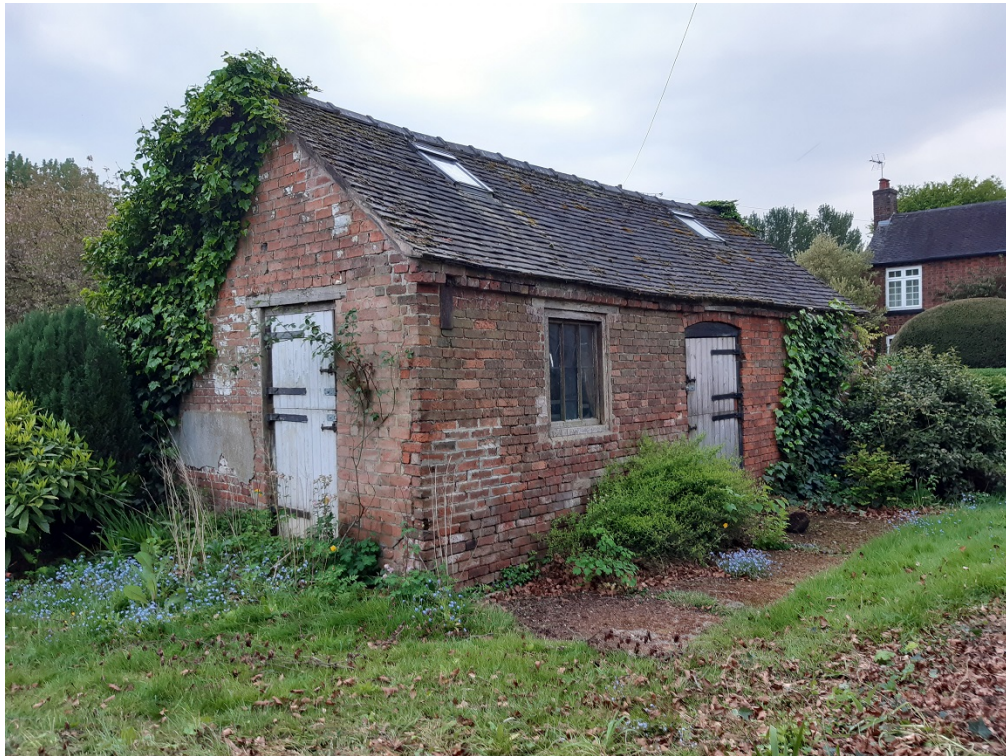
- 3.7 Building B2: This building was a small, single-storey brick outbuilding with a pitched roof covered with concrete tiles. The building did not feature barge boards or soffits/fascias, but it did have two skylights in the roof and a single window located on the northern aspect. Two wooden access doors were noted and above each of these doors were wooden lintels. Dense ivy covered most of the southern aspect and part of the eastern and western gables.
- 3.8 Potential access points and roosting features were noted including gaps under raised tiles on the northern aspect and under loose ridge tiles. There were also gaps above the two access doors between the door and lintel above. Some gaps were present in the brick work where mortar had degraded although the majority of these appeared to be superficial, shallow, and therefore not substantial enough to support roosting bats.

**Photo: eastern gable and northern aspect of building B2**

- 3.9 No internal inspection of B2 was possible at the time of the building assessment. However, it did not contain a roof void and the underside of the roof was observed through the side window. Part of the underside of the roof appeared to be covered by sarking boards fitted between the rafters.

- 3.14 During the nocturnal survey on 3<sup>rd</sup> May a bird was seen flying into the ivy covering the eastern gable of B2. The species of the bird was not confirmed at the time, but it was assumed that the bird was nesting within this vegetation as it was not observed leaving the ivy during the rest of the survey.

- 4.3 Nesting birds were noted within the vegetation covering parts of B2. All birds are protected whilst on the nest under the Wildlife and Countryside Act 1981 (as amended). Therefore any works to this section of the building including vegetation removal should take place outside of the bird breeding season (considered to be March – September inclusive) If this is not possible the building/vegetation should be checked by an experienced Ecologist prior to removal.
