# New House Farm, Etwall Road, Mickleover.

## Preliminary Ecological Appraisal & Daytime Bat Inspection Survey

October 2019

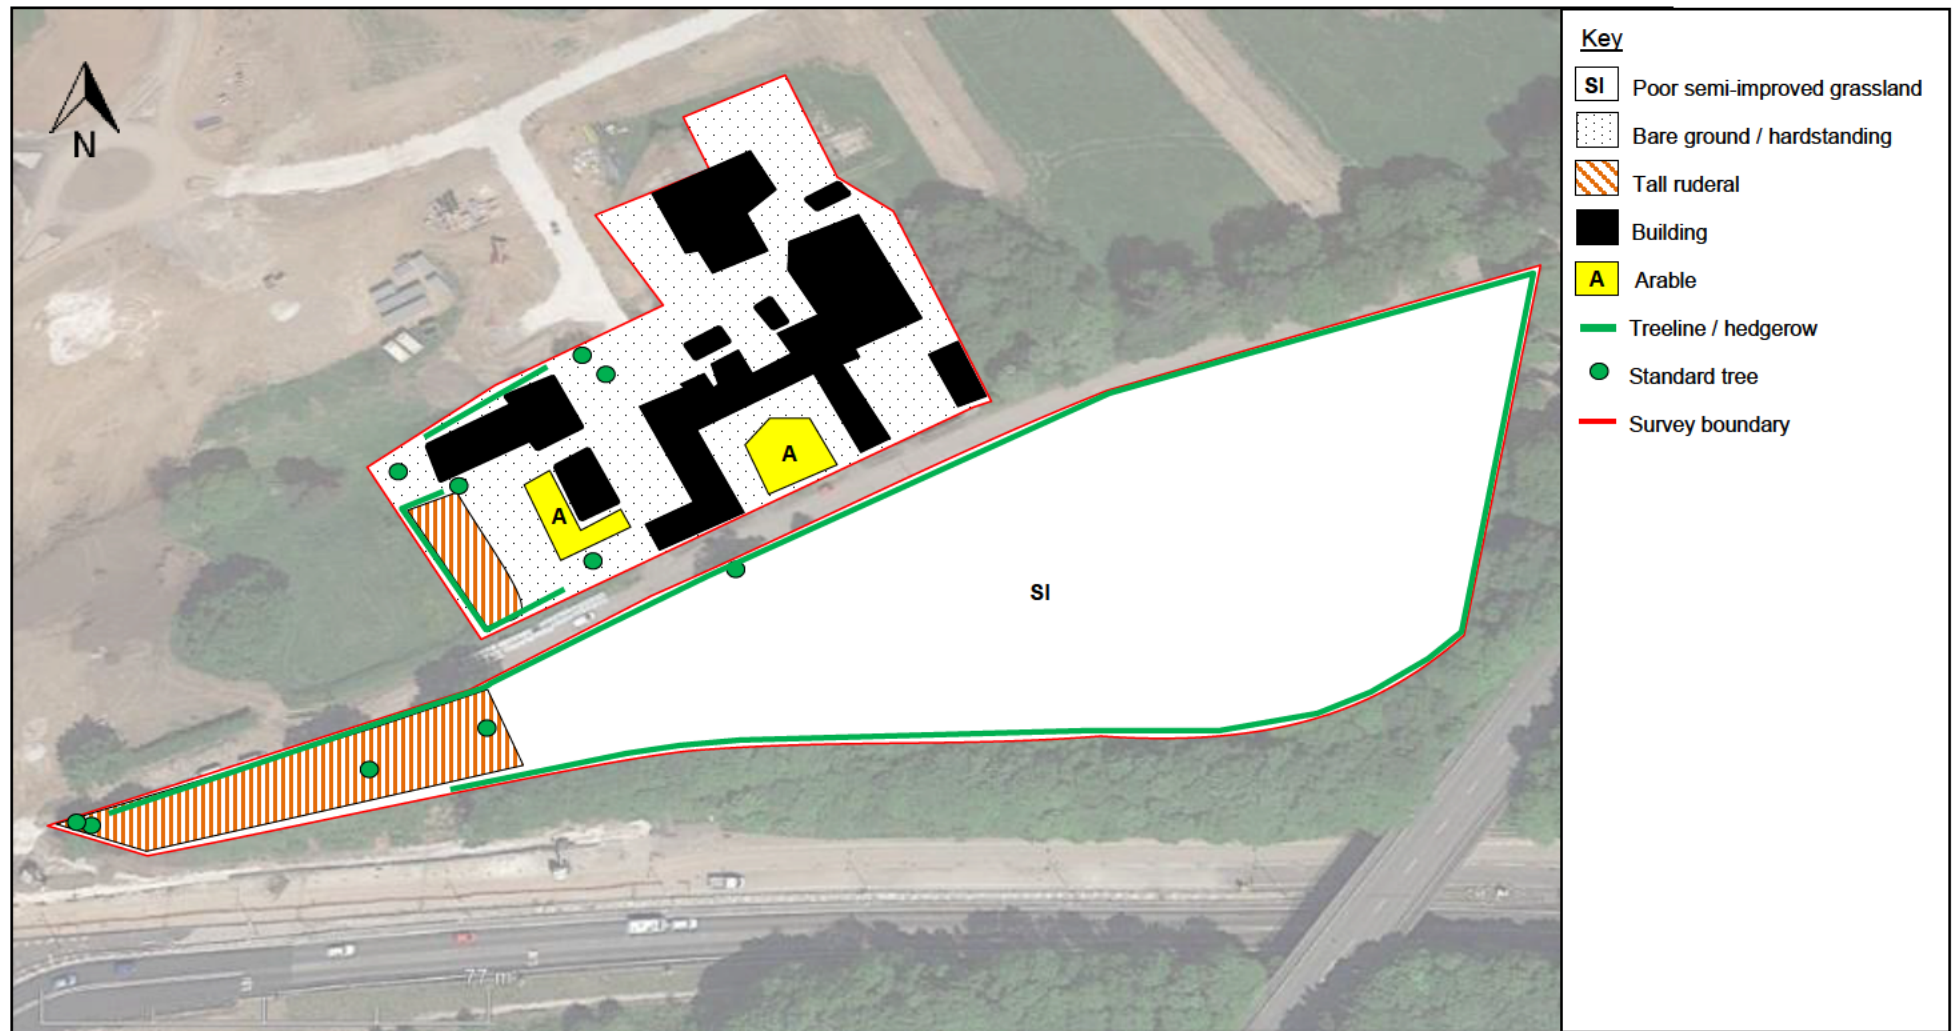
For ease of reference, the site will be categorised as Area 1, the farmstead to the north of unnamed road, and Area 2, the area of land to the south of the unnamed road. See Phase 1 Map in Figure 3 and photos in Appendix 2.

**Figure 3. Phase 1 Habitat Map (Area 1 to north and Area 2 to south)**

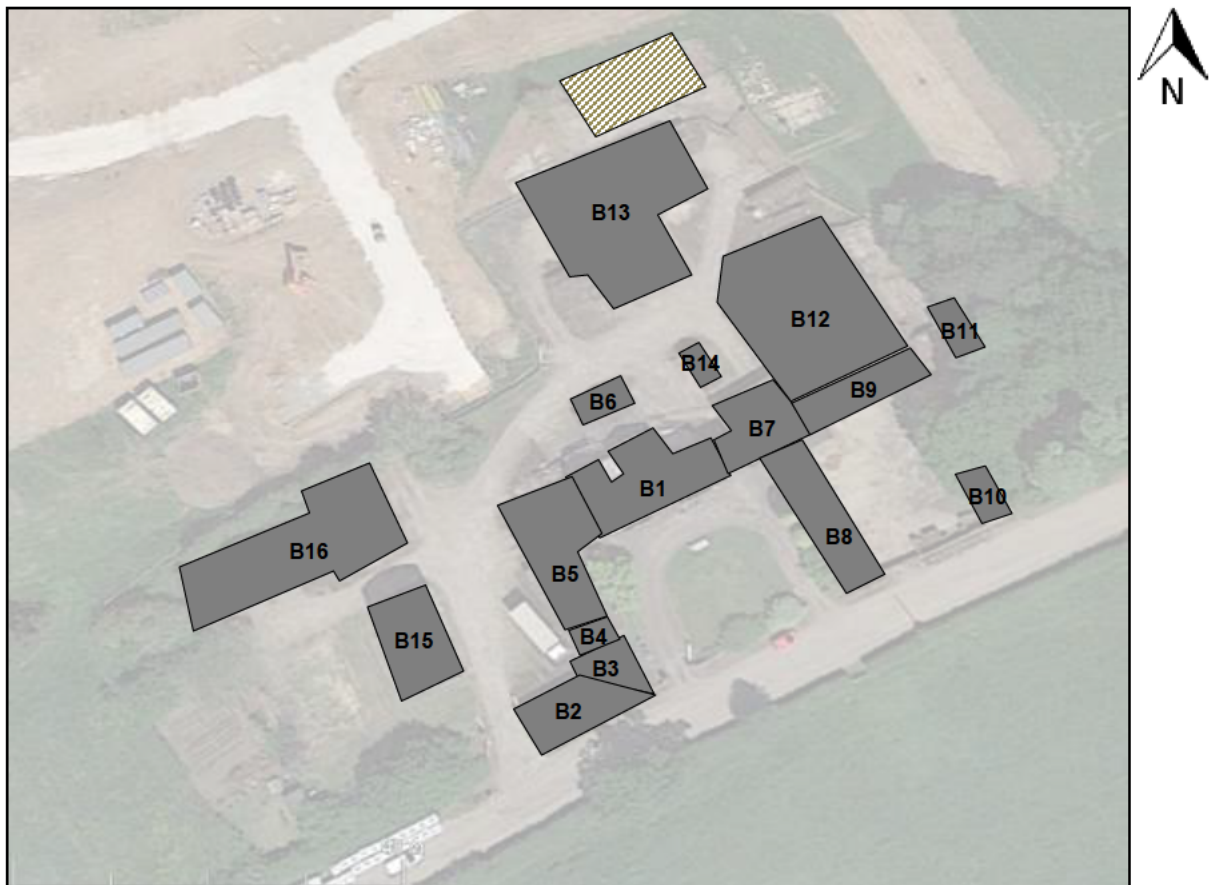
**Figure 4. Building Reference Numbers** (brown lined structure no longer present)

For ease of reference all buildings within the site have been numbered, as seen in Figure 4. All numbers correspond with the details provided in Table 2 on the following page. Also, see photos in Appendix 2.

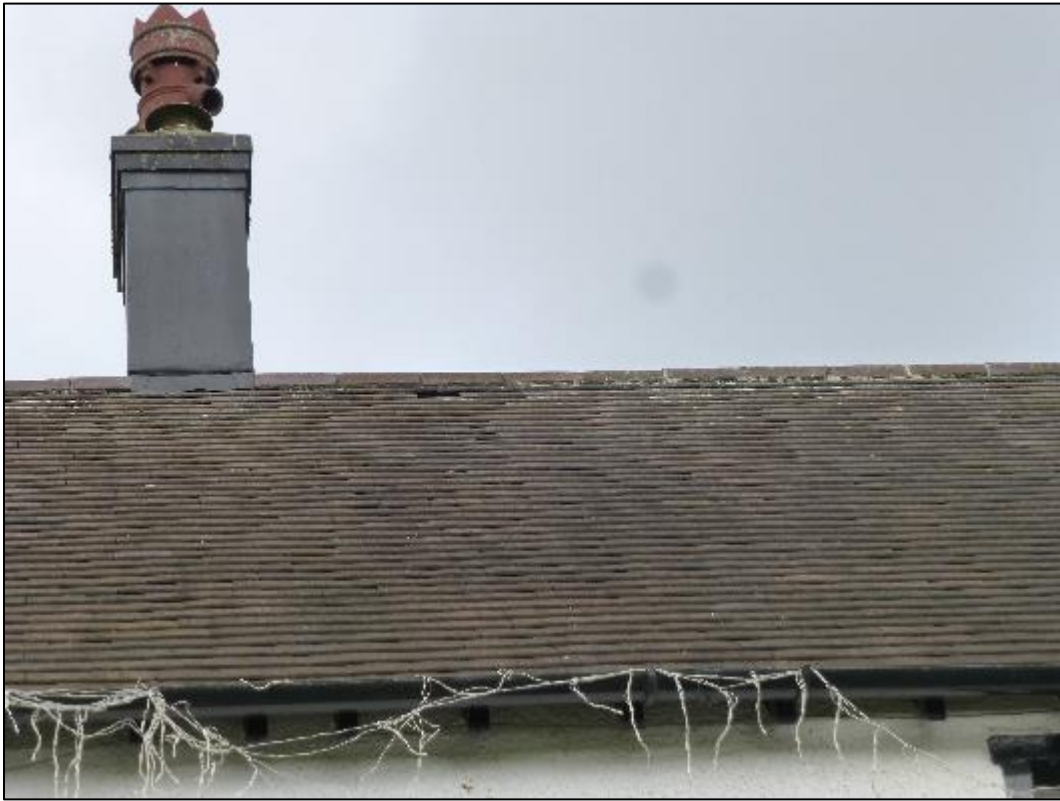
**Photo 3. B1 – example access between tiles and lining**

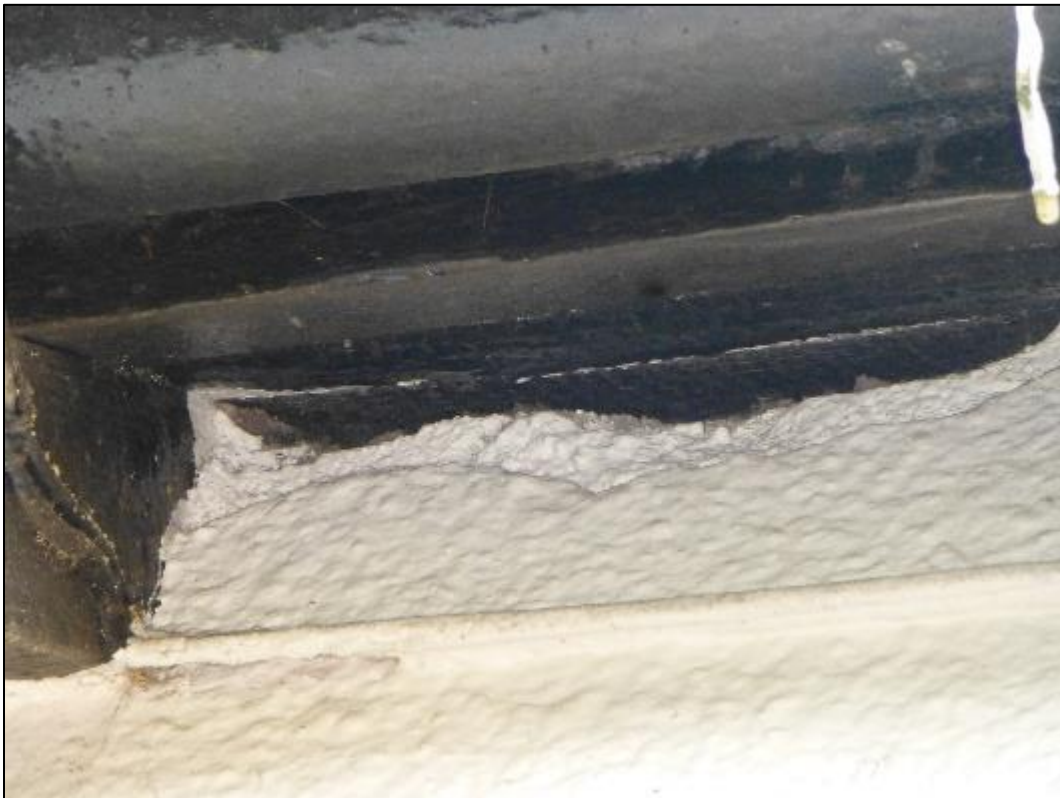
**Photo 4. B1 – example access to cavity**

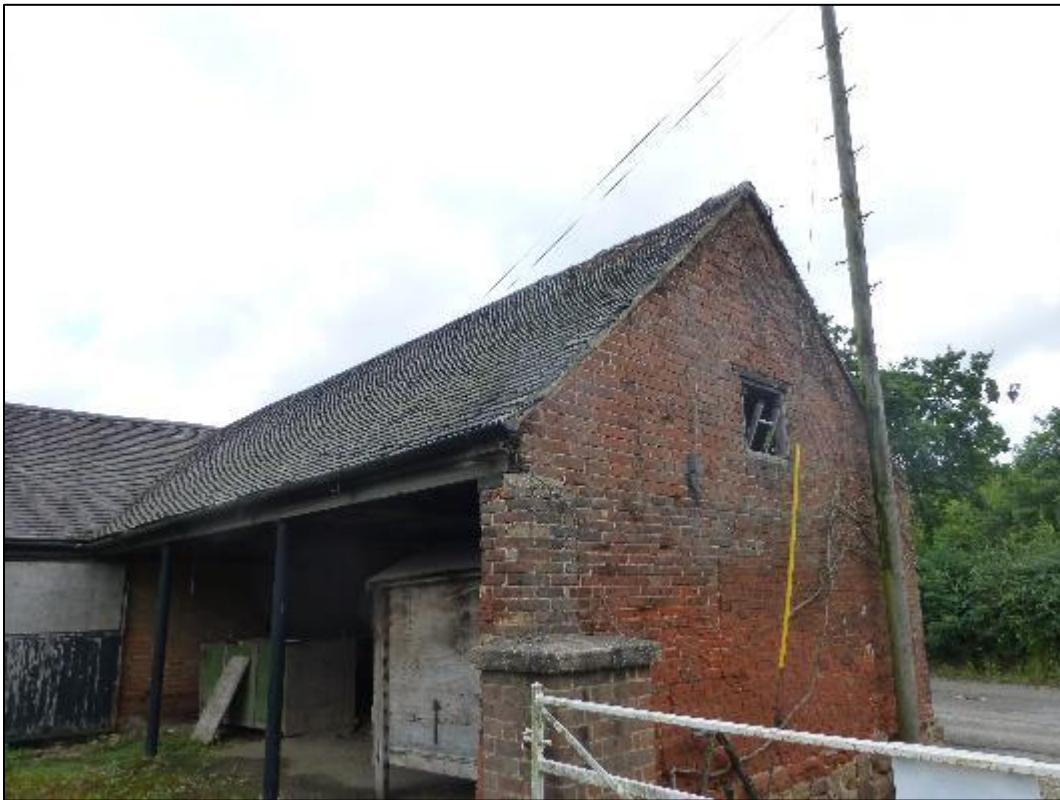
**Photo 6. B2**

| Ref no. | Building Description | Bat Roost Potential |
|---|---|---|
| <b>B2</b> | <p>B2 is a single storey, double skinned, redbrick outbuilding with a ceramic tiled pitched roof. The building is open fronted to the north, with a missing window on the west. The building immediately adjoins B3 on the east.</p> <p>Internally, the building is lined with sarking boarding.</p> <p>A single dropping indicative of pipistrelle species was located in a gap above the sarking on the west of the building with 5x droppings below. Due to the location of the droppings, the building is considered to be a confirmed bat.</p> <p>In addition to the above, approx. 10 droppings indicative of pipistrelle species and 3 droppings indicative of brown long-eared bat, were scattered in the building i.e. not confirming a roost. The floor is full of detritus, limiting the view of other potential droppings.</p> <p>In addition to the confirmed bat roost (based on dropping location), other potential bat roost features include:</p> <ul style="list-style-type: none"> <li>• Gaps below tiles, verge tiles and ridge tiles;</li> <li>• The window lintel;</li> <li>• Crevices in the brickwork;</li> <li>• Crevice between sarking and tiles.</li> </ul> | <b>Confirmed roost</b> |

B2 and B4 are considered to be confirmed bat roost due to the number and location of droppings observed; B4 is considered to be of high bat roost potential (although roost likely due to number of droppings observed); B1, B3 and B9 are considered to be of moderate bat roost potential; B8 and B10 are considered to be of low bat roost potential; and B6, B7, B11 to B16 are considered to be of negligible bat roost potential.

A European Protected Species Mitigation (EPSM) Licence would be required where any of the buildings be found to support a bat roost. As a minimum, Buildings 2 and 4 are confirmed bat roost and will require a EPSM licence.

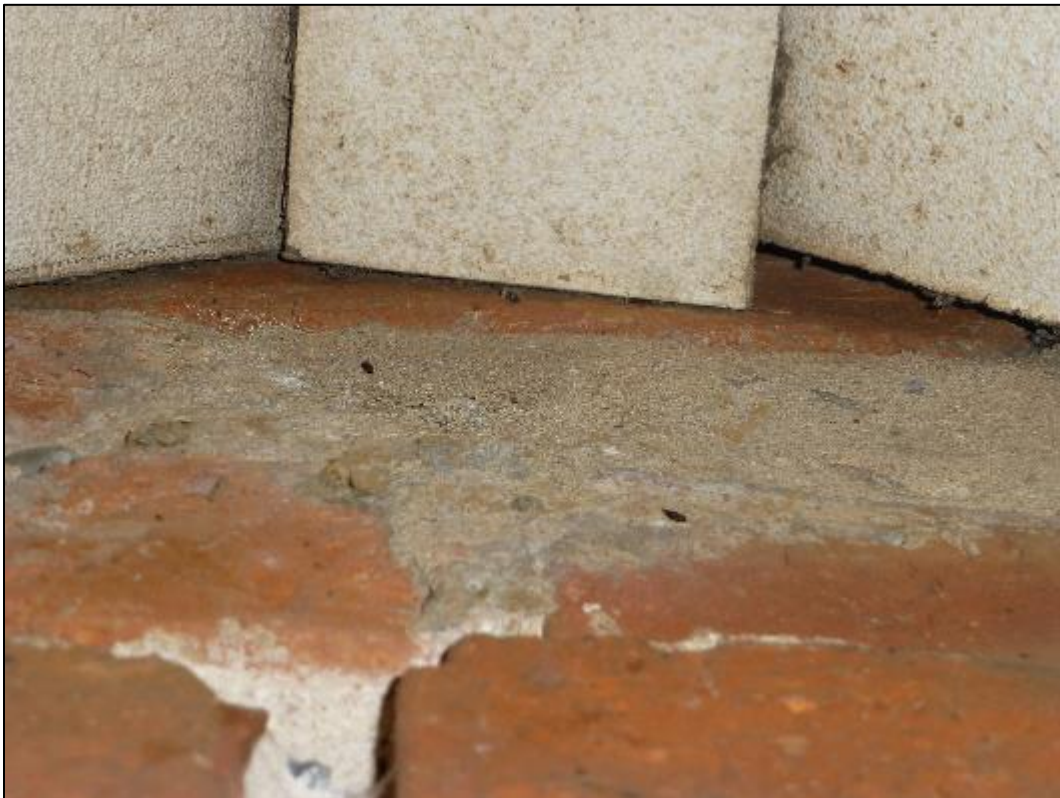
**Photo 8. B2 – example bat droppings, indicative of pipistrelle species, below sarking**

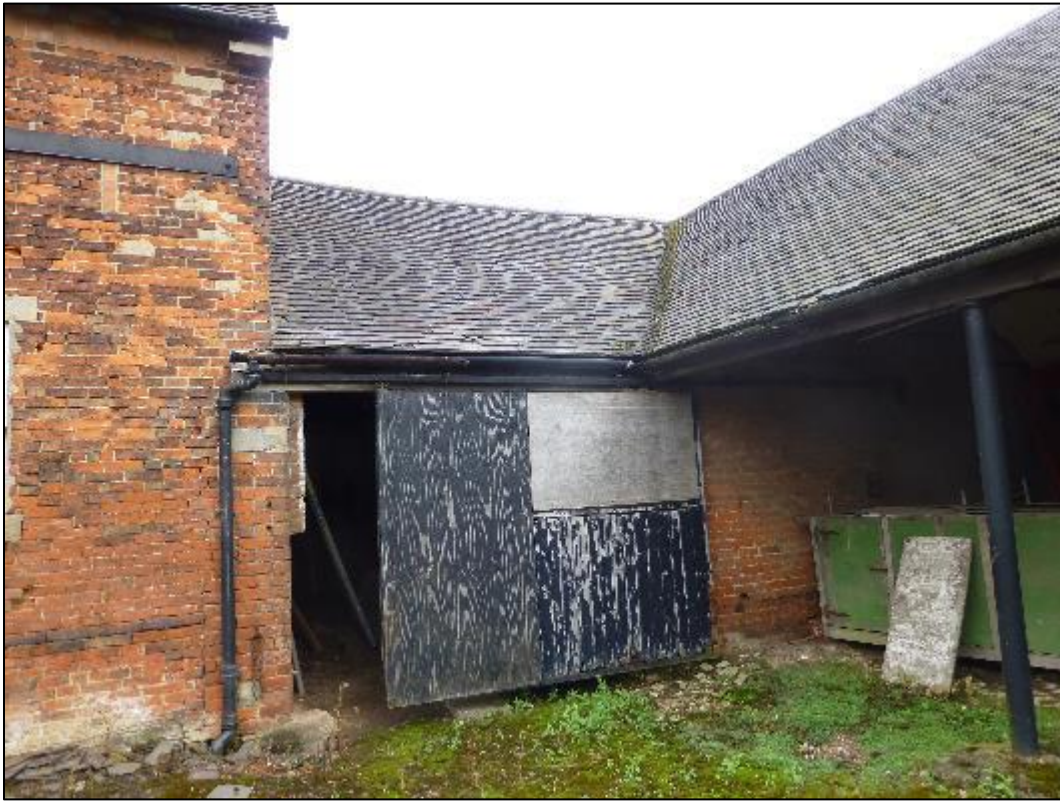
**Photo 11. B4**

| | <p>Approximately 20 droppings indicative of brown long-eared bat were observed within the building, with no feeding remains observed. As there is crawl access into the building only i.e. no flight access, the building is considered to be a confirmed roost.</p> <p>Bat roost features were limited to:</p> <ul style="list-style-type: none"> <li>Internally within the void itself;</li> <li>Raised tiles;</li> <li>Gaps between sarking and tiles.</li> </ul> | |

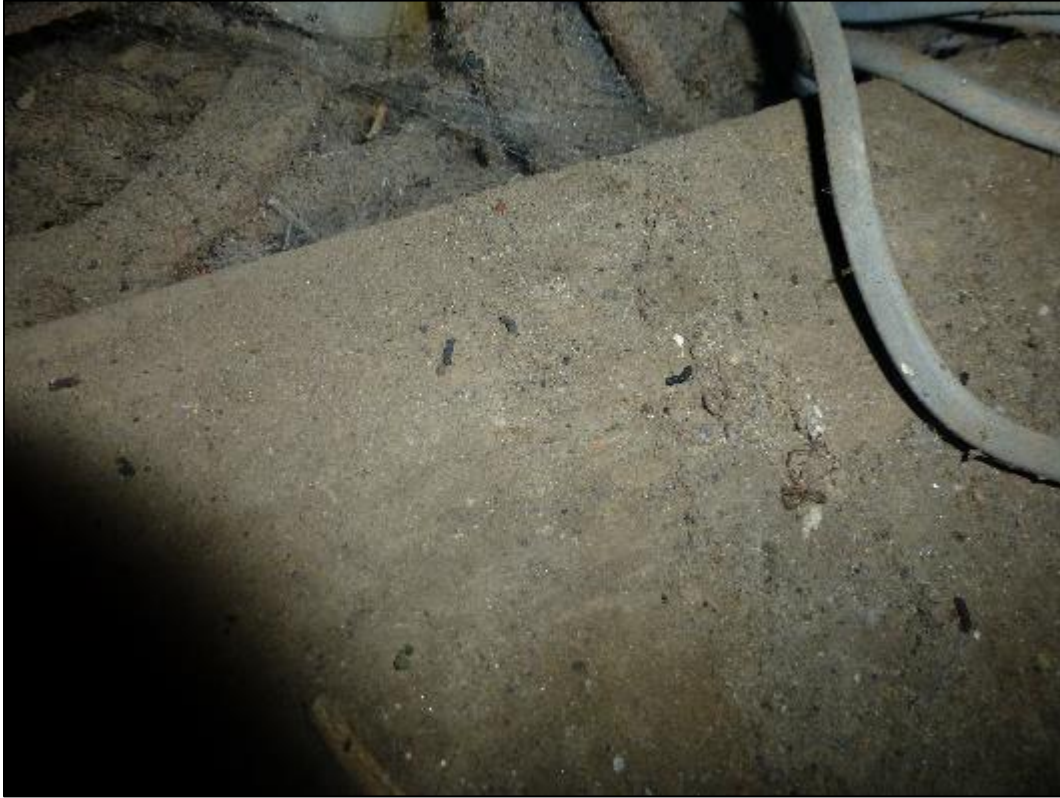
**Photo 13. B4 – droppings indicative of brown long-eared bat**

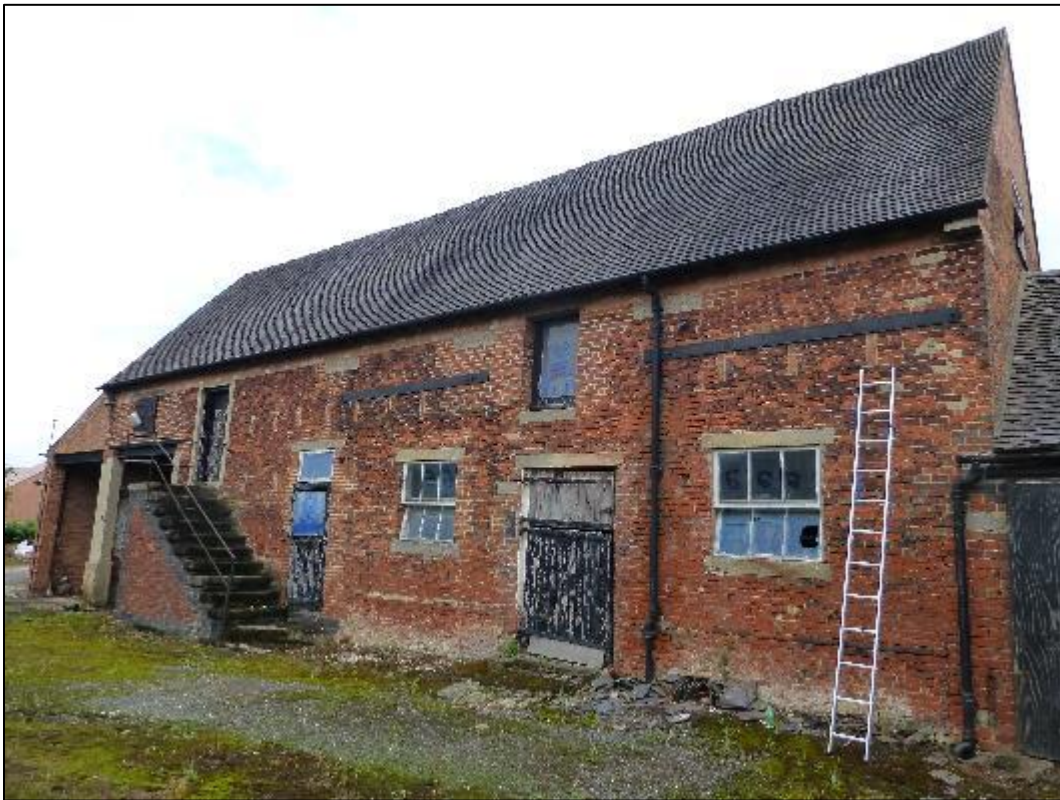
**Photo 14. B5**

| <b>B5</b> | <p>The building is a large 'L' shaped, double storey, redbrick farm building with a pitched ceramic tiled roof.</p> <p>Externally, the building is in a good state of repair and well pointed with no gaps in the brickwork or tiles observed.</p> <p>There is direct flight access via a missing window on the second floor at the south of the building.</p> <p>The ground floor rooms were previously used as a stable and for storage, with a wood boarded ceiling. There are gaps between the wood trusses and walls on this floor which present some potential for roosting bats.</p> <p>The second floor is open vaulted and lined throughout with Bitumen felt, with both wooden and metal support beams. The second floor is approximately 4.5m high from floor to apex. There are windows throughout the building i.e. light, aside from a small protruding annex on the north which is pitched and approx. 1m in height.</p> <p>Approximately 80 droppings, indicative of brown long-eared bat were scattered throughout the building. No pile of droppings or feeding pile was observed. Due to the number of scattered droppings observed, the building is highly likely to be used by roosting bats.</p> <p>Potential bat roost features include:</p> <ul style="list-style-type: none"> <li>Gaps between the support beams and wall;</li> <li>Isolated gaps within the lining;</li> <li>Gaps between the segregating walls and roof;</li> <li>A hanging hessian bag;</li> <li>Window lintels;</li> <li>The void itself.</li> </ul> <p>There are two adjoining areas at the north of the building that are open fronted to the west, with corrugated cement roofs and metal support beams.</p> | <b>Likely roost / High potential</b> |

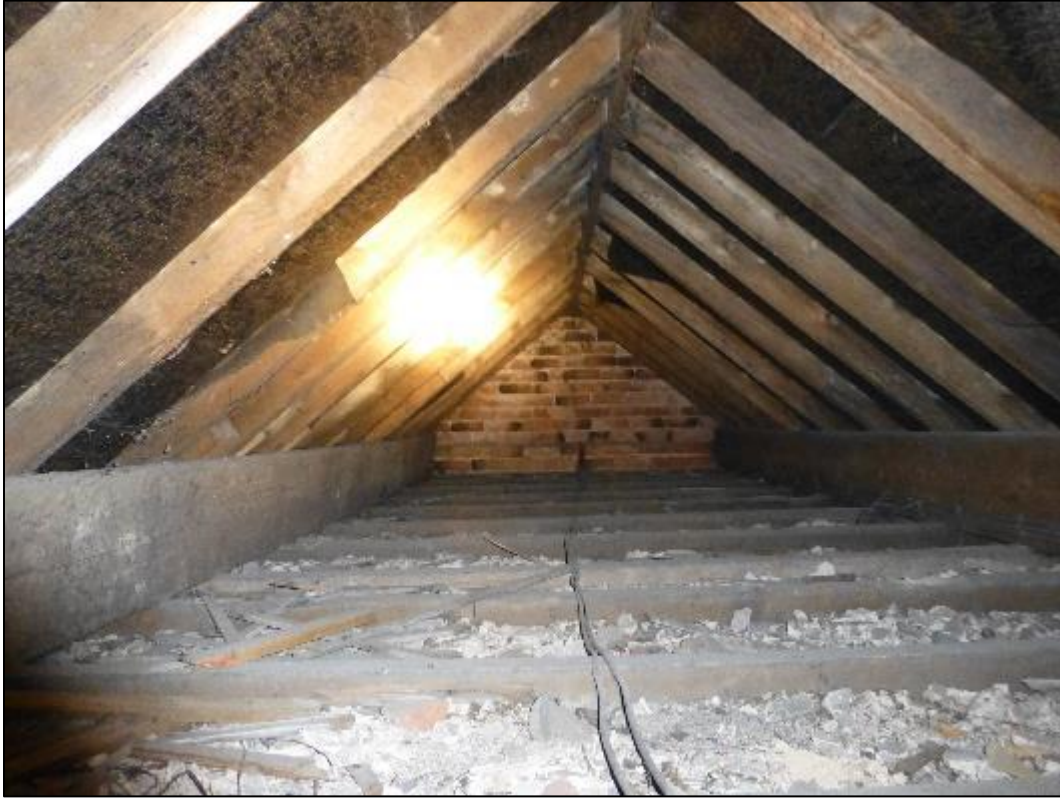
**Photo 17. B5 – annex small void at north**

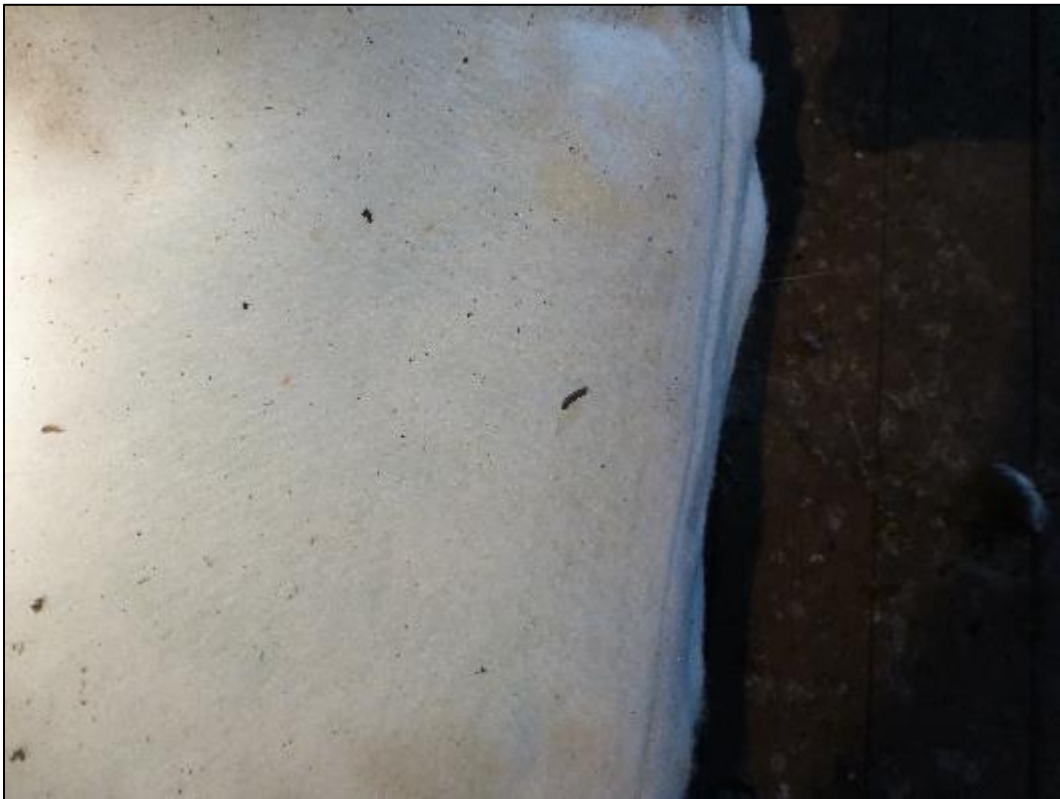
**Photo 18. B5 – example scattered bat dropping**

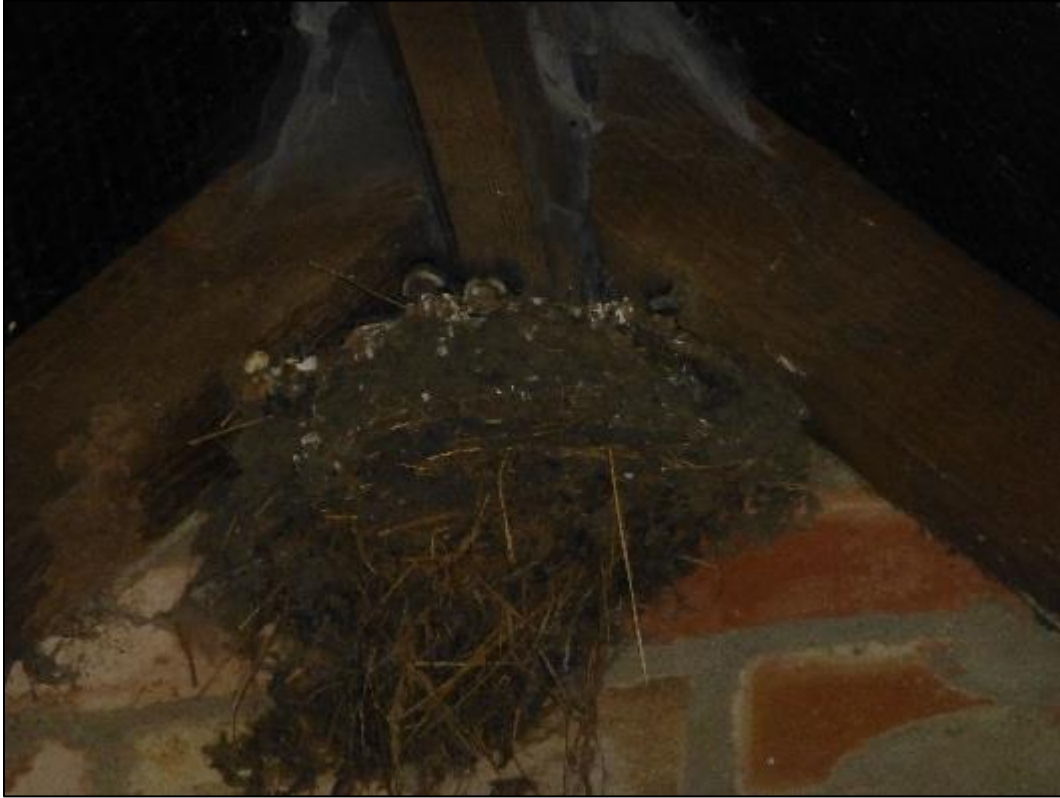
A total of 5x active barn swallow nests were recorded within B2 and B5, as well as old nests within B3, B4 and B13 (although it is noted that there is no longer flight access into B3 and B4). Pigeon nests were also recorded in B5 and B13.

**Photo 19. B5 – example active barn swallow nest**

To compensate for the loss of barn swallow nesting locations, it is recommended that 7x barn swallow nest cups are installed in suitable locations within the site. The nest cups must be installed within an outbuilding such as a shed, stable or barn where there is constant access for birds through a door, window or open sides. Swallows are sociable birds, but the nest cups must not be placed too close together. A minimum distance of 1 m between nest cups is recommended with at least 6 cm free space above the nest cup.

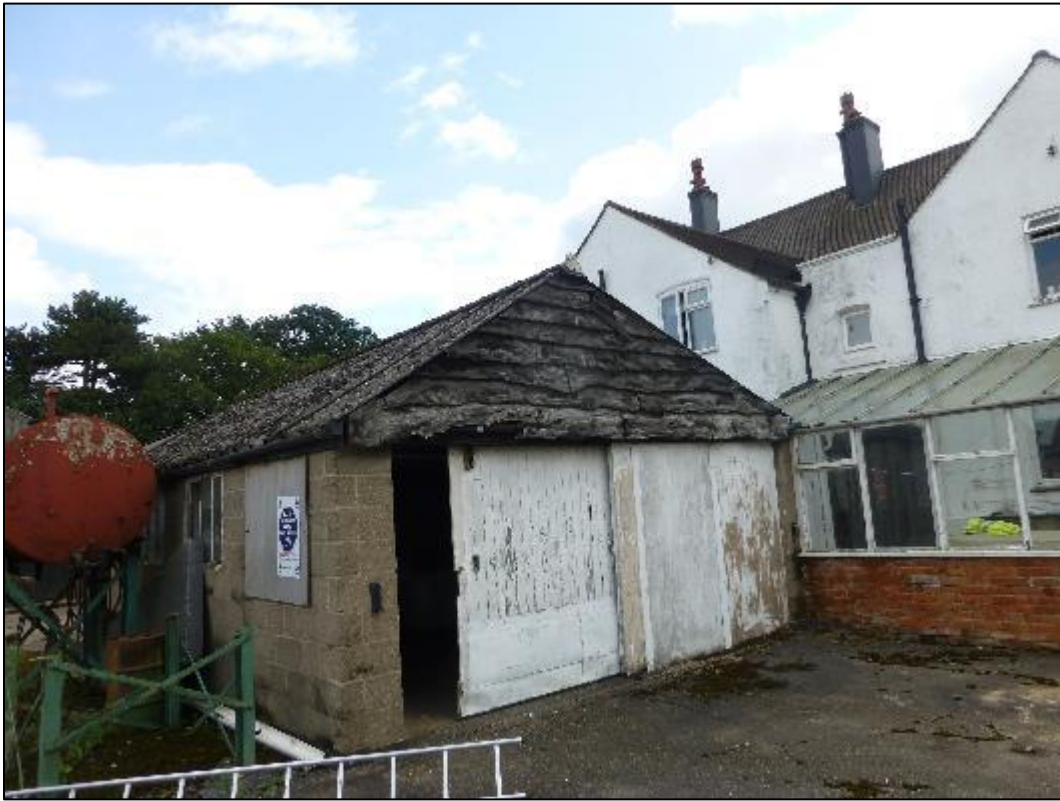
**Photo 21. B6**

| <b>B6</b> | <p>B6 is a detached breeze block workshop and kennels with a corrugated cement roof. There is wooden wavy boarding on both gable ends, but these go straight through with no feature behind to provide a suitable crevice.</p> <p>No suitable crevices were observed within the building.</p> | <b>Negligible</b> |

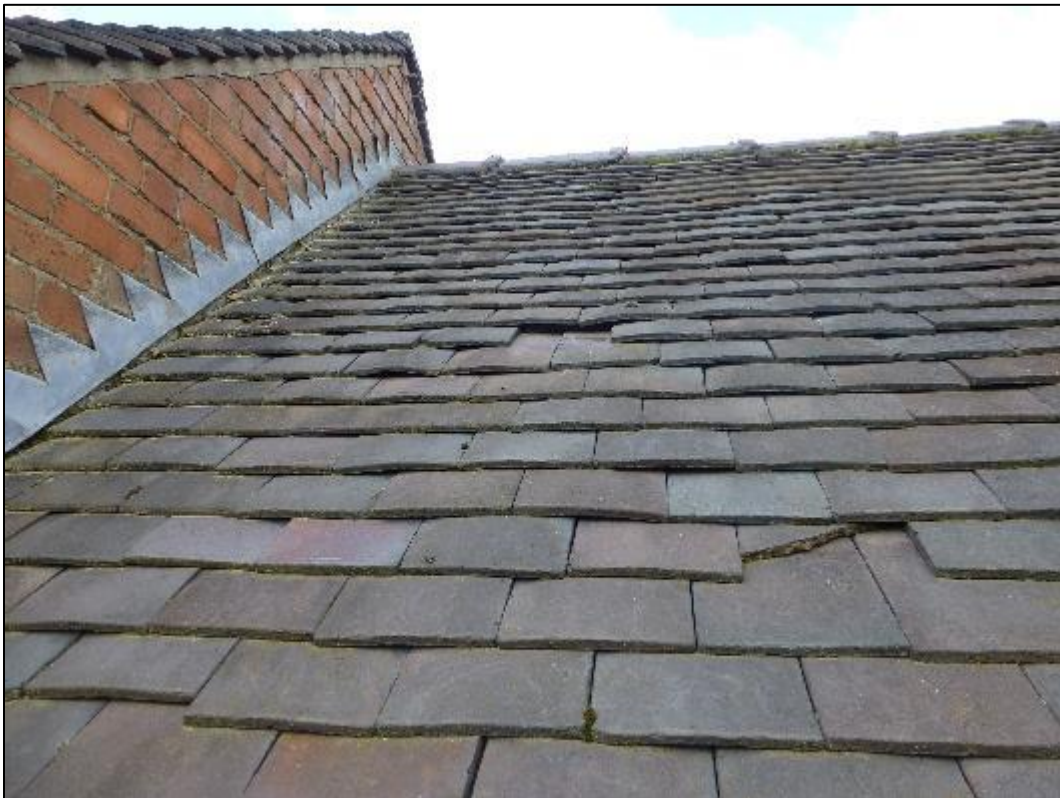
**Photo 24. B7 – gaps below tiles**

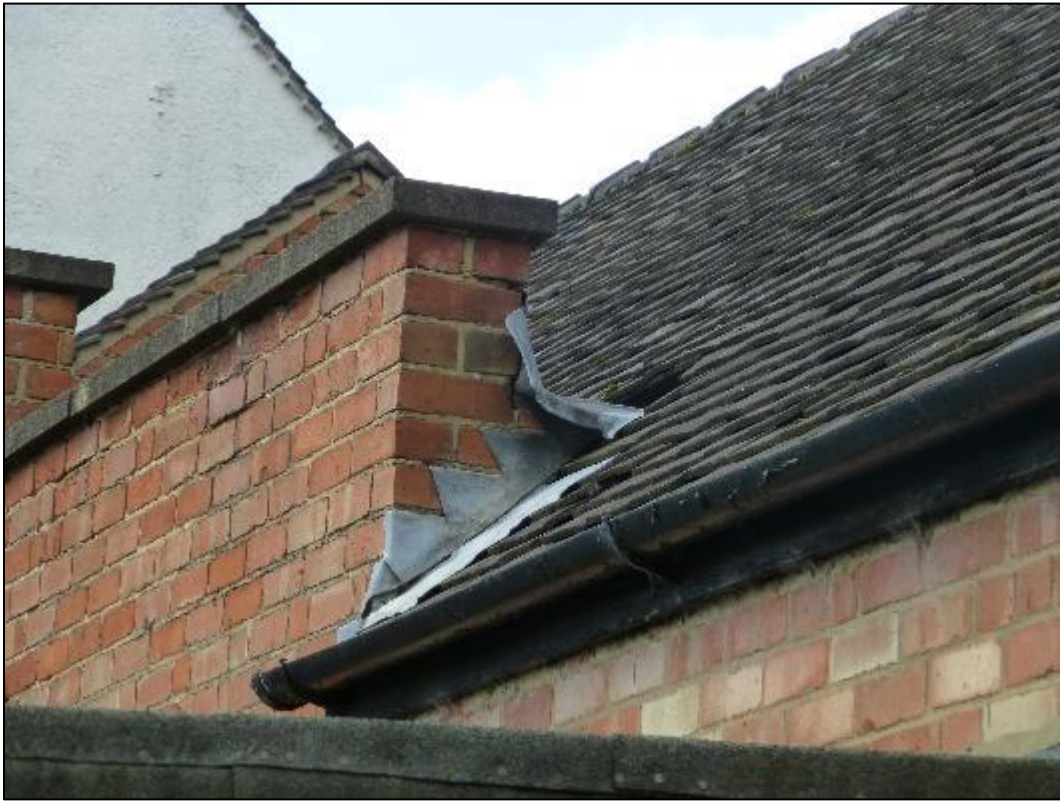
**Photo 29. B9 – gaps below tiles / led flashing**

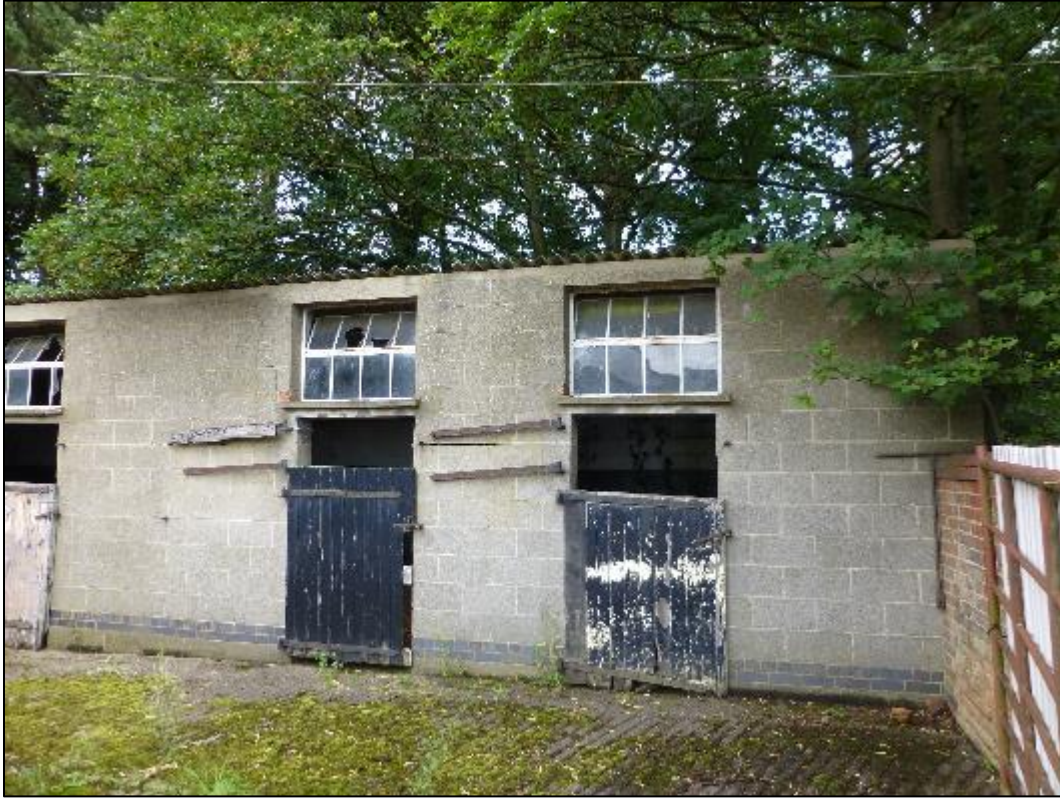
**Photo 33. B11**

| <b>B11</b> | <p>B11 is a detached single storey, breeze block structure with a corrugated cement roof.</p> <p>No gaps or crevices suitable for roosting bats were observed within the building.</p> | <b>Negligible</b> |

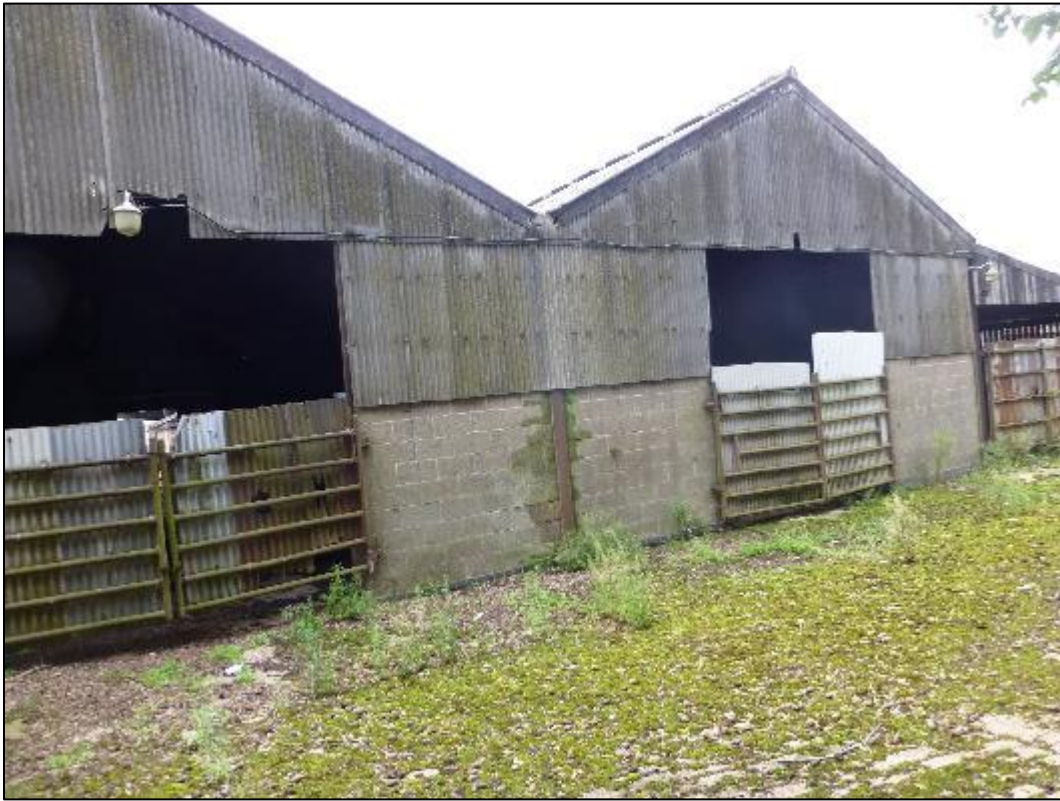
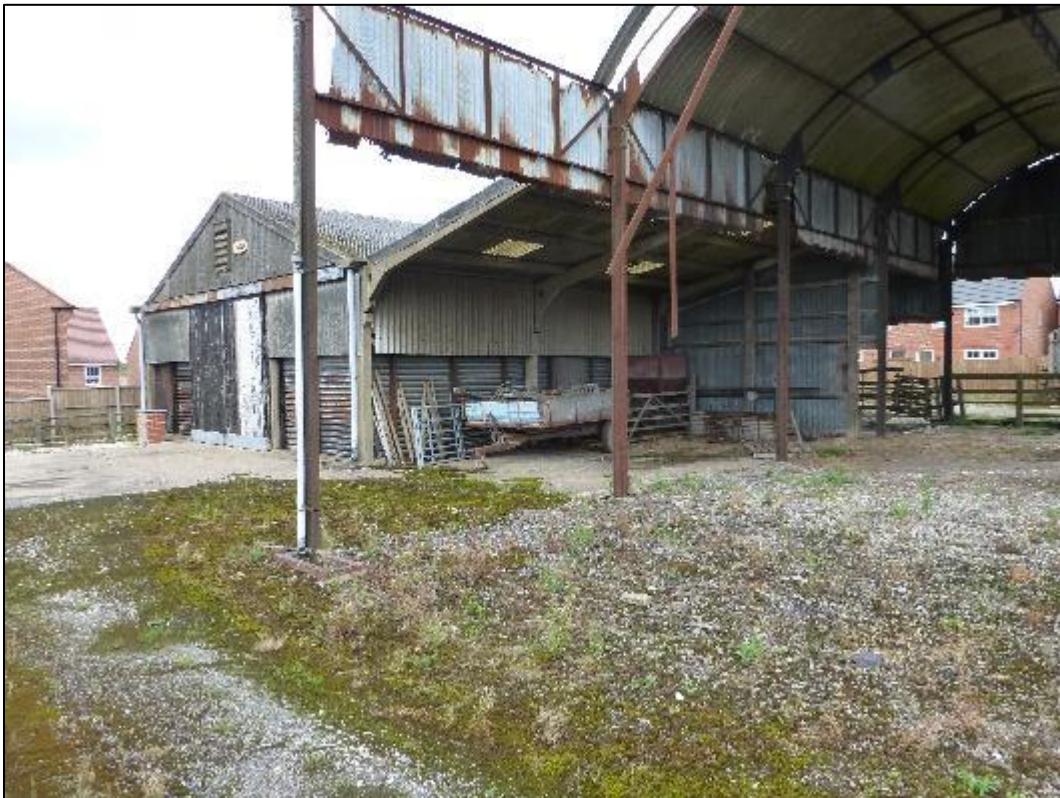
**Photo 35. B12**

| <b>B12</b> | <p>B12 is a large agricultural unit constructed from breeze block with metal support beams and a corrugated cement roof and gable end. The building adjoins B7 and B9.</p> <p>No suitable bat roost features were observed within the building.</p> | <b>Negligible</b> |

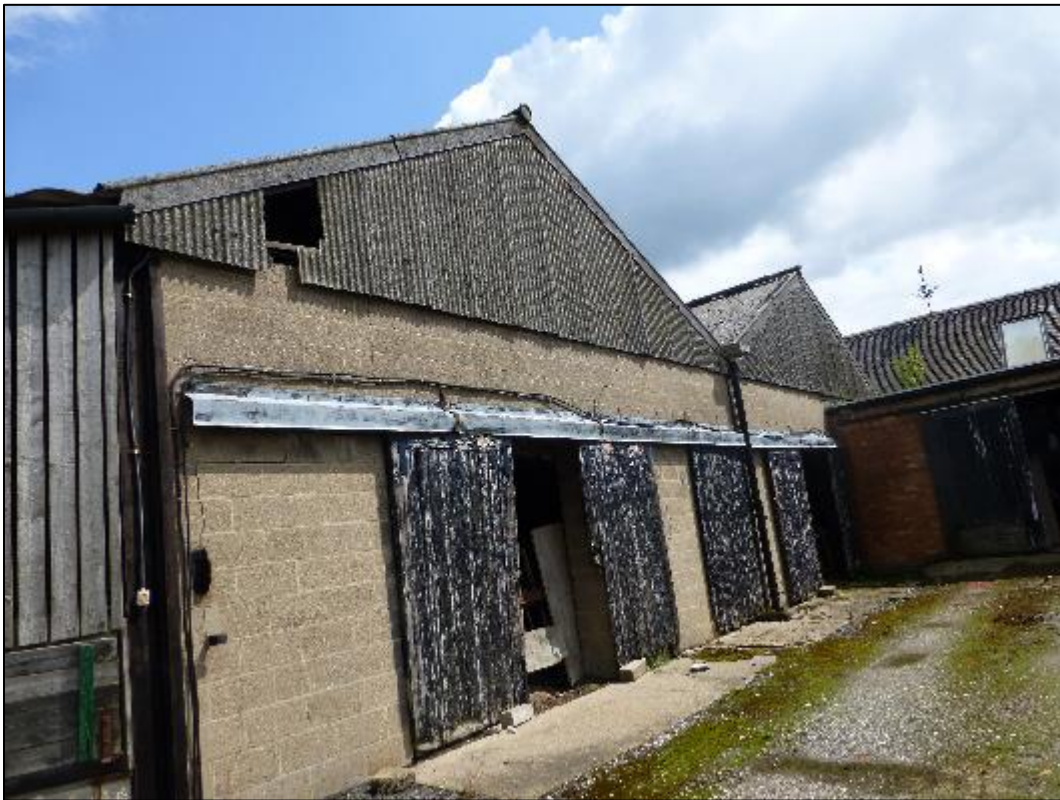
**Photo 38. B13**

| <b>B13</b> | <p>B13 consists of a large agricultural unit and attached open unit. The structures are presumably used for grain storage, although largely empty at the time of survey, as well as to house tractors. The structures are constructed of corrugated metal and cement with cement and metal support beams.</p> <p>Rat droppings were observed within the building.</p> <p>No suitable bat roost features were observed within the building.</p> | <b>Negligible</b> |

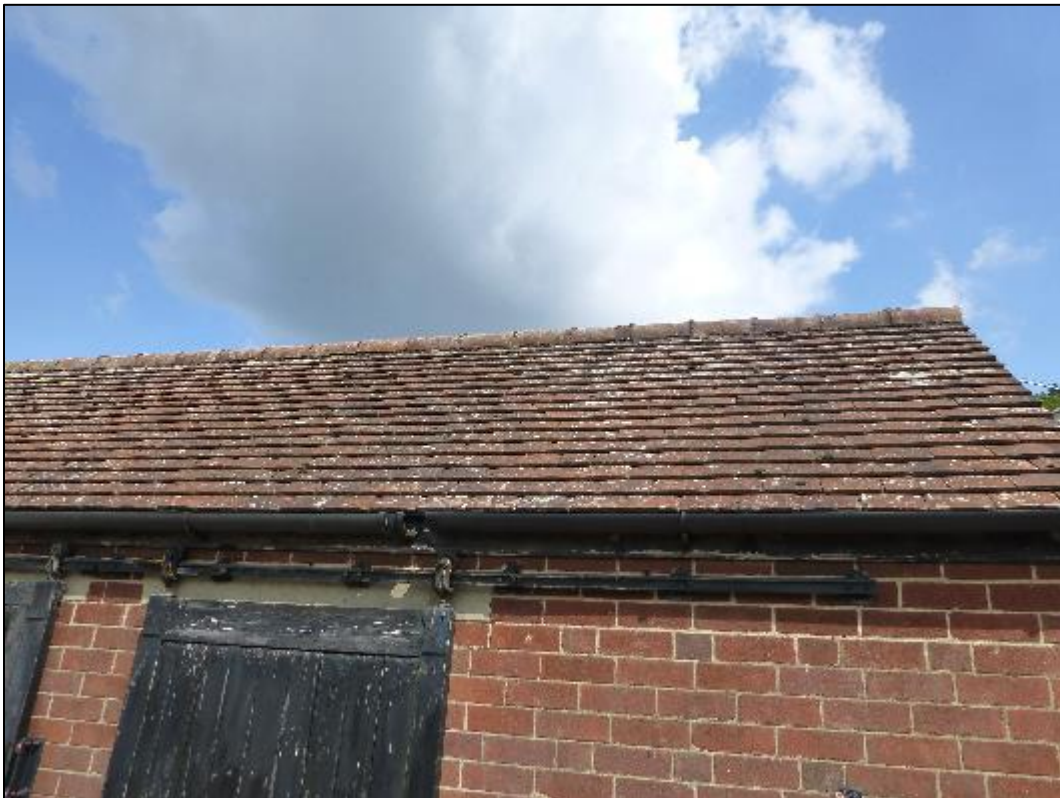
**Photo 40. B14 – well sealed**

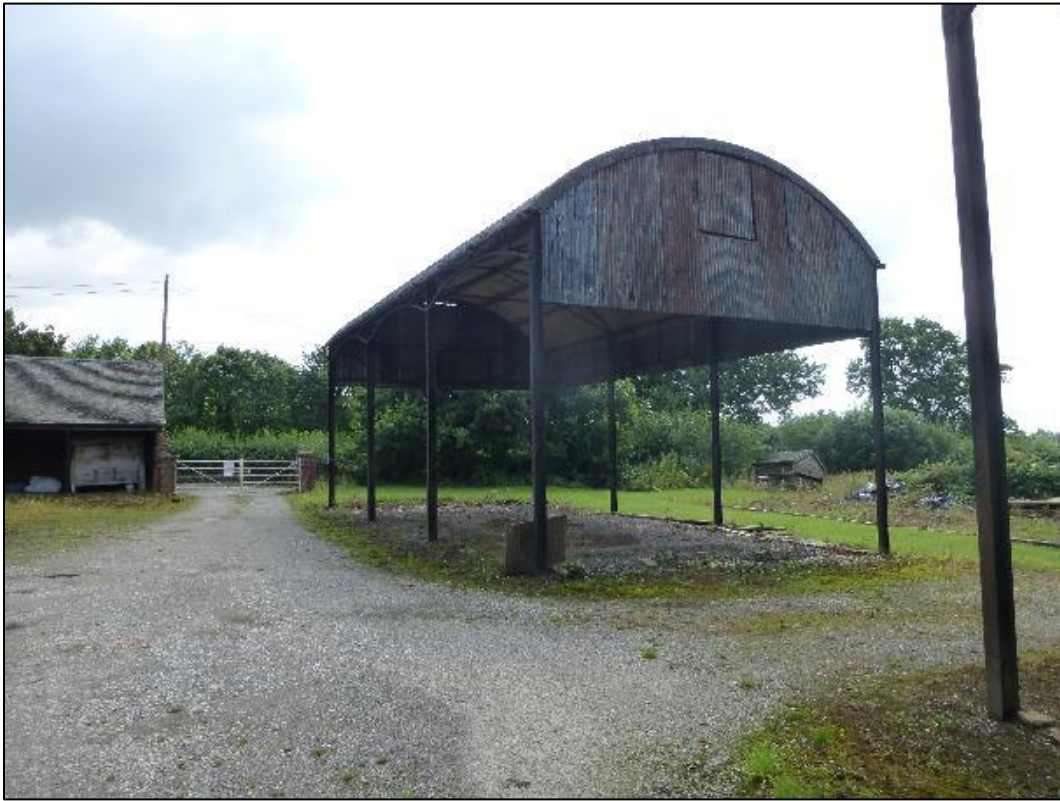
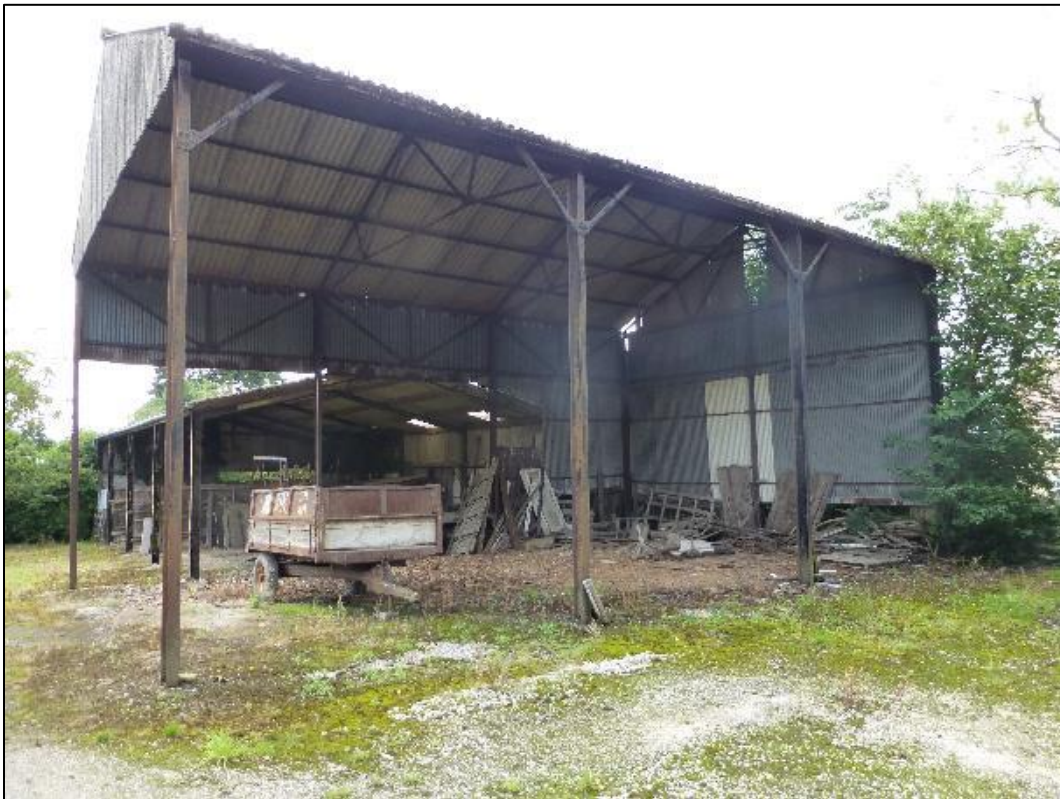
**Photo 41. B15**

| <b>B15<br/>B16</b> | <p>B15 and B16 are large agricultural units towards the west of the site. Both units are open sided and constructed from corrugated metal and corrugated cement with metal support beams.</p> <p>No suitable bat roost features were observed within the buildings.</p> | <b>Negligible</b> |
