# New House Farm, Etwall Road, Mickleover.

## Preliminary Ecological Appraisal & Daytime Bat Inspection Survey

October 2019

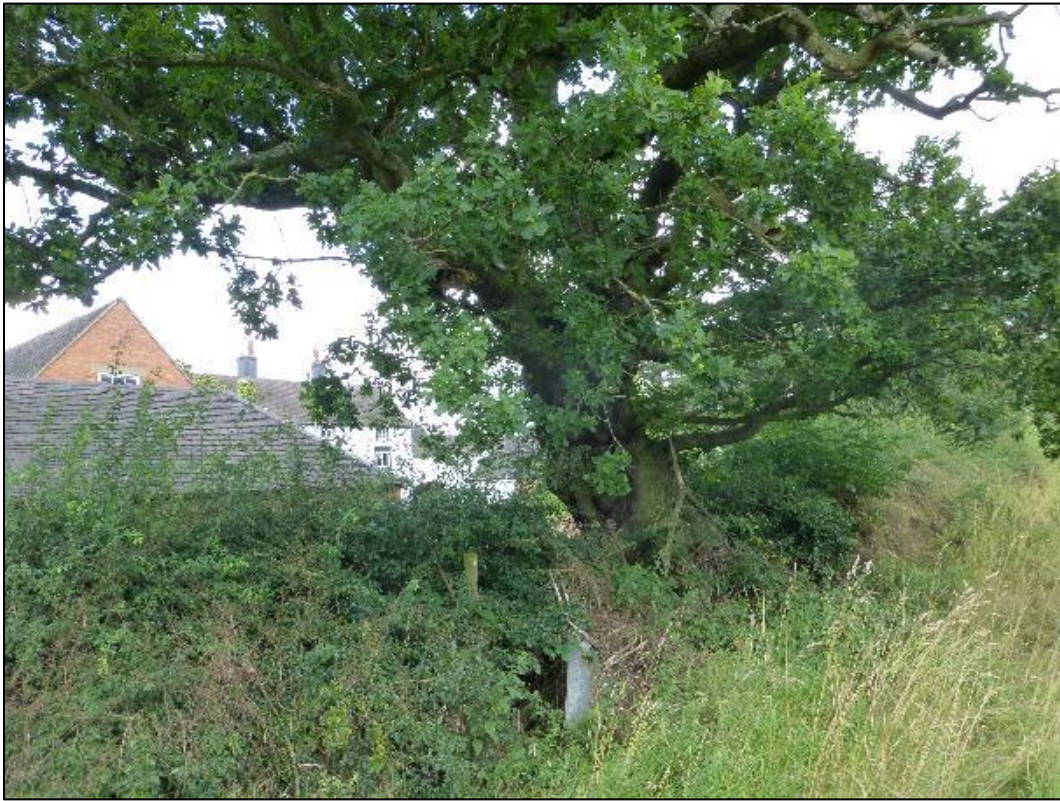
A single oak on the northern boundary of Area 2 was found to have features of moderate bat roost potential, these being shearing splits, knot holes and lifted bark. Other trees along the south of Area 2 may also contain bat roost features, however, it was not possible to fully inspect the trees from ground level due to the density of the canopy.

**Photo 45. Oak containig moderate bat roost potential on north of Area 2**

It is recommended that hedgerows and treelines are retained with appropriate buffer zones as part of any development scheme i.e. in line with roost protection zones.
