# The Nook Bat Survey Report

**Prepared for Planning Design**

**August 2021**

Document Number                  R01-Bat Survey Report-Rev00

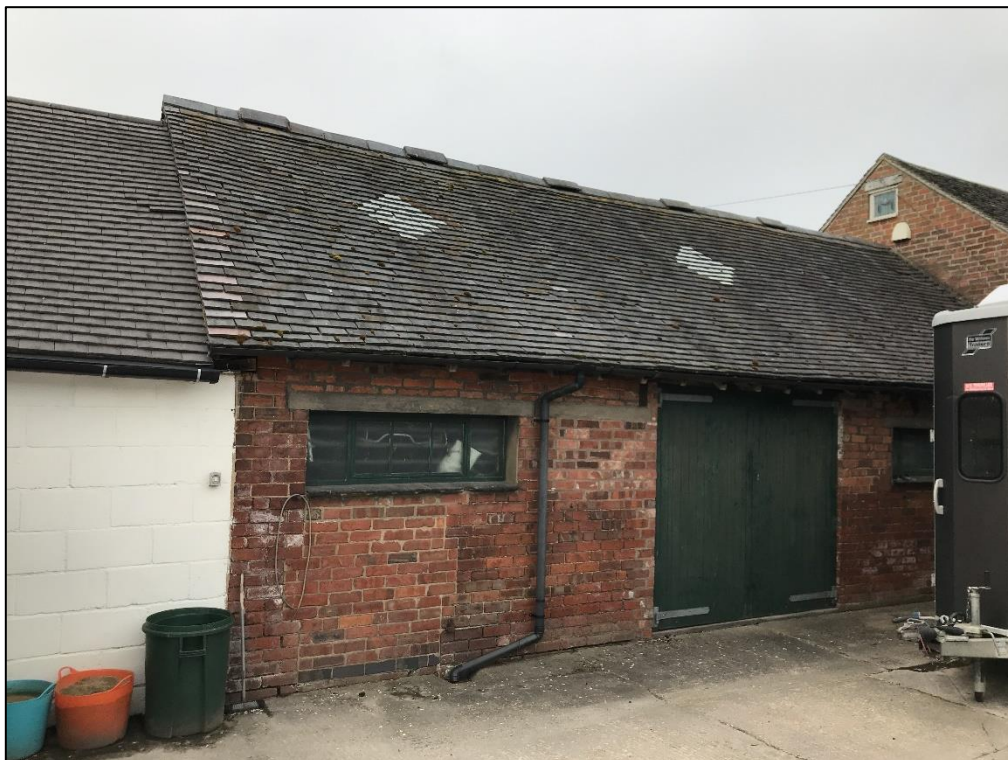
Barn one is a of red brick construction with an unlined tile pitched roof with breathing ridge tiles and glass tile roof lights. It has well sealed windows and a double door on the northern aspect. Multiple lifted roof tiles are present on this roof. (*Plate 1*).

*Plate 1. Northern Aspect of the barn one*

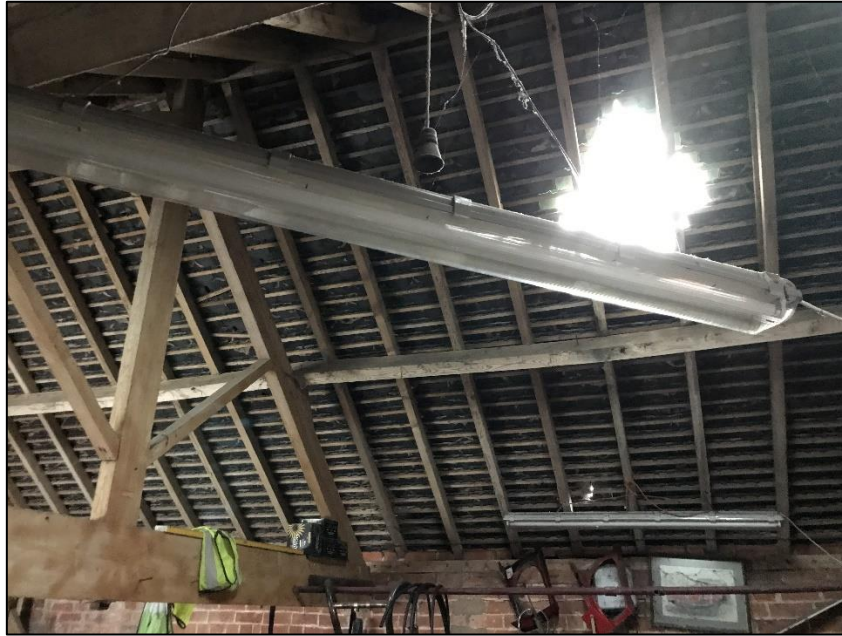
The roof structure for the barn one is supported by multiple wooden beams and purlins, no gaps were found around these structures (*Plate 2*).

*Plate 2. Roof structure and skylights located in barn one*

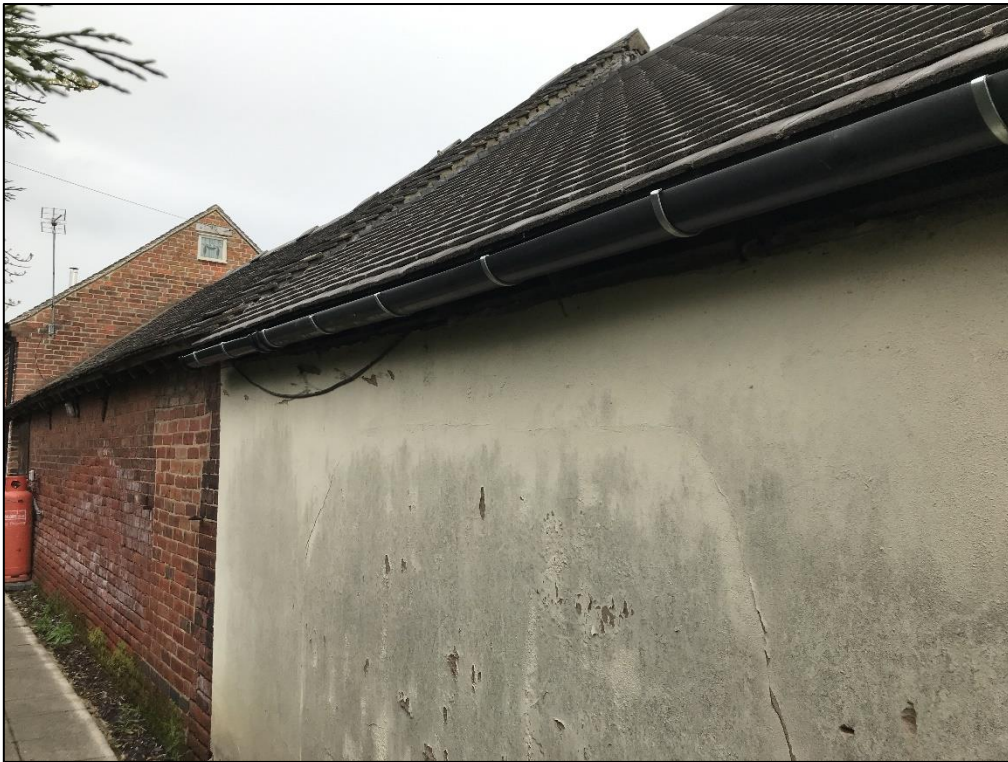
Barn two is an adjoining extension on the eastern aspect of barn one and has a similar roof structure but is lower creating a tiered pitched roof where some lifted tiles were observed (*Plate 3*). It is constructed of rendered blocks and has a wooden door to the northern aspect.

*Plate 3. Southern Aspect of the buildings*

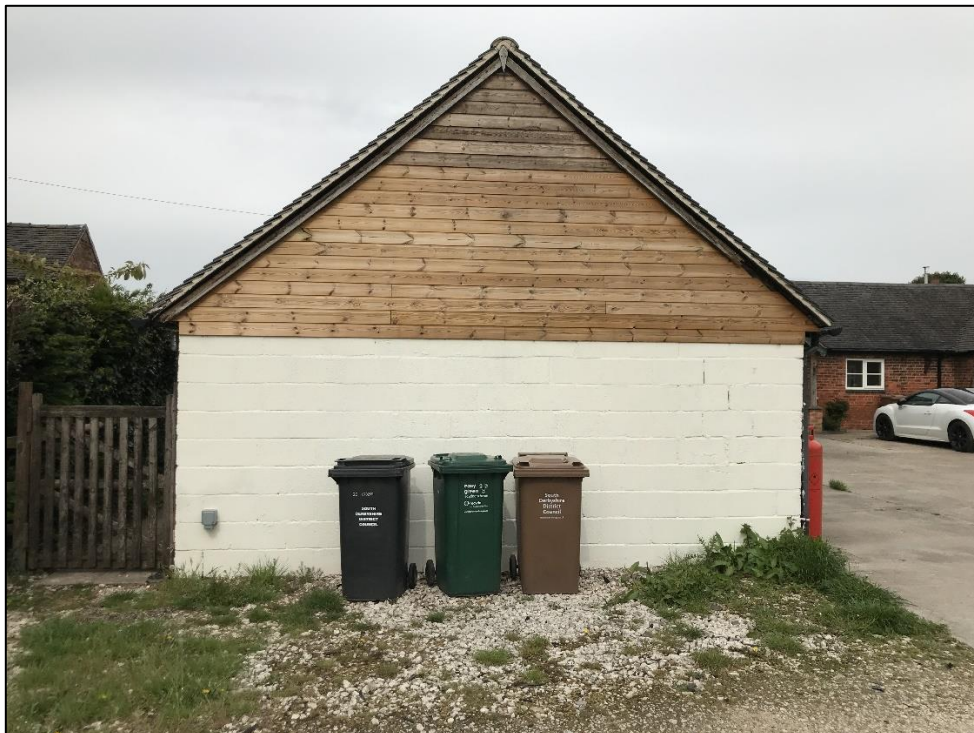
The eastern gable end of barn two is has wood cladding from halfway up, there is also a wooden barge board. There were also gaps found in between tiles on the verge (*Plate 4*).

*Plate 4. Eastern gable end of barn two*

One bat was recorded entering the between tiles on the eastern verge of the barn two on the dawn survey at 04:11, this bat was silent and not identified to the species level, however given the time of entry and lack of echolocation it is thought to have been a Brown Long-eared bat. Bat activity around the site was limited to very occasional passes of up to two Common Pipistrelle bats, a Soprano bat and a Brown Long-eared bat which were seen and heard around the site commuting and foraging.

It is recommended that two bat access tubes be included in the proposed designs to enhance the proposed development for bat species that were recorded during activity surveys (*figure 6*). Works must not obstruct the eastern gable end of barn two where a bat was found to be roosting as indicated on *Figure 5*. In the unlikely event that at any stage of the unsupervised works a bat is found, all works must stop, and a suitably qualified ecologist called to site.

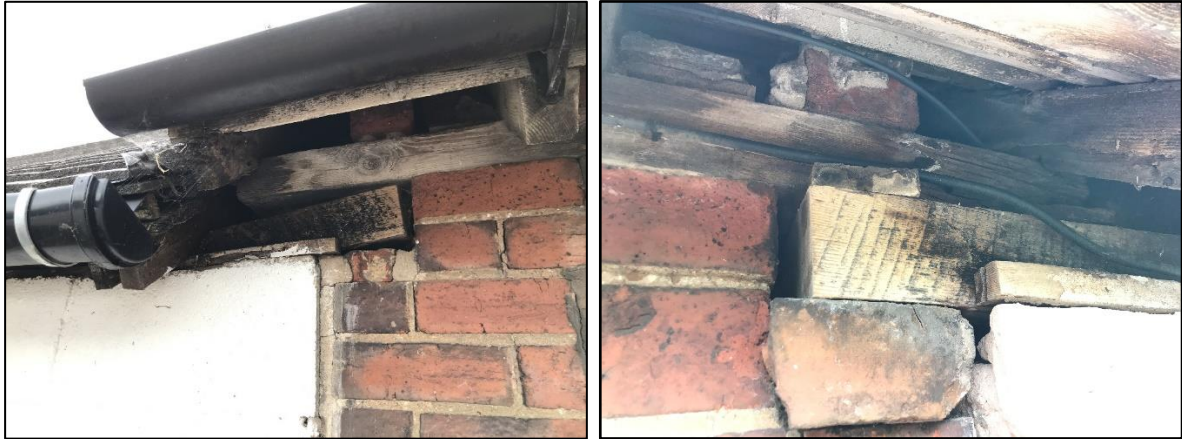
Between the two structures, where the roofs meet gaps are present at the wall tops between the wall top and wooden frame (*Plate 5*).

*Plate 5. Suitable features located at the wall tops on the southern aspect of the building*

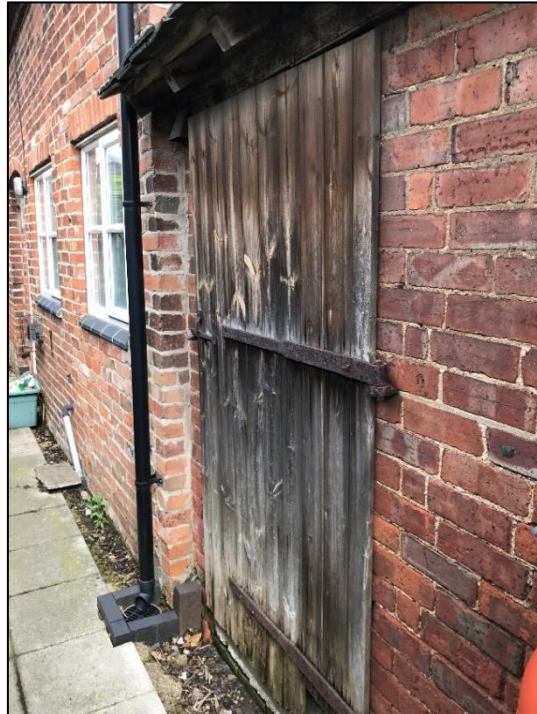
On the southern aspect of the building near where the barn one adjoins to the domestic property is a wooden door which leads to a doorway which has been sealed by bricks, behind the door is a large void which could be a potential roosting feature (*Plate 6*).

*Plate 6. Door forming a void against the redbrick wall*

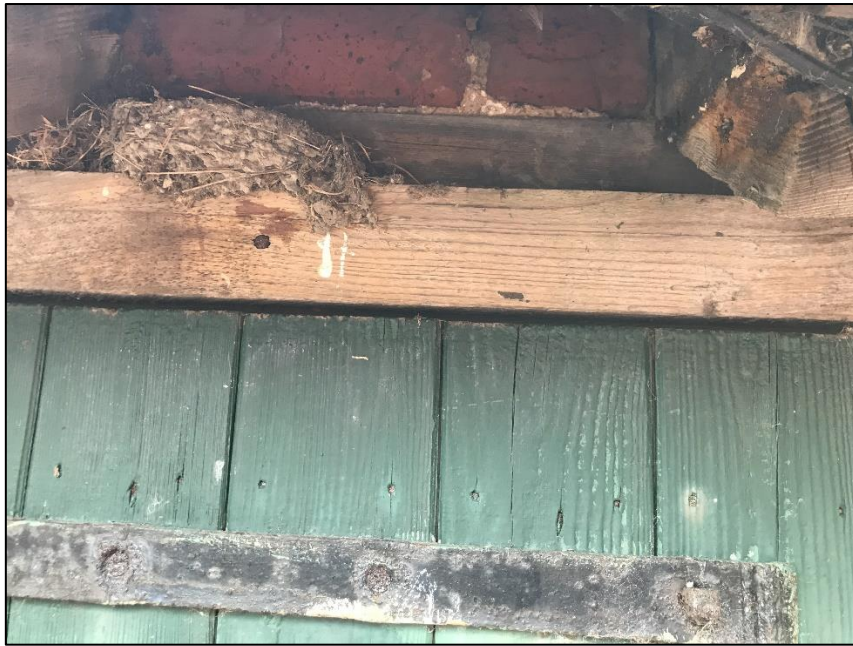
A Swallow's nest was observed above the double doors to the larger barn. House sparrows were also observed nesting in the ridge tiles of the barn one during the PRA (*Plates 7 & 8*).

*Plate 7. Swallow nest located above double barn door on the northern aspect*

As nesting House Sparrows were recorded onsite during the PRA works will need to be timed to avoid the breeding bird season, March to August or a suitably qualified ecologist can check whether there is nesting at the time of works. The vented ridge tiles where the House Sparrows were found to be nesting will also need to be reinstated. Along with this it is also appropriate that a three-hole sparrow box and two single hole sparrow boxes be included in the mitigation (*Figure 6*).

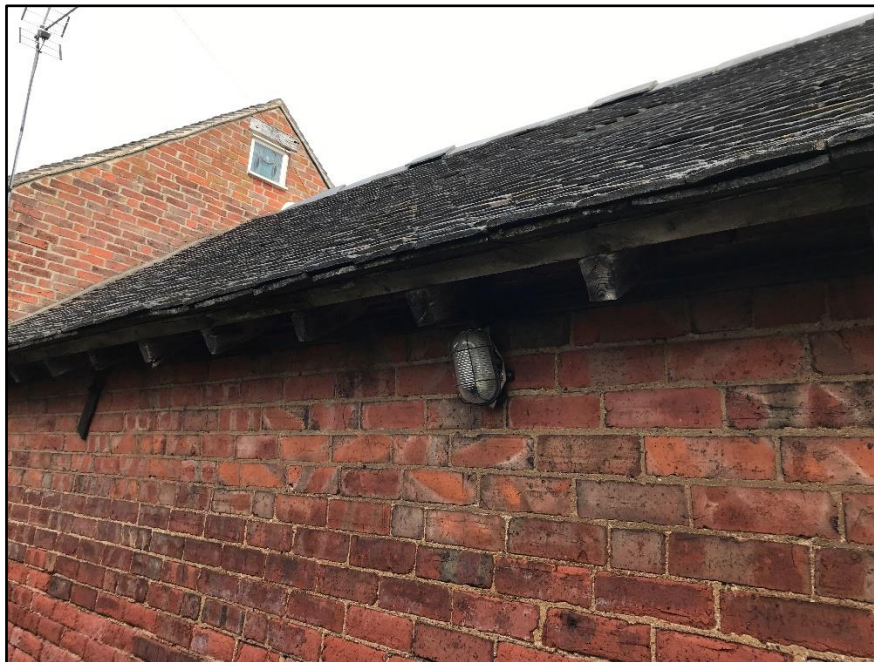
*Plate 8. Ridge tiles where nesting house sparrows were observed*

Evidence of breeding birds was recorded on and within the building. Sparrows were noted nesting in the vented ridge tiles and old Swallow nests were noted in the smaller barn.

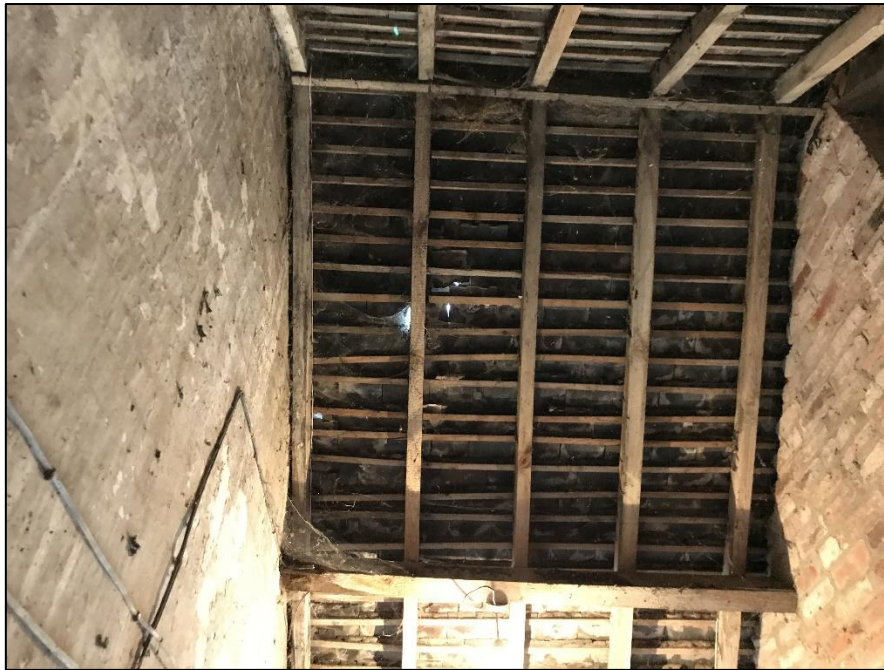
Between the domestic property and barn one was a small disused storage area. It is formed of red brick construction on either side and shares the same roofing structure as the larger barn (*Plate 9*).

*Plate 9. Roof structure and walls of the small storage space*

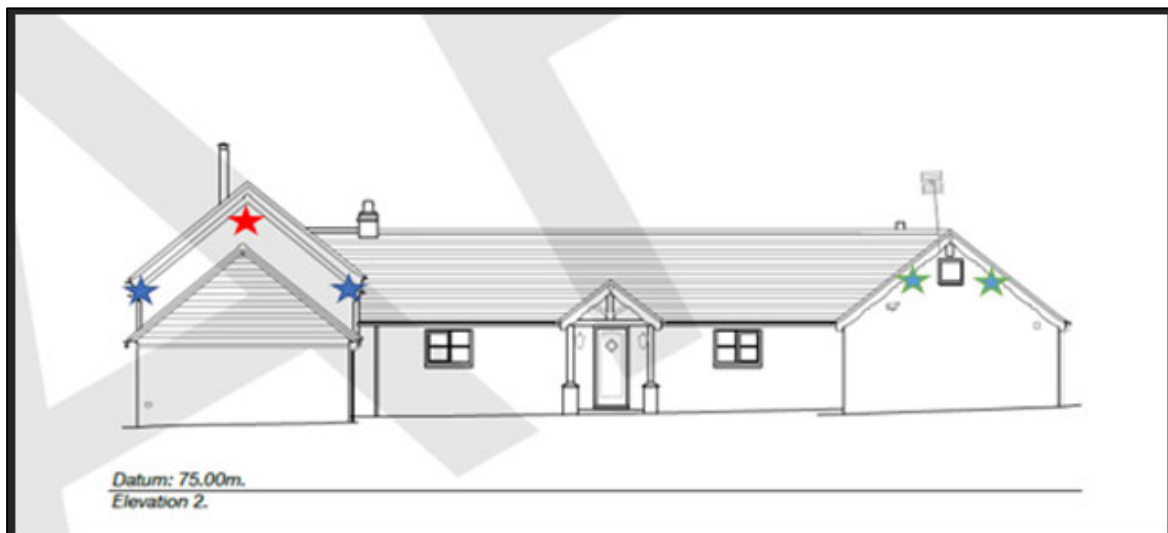
*Figure 6. Proposed mitigation at The Nook (Red star – three-hole sparrow box, Blue star – bat tubes, Green star – single hole sparrow boxes)*
