**Re: APPLICATION 9/2018/1127 - THE CHANGE OF USE OF AGRICULTURAL LAND AND DEMOLITION OF TWO OPEN SIDED EXISTING AGRICULTURAL BUILDINGS AND CONVERSION AND EXTENSION OF BARN TO FORM 6 DWELLINGS, ROOF EXTENSIONS TO THE EXISTING DWELLING AND ALTERATIONS TO ACCESS AT WOOD FARM MARJORY LANE HAREHILL ASHBOURNE**

I write to formally discharge Condition 12 of the above consent which reads as follows,

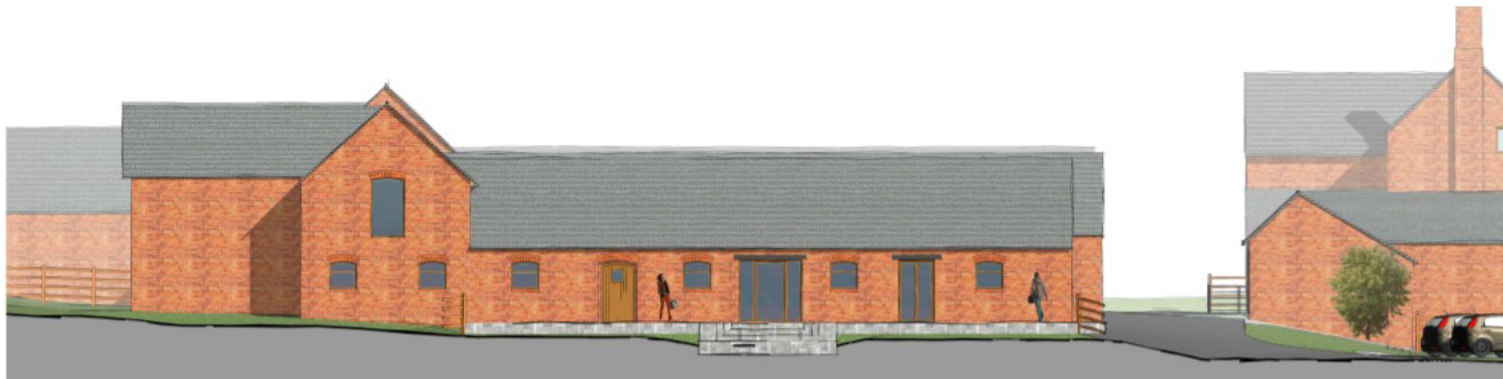
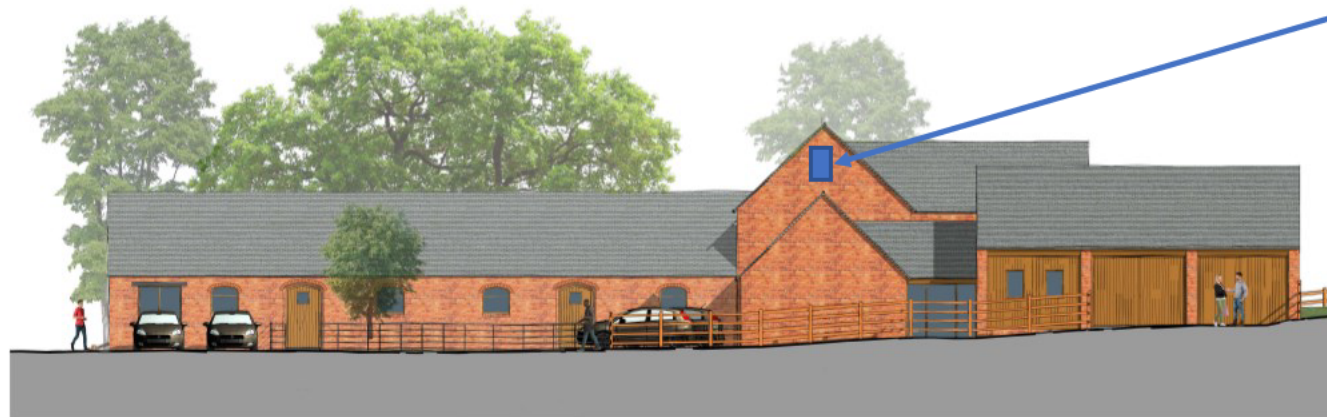
**Figure 2 – Proposed Permanent Roost/Nest Design**

**1 Unit 5 SW Elevation**  
1 : 100

Proposed Access  
Point into  
Nest/Roost Feature

A permanent roosting provision will be installed into the north facing gable end of Unit 5 during the redevelopment process (Figure 2). This will be achieved by creating a slot opening within the brickwork, which will be approximately 15cm by 30cm. This will lead into an enclosed internal area, approximately 1m by 1m, and with a depth of 1m (This area is enclosed so that barn owl cannot enter the full extent of the roof void, which has been designed to form compensation habitat for roosting bats). On the exterior wall, attached immediately below the slot, a platform with a grippable raised edge will be installed measuring 250mm x 500mm. An internal perch will be situated at the entrance slot.

An access hatch for maintenance will be situated on the southern aspect (into the internal roof void).

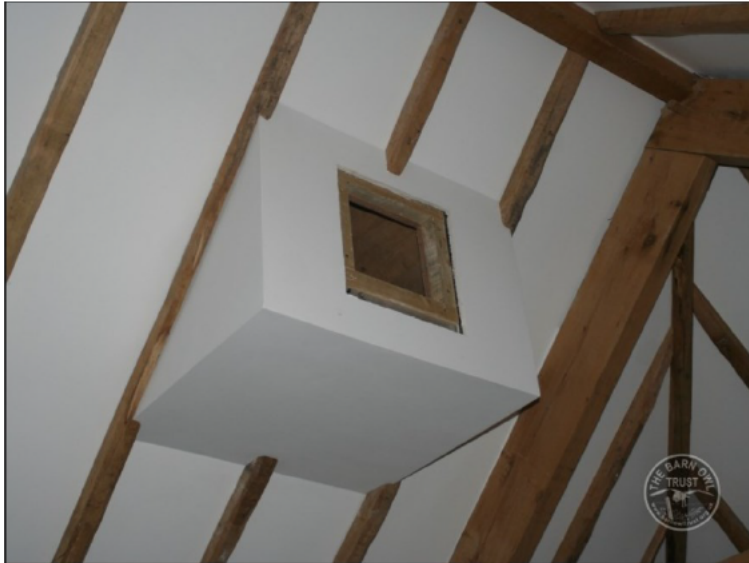
*Example of enclosed permanent nest/roost (from the interior) to be installed on north gable end of Unit 5. Also showing access hatch for maintenance provision.*

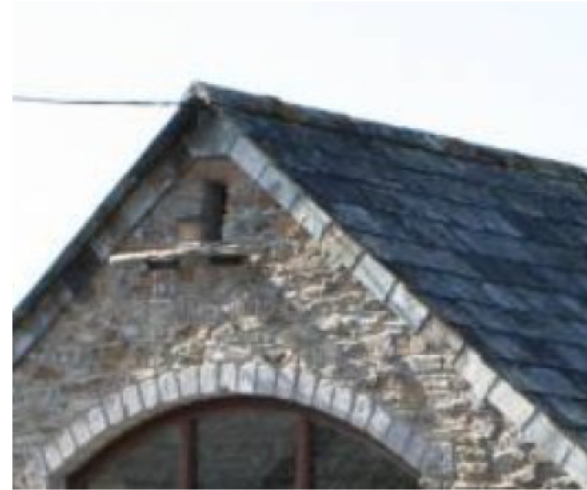
*Example of access slot and exterior platform, to be installed on northern gable end of Unit 5.*
