**PROTECTED SPECIES (BAT) SURVEY**

**THE WORKSHOP  
RIDING BANK  
COCKSHUT LANE  
MELBOURNE  
DERBYSHIRE  
DE73 8DG**

**August 2020**

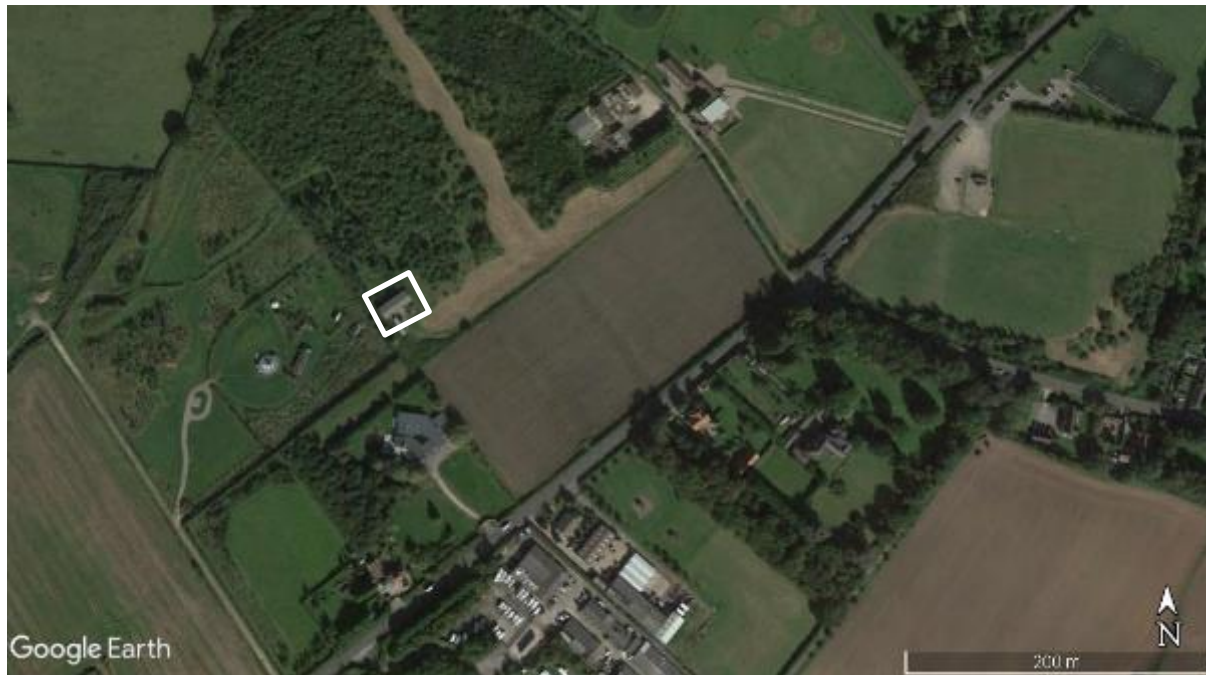
**Photograph 1: Situation of workshop, Riding Bank off Cockshut Lane, Melbourne**

The workshop is situated to the southwest of the town of Melbourne. The building is accessed from grass track leading from Riding Bank.

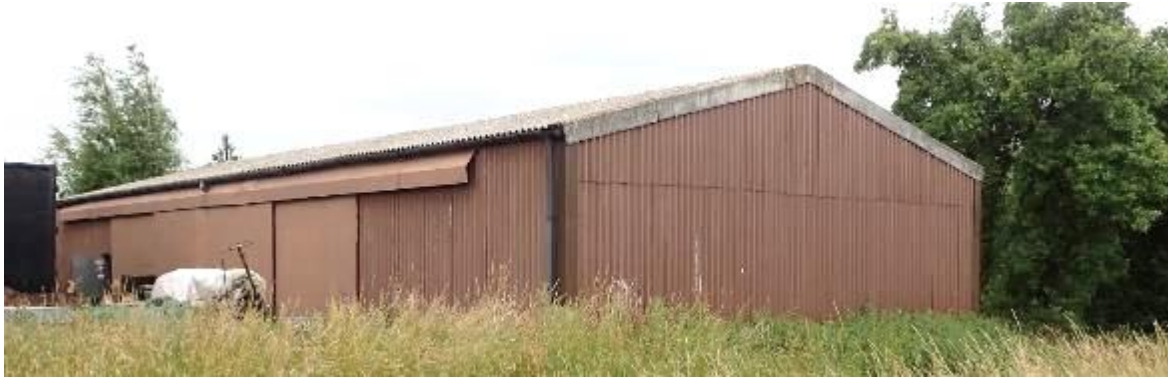
Photograph 2: South and east elevations of workshop, Riding Bank

The workshop is a detached building constructed from modern building materials. The walls are comprised of metal corrugated sheets attached to a timber and steel frame. At the east elevation is large metal sliding door and a metal doorway for pedestrian access. The pitched roof is covered with corrugated asbestos sheets and includes skylights. The gable ends are finished with an overhang of asbestos sheeting.

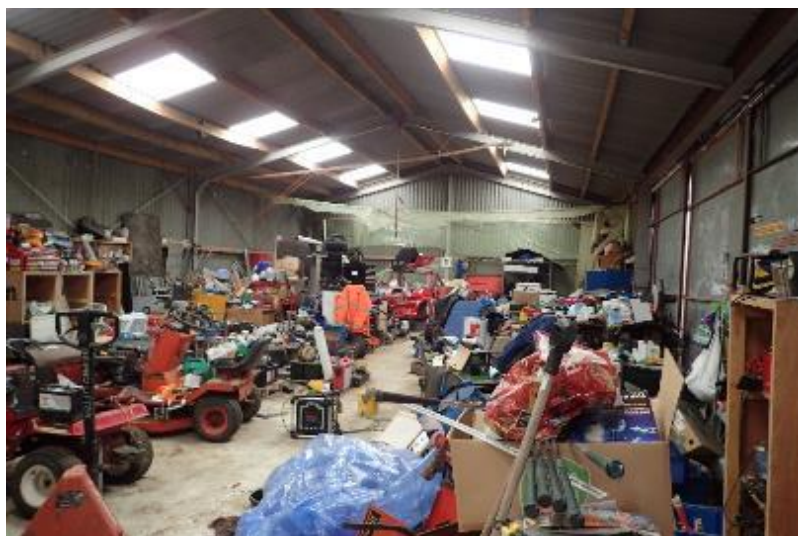
Photograph 4: Interior of workshop

The interior of the building contains a single cell which is used for storage including an aircraft. The items have been stored for some time and are covered with dust.

A search of the interior of the building found the surfaces of the stored items to be covered in dust and therefore any bat droppings or urine staining of surfaces would have been preserved. The timber beams supporting the walls were inspected for any droppings that could have been deposited by bats entering the building via the eaves but whilst there was evidence of use by small bird species there was no evidence of bats found.

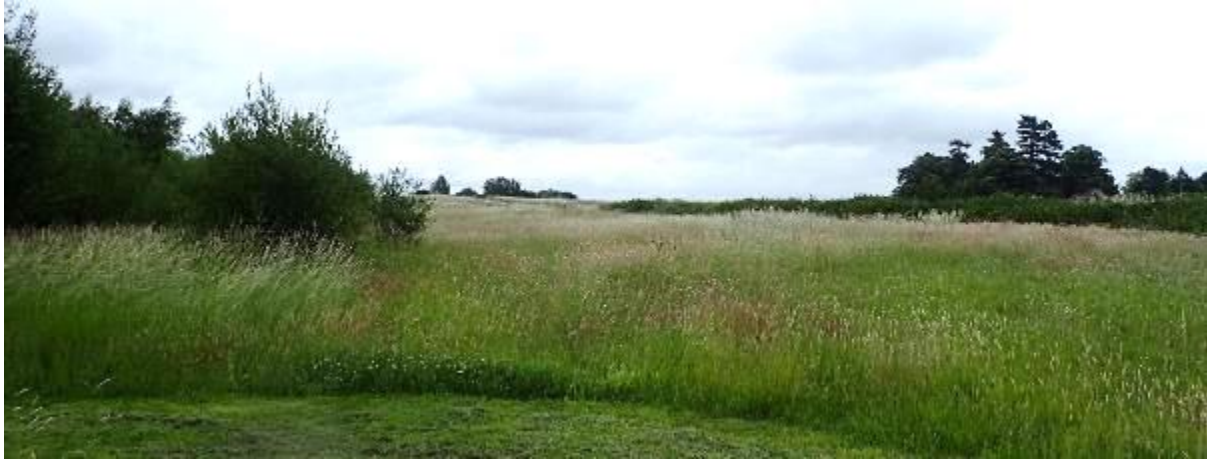
Photograph 5: Land to the east of workshop

Hardstanding is present at the north aspect; unmanaged grassland and tall ruderal vegetation is present the east and north aspects respectively. Immediately adjacent to the west elevation is a boundary treeline. Further to the north and east of the building is a woodland comprised of young trees with picnic areas of mown grass. There is no streetlighting nearby.

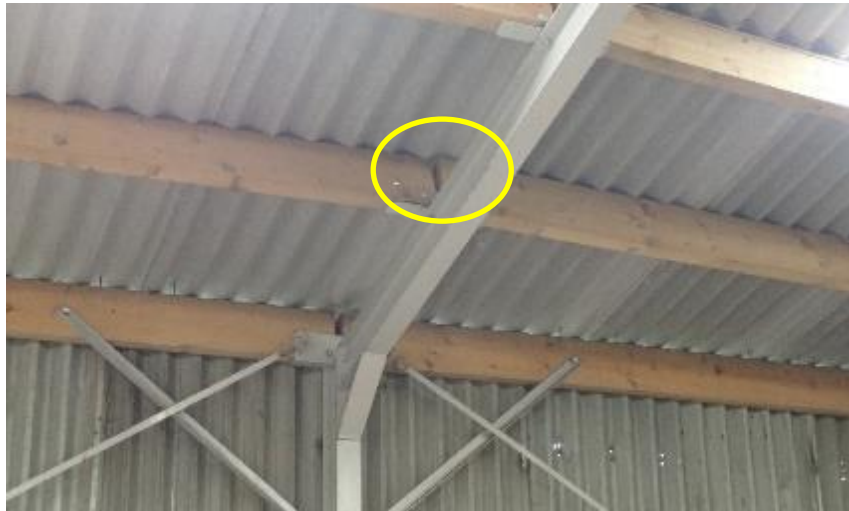
**Photograph 6: Gaps between timber beams in middle of roofing frame**

No evidence of use by bats was found during the visual inspection of the building. The exterior fabric is in good structural condition and lacks the niches and crevices sought by crevice dwelling bat species such as the Pipistrelles.

There is potential access into the interior of the building via gaps in the undulating roof covering and the timber beam at the eaves. The interior of the building is well lit during daylight hours due to the numerous skylights. Gaps were identified at the junction of the timber beams of the roofing frame in one section. A careful inspection was made of these gaps and the surfaces beneath them and no evidence of use by bats was found.

No evidence of use by bats was identified during the visual inspection. The nature of the construction materials has resulted in a lack of niches that are sought by crevice dwelling bat species. The interior of the workshop is light and with exception to the gaps between the timber roofing beams in one section of the roofing frame there are no crevices available to roosting bats. The stored items, such as machinery and tools offer no form of roosting habitat.

It is the conclusion of this report that the workshop is of negligible potential of supporting roosting bats and no further survey work in relation to roosting bats is recommended. In the unlikely event of a bat being found during works a procedure has been provided in Appendix 3.
