**Protected Species (Bat & Bird) Report**

**Out-buildings, Hatton Fields Cottage,  
Sutton Lane, Hilton DE65 5GQ**

**9<sup>th</sup> September 2014,  
Updated 2021**

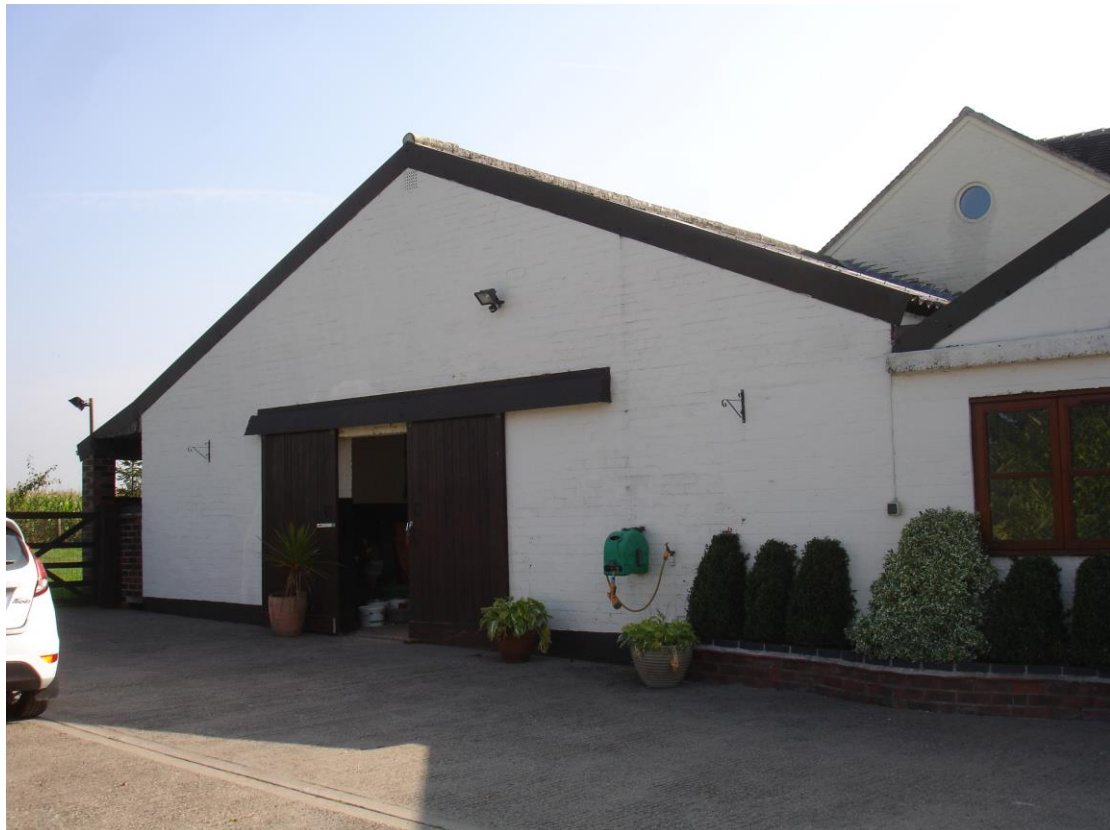
**View from west of North barn**

This has brick walls and a corrugated asbestos roof set on iron supports. The roof is unlined and has six skylights, making the inside light. There is a large wooden sliding door for access in the west side. The east gable is attached to the neighbouring property with a party wall.

There are no divisions inside and the underside of the roof is open to the floor with no hay loft. It is light and generally unsuitable for day-roosting bats.

The underside of the corrugated asbestos roof is unlined and there are no suitable bat roosting places. The support beams are iron and have no crevices that bats could use for roosting. There are no bat signs.

The walls are painted and in good condition with no crevices between bricks or around door or window frames, and no bat signs.

The floor and stored goods have no bat signs on them – no bat droppings, urine splashes or prey remains.

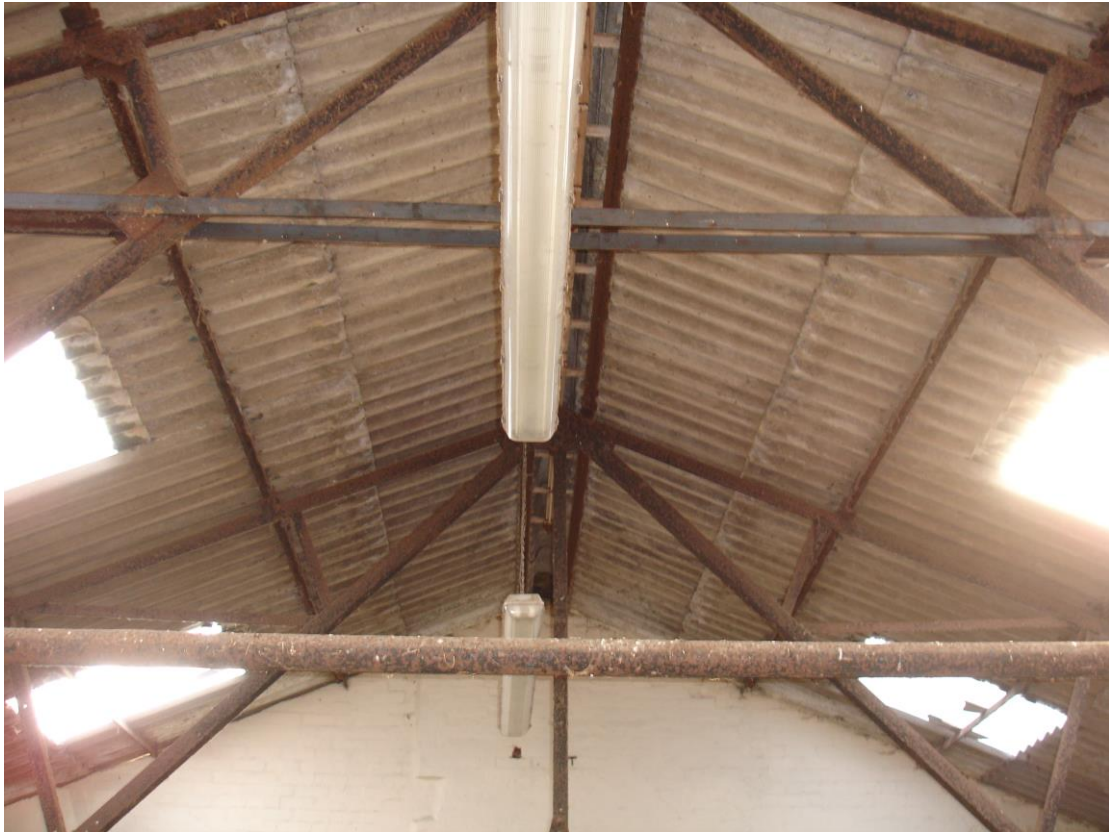
View looking east

The corrugated roof has no suitable places for bats and there are no bat signs. The eaves are not boxed and the corrugations are open allowing access inside, where there are no bat signs. The west verge has no overhang and is covered by a flat metal fascia securely fixed with no gaps around it, and no bat signs.

The walls are well-maintained and painted with no crevices, or gaps around the door and window frames. There are no bat signs.

### **Low probability of bat interest**

No birds nest in or on the building.

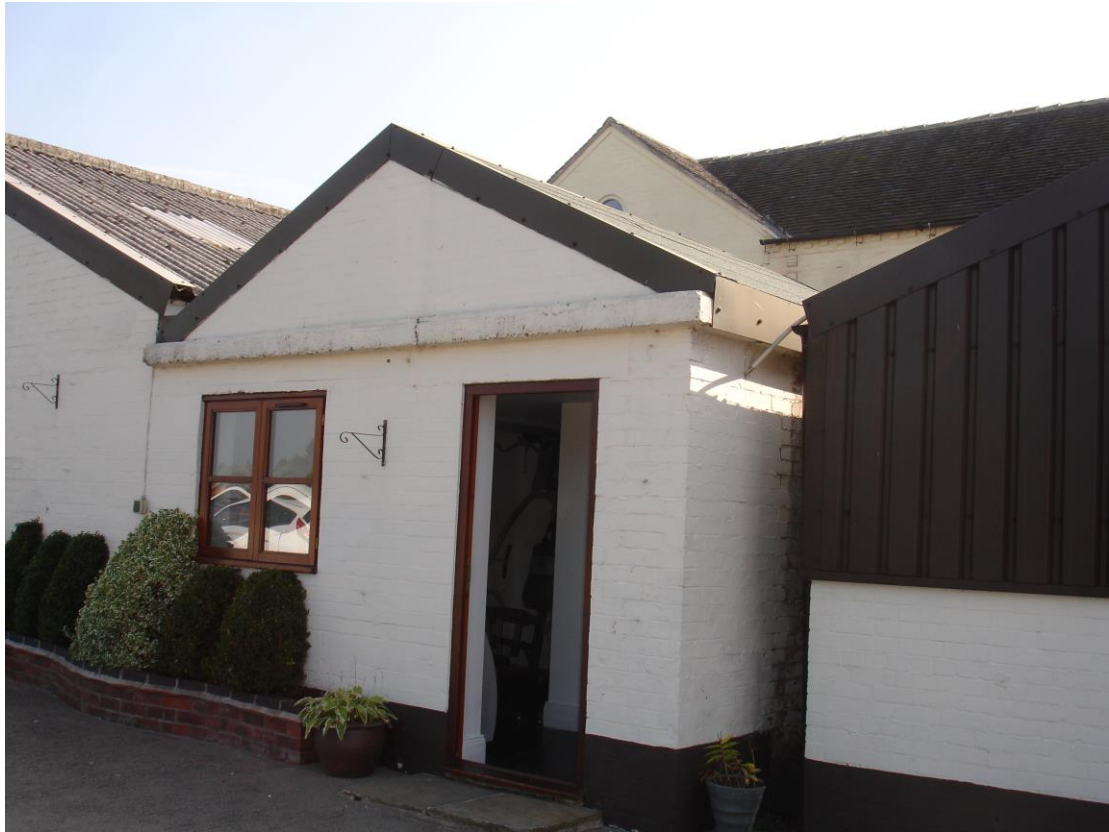
**View from west of Mid-barn**

This is a small single-storey building sandwiched between the two larger barns. It is brick and originally appears to have had a concrete slab flat roof, but a new pitched roof has been placed over it. This new roof is tarred felt on boards. The interior has been plastered and decorated and is in use as a gym. There is a glazed window and door in the west gable end, making the inside light.

The underside of the concrete slab has been plastered as a ceiling and has no suitable bat roosting places. The decorated walls also have no suitable roosting places for bats and no bat signs.

The tarred-felt roof is modern and in good condition. There are no possible crevices in its construction that bats could use and no access points around it.

The verge is sealed tightly closed with a metal fascia with no gaps between it and the walls, and no bat signs.

### **Low probability of bat interest**

House martins have nested under an extended verge on the east side, but not this year.

House martins have bred under the verge of the Mid-barn, but not this year. It would be safer, to avoid any nesting disturbance, to work on this barn outside of the bird breeding season, usually April to September for this species, or prevent them nesting under the verge before they return in April.

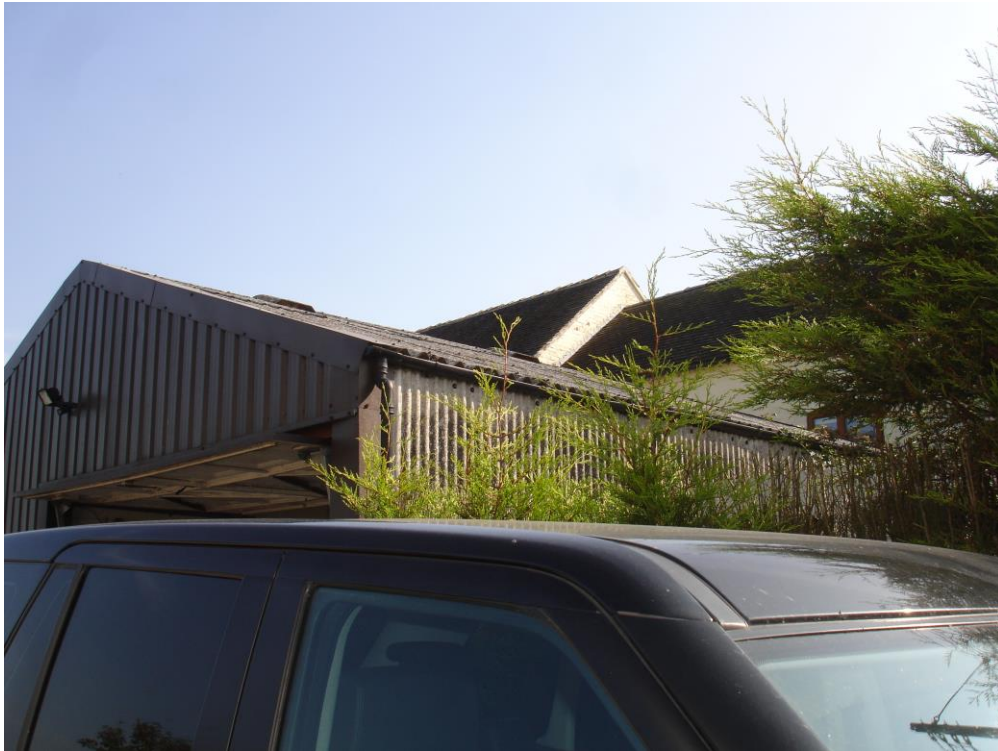
**View from south-west**

This has brick walls from the ground for the first 1-2m, then corrugated sheets fitted above on a wooden frame to reach the roof. The west gable end has new corrugated aluminium sheets and the east and south walls have corrugated asbestos. The pitched roof is corrugated asbestos sheets fixed to a wood and metal frame. There are skylights in the roof making the inside light. A double up-and-over garage door in the west gable end provides access.

The underside of the corrugated asbestos roof is unlined and there is no hay loft. There is nowhere suitable for bats to roost on the underside of the asbestos sheets and no bat signs.

The metal and wood supports also have no crevices and no bat signs are present on them

The walls are sheets of corrugated asbestos or aluminium and have no crevices. The lower brick walls are painted and have no crevices bats could use.

The cubicle inside has no bat signs in it or on it, or any crevices suitable for bats.

The floor and stored goods have no bat signs on them

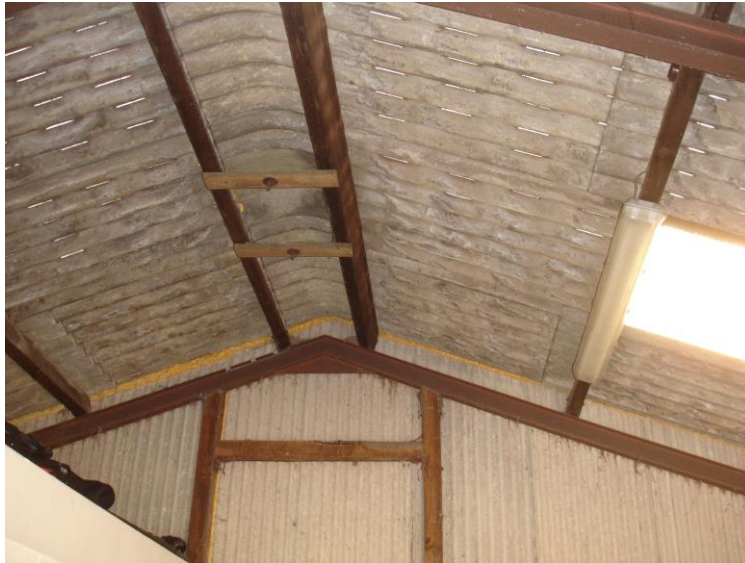
**View from west**

The corrugated roof has no places for bats to roost or enter. The eaves are sealed with expanded foam and provide no crevices suitable for bats. The verges are sealed with a metal fascia board and the gaps under the corrugations are sealed with foam. There are no bat signs.

The door has no gaps around its frame and no bat signs on it or around it.

### **Low probability of bat interest**

No birds nest in or on the building.
