# 76 Commerce Street Melbourne Derbyshire

## Bat Survey Report

Client: Loughborough Building Society

Issue Date: June 2019

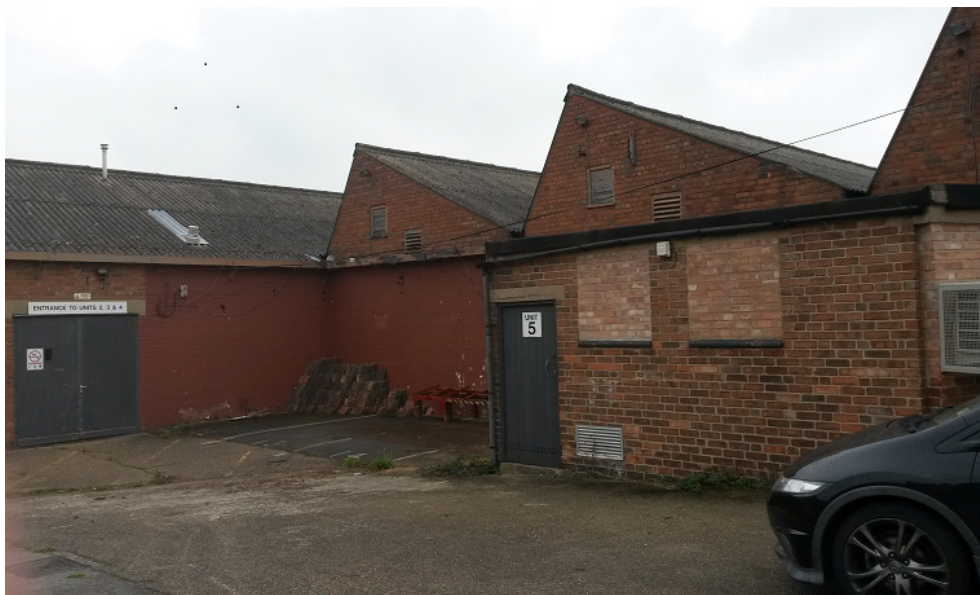
- 3.7 Building B1: the factory section was brick built and featured a northern light roof covered with skylights on the northern pitches and corrugated asbestos sheets on the southern pitches. The building was single storey at the front but had a basement under it which led out to a loading bay at the rear.

**Photo: factory building B1 western aspect taken from the adjacent car park**

- 3.8 This building featured windows and access doors along the southern wall and on the northern wall above the loading bay. At the end of each pitched section was a vent covered with wooden slats and in some instances also with wire mesh.

- 3.9 A brick chimney stack was noted on the western side adjacent to the car park. This was currently being used as a communications tower and featured mobile communications equipment.

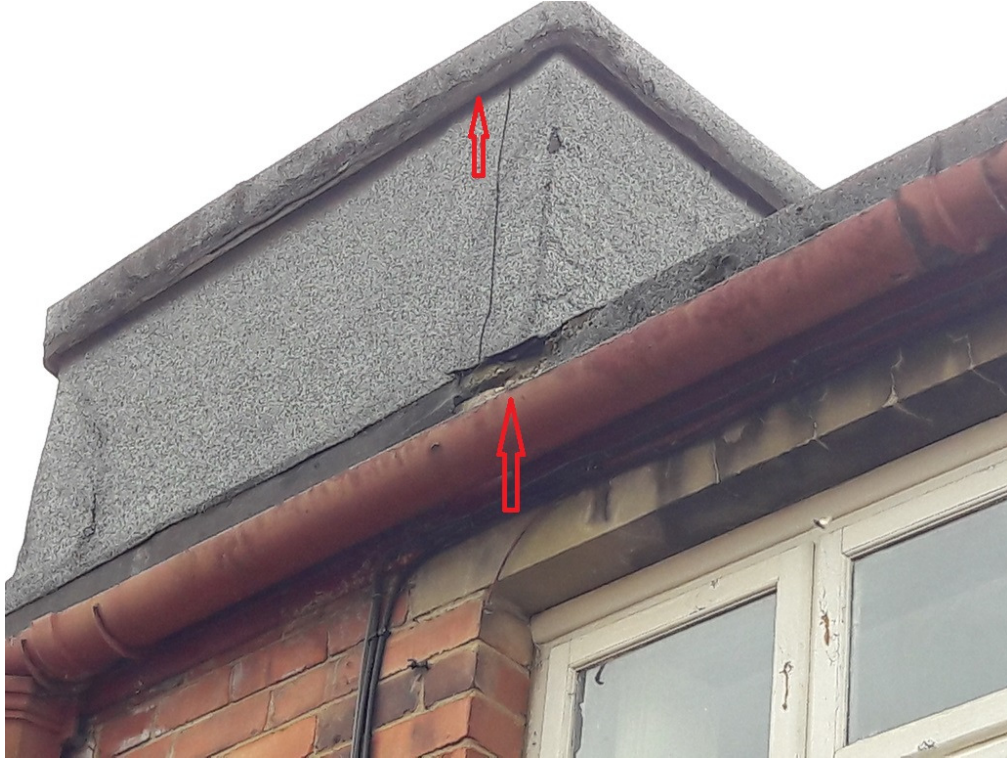
- 3.13 Damage to the roof felt on the western aspect of B1 was also noted as a PRF along with suitable gaps under the top of the box structure on the roof of B1 (Figure 1: Buildings Plan – Target Note 2 and photos below). Gaps under the fascia board in the same location were also noted.

**Photos: potential access points where roof felt damaged and on box structure (indicated by red arrows).**

- 4.2 Two common pipistrelle bats were seen emerging from a box feature on the roof of B1 during the emergence survey on 23<sup>rd</sup> May 2019. This section of B1 has therefore been identified as an occasional roost for a small number of common pipistrelle bats.

- 4.3 All bat species and their roost sites are protected under the Wildlife and Countryside Act (WCA) 1981 as amended and are included in Schedule 2 of the Conservation of Habitats and Species (Amendment) Regulations 2017. Therefore a European Protected Species License (EPSL) will be required from Natural England before the demolition of the building B1 can commence.

- 4.5 A detailed method statement will also be required as part of the application. This will need to include timings and procedures to be followed during demolition works in order to avoid/minimise harm to any bats that may be present within the buildings.

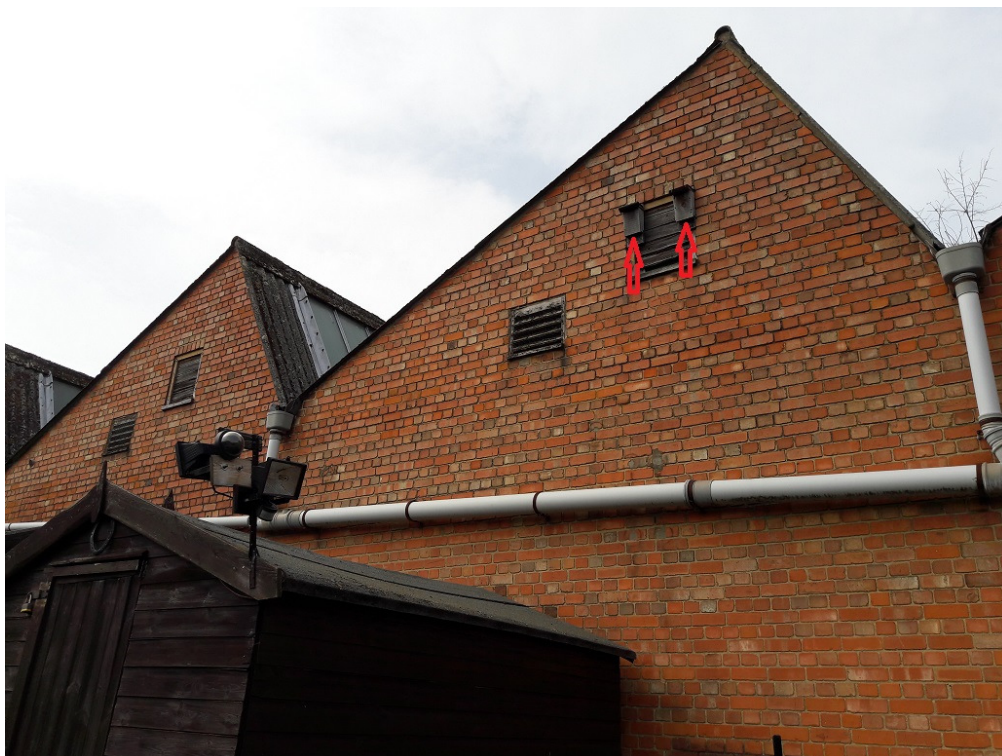
- 3.14 The two wooden bat boxes positioned on the eastern wall of B1 provided suitable external PRFs (Figure 1: Buildings Plan – Target Note 1). Although these could not be reached by ladder in order to carry out an internal inspection, binoculars were used to identify evidence of use such as droppings below the boxes. No evidence of use by bats was observed during the building assessment.

**Photo: Wooden bat boxes on eastern wall of B1**

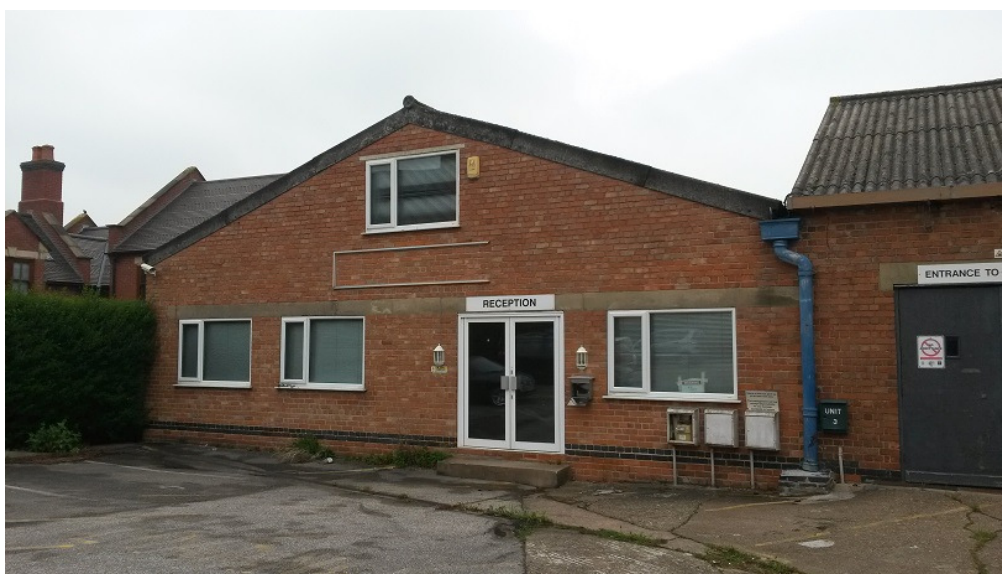
- 3.15 Building B2: this building occupied the eastern part of the site but was attached to B1 and linked internally. B2 was also brick built but featured a pitched roof covered also covered with asbestos sheets.
- 3.16 The gable ends of the building featured barge boards which were formed by the asbestos roof covering and also window and door frames on the front which were PVCu.

**Photo: Front of office building B2**

- 3.17 Potential external access points and PRFs within B2 were limited to potential gaps under the barge boards at the gable ends of the pitched roof. A smashed window on the western aspect may have allowed bat

access to the interior of the building but no internal evidence of use by bats was found in this location.

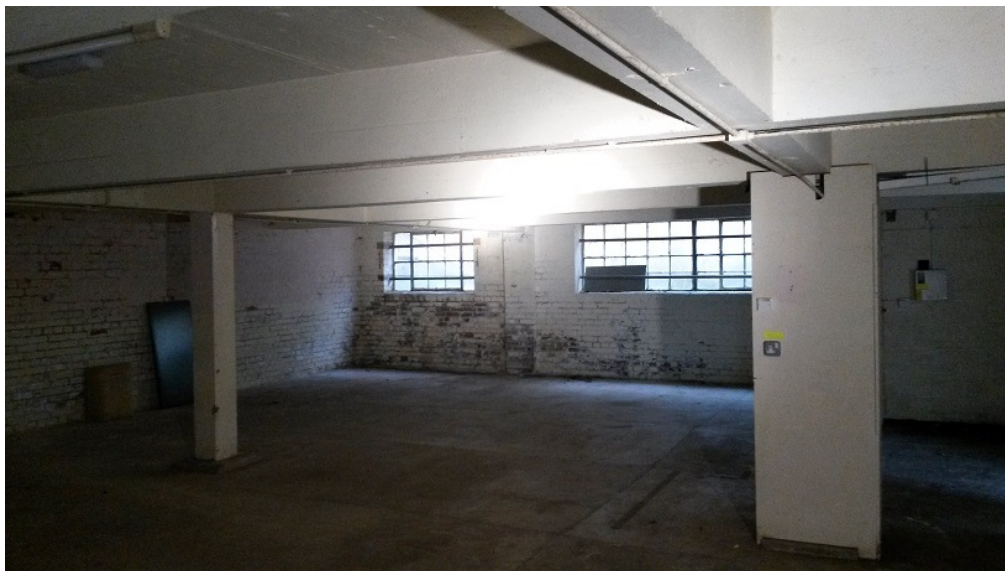
- 3.20 The basement loading bay at the rear of B2 featured windows with frosted glass along the northern wall. This allowed some daylight into the basement in this area. However no other basement windows were noted making the rest of the lower floor much darker than the upstairs factory/warehouse. The basement was simple in structure designed as a storage area and lacked internal features and access points which could be used by roosting bats.

**Photo: Basement leading to rear loading bay**
