# LAND AT 143 PARK ROAD, NEWHALL SOUTH DERBYSHIRE

## Completion Report

Consolidation of Potential Abandoned Coal Mine  
Workings and Entries by Drilling and Grouting

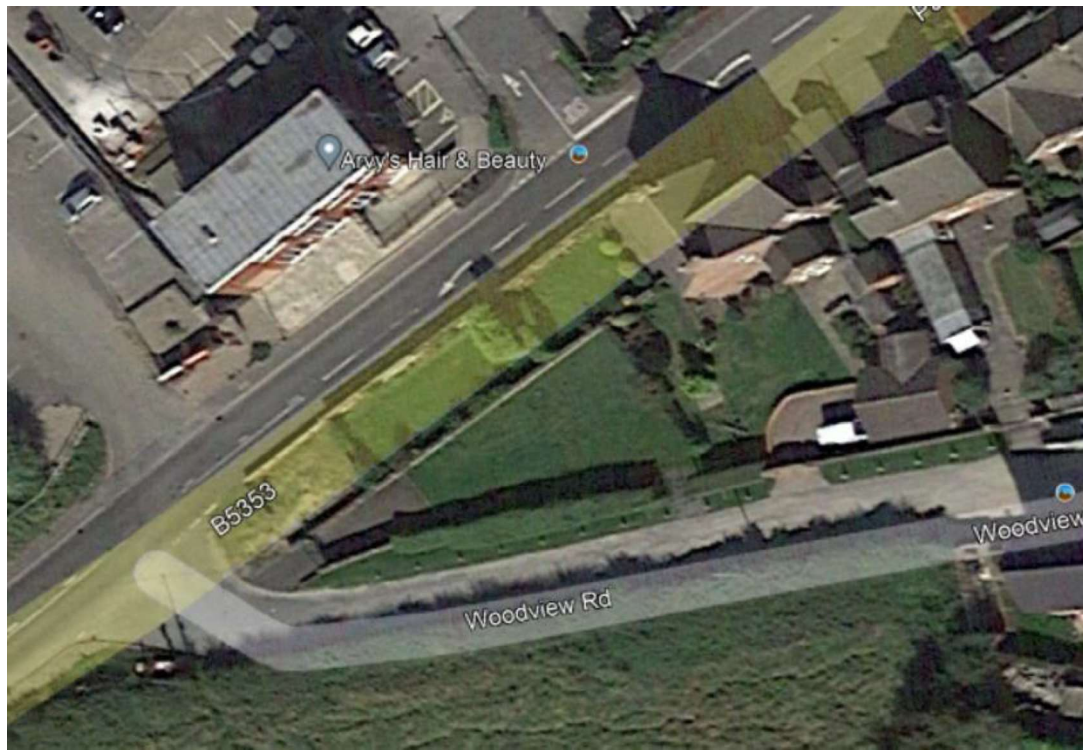
Figure 2

The site is roughly triangular in shape – See **Figure 2** in **Appendix A**, occupying an area of approximately 170m<sup>2</sup> and is located on the southern side of Park Road, Newhall.
