# REPAIRS TO THE OLD ENGLISH GARDEN AT ELVASTON CASTLE COUNTRY PARK:

## DESIGN, ACCESS & HERITAGE STATEMENT

Prepared by: Alex Gilbert (Historic Buildings Architect)

Revision: 00 / Date: 21/06/2021

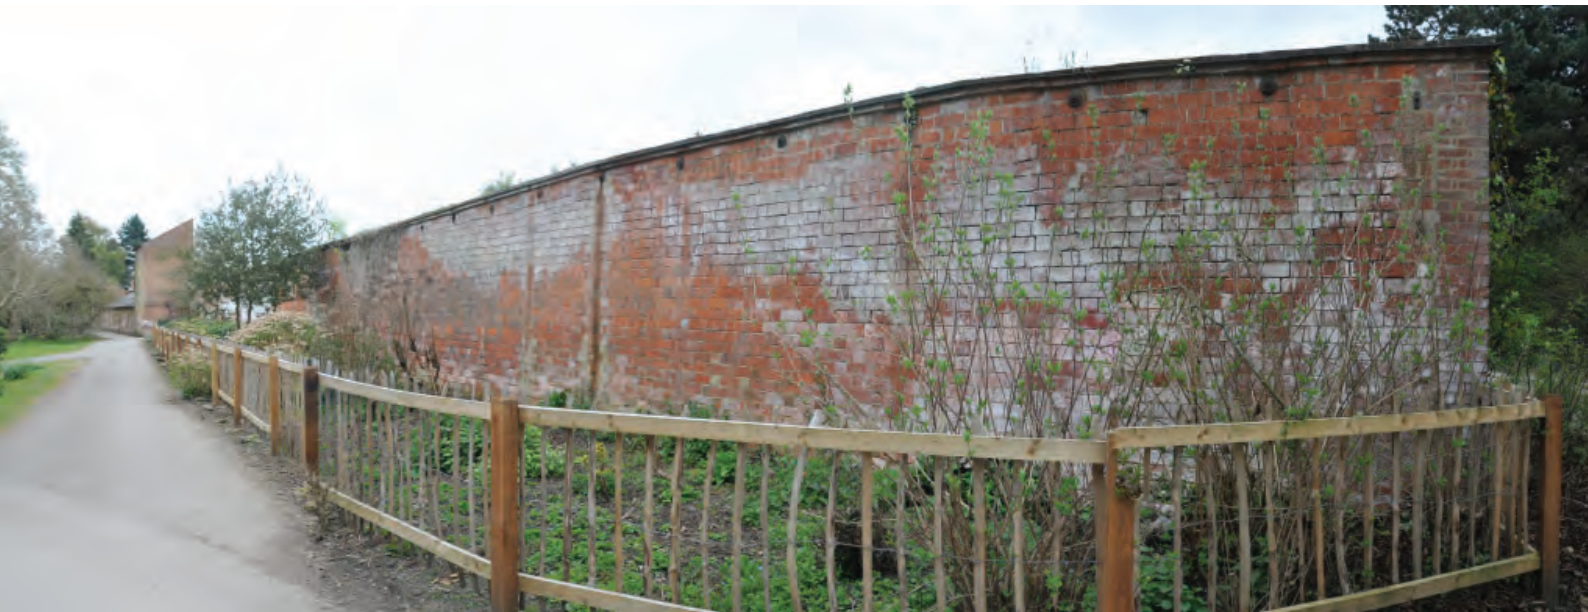
**Fig. 6 (above):** Panoramic view of north elevation of the heated wall; note the large format bricks used in comparison to those shown on; **Fig. 7 (below):** Panoramic view of west elevation of the former heated garden wall

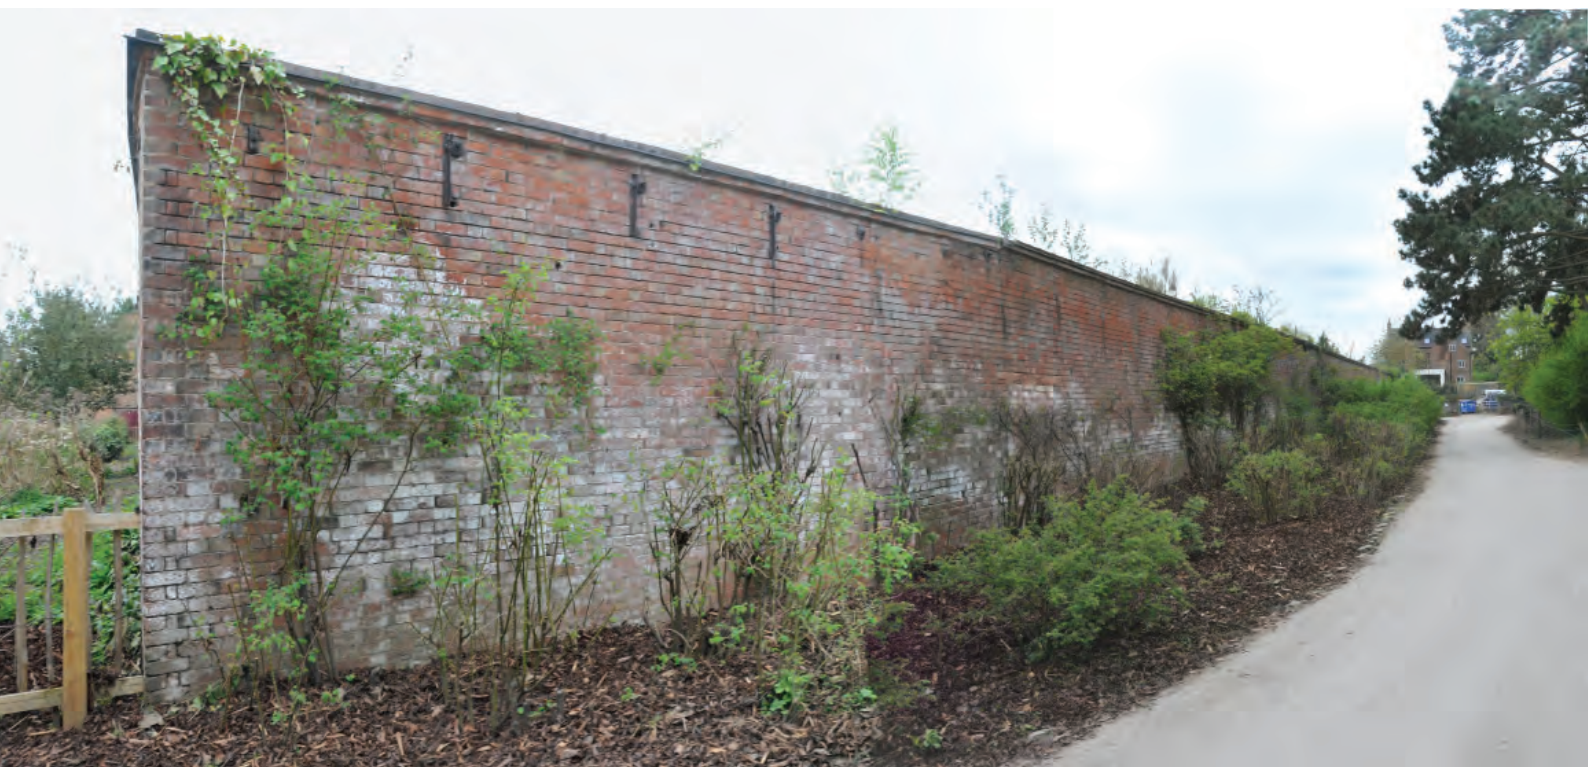
**Fig. 7:** Panoramic view of south elevation of the heated wall (facing east); note the poor condition of the wall with multiple missing areas of brickwork. The wall is to be rebuilt along its entire length to the same height, proportions & materials.

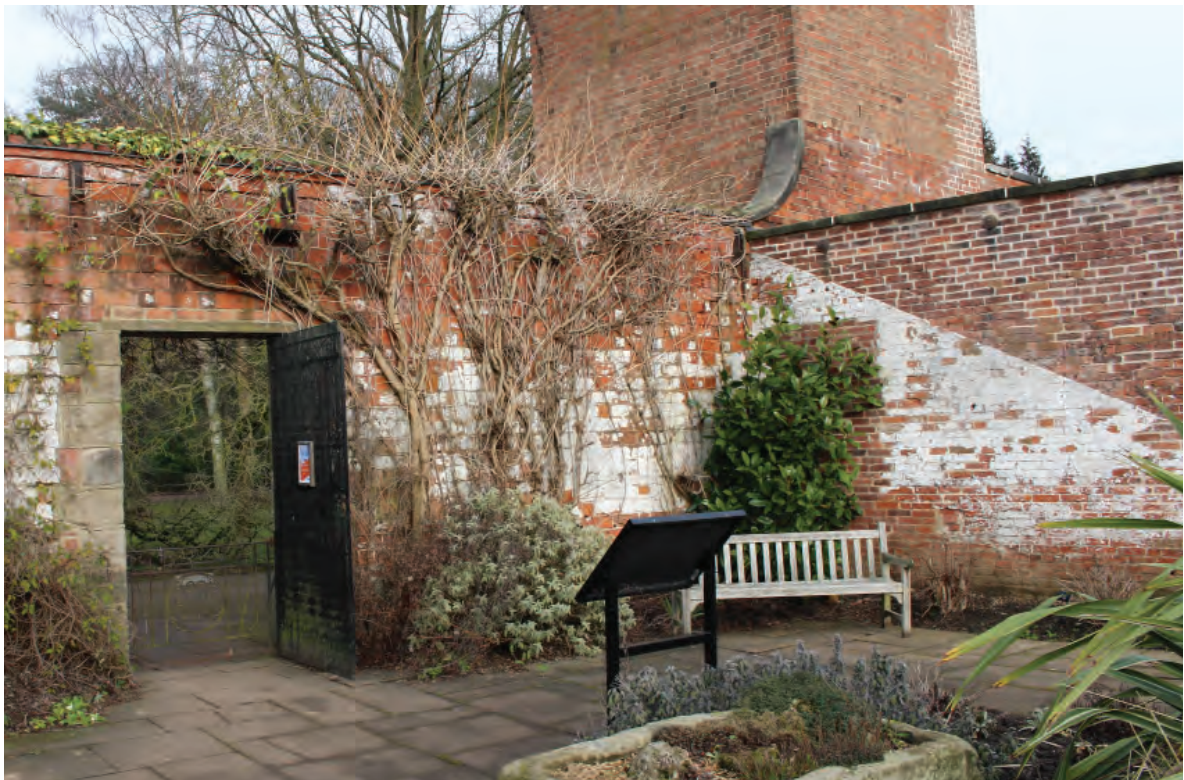
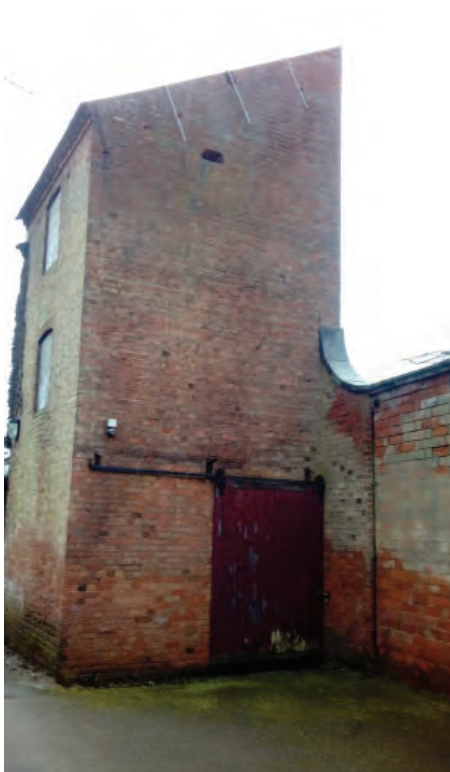
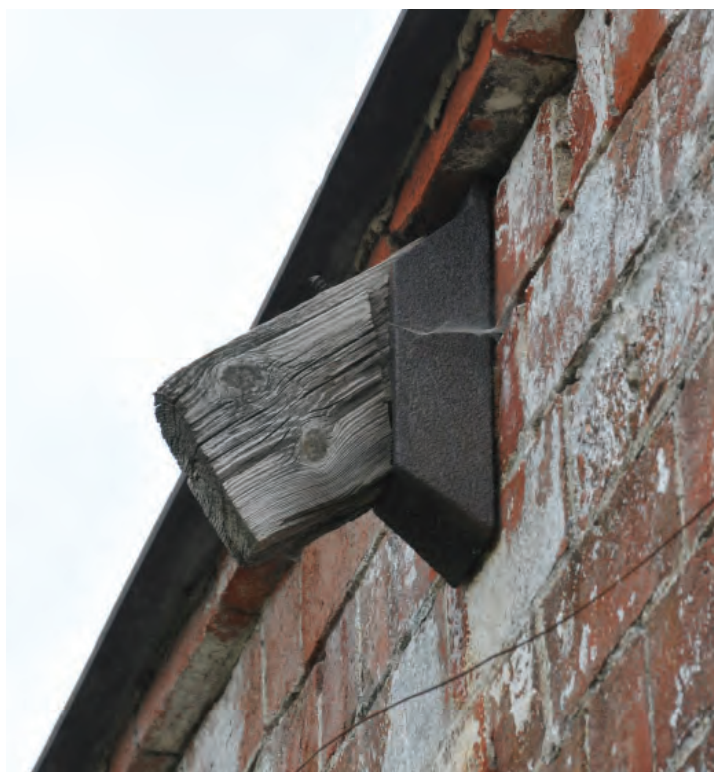
**Fig. 11** A number of truncated rafters are visible along the south side of the wall; these presumably formed the roof structure to the historic glasshouse structure.

**Fig. 12:** The tall boiler house, located close to the visitor entrance, is thought to have fed the heated wall on the north side of the walled garden. The south wall was fed by a separate boiler house.

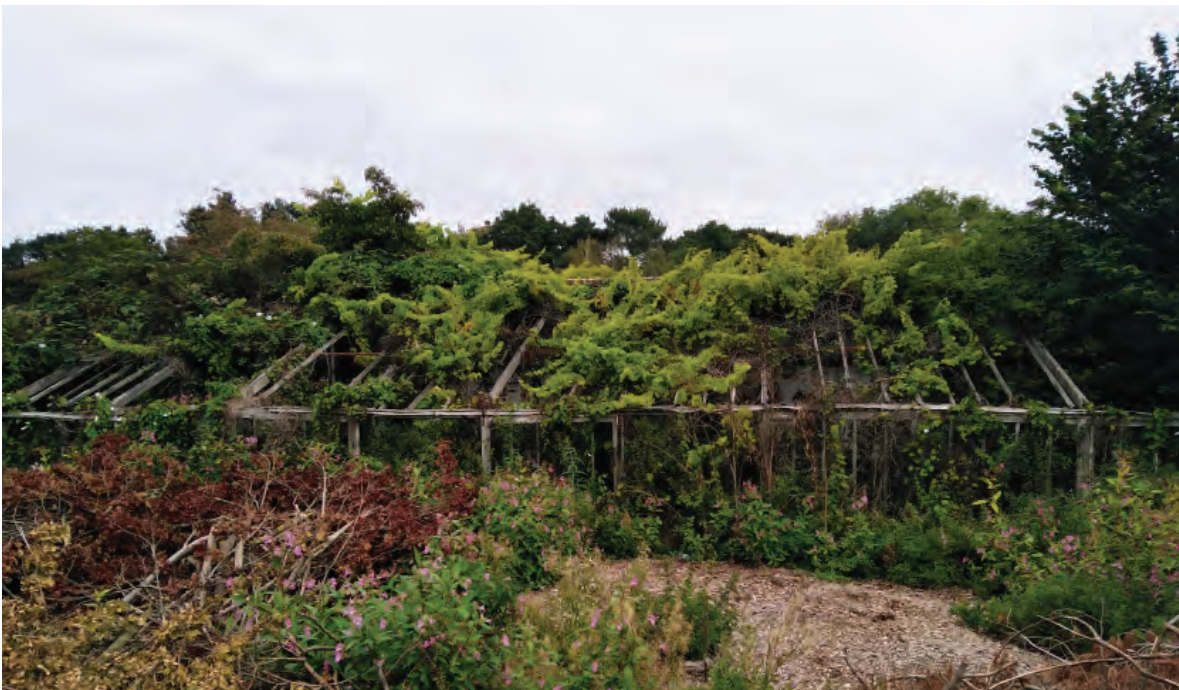
**Fig. 26:** Historic lean-to glasshouses remain on the south side of the south wall to the OEG.

- 4.3.8 Nevertheless, by 1899 the walled gardens were at their most complete with extensive ranges of glasshouses<sup>14</sup>. Surviving tangible evidence of this is plainly visible on both walls; the south wall still retains these glasshouses (Fig. 26), although in a dilapidated state, and clear markings and remnant structural features still exist (Fig. 10).
- 4.3.9 In concluding this investigation, the significance of the north wall, as part of the listed building ‘Nursery Garden Walls and Attached Outbuildings at Elvaston Castle’, in reference to the three categories of ‘interest’, as defined in *PPG Historic Environment*<sup>15</sup>, can be described as follows:

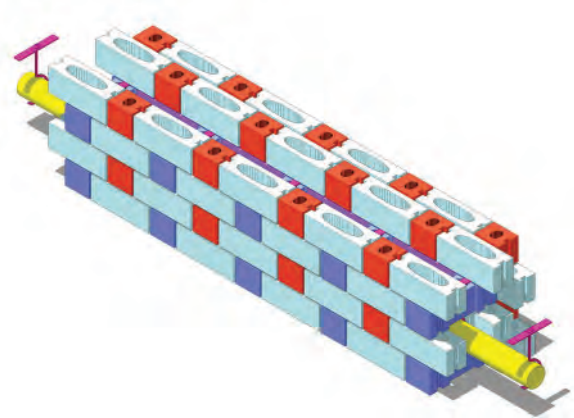
SK\_01

report. The cavities in many of the hollow bricks have been filled with mortar containing coarse aggregate.

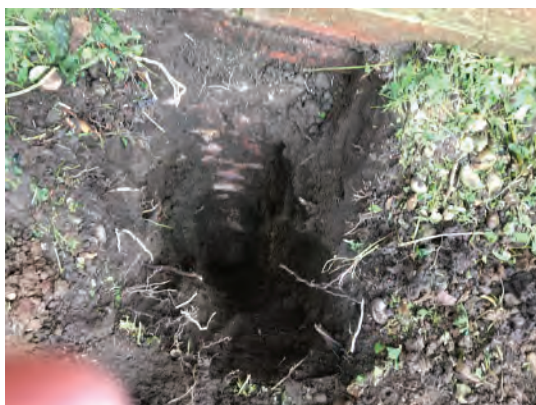
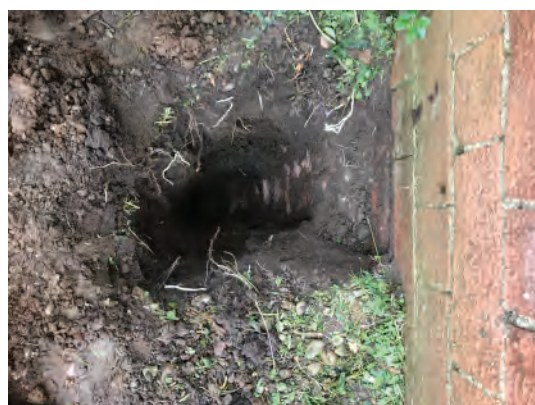
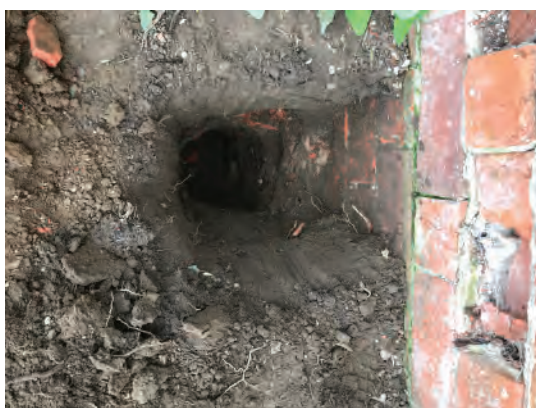
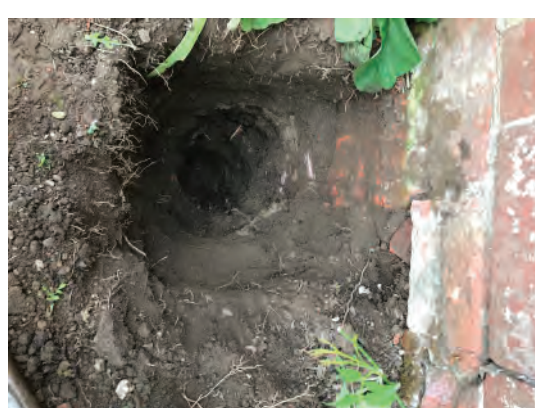
Four trial holes were excavated, two to the north side and two to the south side, to determine the sizes and depths of the foundations and the ground conditions at foundation formation level. In all cases, stepped brick footings founded on firm dry clay approximately 1.05m below ground level were revealed. Some, relatively minor, root activity from nearby trees and shrubs was noted in some of the trial holes.

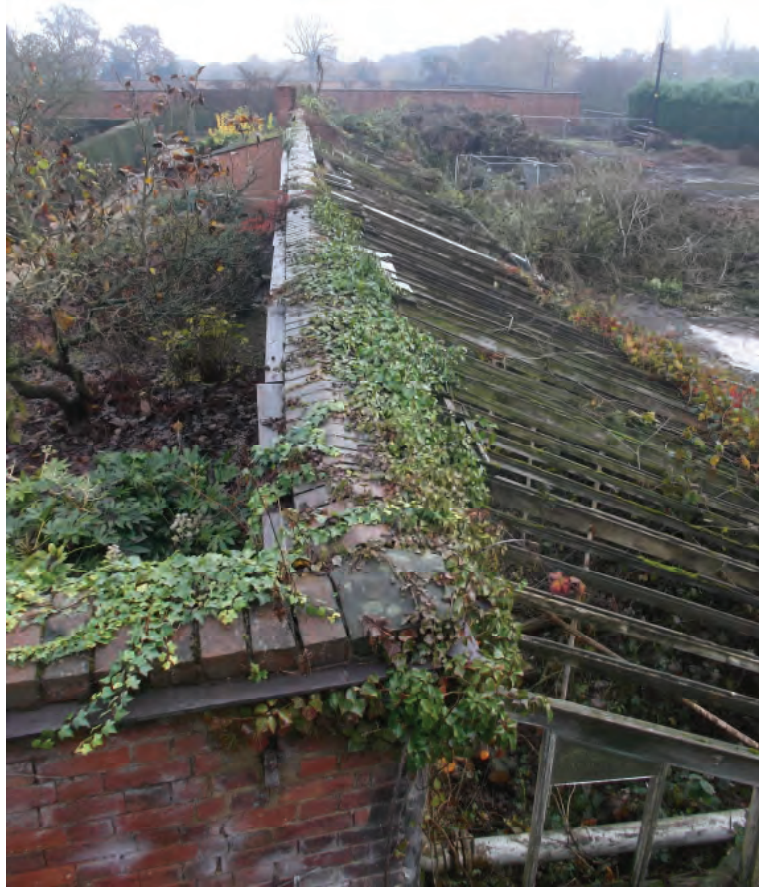
The north face of wall D was previously cloaked in ivy and, some of it had been removed prior to this inspection. From the limited access available and a brief inspection, wall D would appear to be plumb and in relatively good condition. Weathering of mortar and loose bricks and copings were seen in specific locations at the top of the wall and in particular near to the small lean-to shed which is currently fenced off. When viewed from above the wall appears straight (photo 5).

Photograph 5 - Wall D – view along top of wall.
