### DAILY RECORD SHEET

| <b>Employer:</b> Benniman Construction Group Ltd | | <b>Site:</b> Dove Valley Park – Plot 11 | |
| <b>Contractor:</b> Collins Earthworks Ltd | | <b>Engineer:</b> GS | |

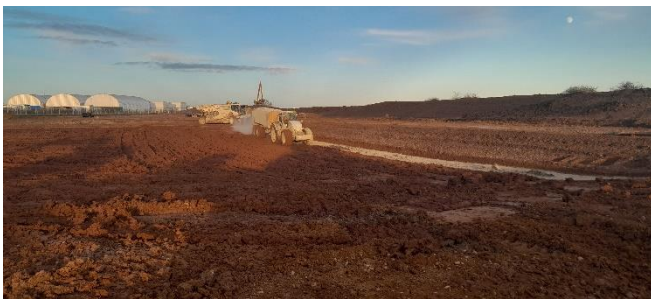
Looking toward Grids J-L;7&8 (North-northeast) – Lime spreading.

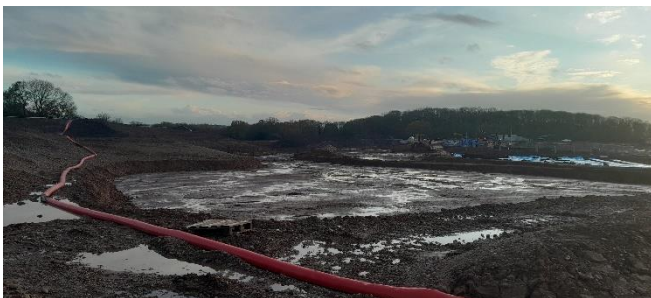
Grid P10 towards South – Pump line from borrow pit to new drainage pond.

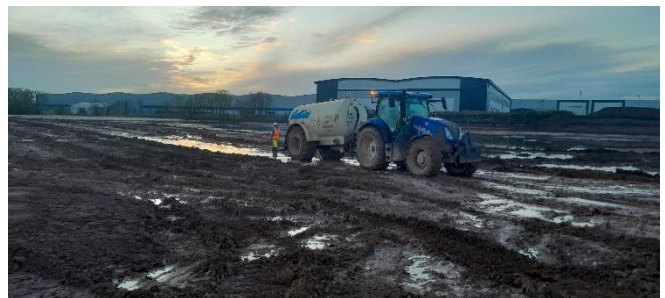
Grid R6 towards East-southeast – Pumping of surface water.

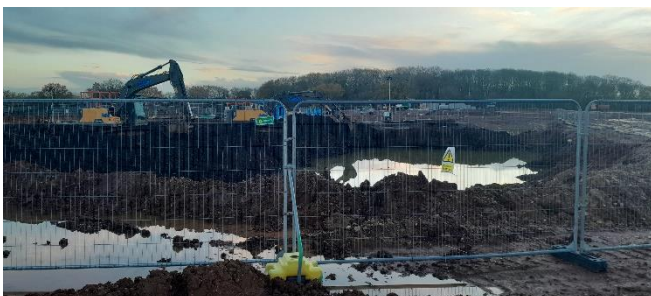
Grid Q6 towards Southeast – Resumed pond excavation.

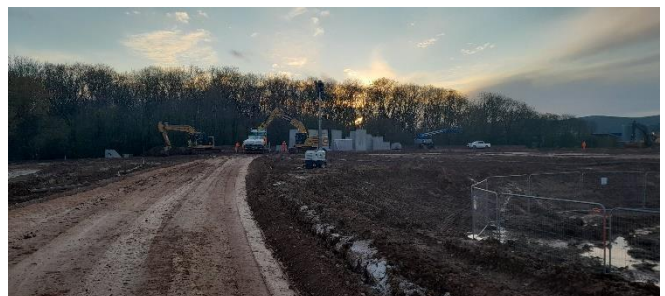
Looking toward Grids AA;7&8 (south-southwest) – Mobilisation to site of retaining wall materials.

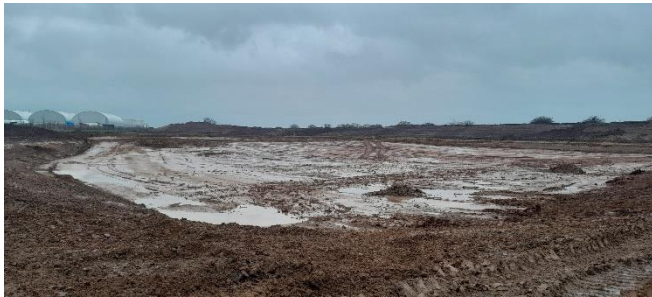
Looking toward Grids K&L;6-8 (North-northeast) – Borrow pit (work paused but infill prior to visit).

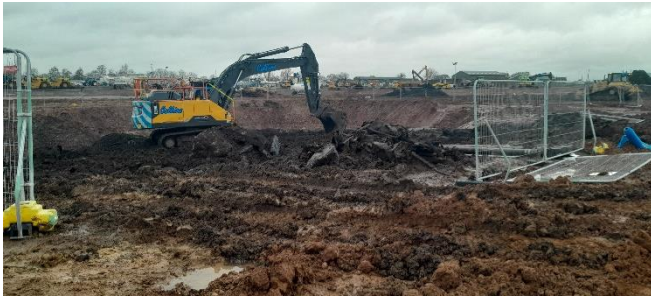
Grid R;10 towards Northwest – Riddled unsuitable materials.

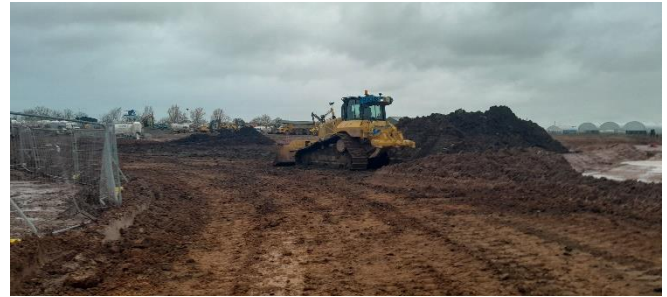
Looking toward Grids Q;8-10 (North-northwest) – New 'Marl Pit' excavation stockpiled.

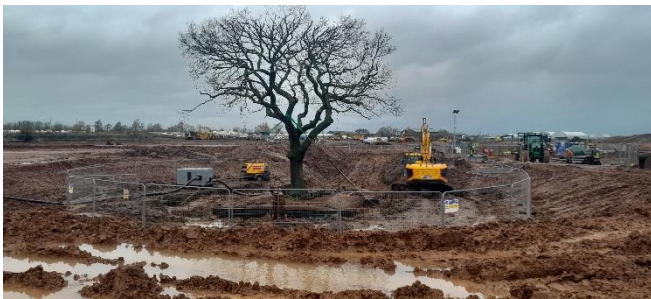
Grid Y;9 towards North – Tree removal is still ongoing.

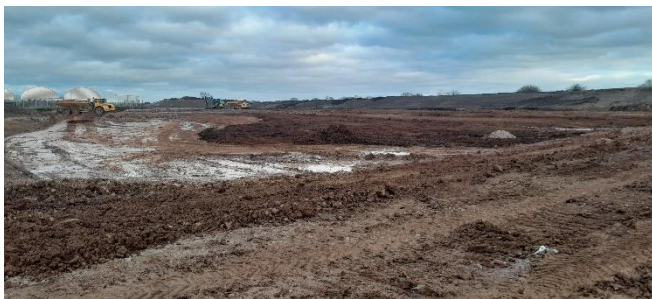
Looking toward Grids J-L;6-8 (North-northeast) – Borrow pit.

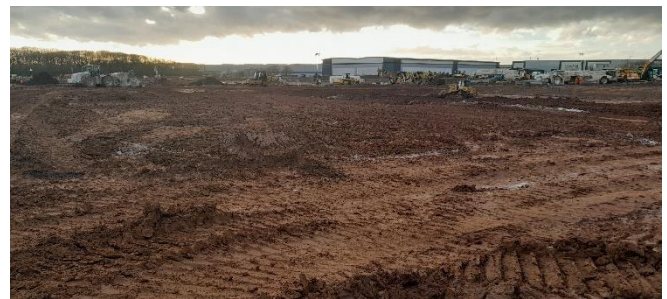
Looking toward Grids J-L;6-8 (South-southwest) – Borrow pit.

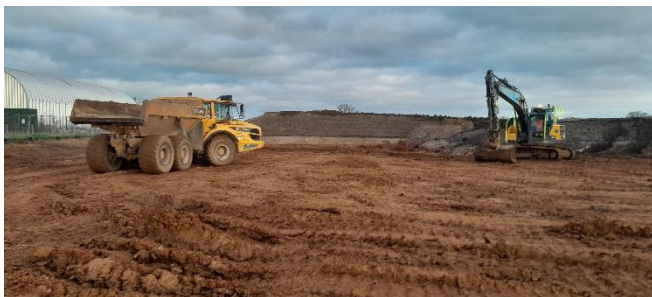
Grid F;9 towards Northeast – Cut and stockpile movement.

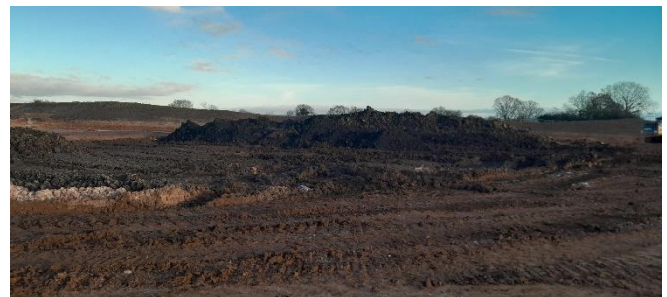
Grids Q;7-10 toward North-northeast – 'Marl Pit' excavation stockpile.

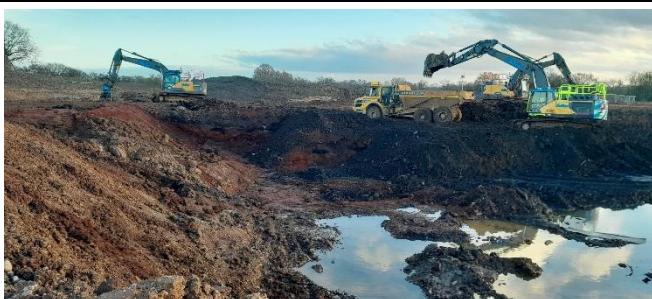
Grid S;6 towards East-southeast – Pond excavation.

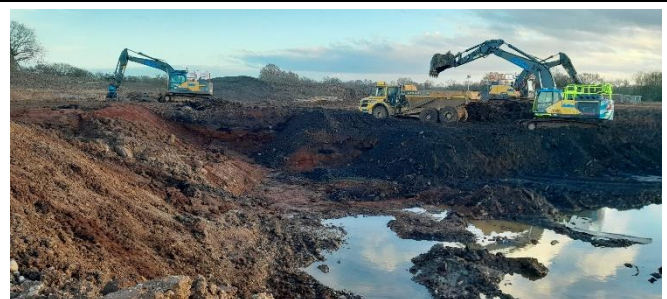
Grid S;6 towards Southeast – Pond excavation.

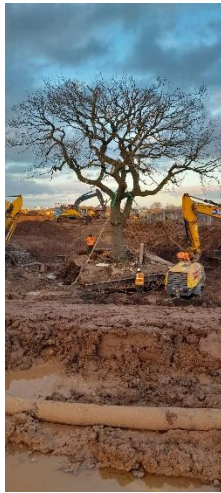
Grid Y;9 towards North – Tree removal is still ongoing.

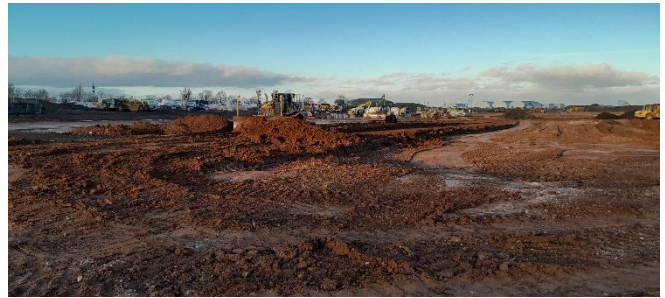
Grid W;6 towards North-northwest – Trimming of overfill ready for rerolling and/or chemical treatment.

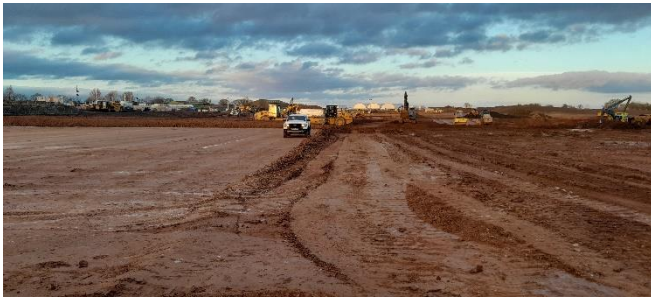
- Validation results from trimmed, re-treated and rerolled fill in Grids W-AA;4-6 have been very good, well exceeding specification requirements (in terms of HSV and CBR).

Grid U;6 towards North – Trimmed rerolled/treated ground (Grids W-AA;4-6)

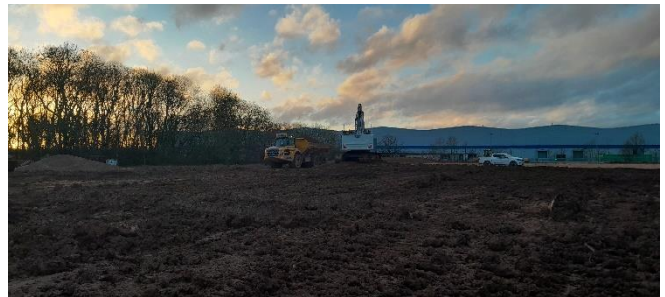
Looking toward Grids Z;8 (Southwest) – Overfill being trimmed, and supplying retaining wall backfill.

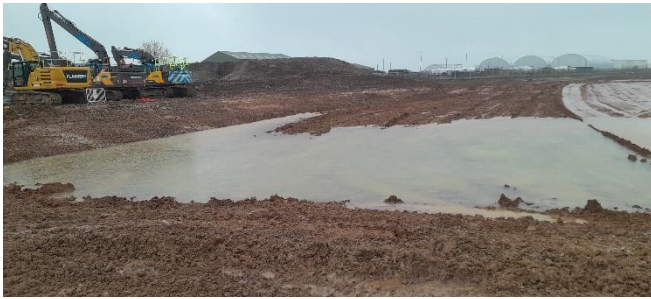
Looking toward Grids J-L;6-8 (North-northeast) – Borrow pit.

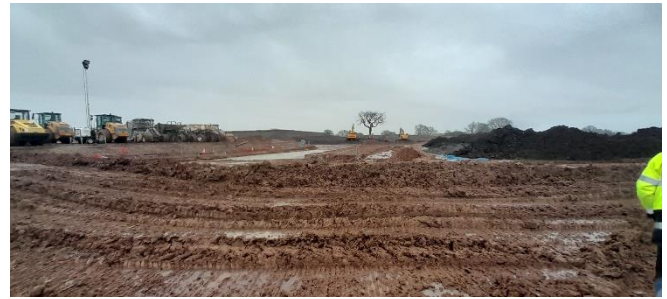
Looking toward Grids M&N;7-11 (Southeast) – Haul/site road and relocated tree.

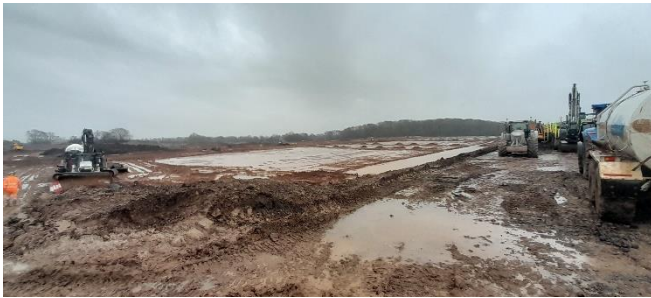
Grid N;3 towards South-southeast – Overview.
