## EUROPEAN TURFGRASS SPECIALISTS

### Cromwell Orchard: Mickleover

**Date: 10<sup>th</sup> April 2026**

## Introduction

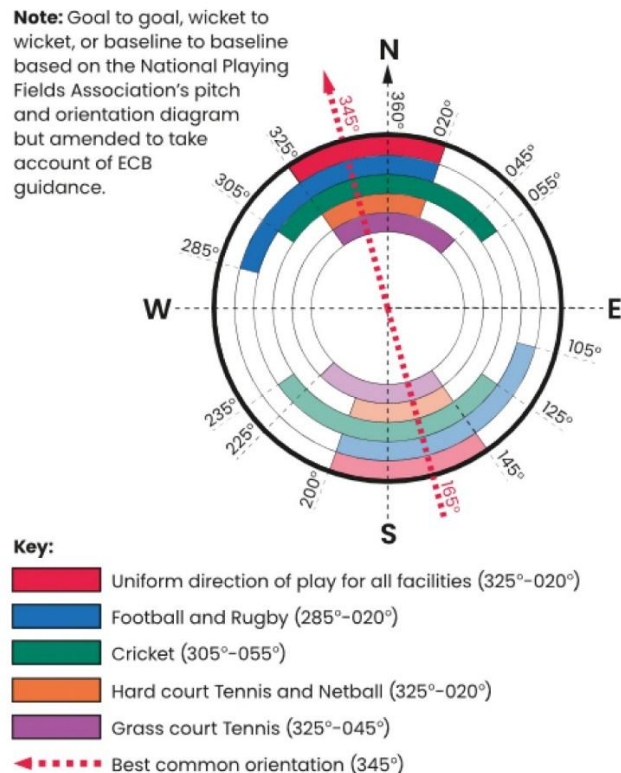
Figure 9. Pitch orientation guidelines from Sport England

The two main pitches shown on the existing layout (Figure 1, page 5) are orientated north-west to south-east. This arrangement aligns with Sport England's recommended pitch orientation guidance for football, which is illustrated in Figure 9 below.
