## **CLOCK TOWER ALTERATIONS**

LISTED BUILDING CONSENT APPLICATION

DESIGN, ACCESS & HERITAGE STATEMENT

Alex Gilbert (Historic Buildings Architect) 24/10/2019

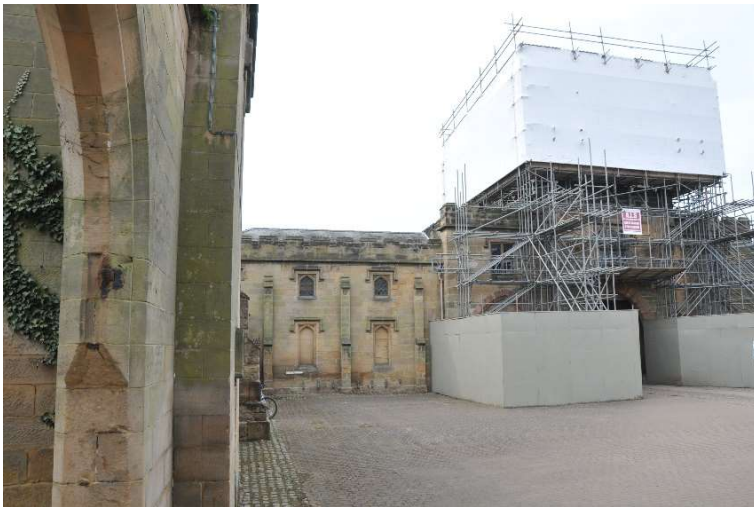
**Fig. 04:** View of the tented scaffold system around the clock tower erected in early 2016 to arrest the worst of the decay & to understand its structural issues. Image date April 11<sup>th</sup> 2016.

- 2.2 The images below show the Clock Tower in context with the Coach House building. Figures 1-3 are photographs of the building taken prior to the erection of the tented scaffold. The scaffold had to be erected to prevent moisture ingress and to help understand the extent of the repairs required to the structure and the abutting ranges. Since then work has been undertaken to demolish the Clock Tower and work is due to commence on the replacement structure during week commencing 28<sup>th</sup> October 2019.

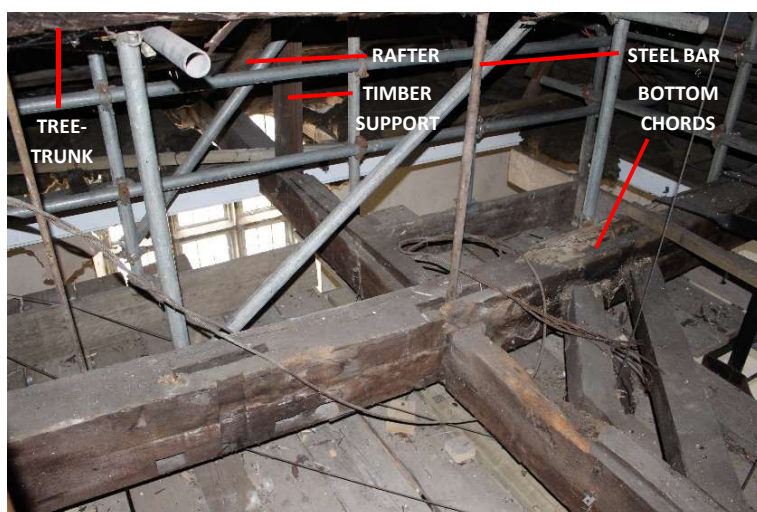
**Fig. 17:** Image from within the Clock Tower showing the bottom chords of the historic trusses. Note how an attempt to restrain these from sagging further has been made with the later central threaded steel tie-bar.; this is in turn supported inadequately by a tree-trunk which is just visible at the top of the image. One of the principal rafters, which has been truncated due to the addition of the Clock Tower, is just visible at the top of the image which is supported by a later timber post.  
Image date July 14<sup>th</sup> October 2017.

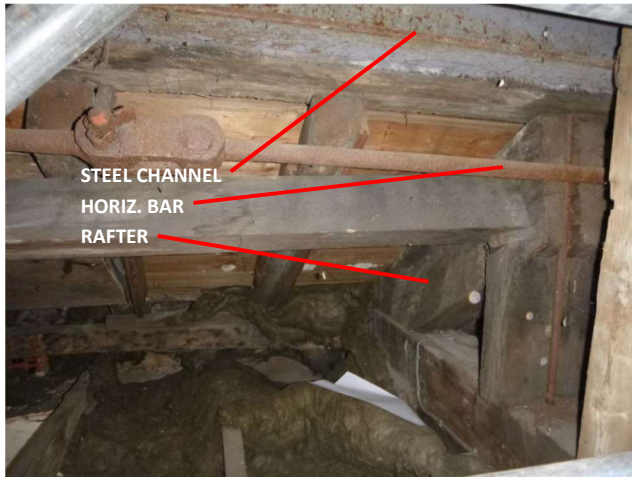
**Fig. 18:** Truncated principal rafter & timber support. Modern steel channels have been added, in addition to the earlier horizontal bar, to strengthen support to the Clock Tower structure. Image Date October 2016.

3.4.7 Some attempt to repair the clock tower appears on the drawings which include measures to strengthen it, including new steel members at the lower level of the structure (Fig's 18 & 19), and a re-cladding exercise; featuring asbestos sheathing (Fig. 22) sandwiched between an external cementitious render and diagonal timber boarding internally. However the modern steel members have caused further structural and aesthetic problems to the earlier ad-hoc structure (Fig's 23 & 24). Prior to the demolition of the Clock Tower the external render system has broken down over time leaving parts of the asbestos sheathing dangerously exposed. Little consideration appears to have been given to the selection of appropriate materials and detailing the structure as all roof finishes have failed, damaging the interior and allowing decay/rot to set in significant areas of the timber structure both externally and internally<sup>9</sup>.

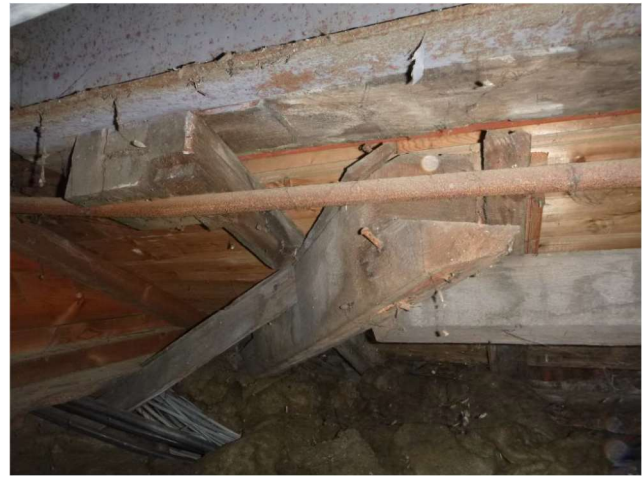
**Fig. 19:** Image of corner/hip rafter – note that the end appears to have been roughly sawn off to accommodate the clock tower structure. Image Date October 2016.

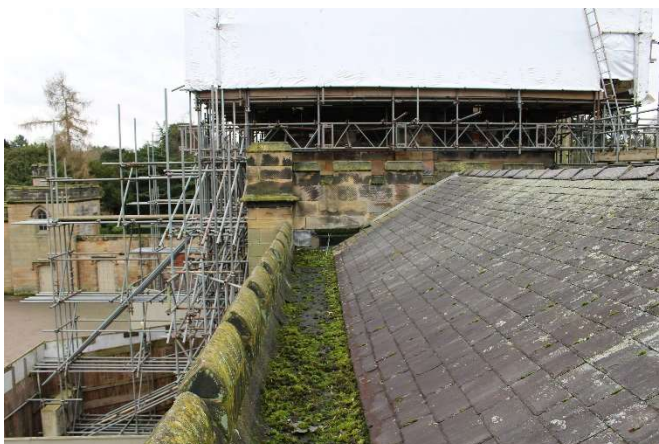
**Fig. 20:** Image from above the east range looking south of one of the Westmoreland roofs; all felt flashings and parapet gutters have failed causing water ingress problems. Image date February 2<sup>nd</sup> 2017.

- 3.4.6 The drawings show that at least the two storey range was re-roofed with new Westmoreland slates and that the south blank arch, on the east elevation, was taken down and quite carefully rebuilt. Whilst some of the roofs are in a reasonable condition they have failed in many places, and particularly along the parapet gutters where mineral felt has been used as a cheaper substitute for leadwork (Fig's 23 & 24).

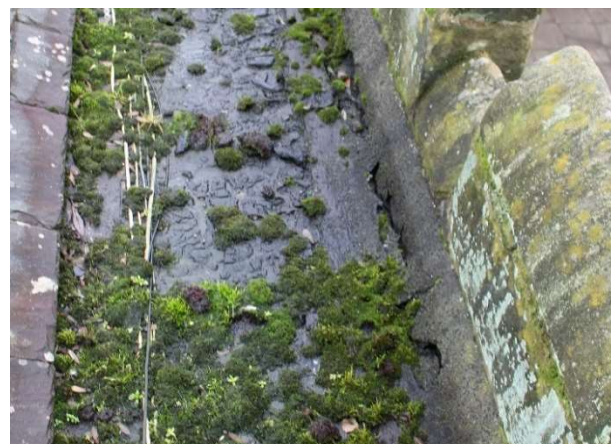
**Fig. 21:** A close-up view of one of the parapet gutters revealing the cracked felt lining & poorly considered routing of cables. Image date February 2<sup>nd</sup> 2017.

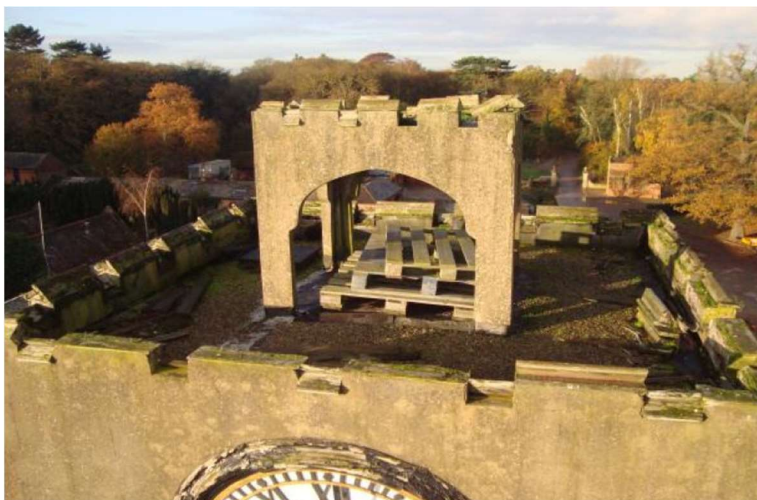
**Fig. 22:** View of the roof to the top of the Clock Tower & Belfry looking west. The roof has generally failed; several of the timber copings on the east side are missing leaving the asbestos cement board substrate exposed. Note; the Bell and weathervane are missing and the poor condition of the clock face. Image date 22<sup>nd</sup> Nov. 2013.

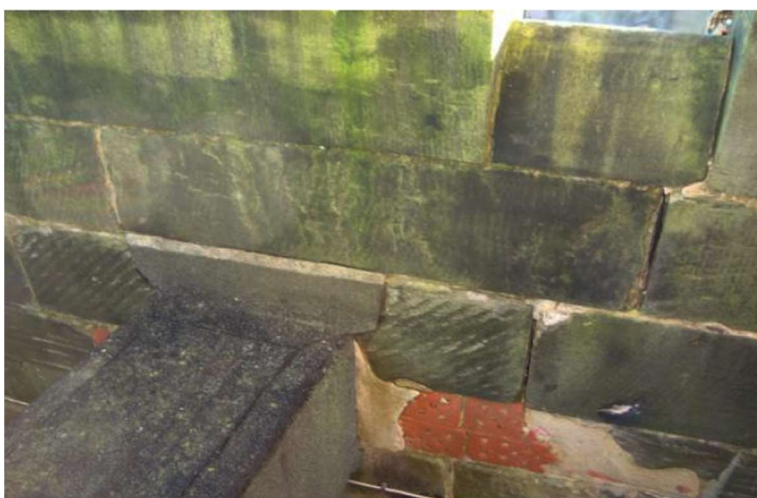
**Fig. 23:** View of one of the beam ends at the parapet abutment; cracking has occurred on both sides of the parapet and the felt covering around the beam casing has cracked/failed. The cracking and enlarged joints within the masonry are likely to have been caused due the additional weight of the modern steel structure used to strengthen the earlier timber beams. Image date 22<sup>nd</sup> Nov. 2013.

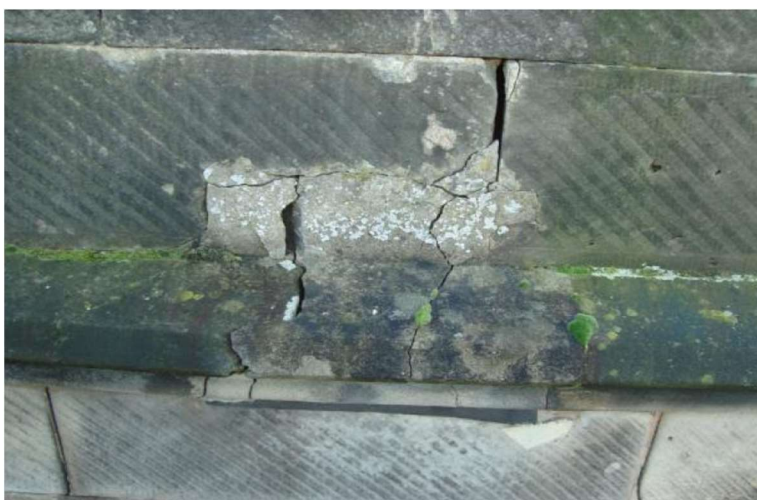
**Fig. 24:** Fracturing occurring to stonework moulding, with mortar patching to the end of the Clock Tower support beam on the west side at the south-west corner. This is most likely to have been caused by both the composite beams embedded within the parapet; the rusting steel channel and decaying timber. Image date 22<sup>nd</sup> Nov. 2013.

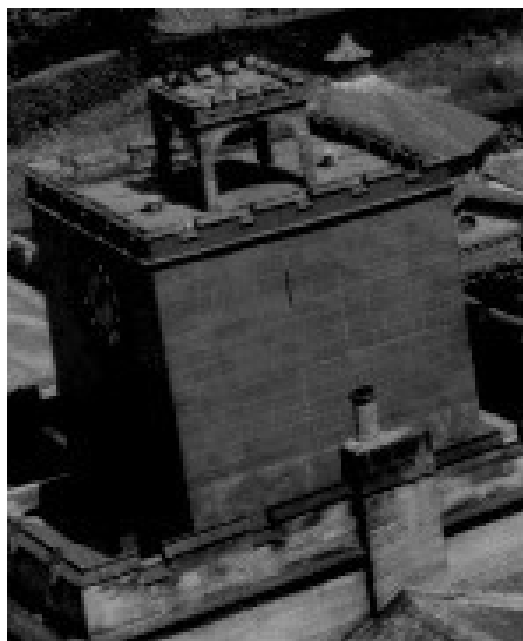
**Fig. 25:** An enlarged extract of Figure 15 (p11) clearly shows more architectural detail on the Clock Tower and Belfry featuring moulded stringer courses and a struck/coursed render giving the structure the appearance which closely resembles fine ashlar cladding.

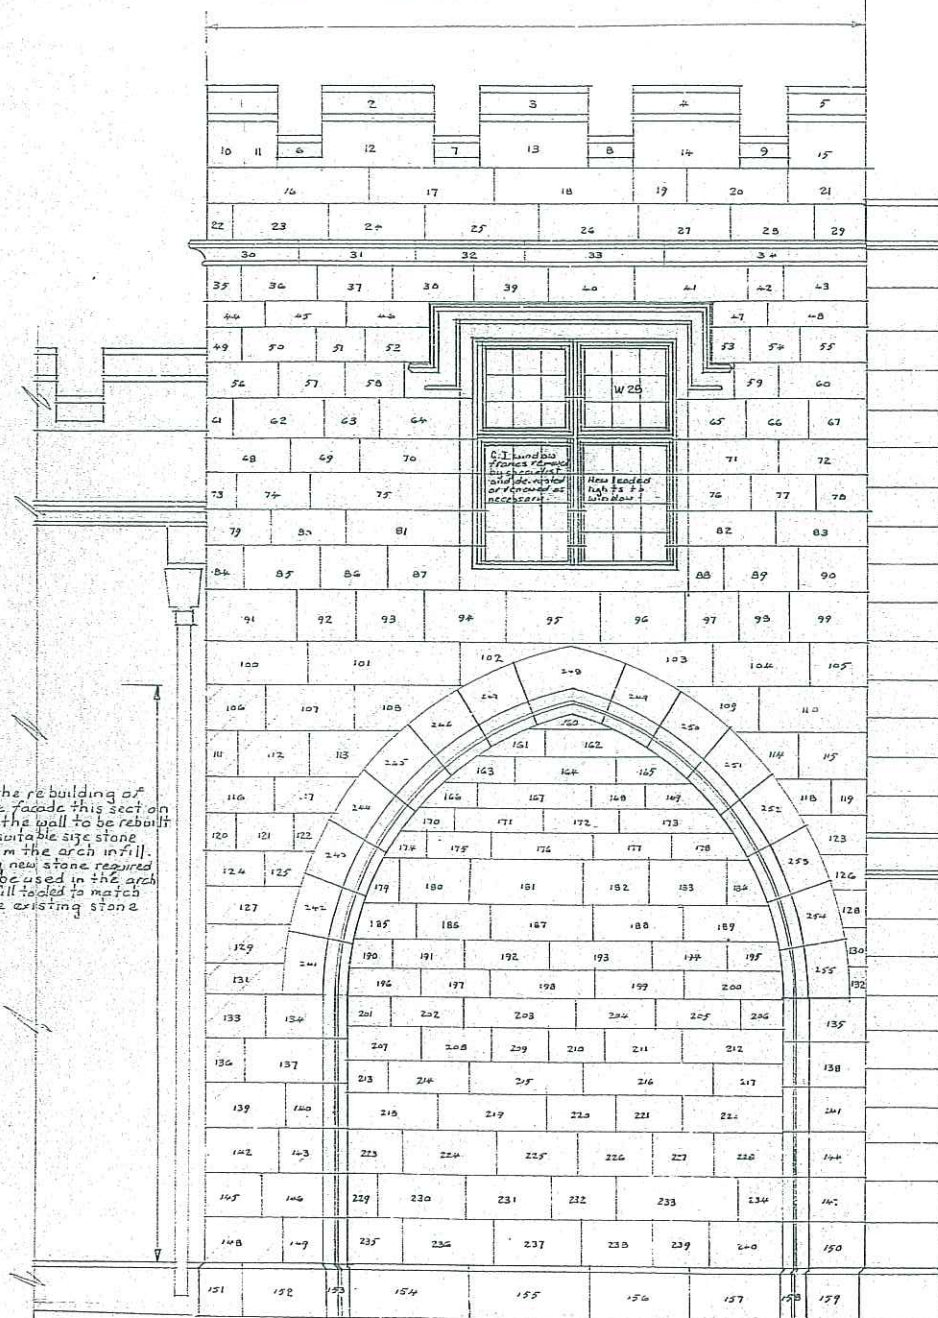
# ELEVATION

In the rebuilding of the facade this section of the wall to be rebuilt in suitable size stone from the arch infill. Any new stone required to be used in the arch infill to also to match the existing stone.

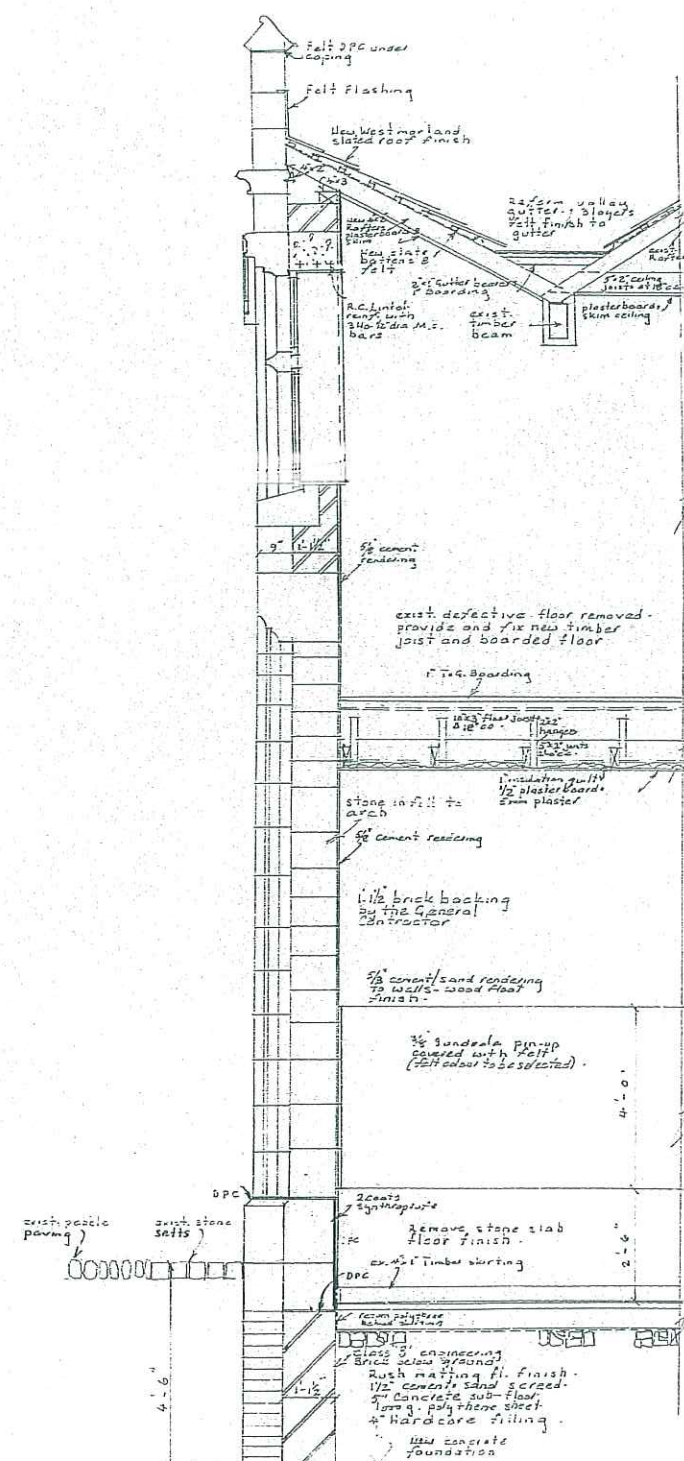
SECTION THRU  
WALL.

| PROJECT DIVISION | ELEMENT | FEATURE |
|---|---|---|
| REPAIRS & RESTORATION | CLOCK TOWER STABLE BLOCK | RE-BUILDING SECTION OF FACADE |

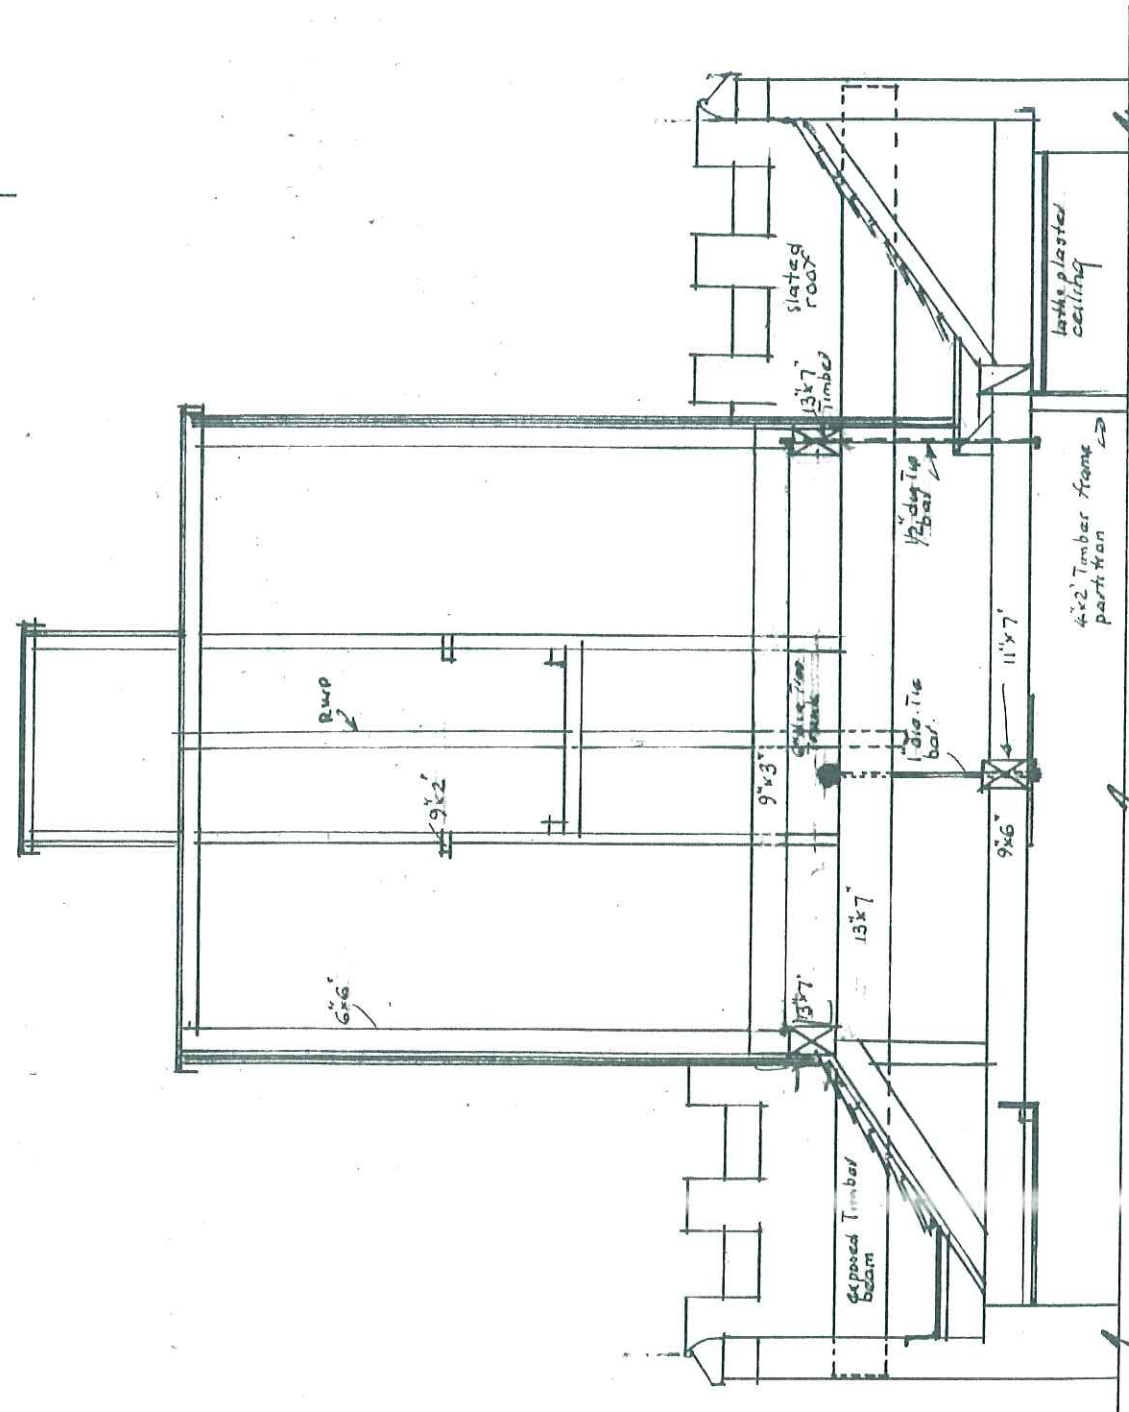
SECTION B-B

*Bedroom on 1st floor. over tenon  
Diagonal support?*

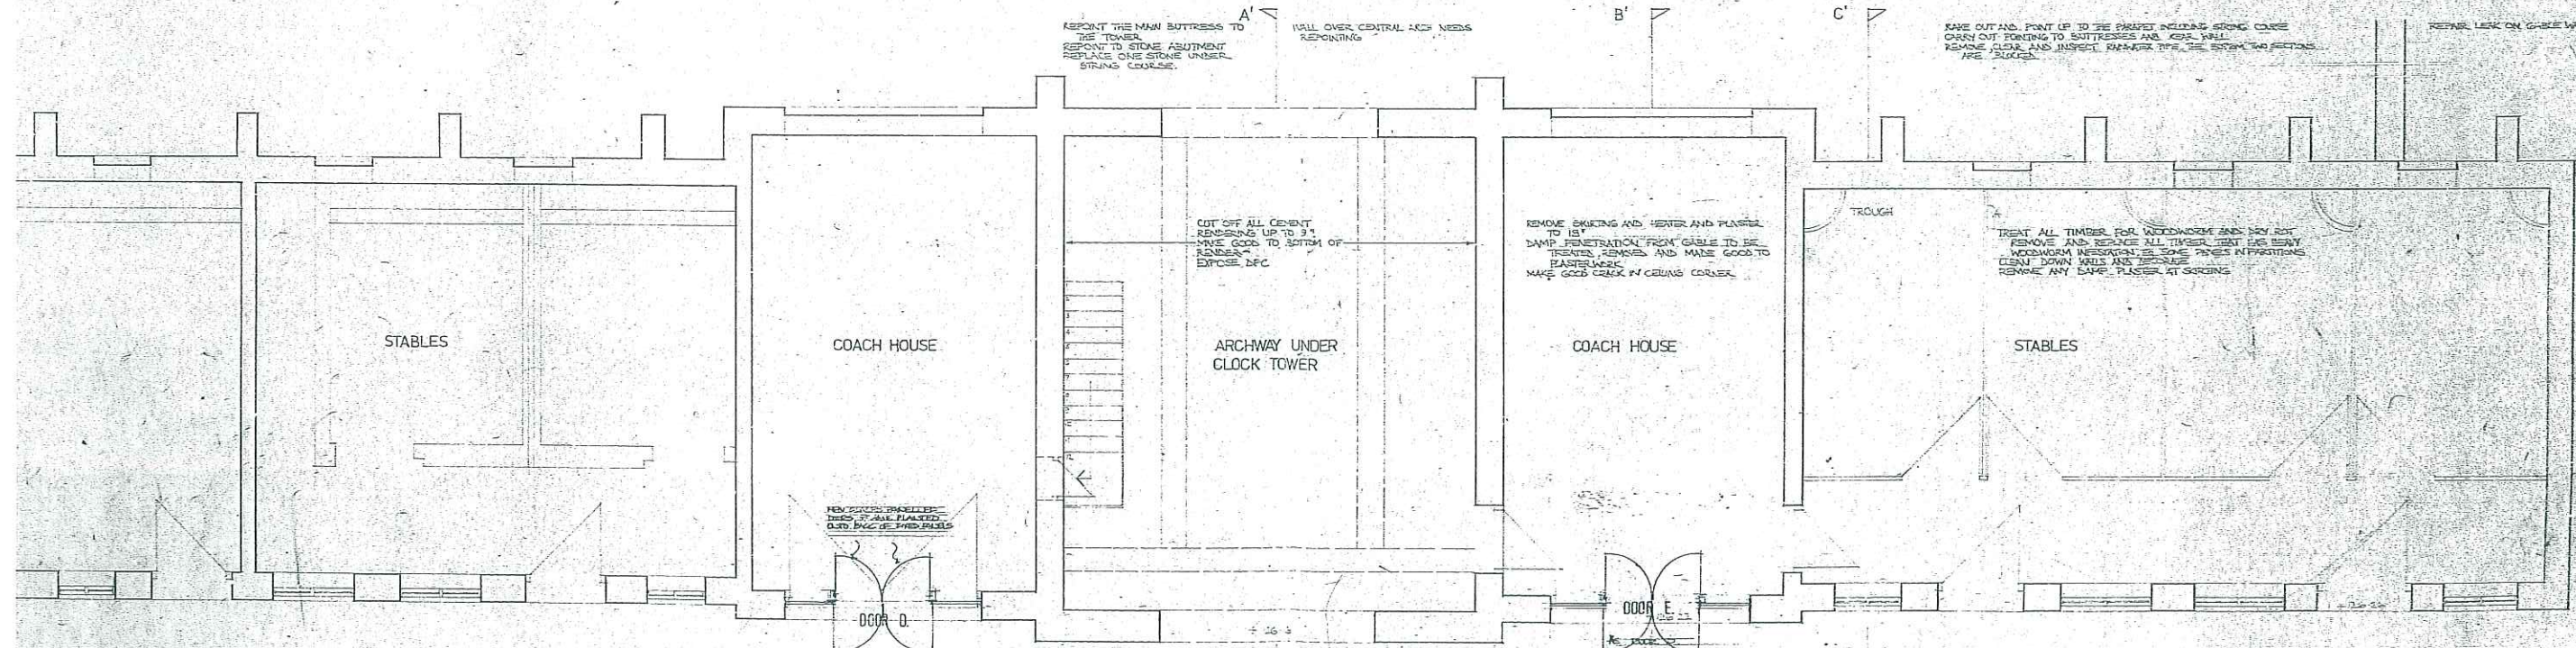
UND FLOOR PLAN

COACH HOUSE BLOCK

REPORT ENTIRELY, INCLUDING STRING COURSE.  
REPLACE 150A WIRE WITH 150A CAST IRON PIPE.  
CLEAN GUTTERING.  
REPOINT ALL MULLIONS, JAMBS AND HOLES, ON DOORS AND WINDOWS.  
REMOVE RUBBER FROM TRANSOM, DOG KEYS, ETC.

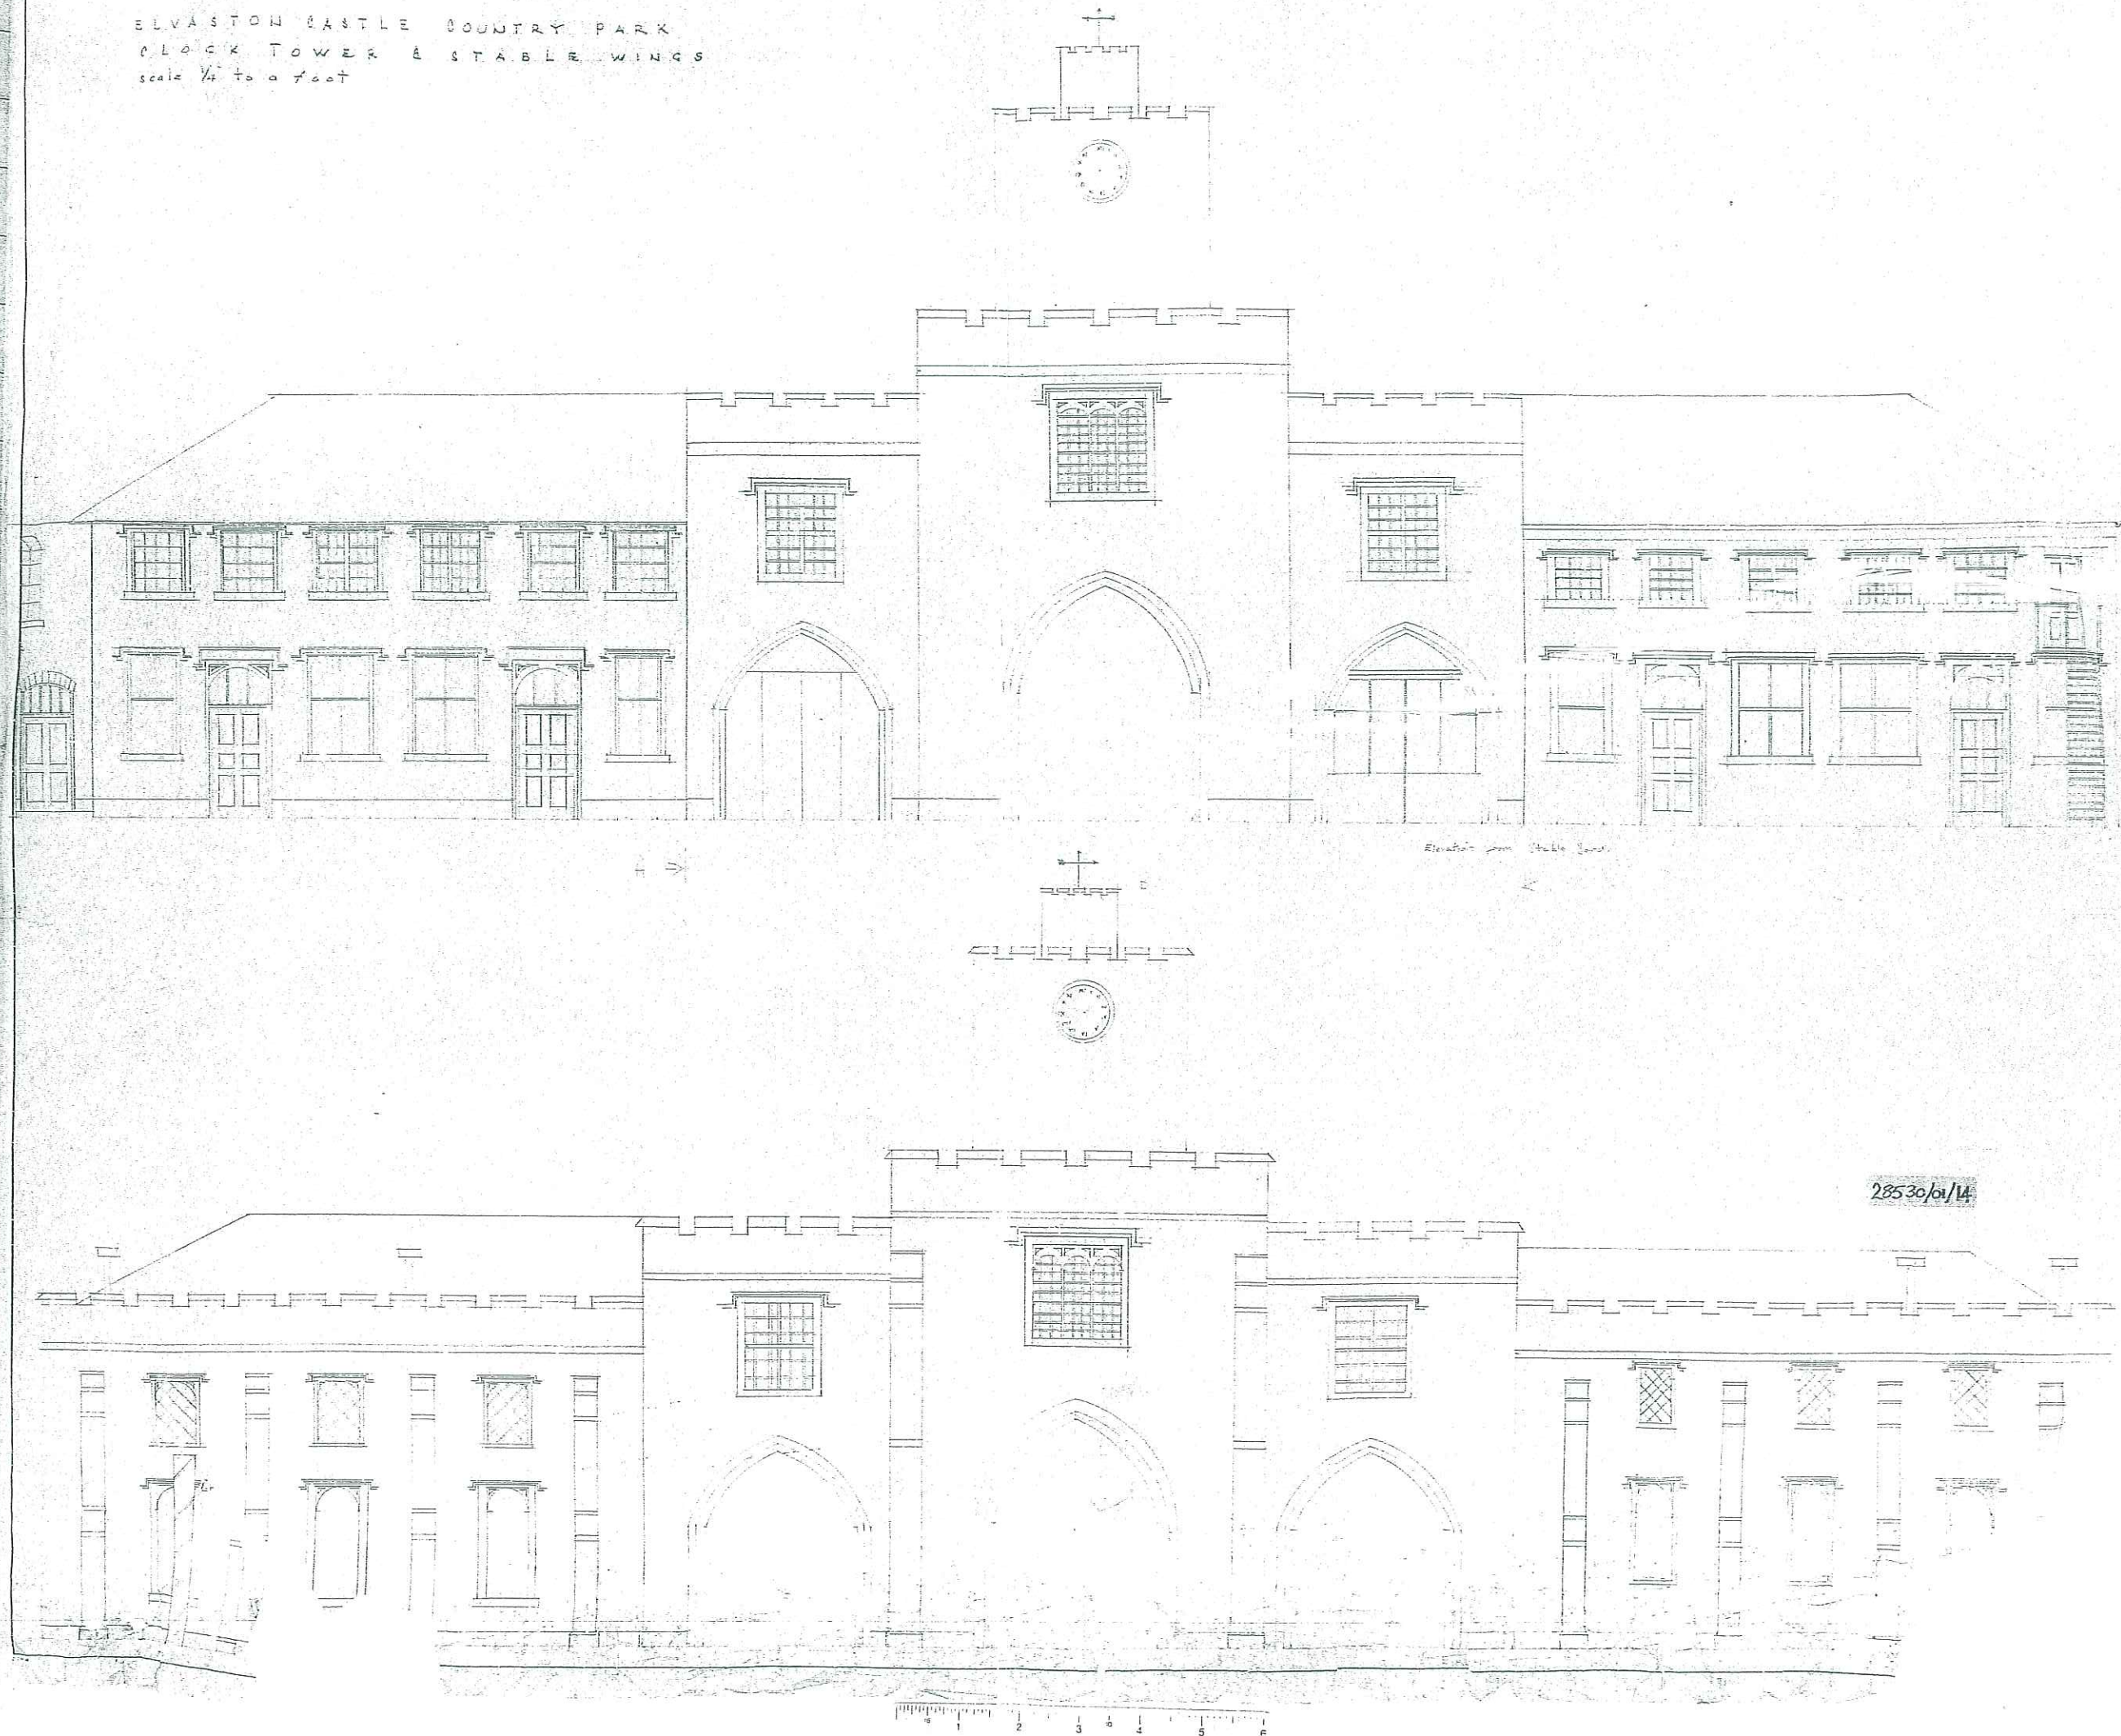
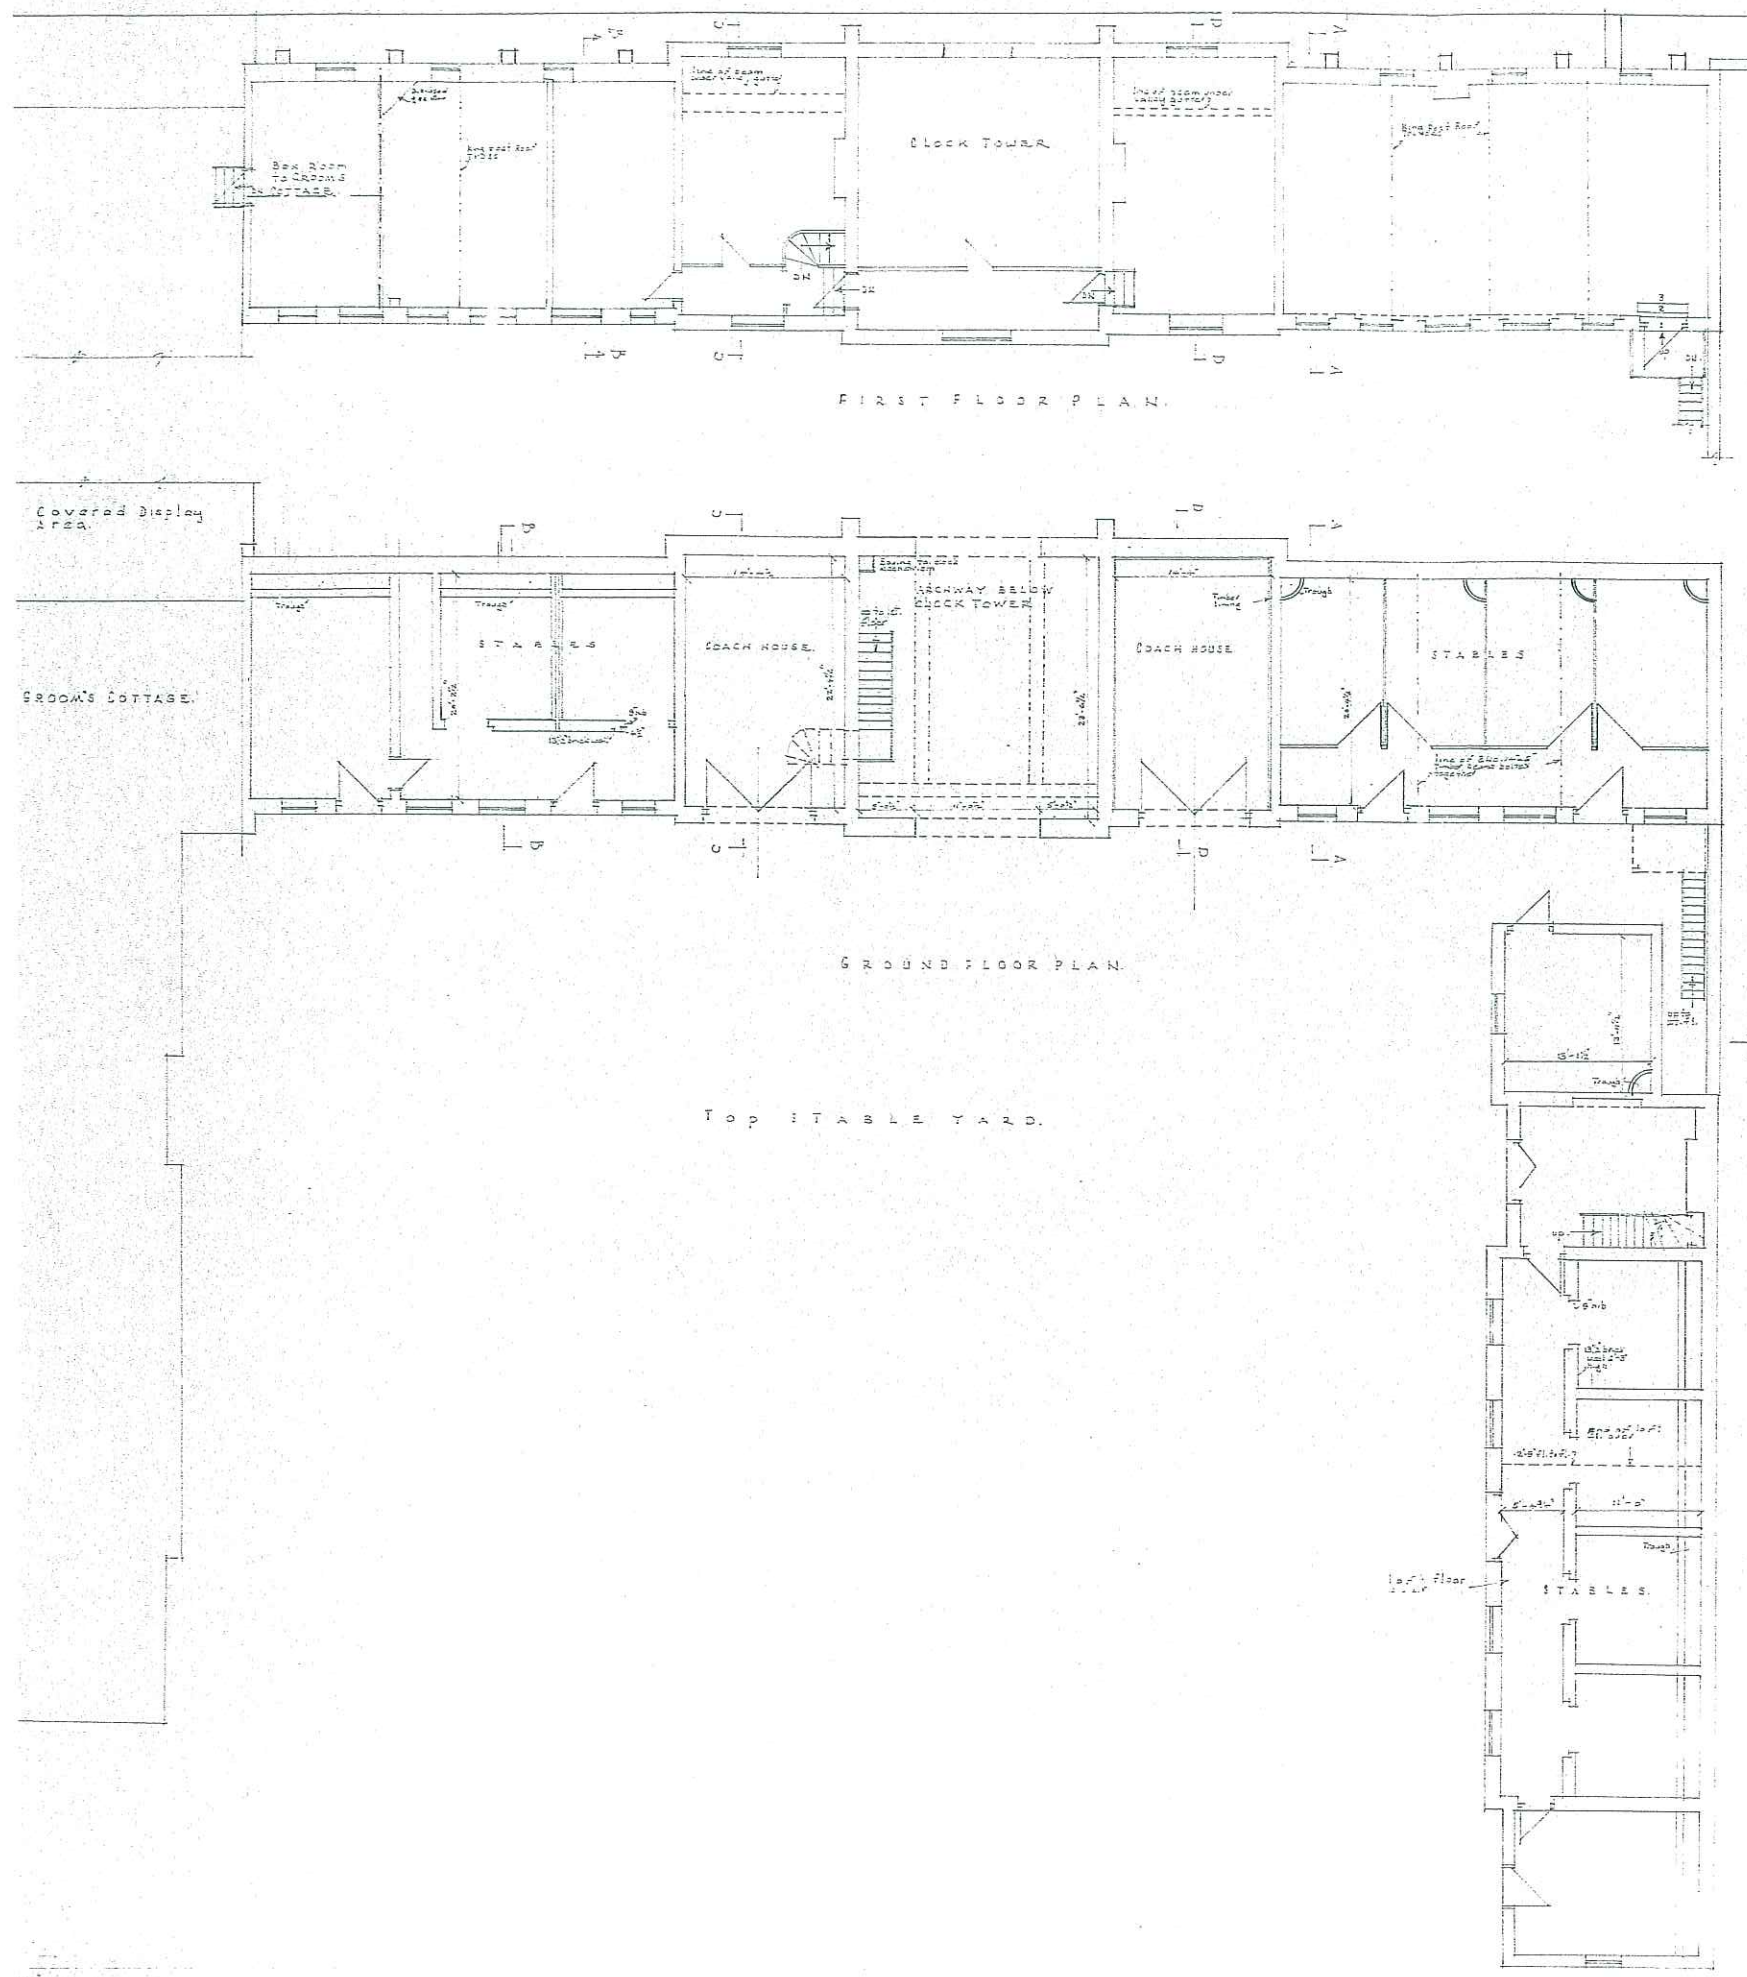
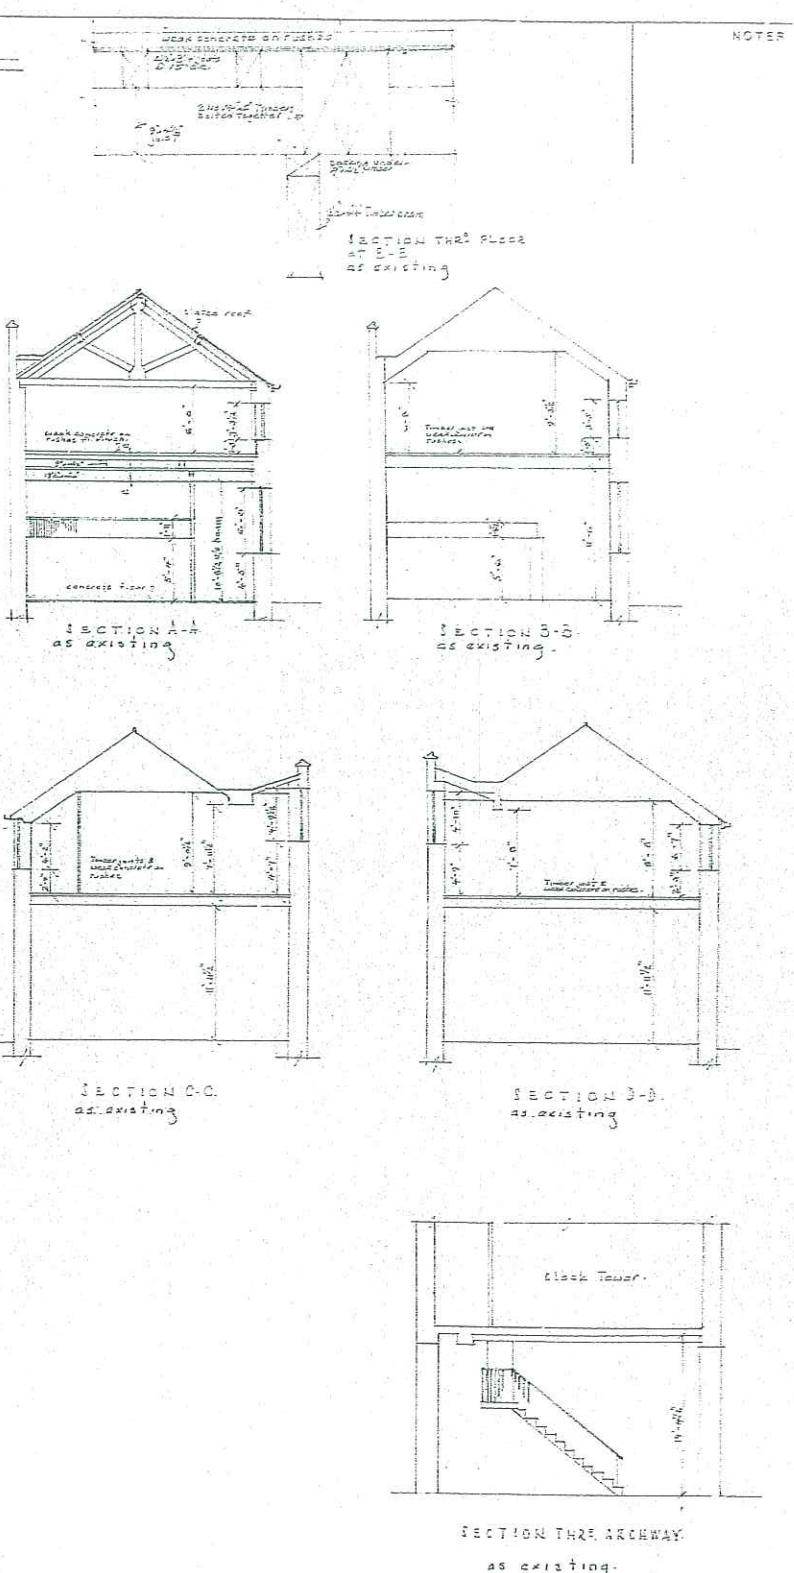
ELVASTON CASTLE COUNTRY PARK  
CLOCK TOWER & STABLE WINGS  
scale 1/4" to a foot
