## 2166\_Heritage Statement and Proposed works at Close House, Church Close, Melbourne, Derbyshire, DE73 8JH Rev C

Date: 26<sup>th</sup> November 2021

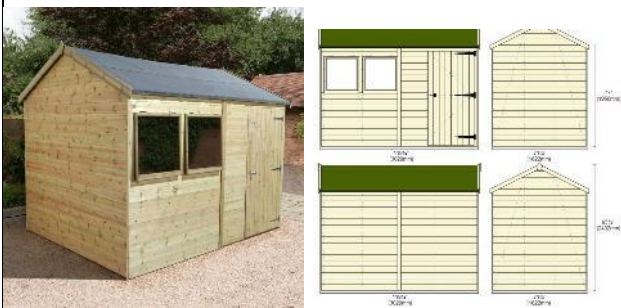
| Drawing List and description of proposed works | | | |
|---|---|---|---|
| | | | <p>1. Wooden Pressure treated timber Tool Shed with Mains power and lighting.<br/>17'x7' (5m x 2m) similar in layout to that shown on the left. Supported off a level concrete base away from the existing wall.<br/>Power is to be provided to the shed from the existing consumer unit.</p> |

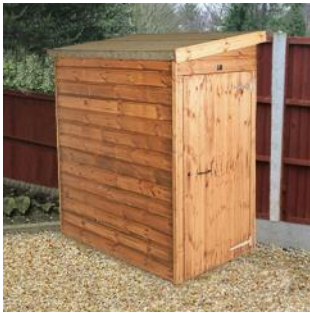
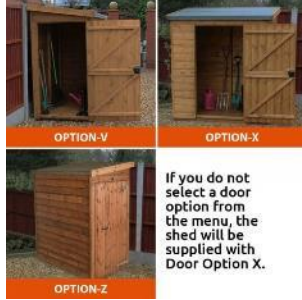
| | | <p>If you do not select a door option from the menu, the shed will be supplied with Door Option X.</p> | <p>2. Wooden Pressure treated timber Garden Shed with Mains power and lighting.<br/>10' x 3' (3m x 0.9m) similar in layout to shown on the left.<br/>Supported off paving slab base away from the existing external wall of the property.<br/>Power is to be provided to the shed from the existing consumer unit.</p> |

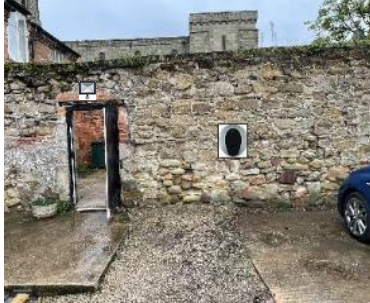
| | | | <p>3. Location of EV charging on existing boundary wall.<br/>The wall faces the entrance to the site from Church Road in a courtyard behind Melbourne Gun Ltd.</p> |

| | | | <p>4. PIR sensor light over existing entrance in the boundary wall (see image above) and above the French doors.<br/>The boundary wall faces the entrance to the site from Church Road in a courtyard behind Melbourne Gun Ltd and will provide courtesy and security lighting when someone approaches the entrance.</p> |

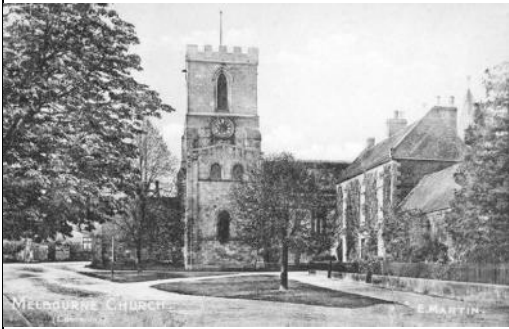
| | | <p><a href="https://picturethepast.org.uk/image-library/image-details/poster/dchq000273/posterid/dchq000273.htm">https://picturethepast.org.uk/image-library/image-details/poster/dchq000273/posterid/dchq000273.htm</a></p> | <p>5. The reinstatement of iron Railings to existing front wall similar in design to those previously removed and the making good of the dwarf wall at the front of the property will return the property to its original appearance.</p> <div> </div> |

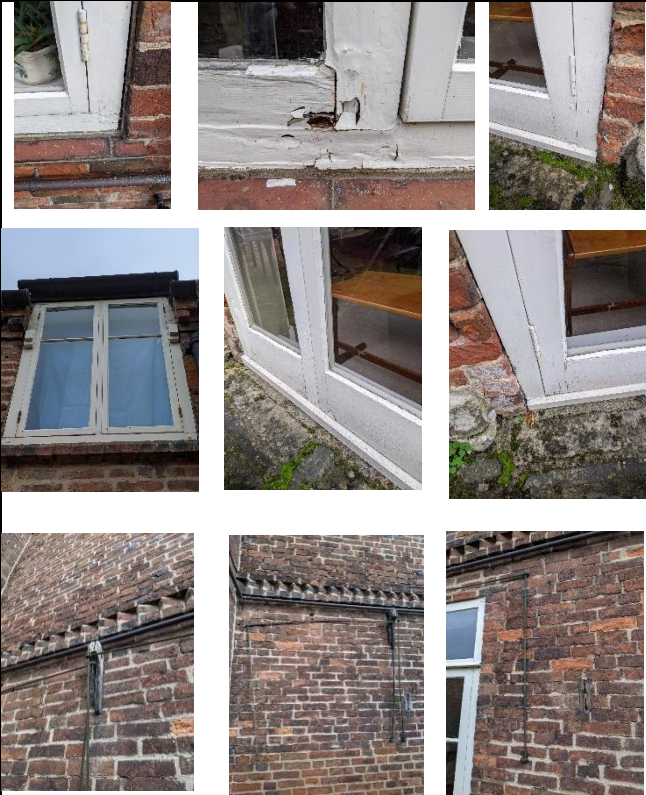
| | | | <p>1. Replacement of decayed awning frames and hinges with similar, to the rear of the property, outside of the sitting room.</p> |

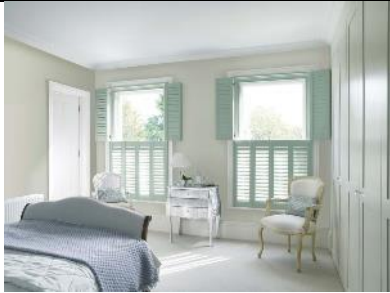
| | | <p>The image on the left is indicative of 'Plantation' Shutters</p> | <p>2. Add Plantation shutters on separate frame to inside of ground floor front windows, Sitting room French doors and First floor Dressing room window.</p> <ul style="list-style-type: none"> <li>- Ground floor sitting room existing shutter to be removed and relocated to first floor front window which does not have an existing shutter. This will then provide consistency across the whole of the first-floor front windows, in that they will all have existing shutters in fitted.</li> </ul> |

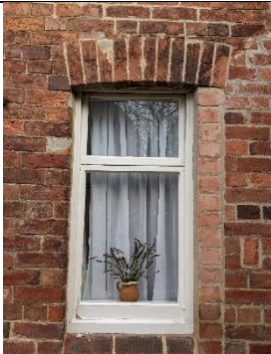
| | | <p>The soldier arched brickwork over and to the right of the window indicates the original aperture.</p> | <p>3. Enlarge existing WC window to original size and make good.</p> |
