# Design, Access and Heritage Statement

Milton Village Hall Heritage Impact Assessment  
Combined with a community statement and Design and Access Statement

Date: 18-03-2025

Milton Village Hall, Milton, Derbyshire

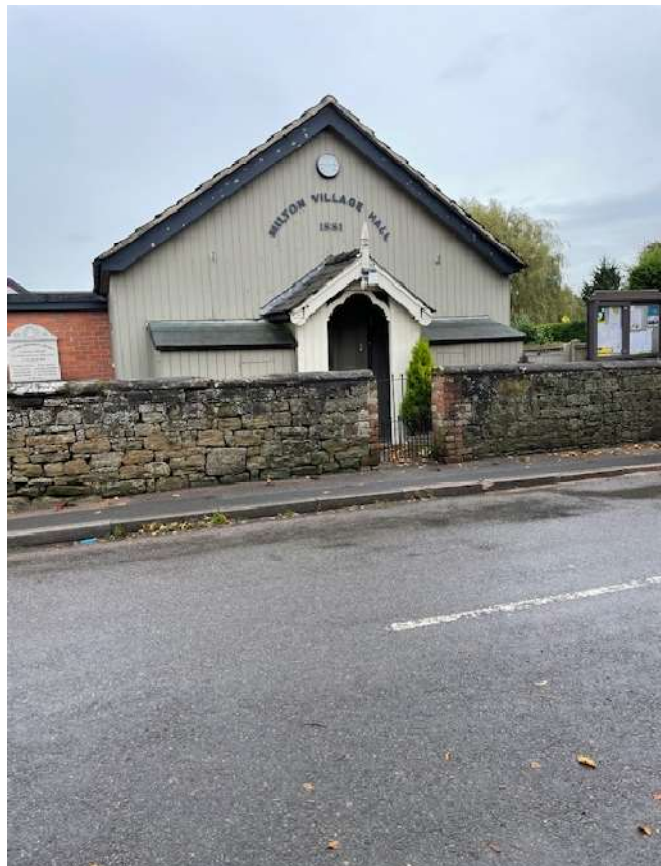
Picture 01. Milton Village Hall

Milton Village Hall is located on Main Street Milton and is essentially a timber framed and clad building with later brick additions (1905). Formerly known as the Mission Room, the hall was originally built in 1881 by the Reverend Arthur Forman who was a Master at Repton School. Previously a Master from the School had conducted prayer services in private houses. By the time of the arrival of Reverend Arthur Forman and his new bride in the late 1870's a fit for purpose place of worship was needed. Sir Francis Burdett, 7th Baronet took over the Foremarke Estate in 1880.

The Village Hall sits in the heart of the conservation area and is of timber boarded construction with a modern concrete tile pitched roof. The side extension to the north is of brick and is a later addition, this section has a flat roof. There are two small “lean to” external stores to the front gable set either side of the entrance. Over the top of the porch in a semi circular form is some signage reading “MILTON VILLAGE HALL 1890”. There is a stone wall which defines the front boundary up to the back pavement line with a single gate set centrally to the entrance porch.
