### DAILY RECORD SHEET

| <b>Employer:</b> Benniman Construction Group Ltd | | <b>Site:</b> Dove Valley Park – Plot 11 | |
| <b>Contractor:</b> Collins Earthworks Ltd | | <b>Engineer:</b> GS | |

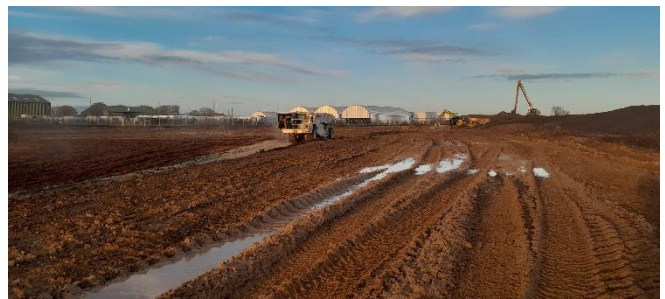
Looking toward Grids J-L;7&8 (North-northwest) – Rotovating/mixing.

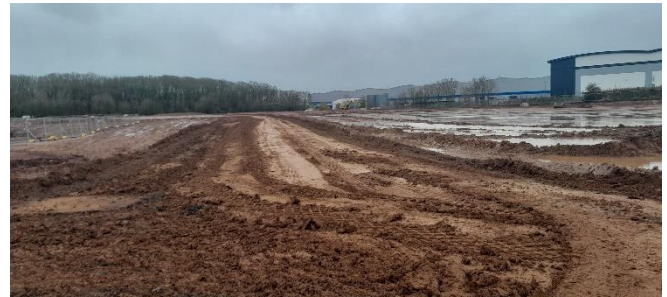
Looking toward Grids Q-AA;6 (South-southeast) – Treated haul routes.

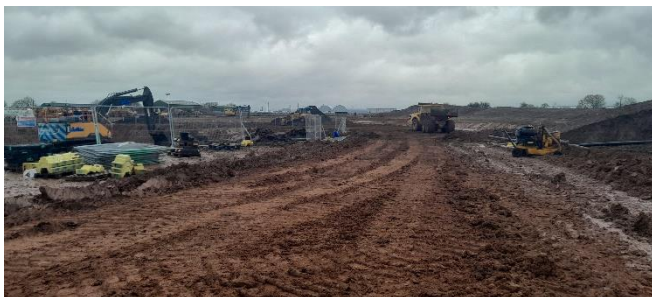
Grid S;10 towards North – Treated haul routes.

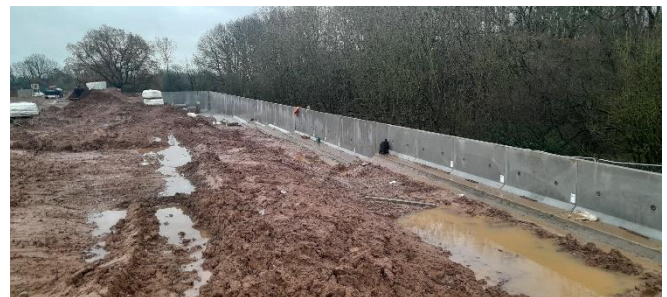
Grid AA;6 towards East-southeast – Installed retaining wall stems.

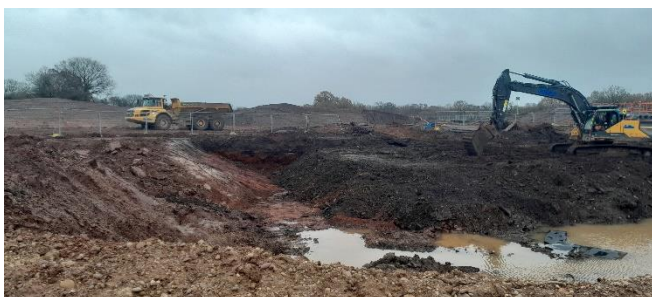
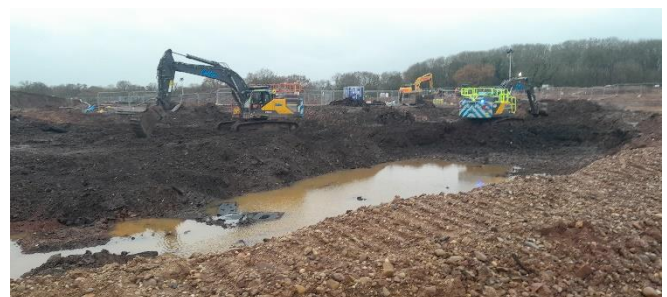
Grid S;6 towards East-southeast – Resumed pond excavation.

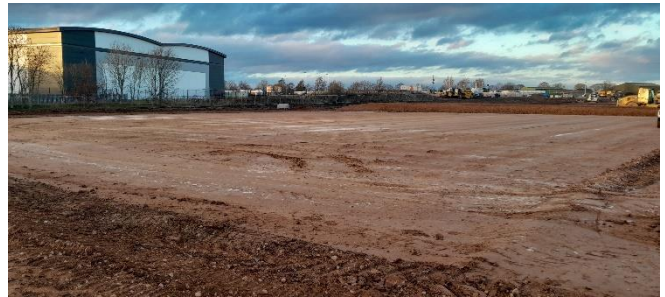
Grid U;6 towards North-northwest – Trimmed rerolled/treated ground (Grids W-AA;4-6)

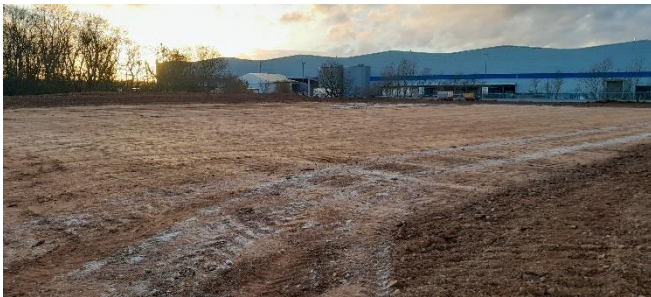
Grid W;6 towards Southwest – Trimmed rerolled/treated ground (Grids W-AA;4-6)

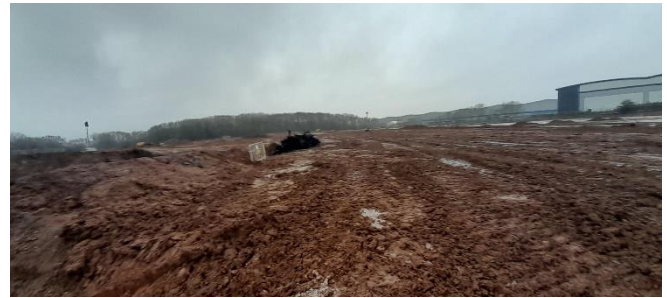
Grid S;6 toward South-southwest – Overview.

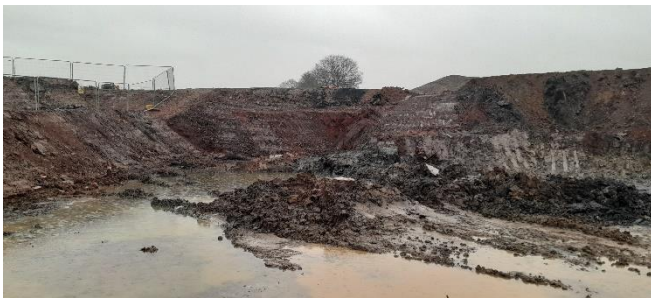
Grid S;7 looking Northeast – 'Marl Pit' excavation.

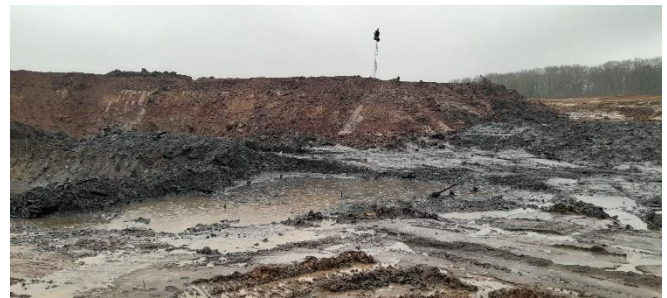
Grid S;7 looking Southeast – 'Marl Pit' excavation.
